Drain Doctor Plumbing & Drainage

19 Rona Road, London NW3

Pipe Condition Grade Summary

Inspection Report

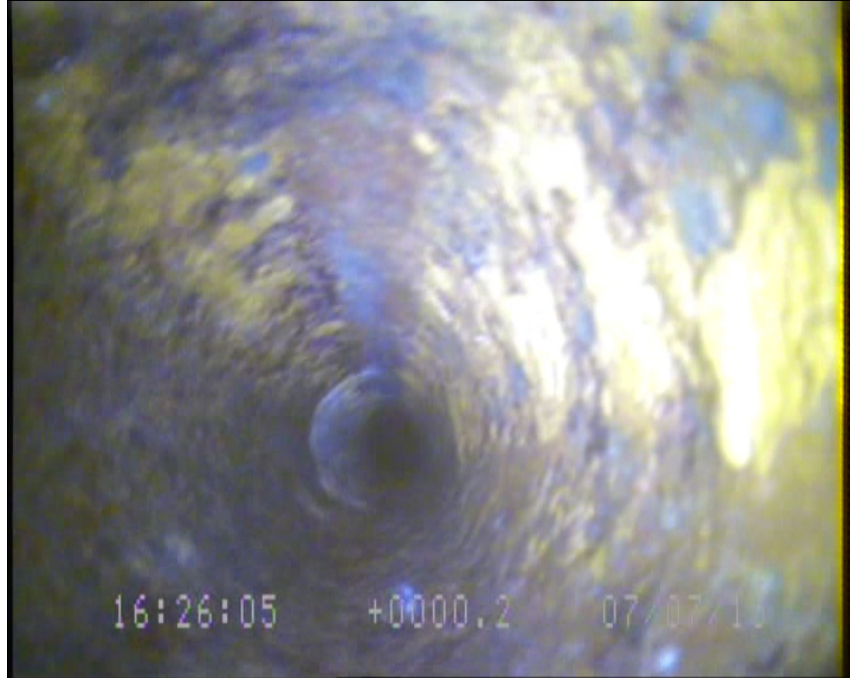
Photo: 1_1_5_A.jpg
0.2m, Attached deposits, encrustation, from 12 to 12 o'clock, 10% cross-sectional area loss

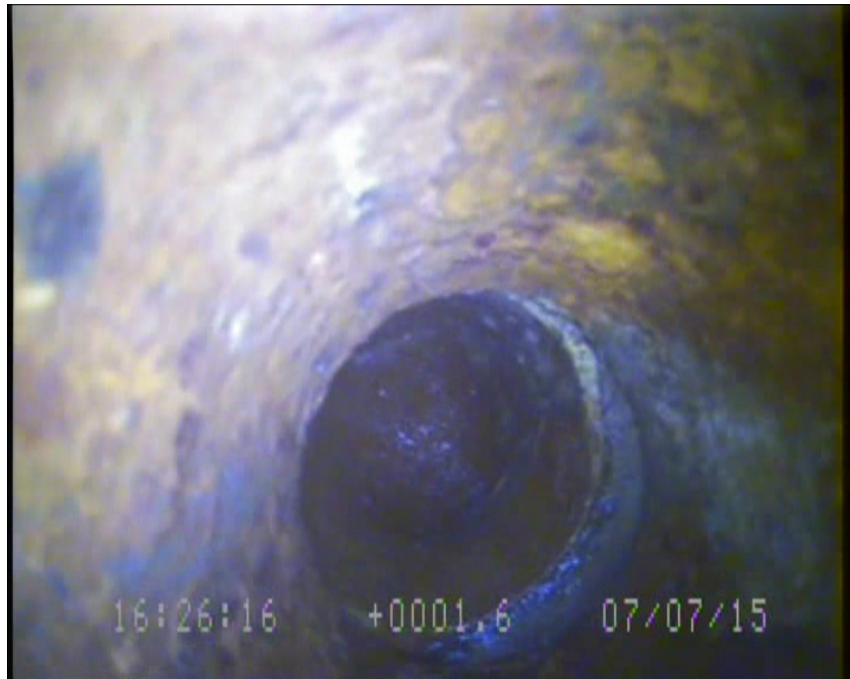
Structural defects			
Section	PLR	Grade	Fault description
1	Downpipe X	5	Open joint, 50mm of diameter

Photo: 1_1_6_A.jpg
1.6m, Open joint, 50mm of diameter

Grade 5: Best practice suggests this pipe is at risk from structural failure at any time and urgent consideration should be given to repairs to avoid risks to public health.

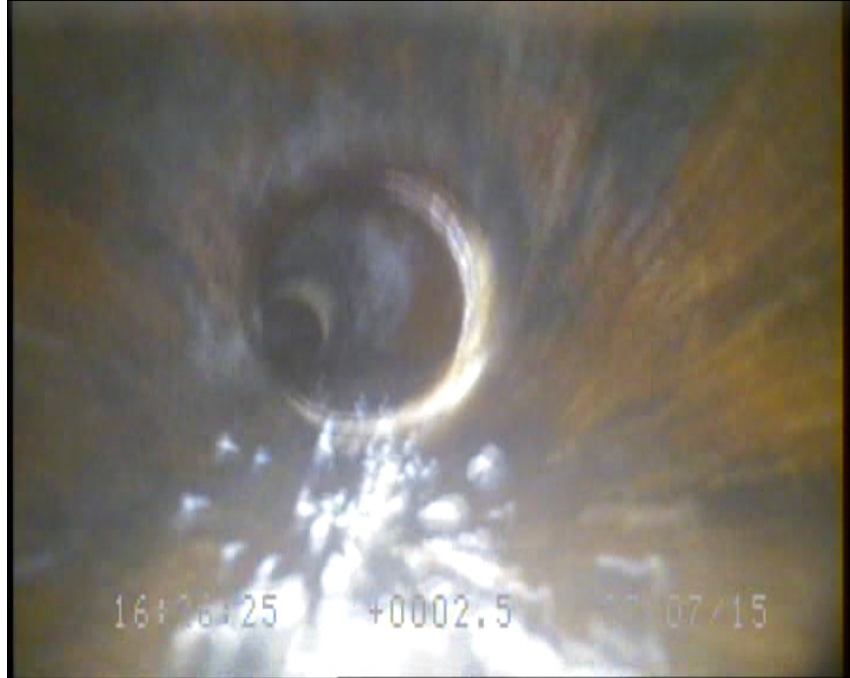
Photo: 1_1_9_A.jpg
2.6m, Joint displaced, medium

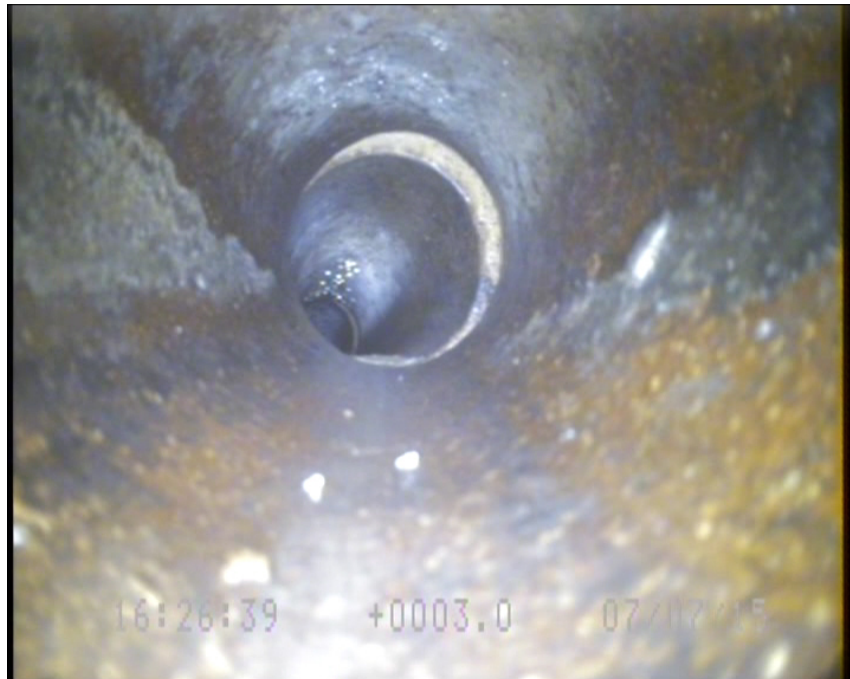
Photo: 1_1_11_A.jpg
3.2m, Joint displaced, medium

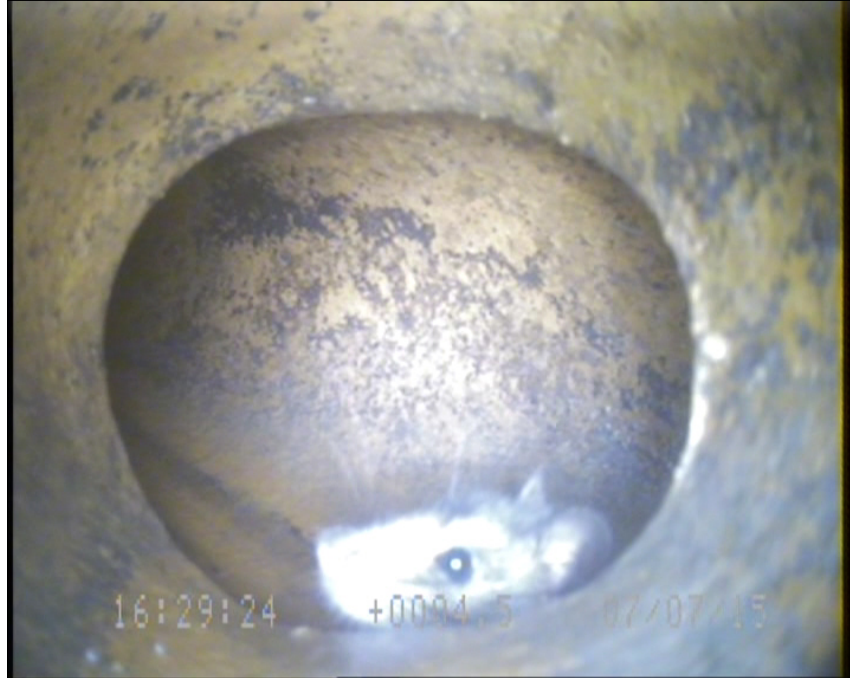
Photo: 1_1_14_A.jpg
4.6m, Vermin, rats observed in connection
