Arboricultural Appraisal Report

Subsidence Damage Investigation at:

19 Compayne Gardens
London
NW6 3DG

CLIENT:	Crawford & Company
CLIENT REF:	SU1502293
MWA REF:	SUB150812-170
MWA CONSULTANT:	Giles Mercer (B.Sc Hons)
REPORT DATE:	21-08-2015

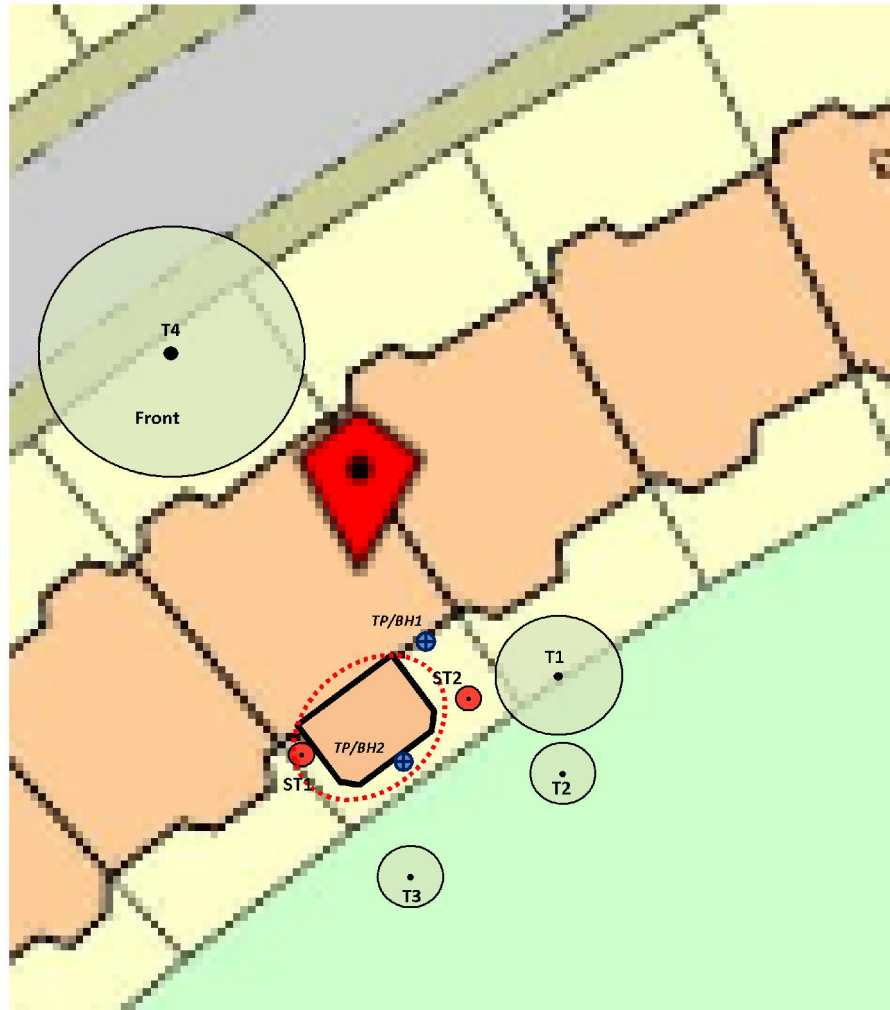
SITE PLAN

Approximate areas of damage

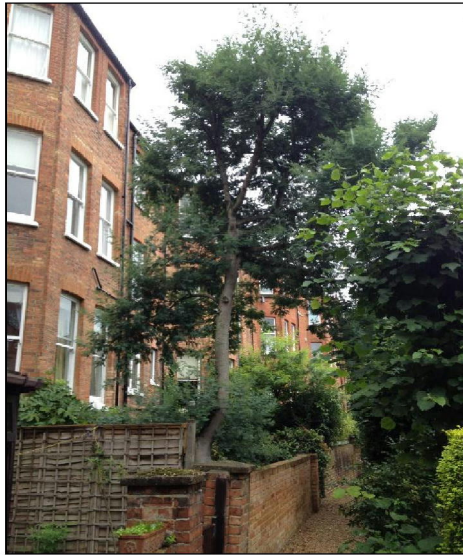
Having considered the available information, it is our opinion that the Mimosa (T1) and the Lime trees (T2 and T3) are the material cause of the current subsidence damage.

View of T1 & T2

If an arboricultural solution is to be implemented to mitigate the current damage and allow the soils beneath the property to recover to a position such that an effective repair solution can be implemented we recommend that the Mimosa (T1) and the Lime trees (T2 and T3) are removed.

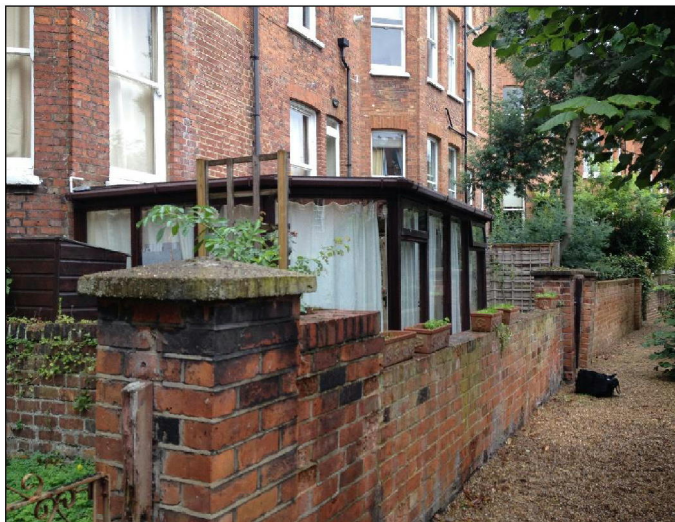
Whilst the foundations of the conservatory bear onto made ground, in -situ Mackintosh probe testing of the material indicates that it is sufficiently consolidated to bear the imposed load and as such the damage cannot be attributed to consolidation settlement. This is borne out by the relative age of the structure and the recent appearance of damage.

View of conservatory with T1 in background

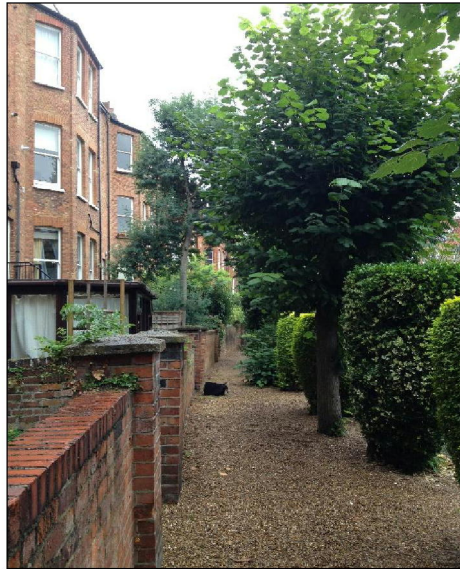
View of T1 & T2

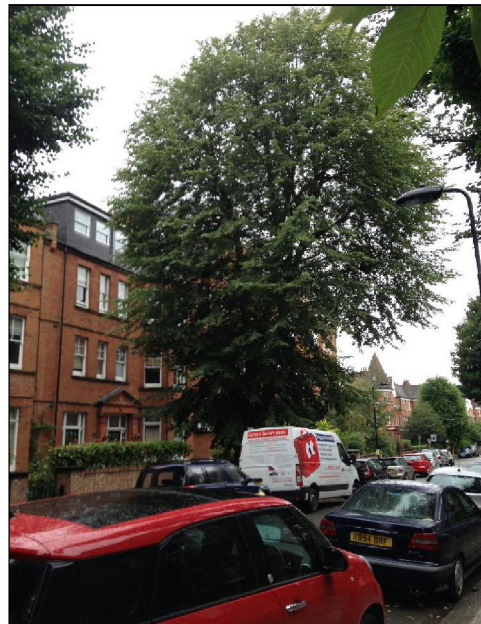
View of T4
