Simon Pryce Arboriculture

Report

Site: 27 Pilgrims Lane, Hampstead, London, NW3 1SX

Subject: Climbing inspection and test drilling of ash tree

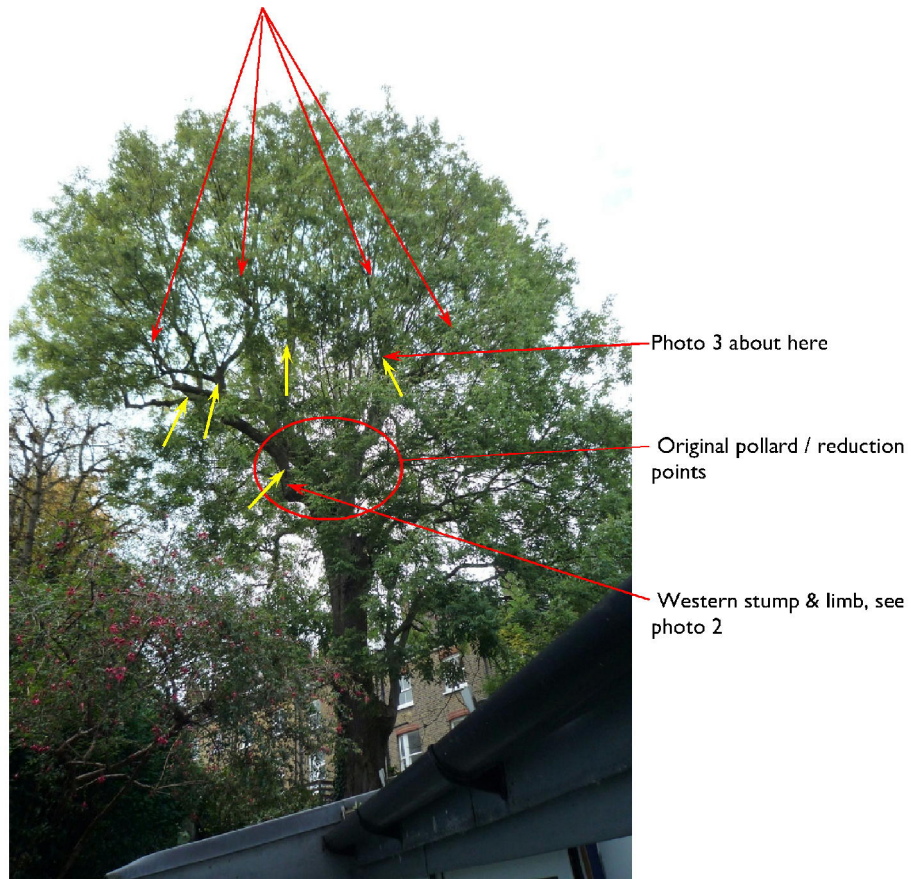
1) View of the tree from SE near the back of no.27.

Most recent reduction points

- 5.6 The tree would need to be reduced more than the previous light reduction indicated by the red arrows in photo 1, but anything similar to the drastic initial lopping would create another set of large wounds, so would be counterproductive. A more practical option would be to reduce it back to just above the main reduction points, removing the younger shoots, which are up to about 200mm diameter, as shown in photo 4. That would keep the wounds as small as practical, whilst still achieving a substantial reduction in weight and wind resistance and retaining the main limb framework. This is indicated by the set of yellow arrows in photo 1, although precise cutting points will need to be determined by the team whilst working. The lower western limb is beyond saving, but cutting back to the stump rather than the top of the trunk would also minimise wounding.

1. Reduce crown by up to approximately 6m to about the points indicated by the short yellow / light coloured arrows in photo 1, by cutting the more recent shoots up to about 200mm diameter back to just above the parent limbs. Remove the long low western limb, also indicated by a yellow / light arrow back to the stub from which it grew, show in photo 2.
2. All work is to be carried out in accordance with BS3998:2010, Recommendations for Treework.
3. Cavities should be checked for use by bats or protected birds before any work is undertaken and appropriate measures taken to safeguard them.

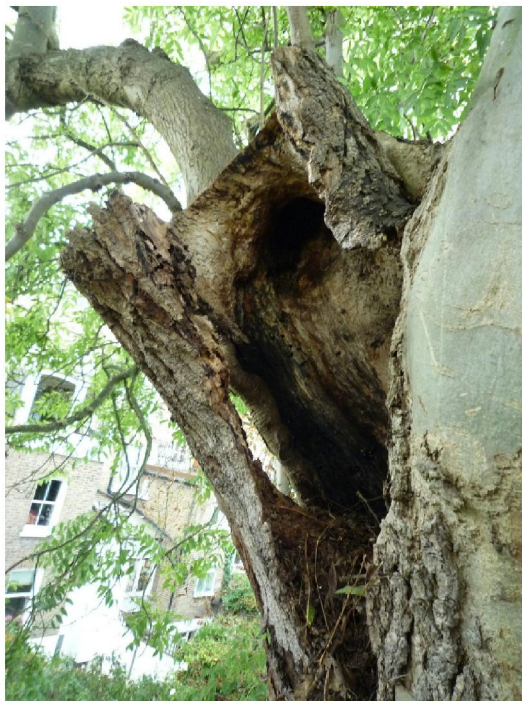
- 5.3 This is more serious than the decay at the base, partly because the tree was substantial when it was first reduced, so the pruning cuts were large and have now decayed to form large cavities at the bases of the major limbs that formed since the tree was reduced. The one on the west side was noted as potentially problematic in the 2003 decision and has worsened markedly in the 12 years since then, as shown in photo 2. The pruning in recent years has reduced the mechanical load on these areas, but the decay is advancing steadily and they are becoming progressively weaker.

2) Stub of original western limb showing advanced decay spreading into the base of the branch beyond.

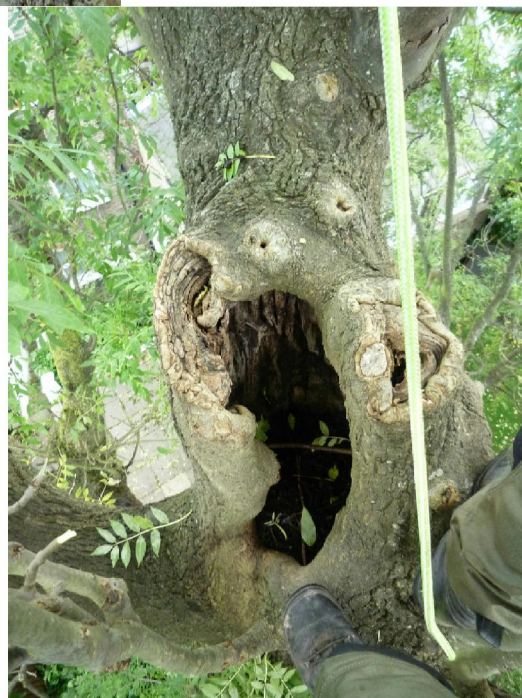
3) Typical cavity in one of the main limbs.

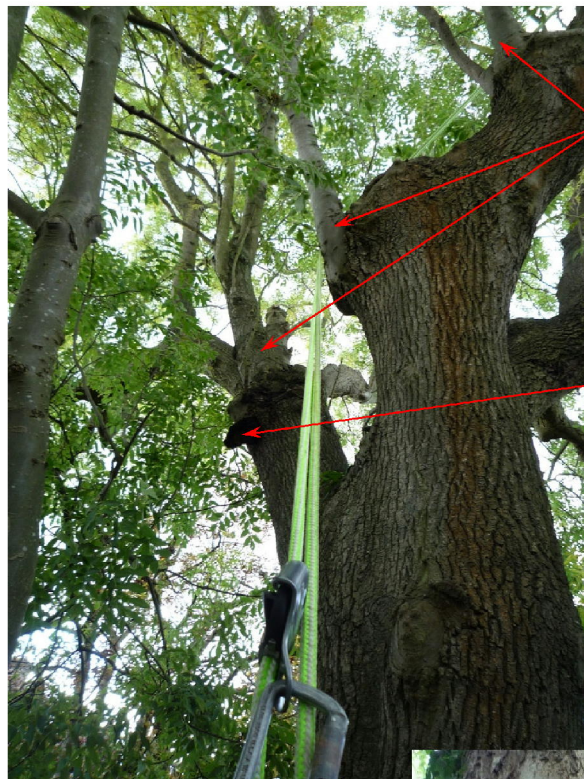
- 5.4 The other concern is the presence of the *Inonotus hispidus* brackets. This fungus colonises several species of tree including London plane, walnut and apple, but in ash it is particularly significant. Ash is particularly susceptible and the fungus causes drastic strength loss in the early stages, often before the timber is visibly decayed. This tree had several brackets growing on the main limbs and there were also marks where others had been shed, which normally happens at this time of year.

4) Younger shoots growing from near old pollard points. These could be cut back to their bases to achieve a substantial reduction whilst minimising wounding .

Inonotus hispidus bracket

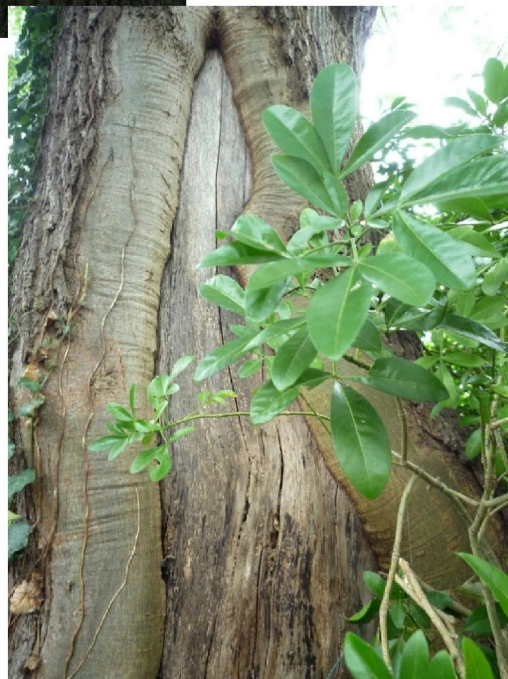
- 3.1 On the southeast side of the trunk is a wound about 2m high and about 400mm wide at the broadest point. The exposed timber is not physically damaged, but is weathered and there are signs of decay. There is callus growth up to about 150mm wide at the edges which, combined with the appearance of the exposed timber, shows that the wound has been present for many years.

- 5.1 The wound at the base of the trunk is large and long standing, but the decay is not particularly extensive or advanced and there is a significant amount of sound wood. The absence of any physical damage to the exposed wood suggests that the wound was caused by localised death of the bark, which would have remained in place for some time protecting the wood before disintegrating and being shed. This is quite common where bark is heated by fires lit nearby and in such cases decay can be slow. There were no signs of any fruiting bodies, which might have enabled the fungus to be identified, but it is not likely to be *Inonotus hispidus*, which generally affects main limbs and branches rather than the bases of trees.

5) Old wound on the SE side of the lower trunk. No signs of physical damage to the exposed wood.

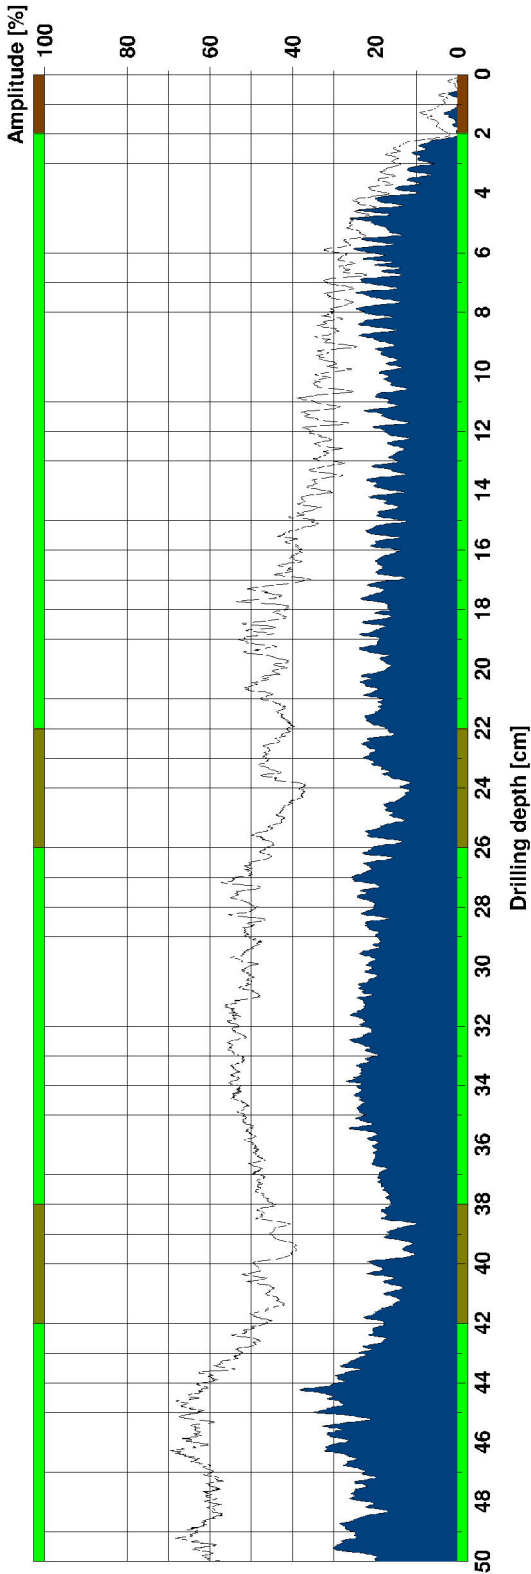
From	0.0 cm	to	2.0 cm	: Bark
From	2.0 cm	to	22.0 cm	: Sound wood
From	22.0 cm	to	26.0 cm	: Suspected decay
From	26.0 cm	to	38.0 cm	: Sound wood
From	38.0 cm	to	42.0 cm	: Suspected decay
From	42.0 cm	to	50.0 cm	: Sound wood

Black line is resistance to drill rotation and increases with depth (drilling curve). Solid blue line is direct resistance to penetration (feed curve).
Resistance drops in two places, possibly very early decay.

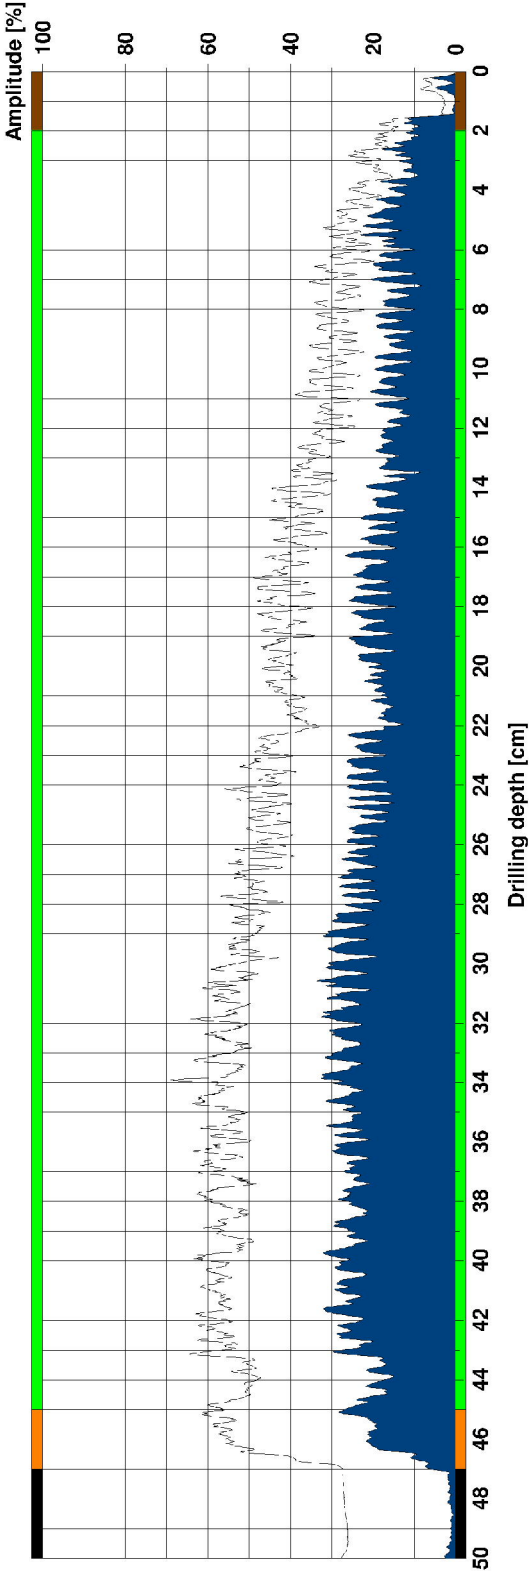
From	0.0 cm	to	2.0 cm	: Bark
From	2.0 cm	to	45.0 cm	: Sound wood
From	45.0 cm	to	47.0 cm	: Decay
From	47.0 cm	to	50.0 cm	: Cavity
From	0.0 cm	to	0.0 cm	:
From	0.0 cm	to	0.0 cm	:

Far side from the wound, 50cm drill goes just beyond the centre of the trunk. Regular serrated pattern is typical of sound wood, indicating that the decay has not spread right through the trunk

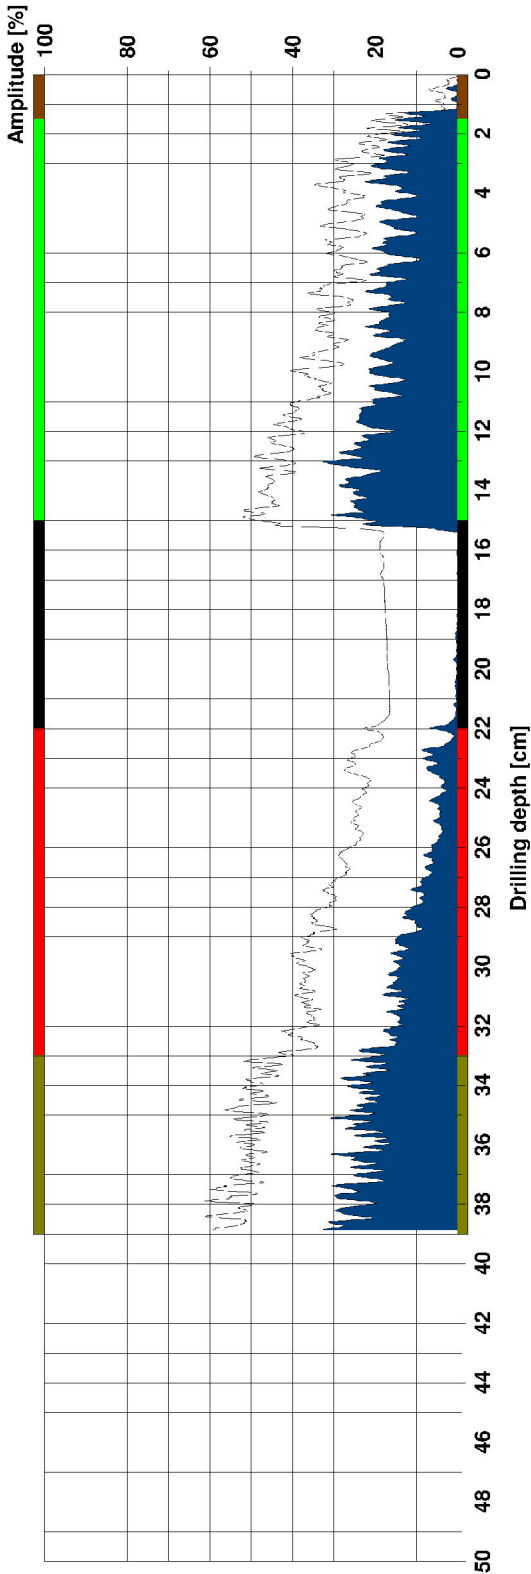
From	0.0 cm	to	1.5 cm	: Bark
From	1.5 cm	to	15.0 cm	: Sound wood
From	15.0 cm	to	22.0 cm	: Cavity
From	22.0 cm	to	33.0 cm	: Advanced decay
From	33.0 cm	to	39.0 cm	: Suspected decay
From	0.0 cm	to	0.0 cm	:

Instrument stopped at 39, possibly on embedded object. Abrupt transition from sound wood to decay shows that the tree is actively resisting it. This outer layer probably grew after the wound, inner wood appears to become better from about 33cm.

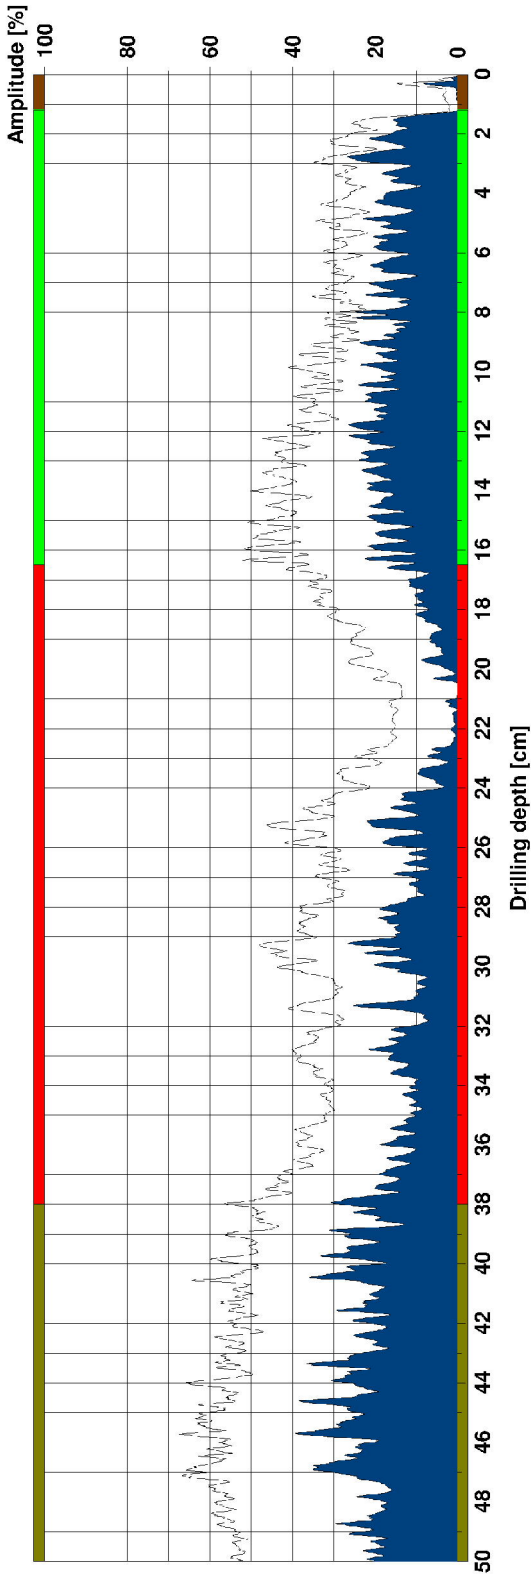
From	0.0 cm	to	1.2 cm	: Bark
From	1.2 cm	to	16.5 cm	: Sound wood
From	16.5 cm	to	38.0 cm	: Advanced decay
From	38.0 cm	to	50.0 cm	: Suspected decay
From	0.0 cm	to	0.0 cm	:
From	0.0 cm	to	0.0 cm	:

Outer layers formed after the wound are sound, but transition is less apparent than in reading 3. Resistance starts to increase from about 21 cm and serrated pattern is present but is irregular and resistance is lower than in reading 2, suggesting possible early decay.

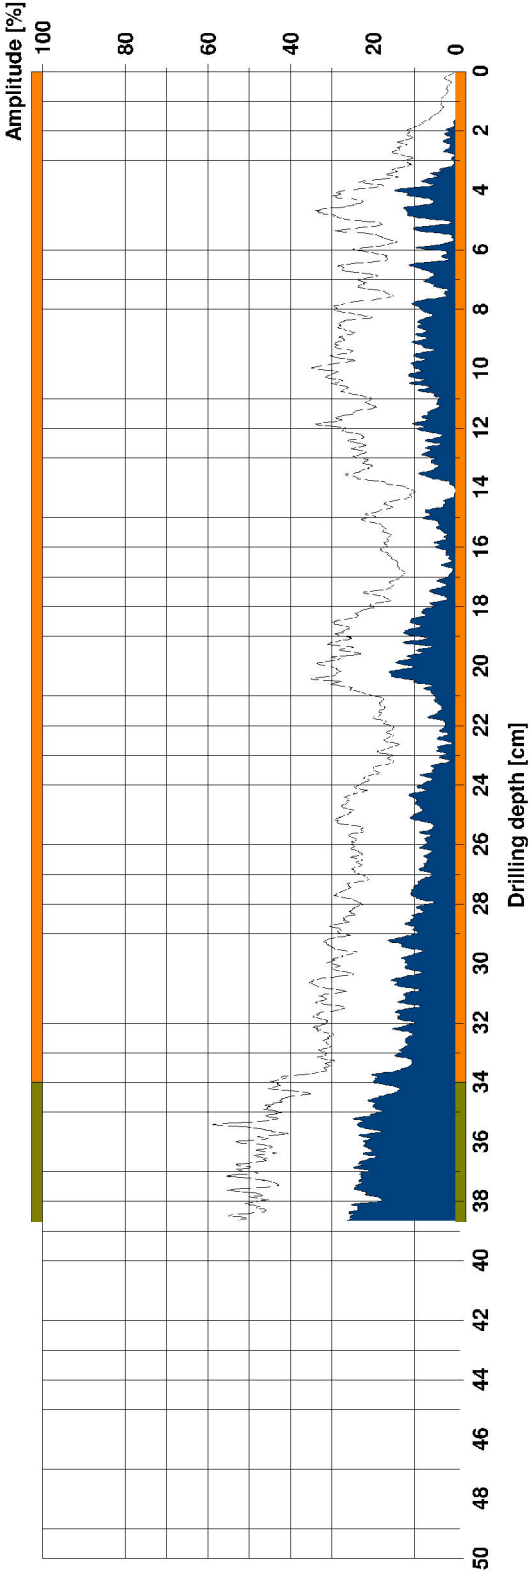
From	0.0 cm	to	34.0 cm	: Decay
From	34.0 cm	to	38.7 cm	: Suspected decay
From	0.0 cm	to	0.0 cm	:
From	0.0 cm	to	0.0 cm	:
From	0.0 cm	to	0.0 cm	:

Directly into wound. Irregular serration indicates decay but wood has not degraded completely. resistance increases and serration becomes more even from about 34cm. Drill stopped automatically at 38.7cm, probably on the same obstruction as measurement 3
