Georgiana Street, London NW1 0QS

Bangor Wharf

Report to accompany planning application:

Report on Trees
Broad Oak Tree Consultants Limited
February 2016

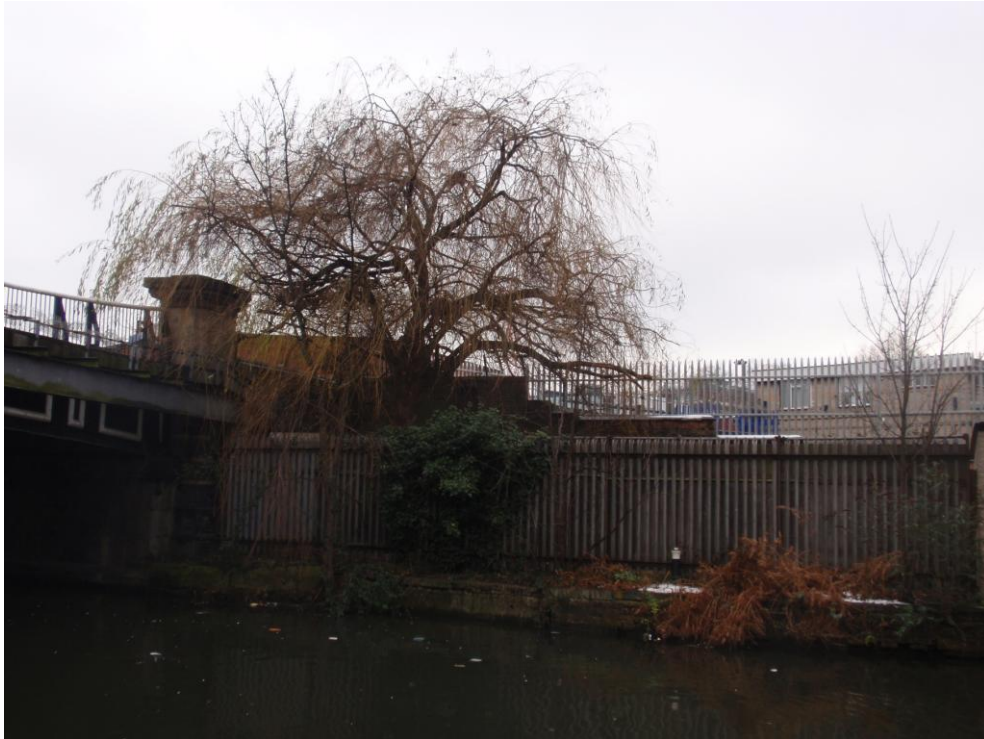
7. COMMENTS ON WILLOW TREE AND ITS SURROUNDINGS

- 7.1 The willow is a maturing tree, poorly located for its potential mature size. This could be up to 16m in height and circa 50% increases in radial branch spread. However it is clear that due to its location its development has been controlled at least on several locations.

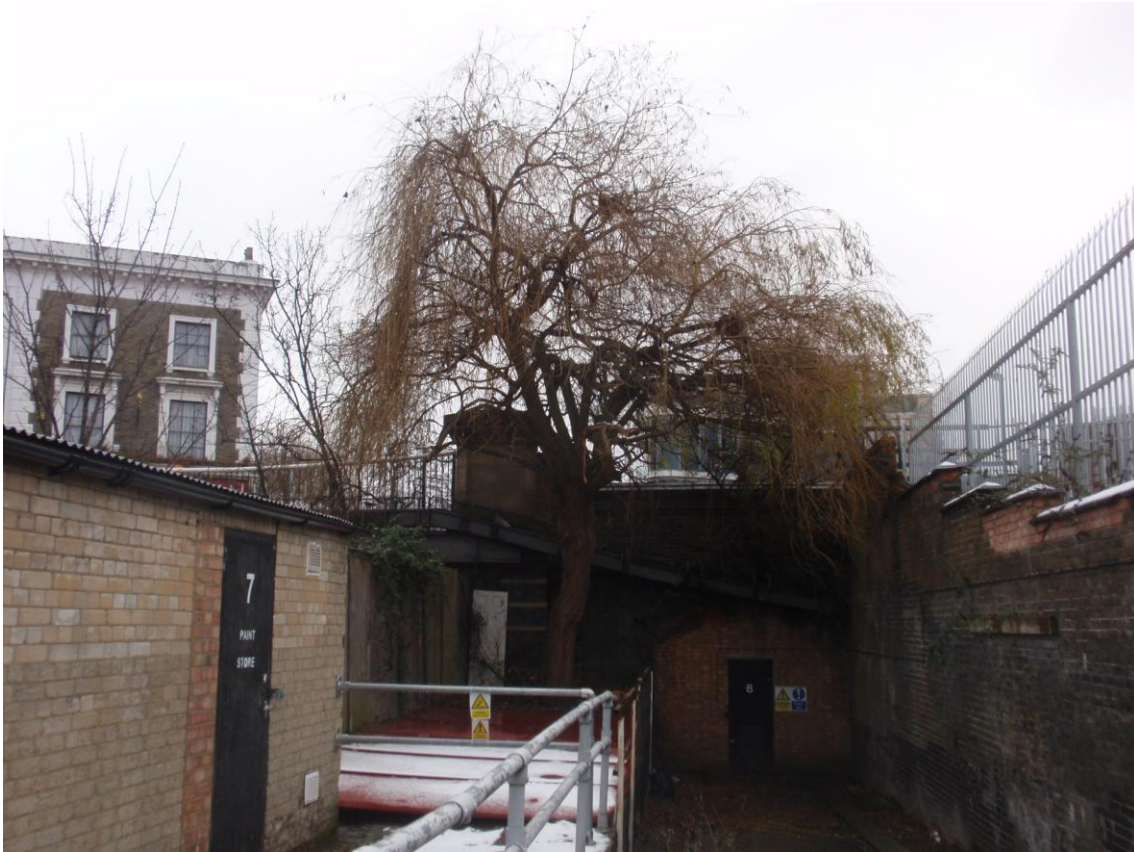
- 7.2 The multi stemmed nature of the tree is suggestive of it having been pollarded (topped back to a large stub) at circa 3.5m-4m up to 15 years ago, presumably to control its development. Such harsh pruning was common in the past for such species and they respond rapidly. More recently, within the last 1-2 years, the crown has been reduced all over to remove growth from the bridge and other structures. Within the winter months of 2014/2015 the lower crown to the west/south-west has been heavily cut back to provide maintenance clearance of the internal structures to the site. The largest low limb to the south-west also displays a significant split and the potential collapse of this limb may have instigated the recent works.

View from west to east towards willow. Note recent removal of low limbs to the west/south-west of the tree and constrained nature of the existing space.

- 7.3 In visual terms the tree does provide local visual amenity in an area dominated by built structures. However it is clear that even in its current context the tree requires ongoing, regular maintenance to keep its canopy clear of existing structures and maintain access beneath. The tree cannot readily be allowed to increase in size and given the very rapid growth rates of willow recutting on a maximum two year cycle is likely to be required. The alternative would be a heavier overall reduction to increase the maintenance cycle. Such works would not be detrimental to the tree as a vigorous growth response will occur.
