Tree Hazard Report

- 1.1 This report is to assess the Horse chestnut tree for its health and any potential hazards. Also, to recommend future management procedures.
- 1.2 This report was commissioned by Mr Atkinson of Chestnut Cottage, the Vale of Health, London NW3 1AZ.

- 2.1 This report is a visual assessment of *Aesculus hippocastanum* situated at the front of the property
- 2.2 Visual inspection was carried out on 14th August 2015. There is to be a follow up aerial inspection which will be added to this original report.
- 2.3 The visual inspection and the report were conducted by Simon Causer.

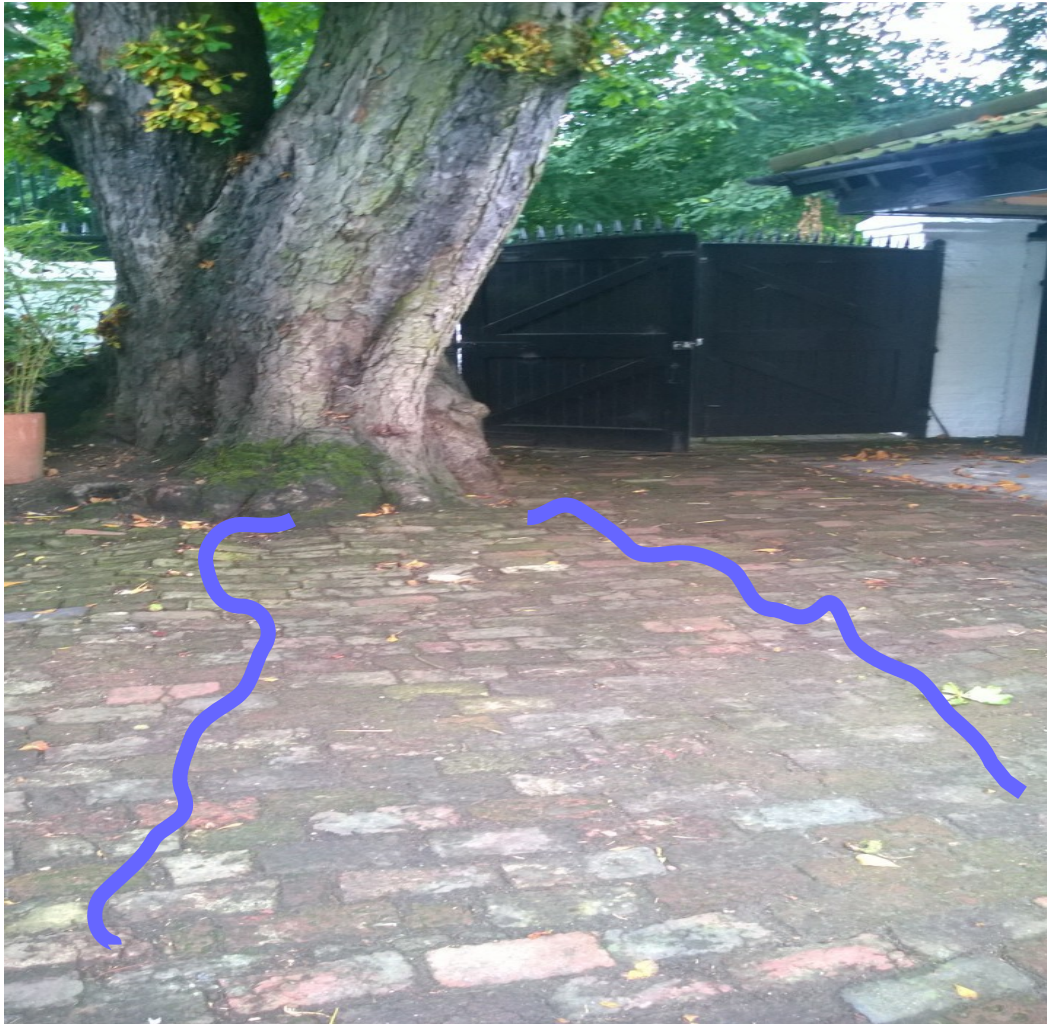
4.5 The area around the tree is flat brick and on the northern side butts up to the boundary wall. The flat bricks have an uneven spread and undulate, which suggest buttress root spread, which has caused direct lifting of the bricks.

The blue lines indicate the probable direction of the buttress roots.

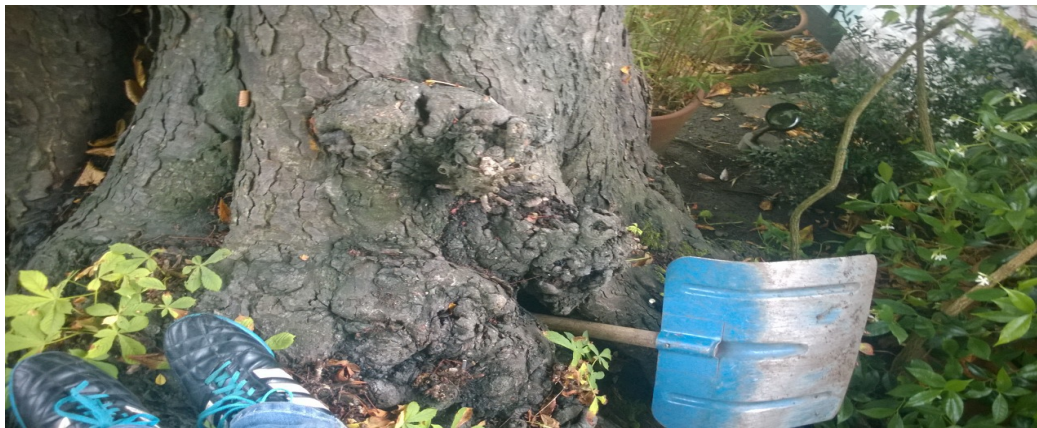
Photo 3

- 6.1 Upon investigation of the butt area there are many points of decay and dysfunction, resulting in a large cavity (see photo 3-4).

6.2 On tapping with a hammer around this area, it became apparent that a large portion of the easterly side of the butt is either hollow or has developed dysfunctional heart wood.

Photo - shows a visual demonstration of the extent of the decay in the butt. The right side of the stem sounded hollow and had signs of dysfunctional heartwood.

- 7.8 If monitoring suggests dramatic decline, then it is recommended that further investigation with decay detection equipment takes place in order to give more evidence of the soundness of the structure.

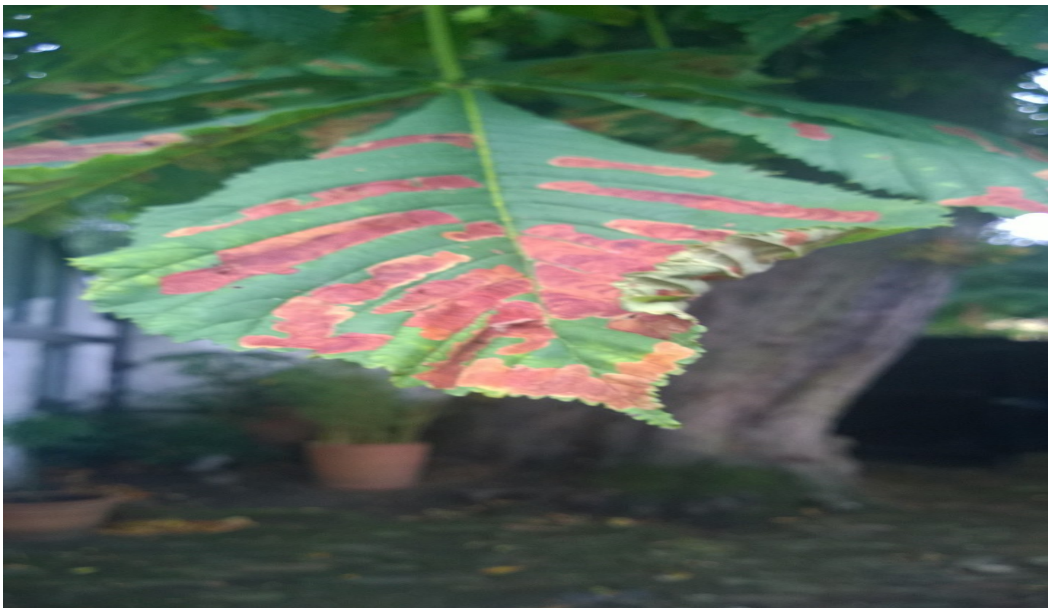
- 5.7 The foliage on the crown is full but does appear to show signs of leaf miner *Cameraria ohridella* this can have an effect on the trees ability to photosynthesise , which has an effect on the trees ability to creating energy in the form of starch, which is used in growing and sealing off wounds.

6.8 See Photo 5 – for an image of a leaf showing leaf miner damage.

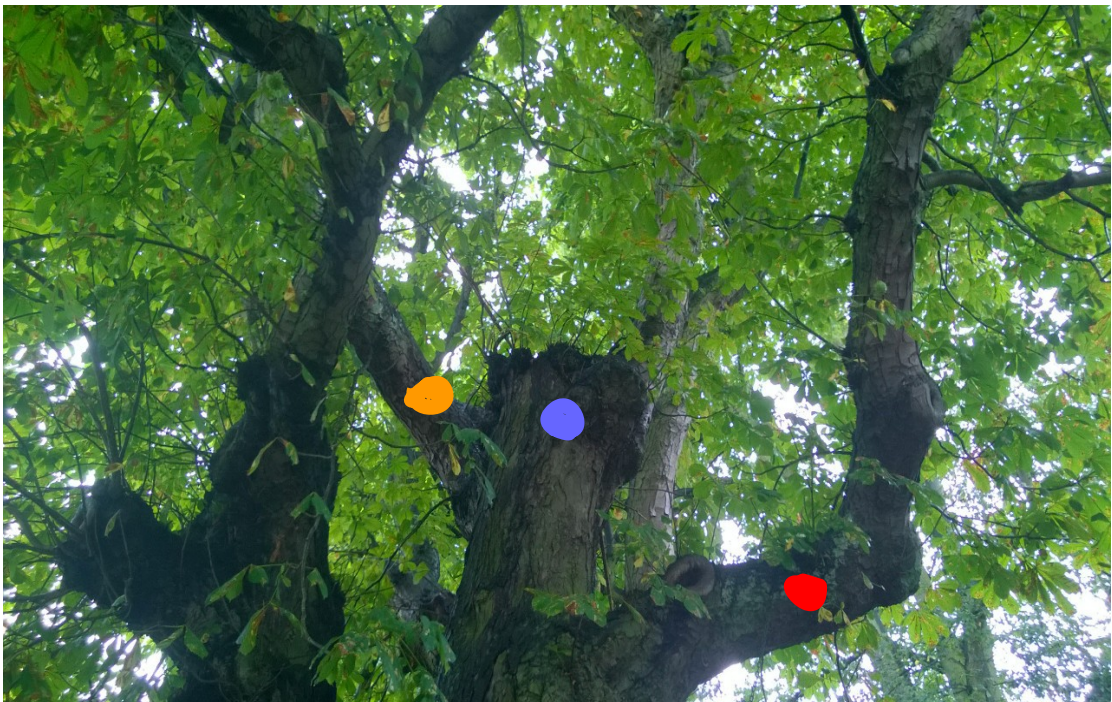
8.2 My attention was focused on the central limb which from the ground appeared to be an occluded wound - perhaps from a ripped out limb or removal by previous arborists. Photo 6

The blue dot in photo - shows the centre most limb. As can be seen it comes to an abrupt stop with 2 large limbs attached to either side (orange and red spot).

After climbing the tree my conclusion from the visual report remain the same. Weak attachments, unions and areas of dysfunctionality are in critical positions whose failures could be catastrophic and remain a risk to health and property. Recommendations are the same as before: phased reductions of the major limbs to elevate the strain and force caused by wind-loading of the upper-crown.

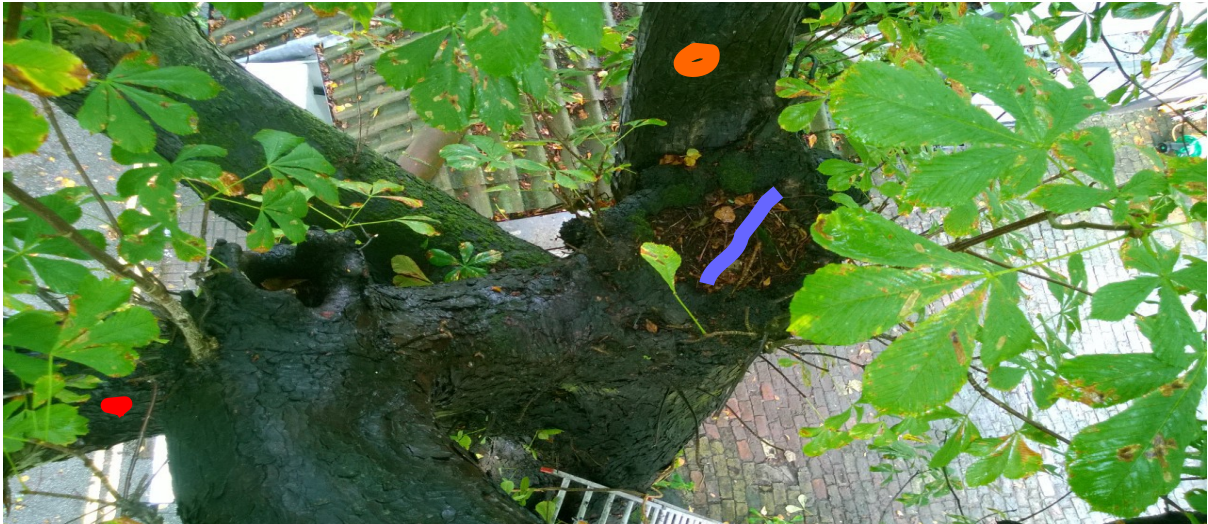
PHOTO 7 depicts the view from above focusing on the centre limb (the blue line shows the abrupt stop of the removed limb also giving an idea of its size). The orange spot limb is of concern as the attachment to the centre is close to the dysfunctional wood from the blue centre limb. As can be seen from photo 6 the orange spot limb has put on adaptive growth to compensate for the weight of itself ,however the union of orange to blue is at best adequate . The target of the property can be seen from Photo 7. The orange spot limb from that point extends approximately 5-7 metres up over the property its weight is considerable. Photo 8 shows a close-up of that attachment.
Photo 8

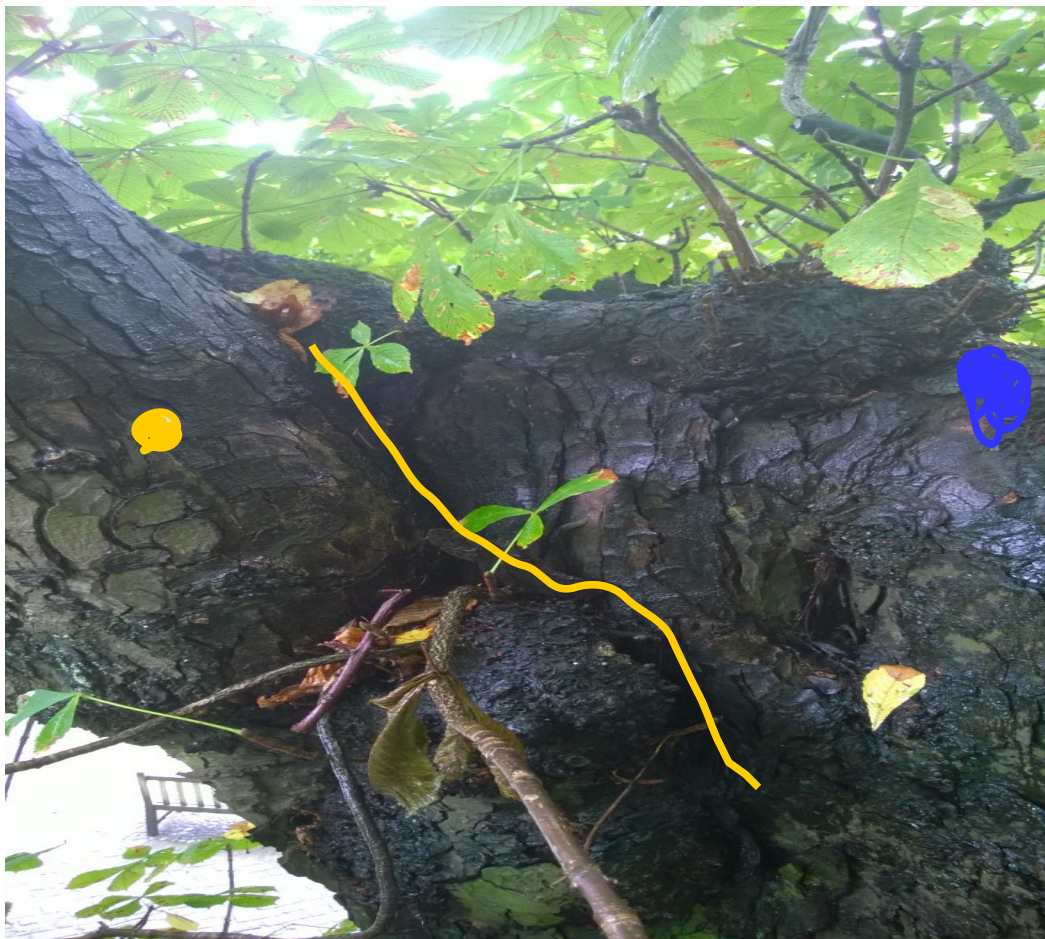
The orange line represents the approximation of the attachment point from the orange limb to the right and the blue centre blue limb. This union has overlapping crevices and entry points which are potential fault lines. These could rip out due wind-loading on the above crown or other mechanical failure.

The red-spotted limb also has potential issues, which in the unfortunate circumstances e.g extreme weather patterns ,could have catastrophic consequences.

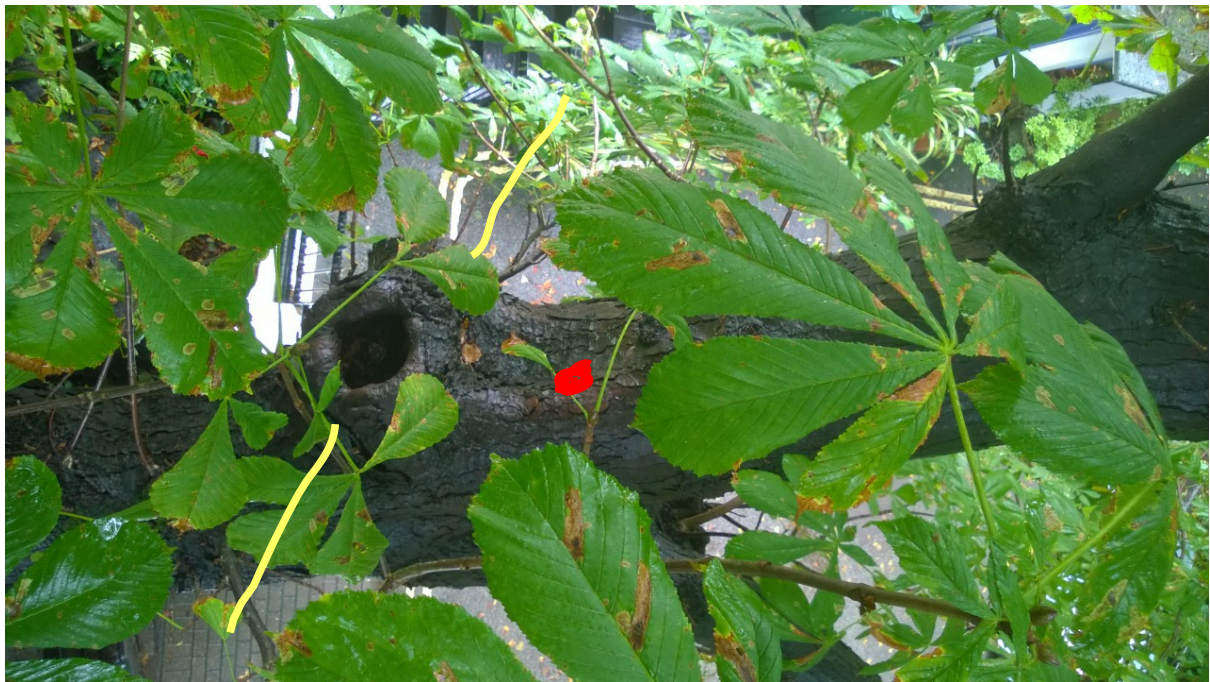
Photo 9 shows cavities and areas of dysfunction. It also shows the neighbour's property as potential target. There is another cavity on the underside of this limb. Both these faults have been highlighted by the yellow lines.

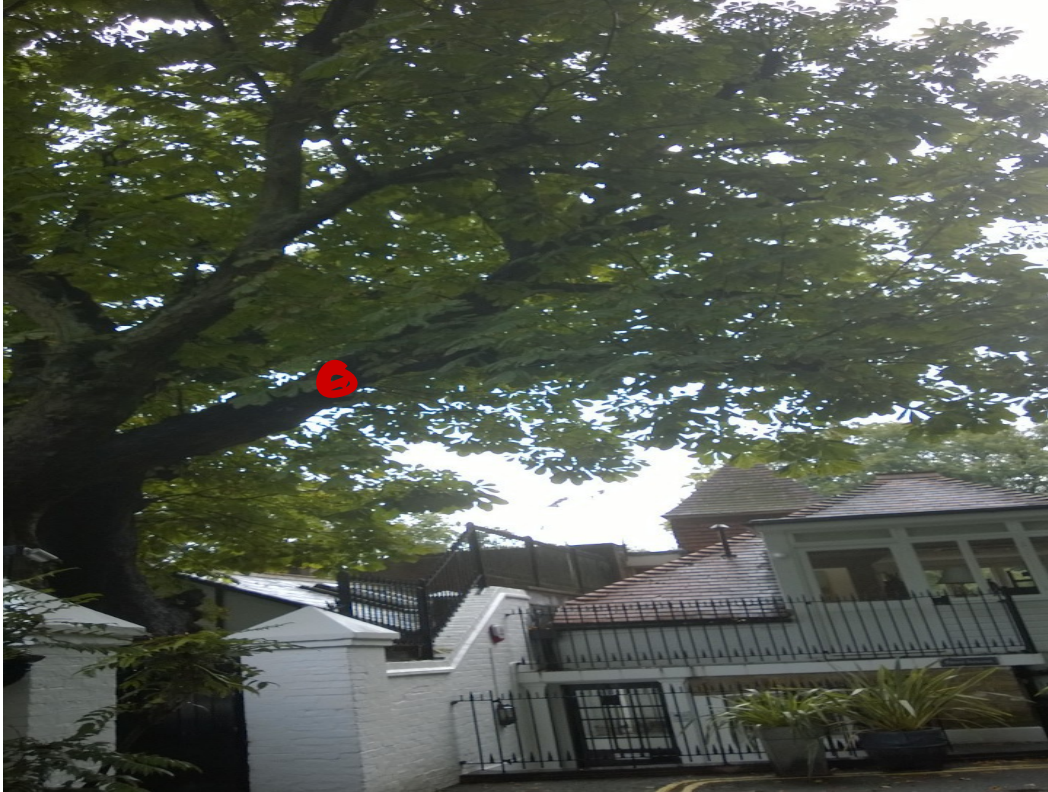
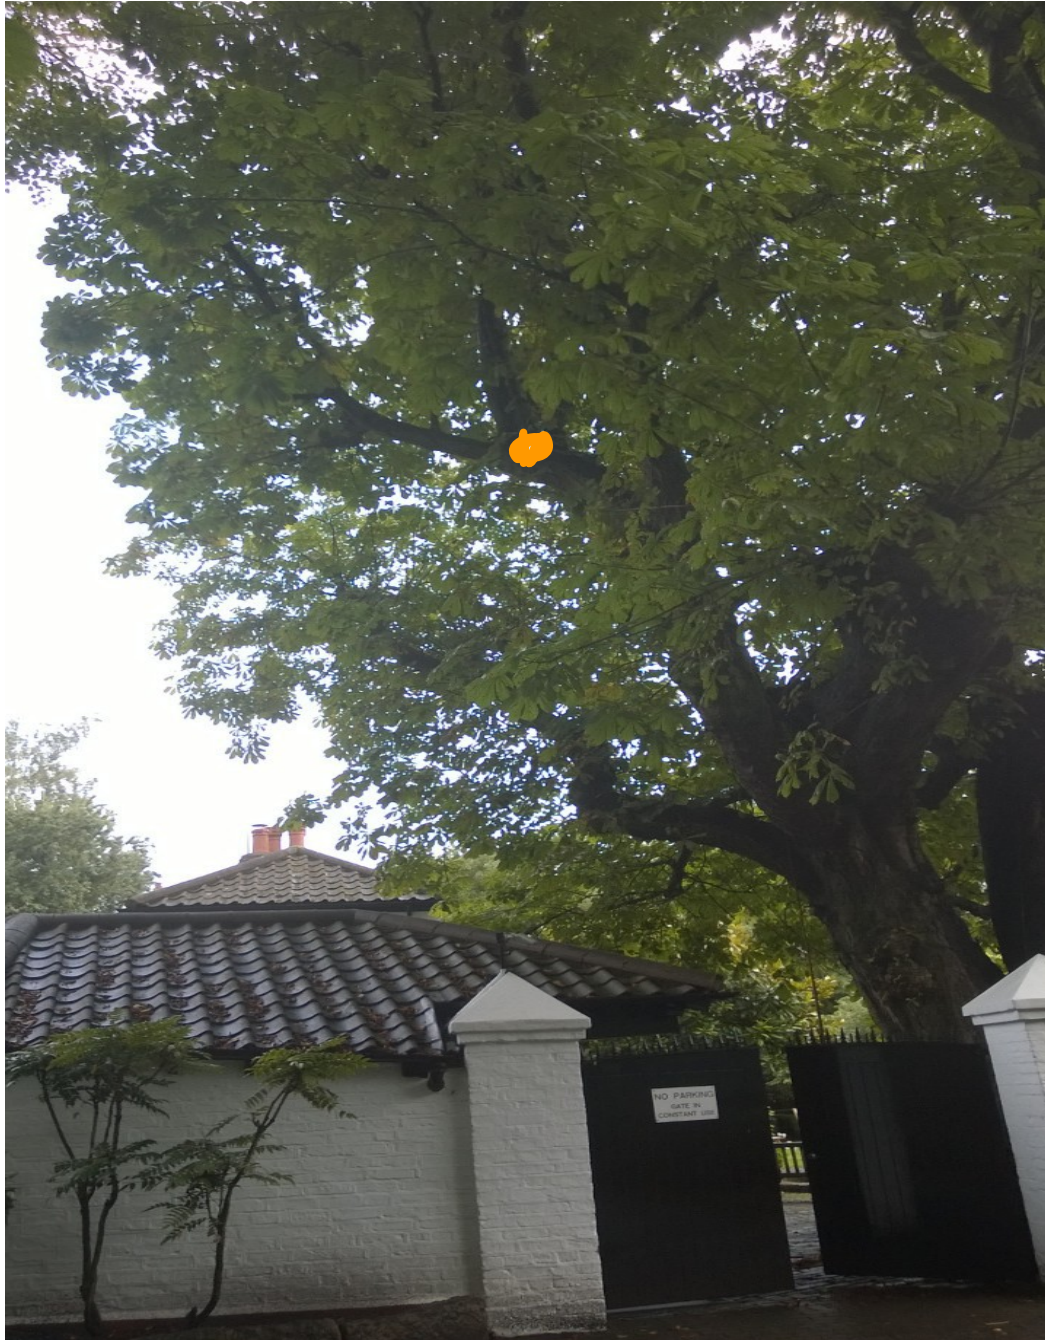
Photo 10 and 11 show the extent of the overhang from the limbs that have been mentioned.
