## **Tree Inspection Report**

**Lincoln's Inn  
London WC2A 3TL**

### TREE INSPECTION REPORT

**Date of inspection:** 26 June 2015

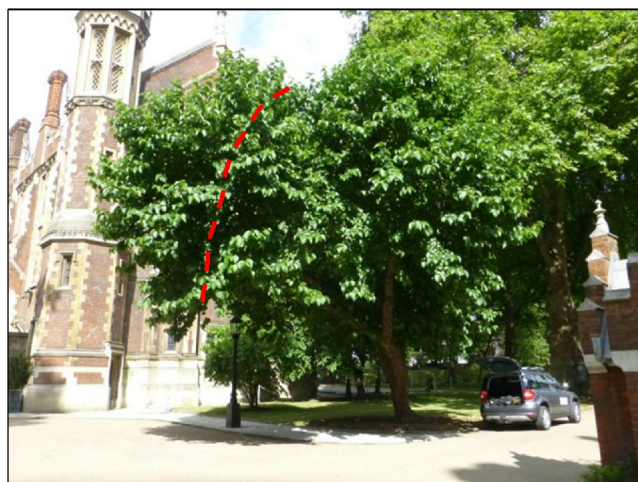
No significant structural issues were identified by the inspection, although the crown is developing a distinct and characteristic lean to the south. Typically this recumbent attitude in older trees of this species is managed by propping but this is obviously not practicable due to the presence of the tarmaced area beneath. I advise that the crown support systems already installed are supplemented by light and careful crown reduction on the south side.

For guidance, a photo of the crown is shown below with a red dotted line overlaid to indicate the *approximate* extent of reduction envisaged, if practicable. Please note the actual location of individual pruning points will of course be dependent on suitable side growth in each instance.

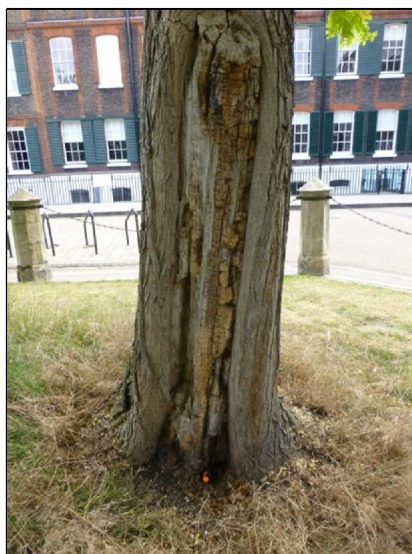
T55 was selected for investigation due to the presence of a deteriorating stem wound from ground level to a height of approximately 1.8 metres, the site of an old pruning wound (see photo).

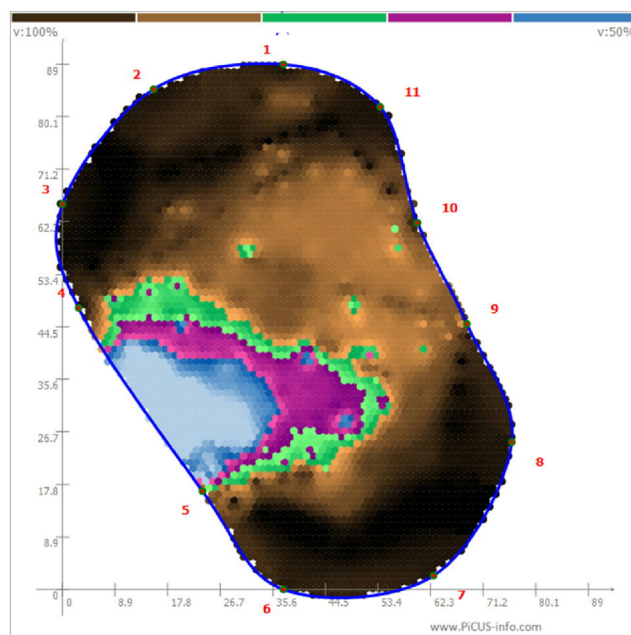
Tapping the stem with a nylon-headed hammer suggested deterioration was greatest close to ground level, indeed it was possible to insert a 25cm-long screwdriver into the stem at this level. Accordingly the Pius was used at this level, with a total of 11 measuring points; the tomogram, shown below, confirms the presence of decay in the vicinity of the wound (between MP 4 and 5):

Deterioration appears to extend a maximum of 30cm across the stem. In view of the length of the wound a further tomogram was measured at a height of 70cm, using only 9 measuring points due to the limited stem size; the result below indicates more limited deterioration at this level.

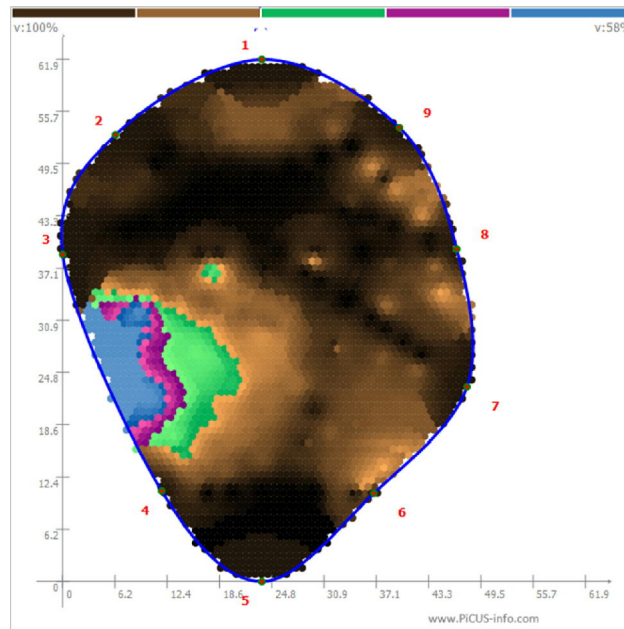
The current extent of deterioration associated with the stem wound is not likely to be structurally significant in my view, although further enlargement of the decayed area could occur in time.

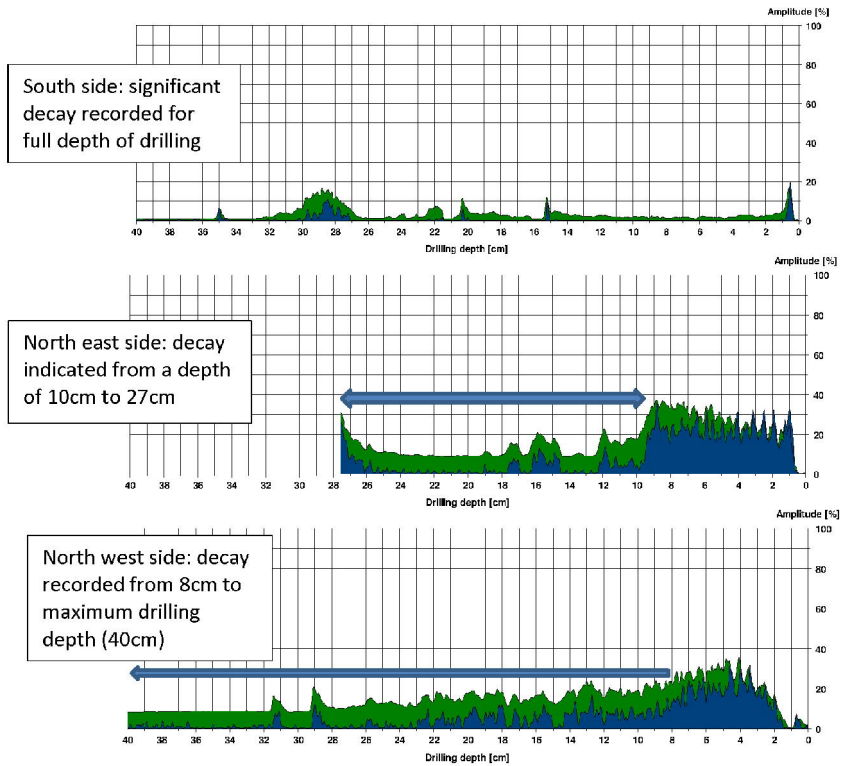
North east tree:

The drill traces are shown on the next page in the order of assessment; the results indicate that both stems contain significant decay. Coupled with their poor physiological condition the continued retention of T55 and T56 appears limited.

Much of the visual appeal of the group has already been lost and, although none of the trees in the group represents a risk of failure (due to the presence of the cabling) I suggest the removal of all three trees should be considered. This would facilitate replanting with a new group of trees to provide future amenity in this part of the grounds.

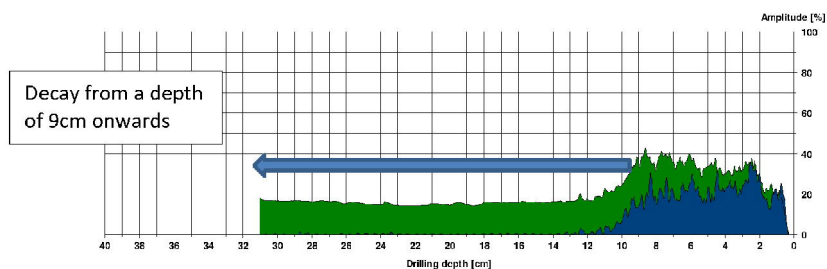
North west tree:

This final drilling auto-retracted at a depth of 31cm; this was due to drill deviation within a cavity.
