**STRUCTURAL STATEMENT  
FOR  
40 GREAT JAMES STREET  
LONDON**

**Date:** May 2015

**Reference:** MC/16062~rep

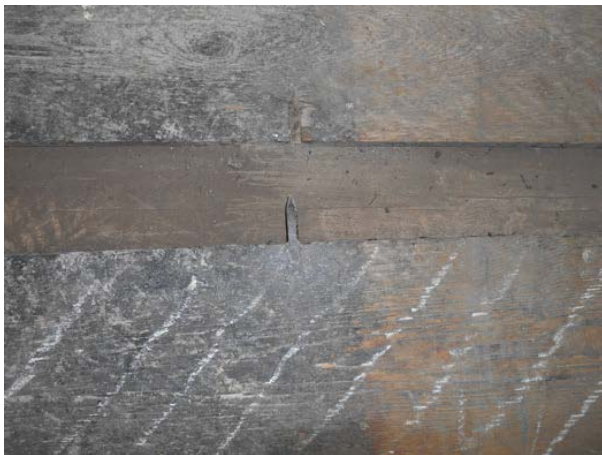
- 2.3 Generally the floors are made up with timber boards, supported off the top face of the joists and lath and plaster ceilings supported directly off the bottom face. The boards have been scribed over the joists to allow for the variation in board thickness and have timber 'pins' recessed into their top face in some locations (refer to photo 1).

Photo 1: Timber pin recessed into top face of boards.

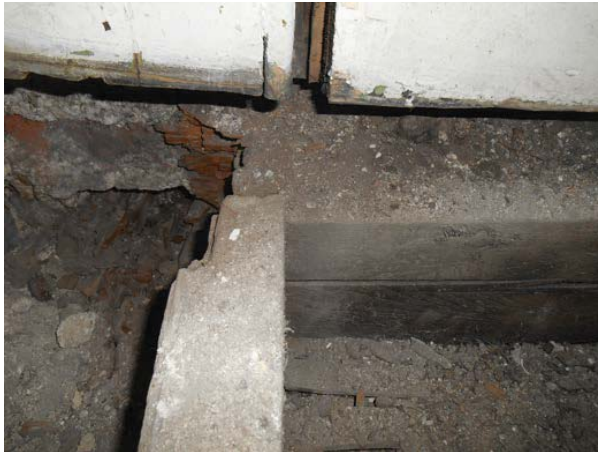
- 2.5 We have reviewed the condition of each of the floors and there is a significant amount of undulation in them as you rise up through the building, particularly within the rear room. This appears to be due to a combination of factors; Firstly, there has been some water ingress to the rear of the property which has caused rot to beam ends and embedded timbers in the rear wall. This is particularly the case at first floor level (refer to photo 2) and to a lesser degree at ground floor level. Secondly, the joists at third floor level have had a significant number of notches cut out of them in the rear room, to allow for services to be installed (refer to photo 3). This has led to weakening of the joists and some significant deflections across the floor. Further to these external factors, the timber beams themselves are inherently relatively small for their spans, with little propping provided by the panelled partitions.

Photo 2: Rot to first floor beam end (beam A).

- 3.6 Where water ingress has occurred at the rear of the property, we propose that additional timbers are bolted alongside the strengthened floor beams and that the bearings are enhanced to reinstate the load path back to the load bearing masonry of the external wall.

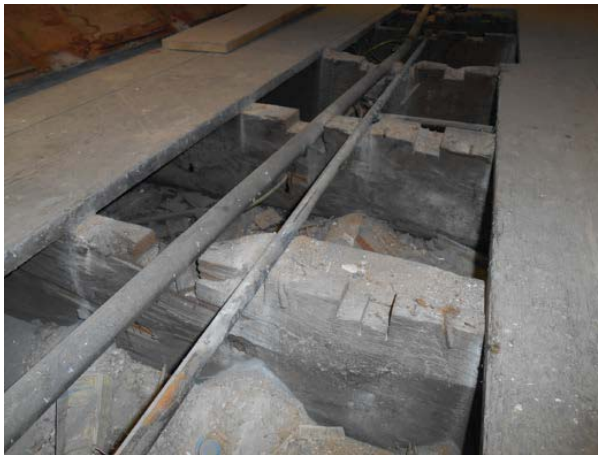
Photo 3: Notches to third floor rear room joists.

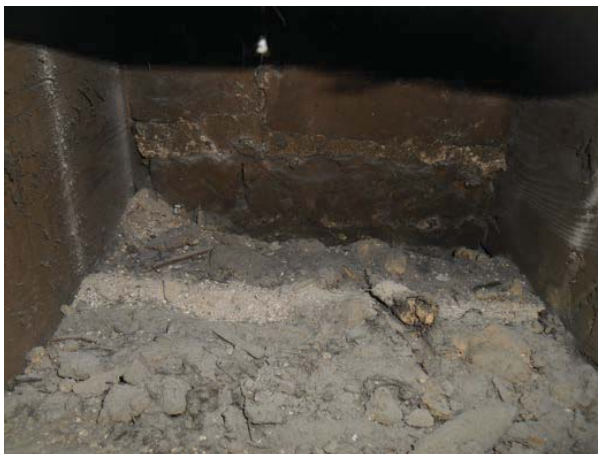
- 2.6 The principal beams and joist ends are built into the masonry walls (refer to photo 4). The bearings generally appear to be sound, with no pulling of the joists noted. We have not however been able to ascertain the length of the bearings into the walls.

Photo 4: View of joists built into party wall.

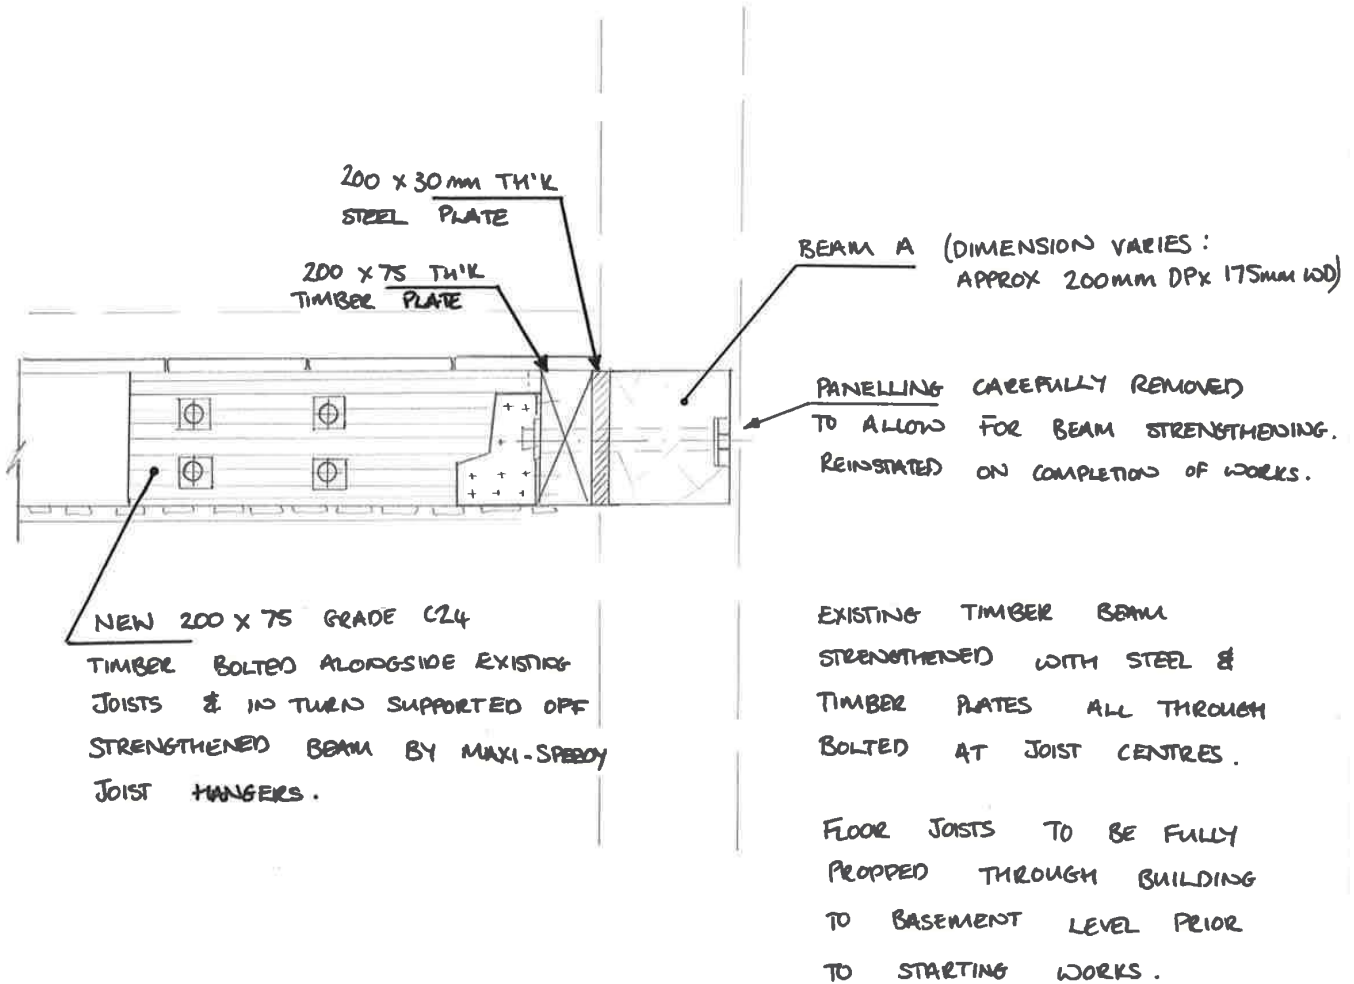
DETAILS 16062 / SK02  
PROPOSED STRENGTHENING TO BEAM A

- 3.3 Taking the above as the basis for the proposed loadings, at each floor level the joists are within permissible stress limits, however the three principal beams would theoretically be overstressed and would theoretically deflect in excess of what is recommended to prevent damage to plaster finishes. Having discussed the analysis in detail with the Architect, we propose that the timber floor beams are strengthened at each floor level.

- 3.4 In order to stiffen the beams adequately, we propose that flat steel flitch plates are used, either recessed into the centre of the beam (as in the case of the front room beam) or added to the sides of the beams, all through bolted. The connections between each of the beams and also where they bear into the masonry walls could also be enhanced to ensure that the loads are transferred adequately.
