**STRUCTURAL STATEMENT
FOR
40 GREAT JAMES STREET
LONDON**

Date: May 2015

Reference: MC/16062~rep

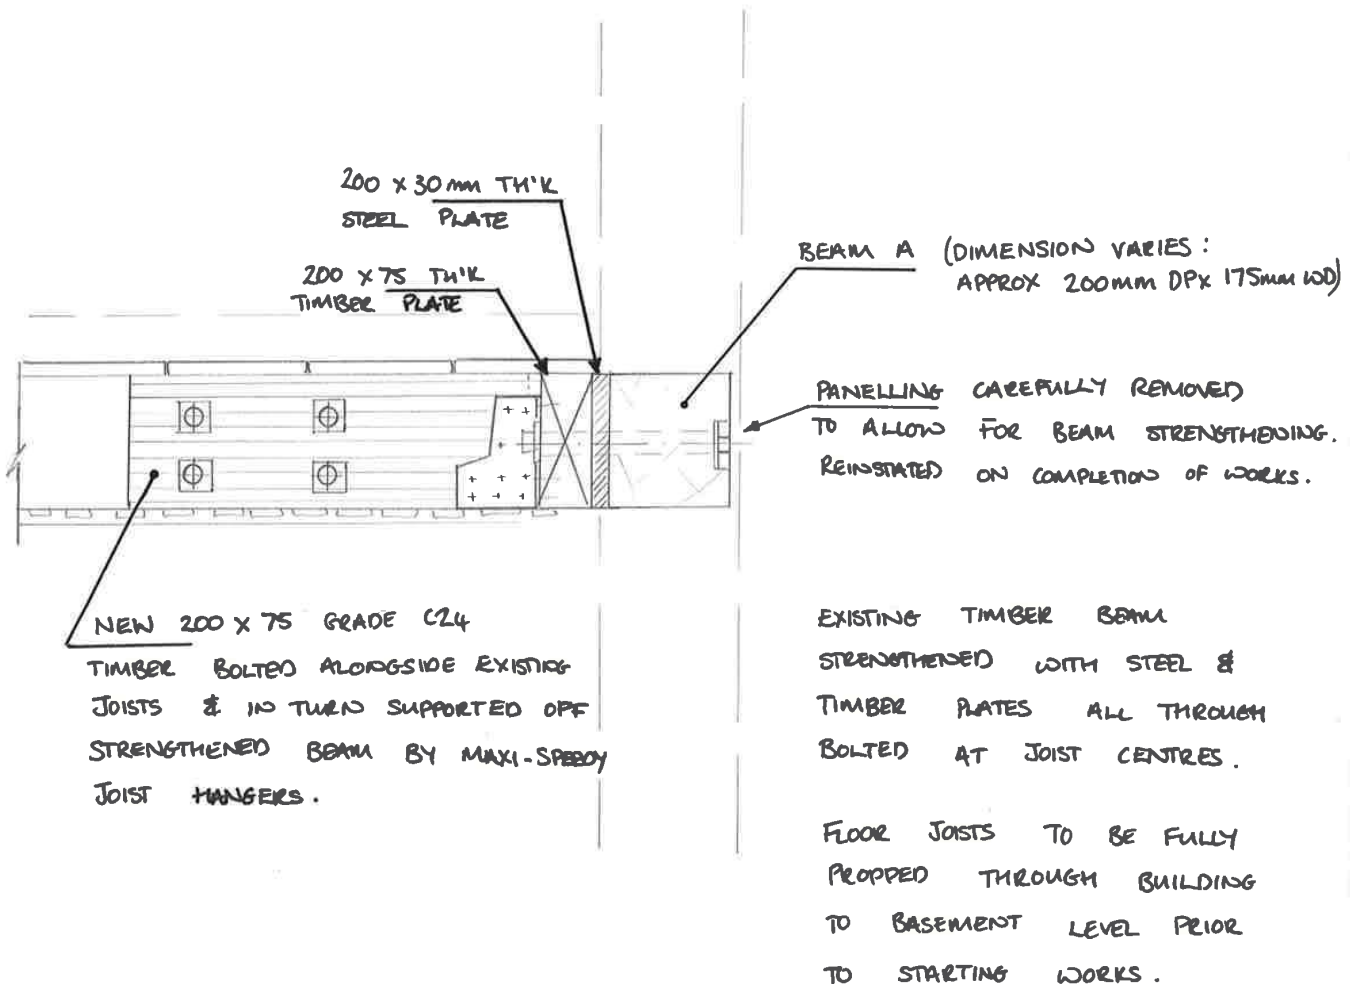
DETAILS 16062 / SK02
PROPOSED STRENGTHENING TO BEAM A

- 3.3 Taking the above as the basis for the proposed loadings, at each floor level the joists are within permissible stress limits, however the three principal beams would theoretically be overstressed and would theoretically deflect in excess of what is recommended to prevent damage to plaster finishes. Having discussed the analysis in detail with the Architect, we propose that the timber floor beams are strengthened at each floor level.

- 3.4 In order to stiffen the beams adequately, we propose that flat steel flitch plates are used, either recessed into the centre of the beam (as in the case of the front room beam) or added to the sides of the beams, all through bolted. The connections between each of the beams and also where they bear into the masonry walls could also be enhanced to ensure that the loads are transferred adequately.
