Sheet 1. Second floor

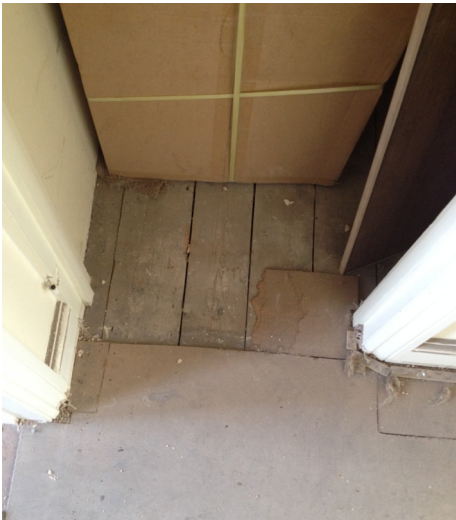
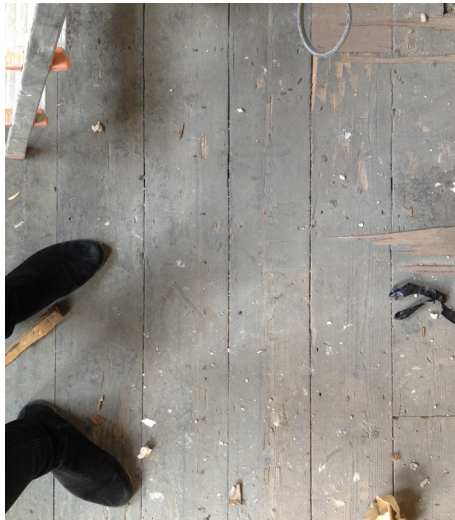
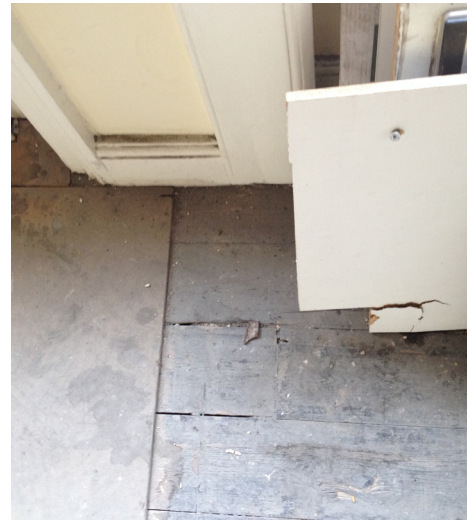
Floorboards mostly in reasonable condition

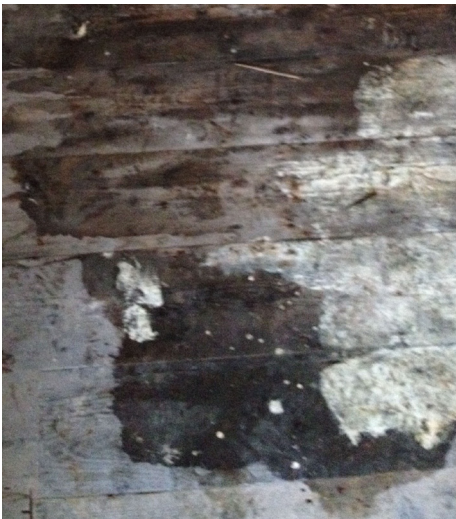
04

Evidence of water ingress in contained location to front room

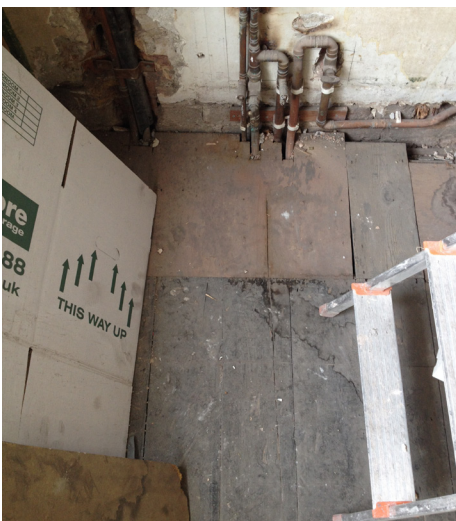
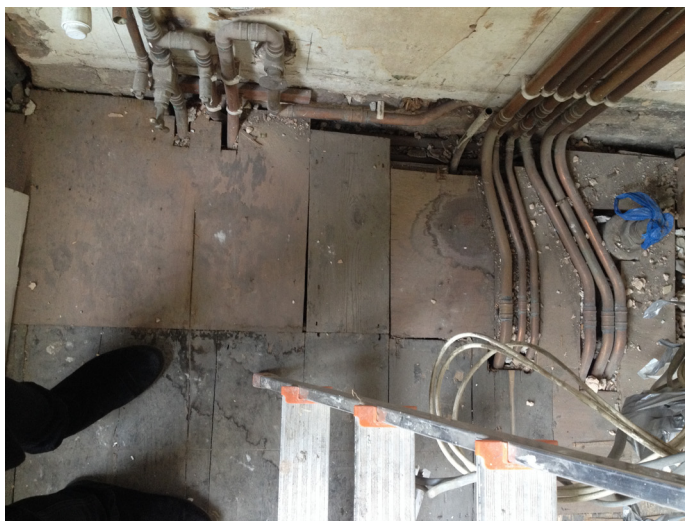
Areas of non-original floorboards where bathroom & kitchen services have been installed in 1960s

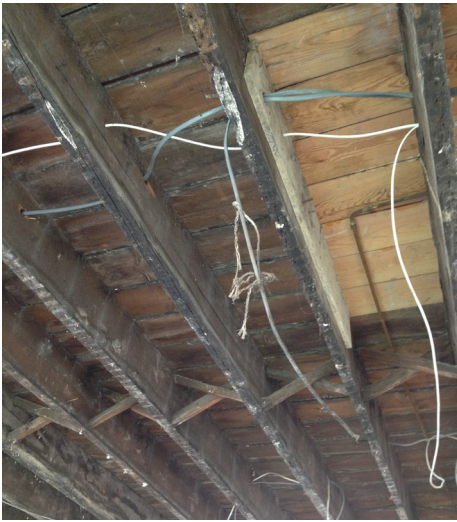
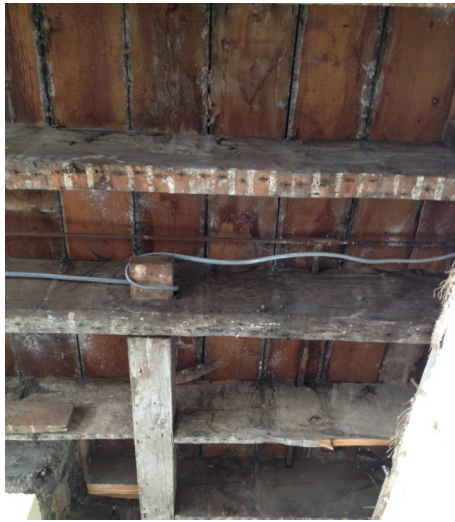
Most joists affected by water ingress

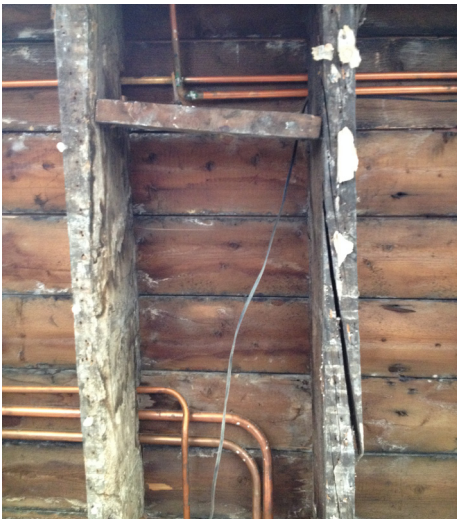
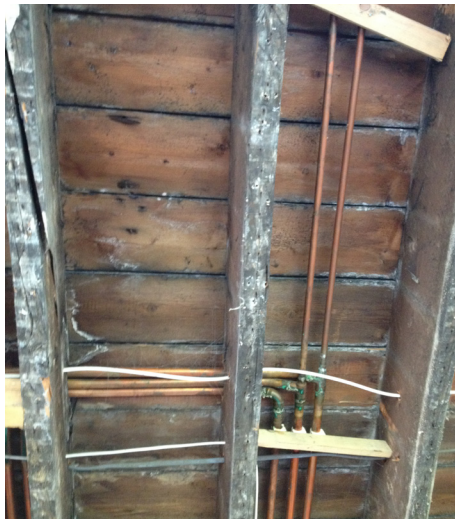
Alterations to accommodate pipework dating from 1960s

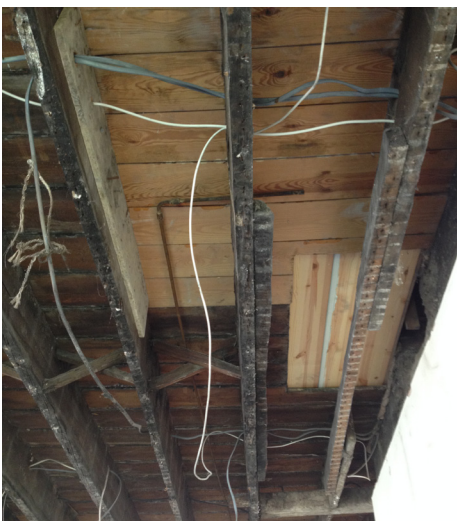
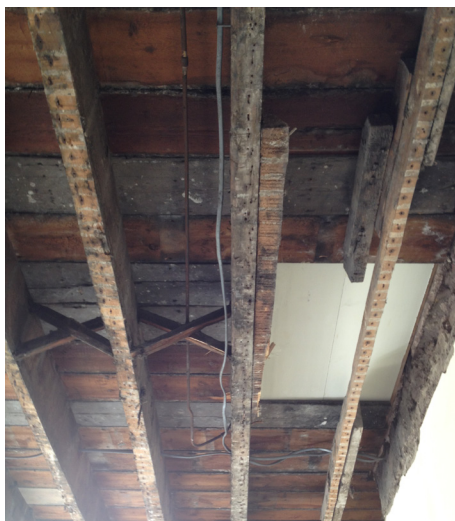
Spliced joists close to chimney breast, and gaps where original hearths have been removed

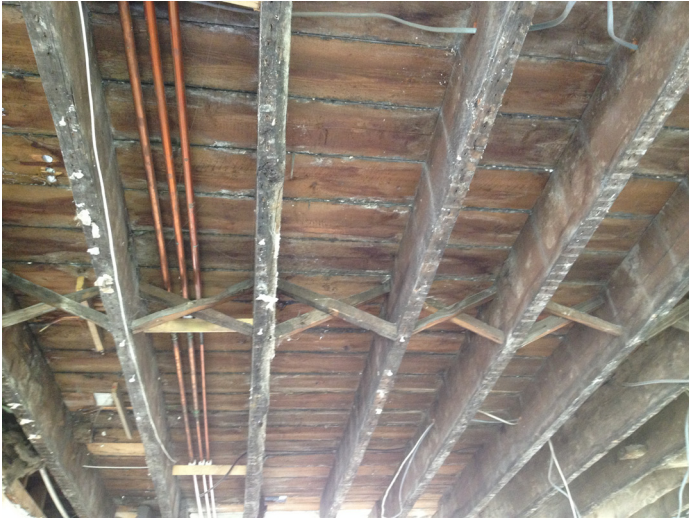
01

Two lines of herringbone strutting

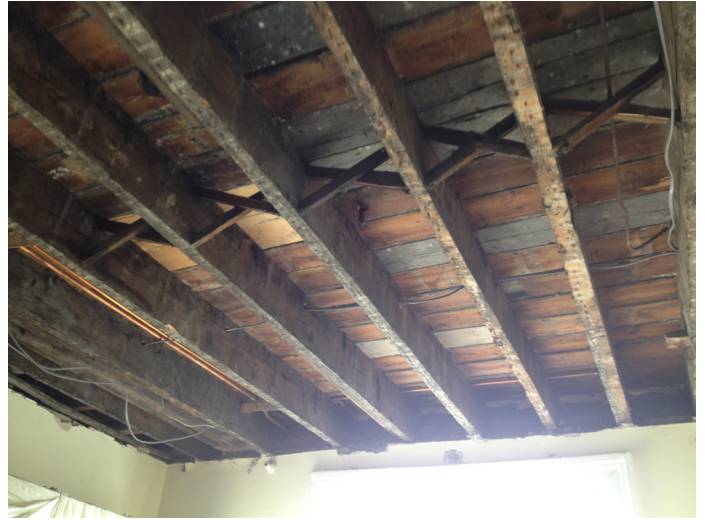
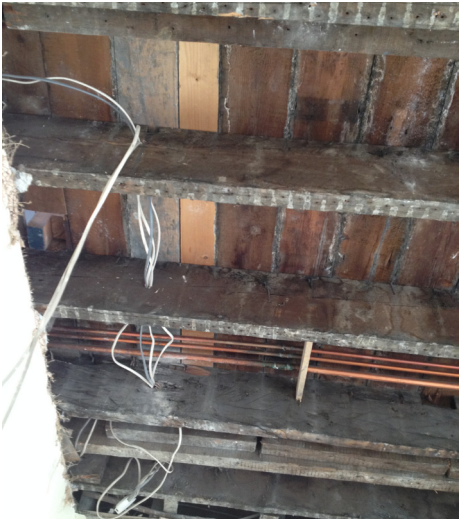
Modern floorboards to two locations

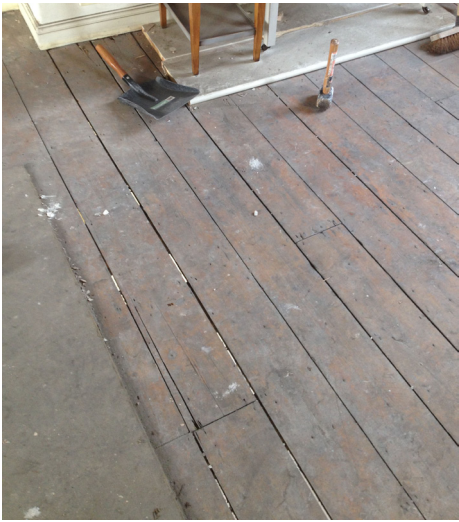
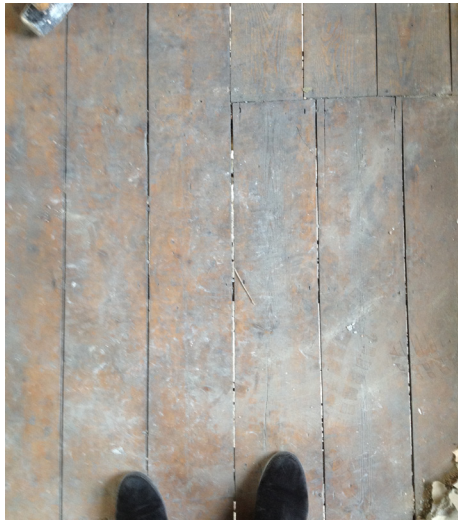
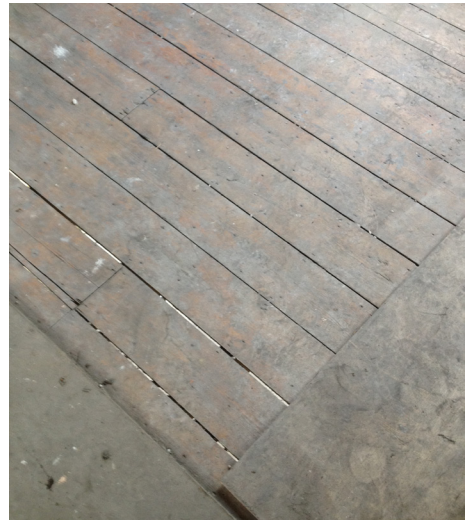
Topside of floorboards mostly in reasonable condition

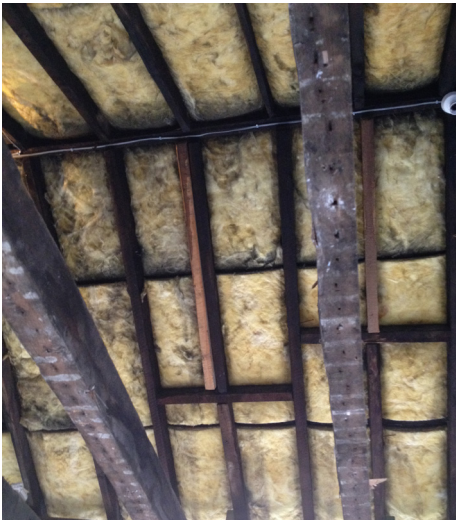
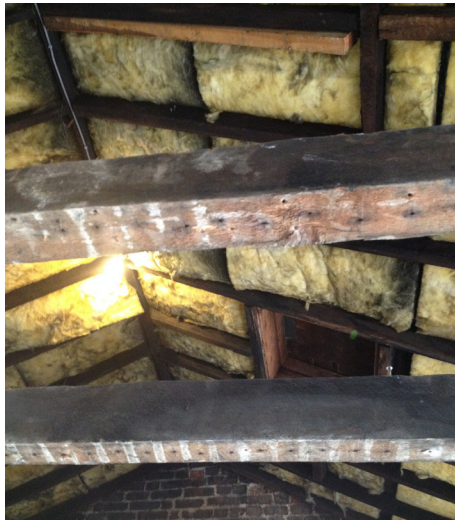
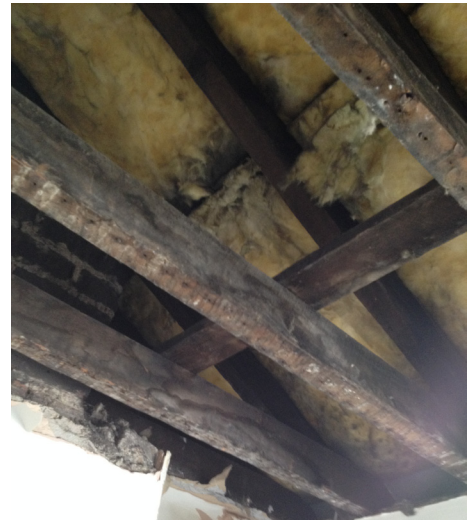
Evidence of water ingress to ceiling joists, rafters and insulation

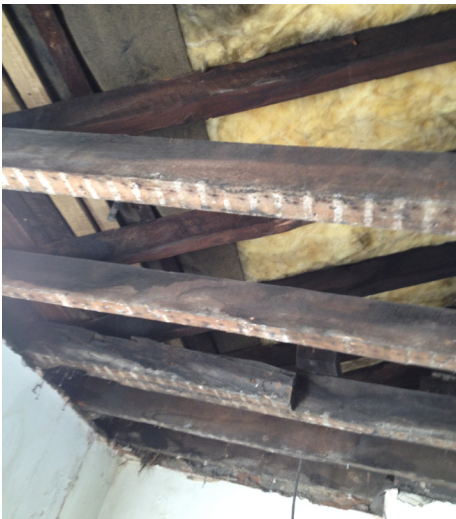
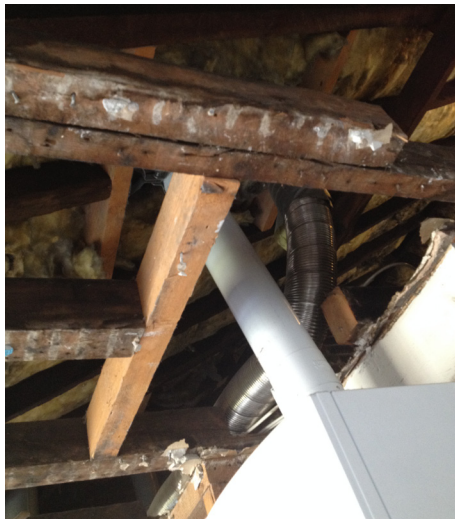
Spliced & cut ceiling joists in two locations

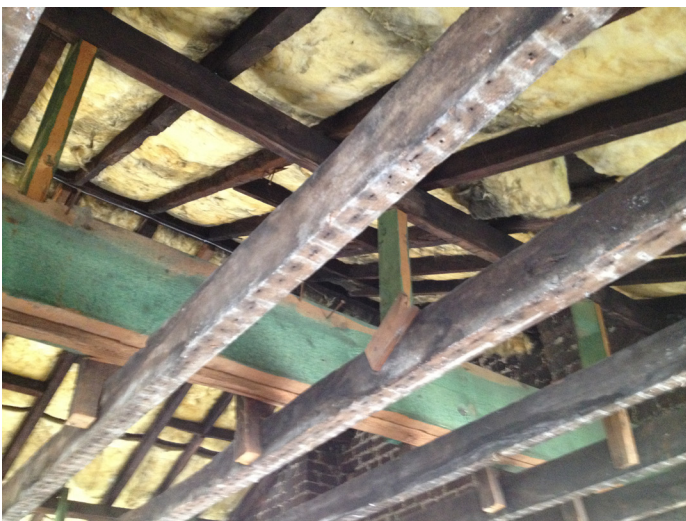
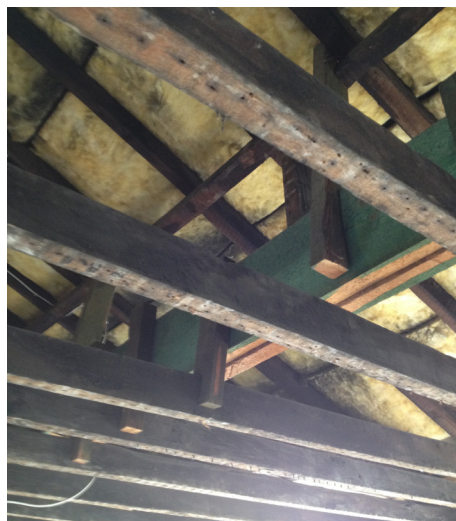
Non-original structural timbers added to roofspace above ceiling joists
