Photosheet P 040 Existing Photographs 1st floor North floor repairs and strengthening

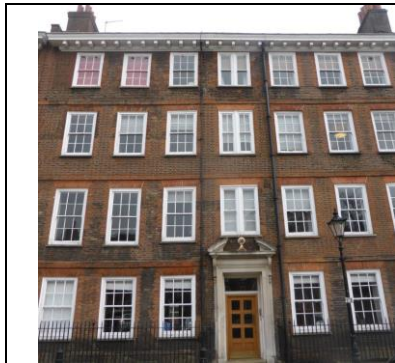
Fig 1 No12 Entrance & West Elevation to North/South Accommodation above

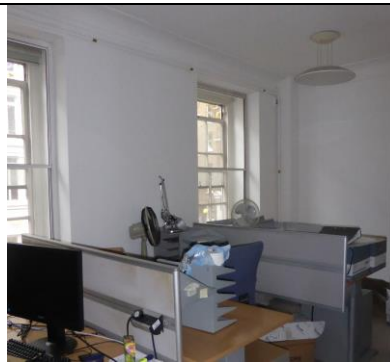
Fig 2 Existing First Floor Office F1 to Gray's Inn Road

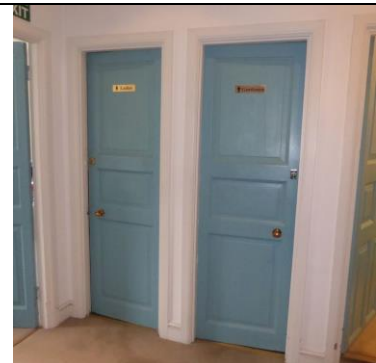
Fig 3 Hall and Toilet Entrance Doors

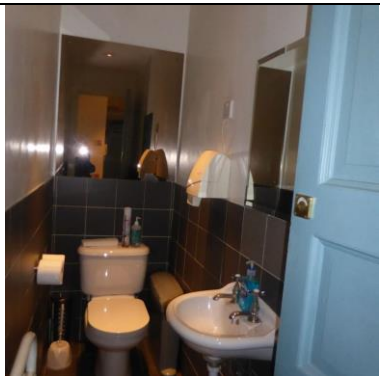
Fig 4 Existing 1st Floor Toilet

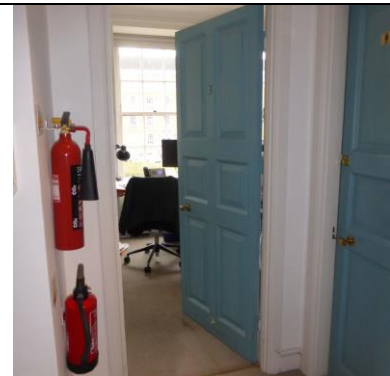
Fig 5 Hall looking into Office facing Gray's Inn Square

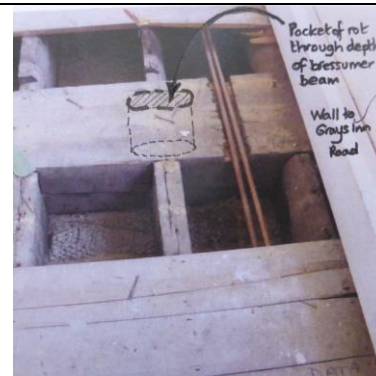
Fig 6 Floor structure in Office East side of First Floor & pocket of rot in bressumer beam

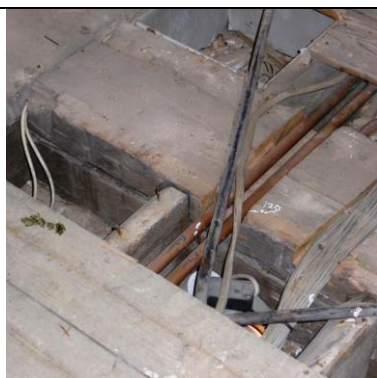
Fig 7 Existing split bressumer beam/ junction to centre beam below the Hall flooring

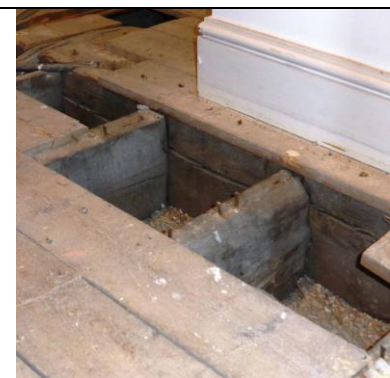
Fig 8 East/West bressumer beam below Hall spanning to Grays Inn Square external wall

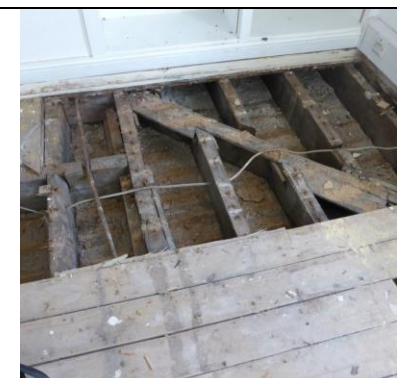
Fig 9 Floor structure in North East corner of The First Floor
