## PEARS BUILDING ROYAL FREE HOSPITAL NW3 2PF

### A geotechnical and structural assessment of matters affecting the potential impact of subterranean elements of planning application 2014/6845/P upon St Stephens Church and Hampstead Hill School

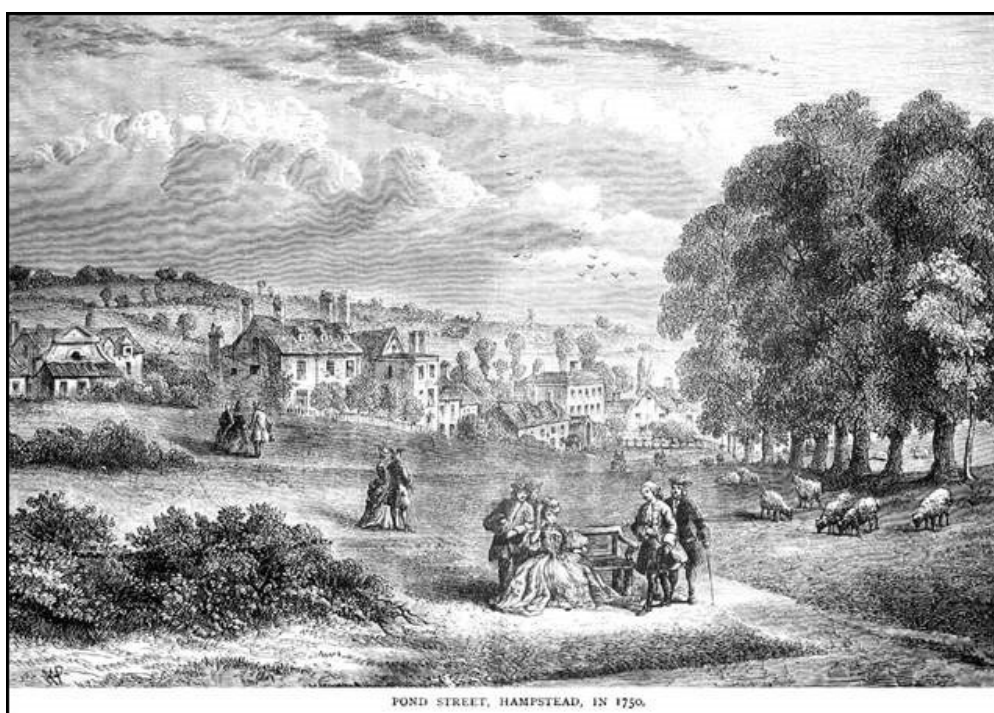
Plate 1 Engraving of Pond Street Hampstead in 1750 in Edward Walford, 'Old and New London', Vol V, 1878.

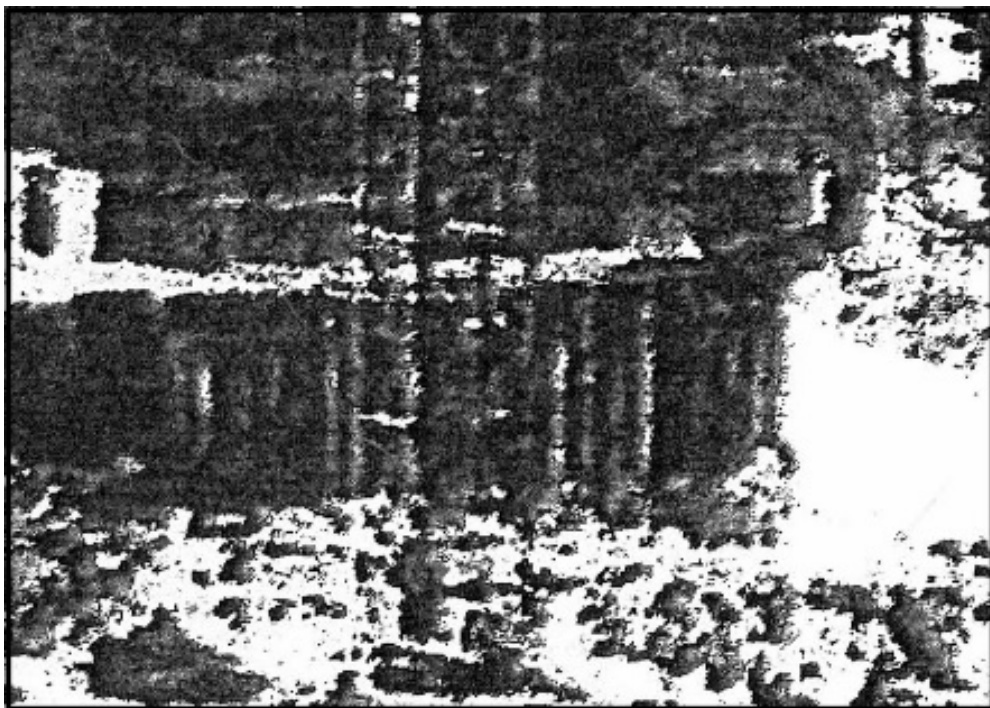
Plate 4A – Detail from Plate 4; piled retaining wall cantilevered without temporary lateral supports.

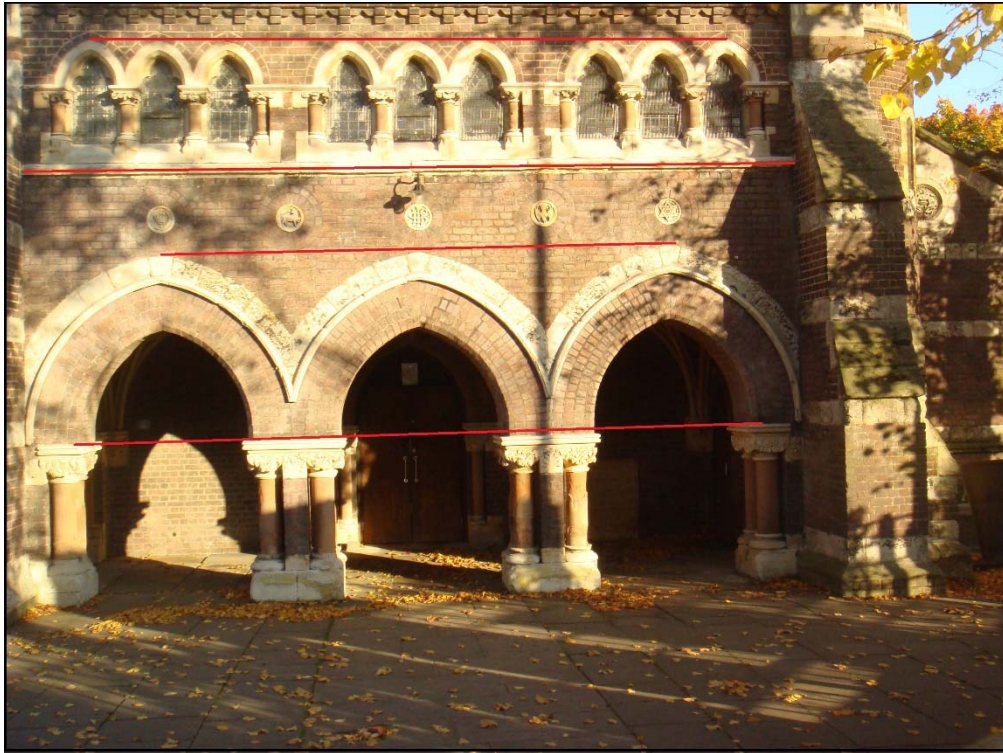
Plate 5. Narthex showing settlement of column right of centre and negligible effect on alignment of wall above.

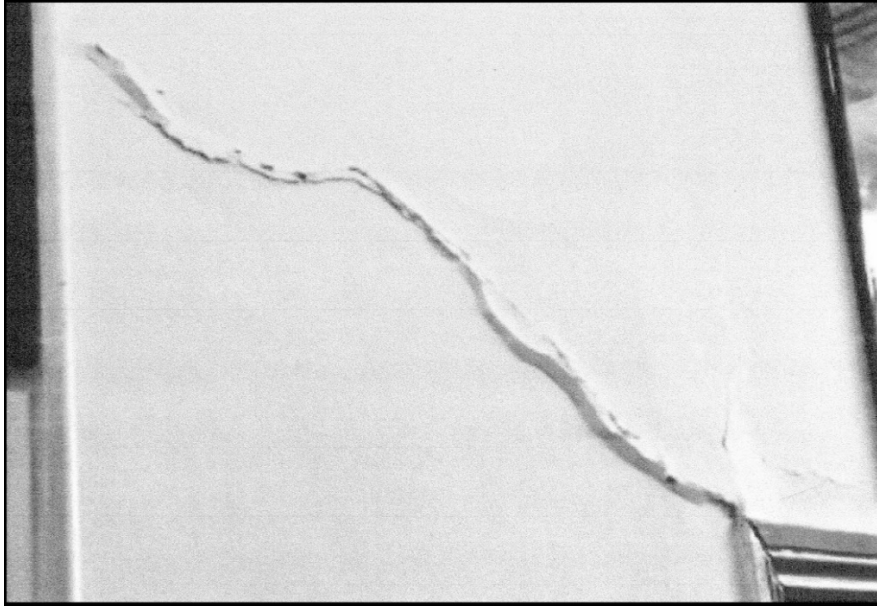
Plate 6 Client photograph

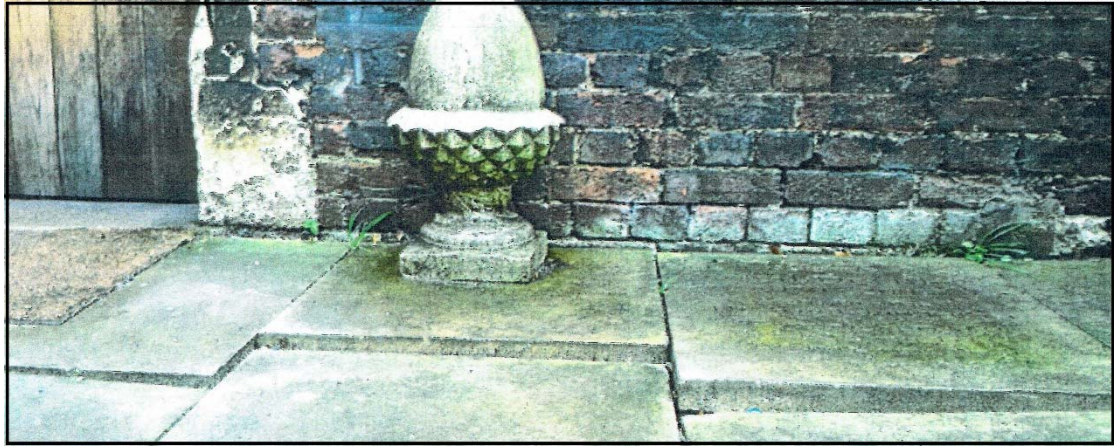
Plate 10 Client photograph

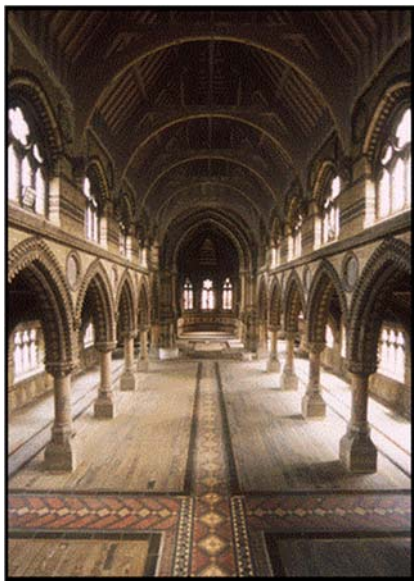
88. The structural arrangement of the church is inherently weak in that it lacks robustness. That is to say that if one part is weakened or gives way, the load it previously carried cannot be easily transferred to neighbouring parts without damage occurring.
