Condition Report

Prepared On Behalf of:
City and Provincial Properties PLC

Of the Property:
20-21 King's Mews London WC1N 2JB

Job Ref:
DK/mh/P1585

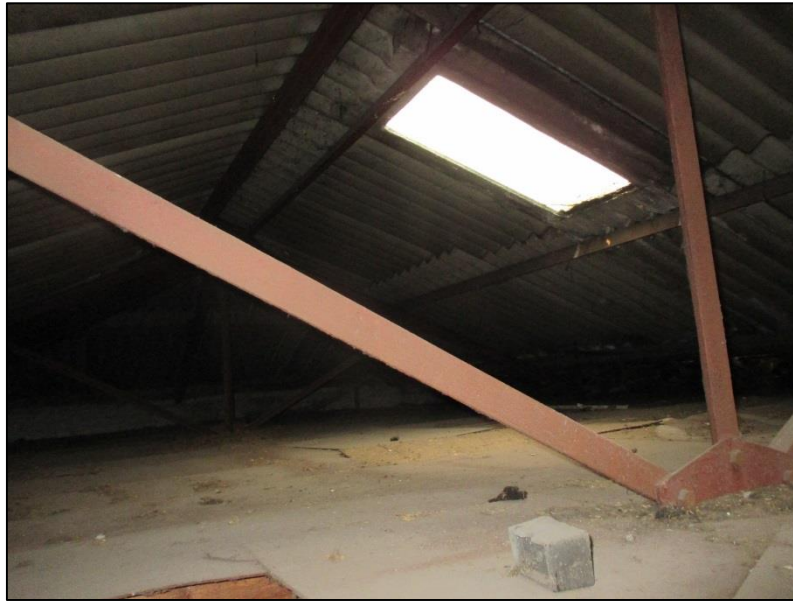
1. General rear facing view of underside of roof covering.

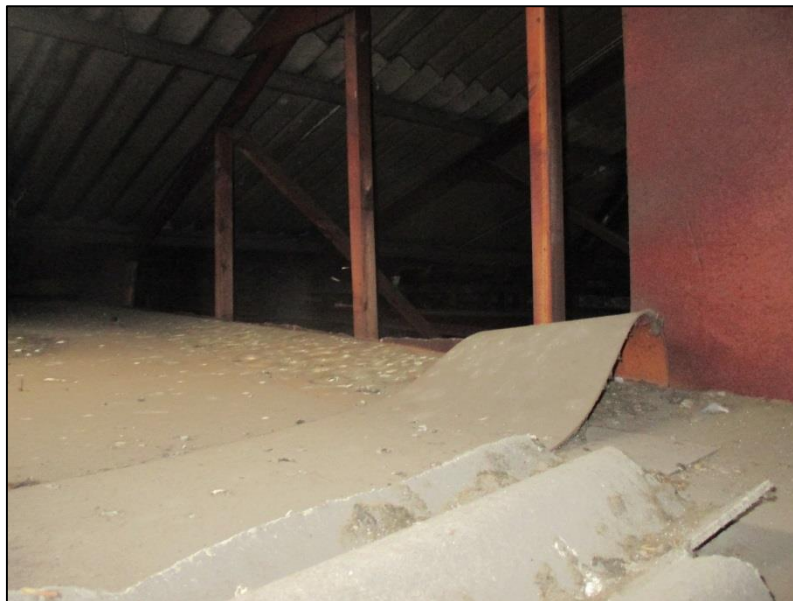
2. General front facing view of underside of roof covering.

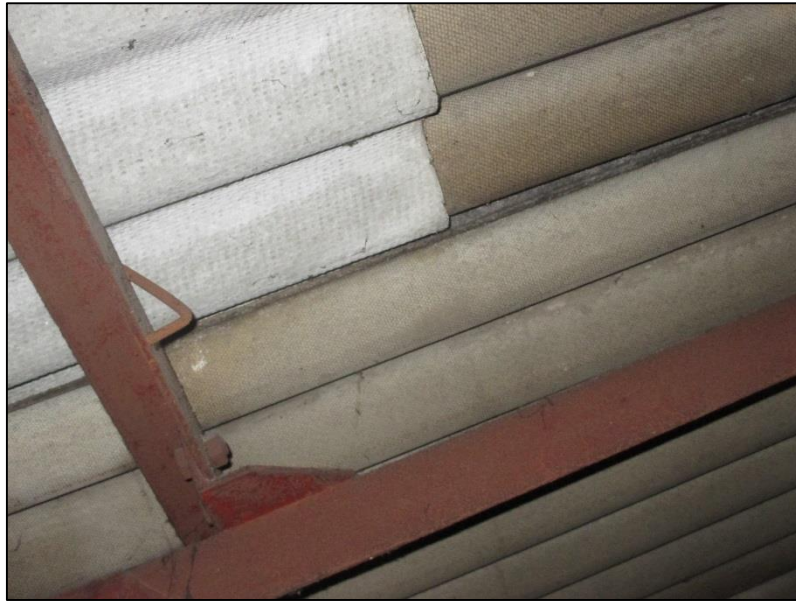
There is evidence to suggest that localised repairs have been undertaken to the fibrous cement covering with replacement sheets and/or a liquid coating applied in part which can be seen 'grinning' through the joints as external views could not be obtained. The localised patch repairs and extensive damp staining throughout the roof which has penetrated down to the ground floor ceiling with staining, fungal growth and mould noted suggests that damp ingress is current. Water dripping from the valley gutter/rainwater outlet is accumulating in a bucket to the front central office with decay to the floor structure adjacent.

3. Replaced corrugated fibrous cement sheets fixed to roof truss.

Whilst it would be prudent to carry out an assessment of the roof covering externally where safe to do so, we would recommend that you budget to replace the roof covering throughout. It is considered that the roof structure can be salvaged if replacing on a like-for-like basis however, the steel should be primed and decorated with the structural integrity assessed (particularly off the central steel beam and columns below). You may wish to consider installing edge protection for future maintenance.

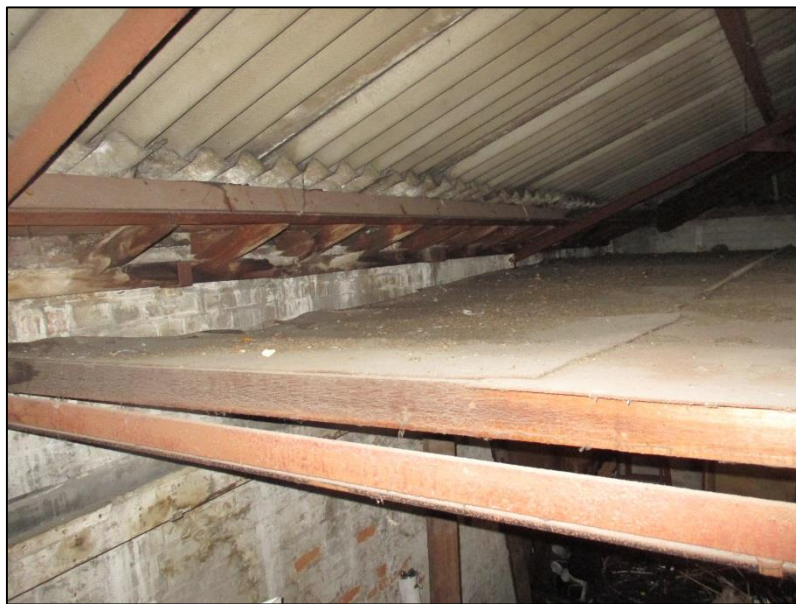
4. Damp staining and decay to base of roof slopes/rainwater disposal system.

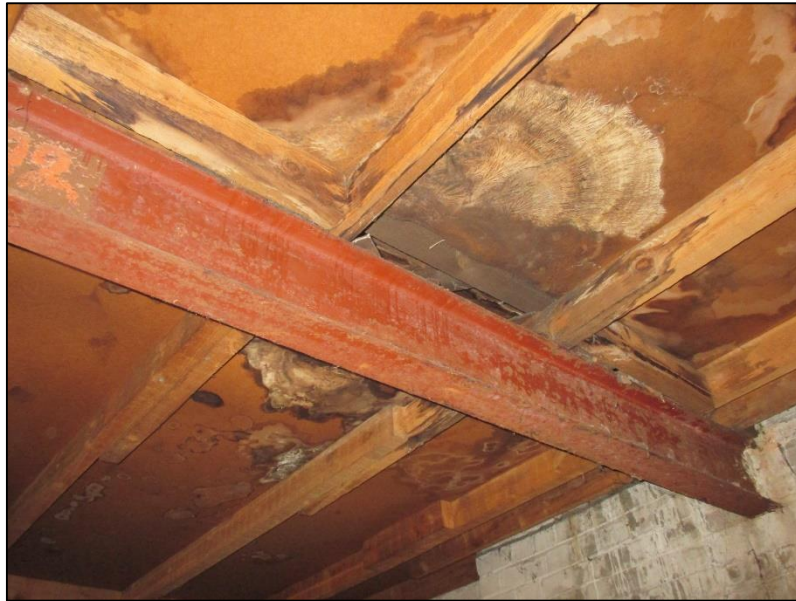
5. Extensive damp staining and suspected wet rot to first floor ceiling structure.

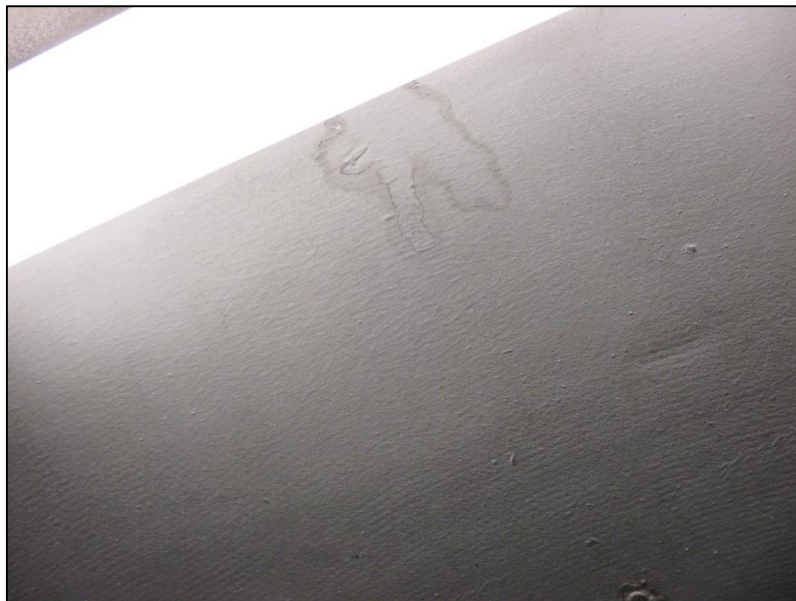
Fibrous cement boards are fitted to the workshop ceiling which are considered to be fixed to a timber structure as noted to the first floor. The ceiling structure is considered to be in better condition than the first floor however, the fibrous cement boards are considered to contain asbestos. The boards are bowing or detached in areas with mould growth towards the front of the workshop due to damp ingress from above. The timber structure and fibrous cement board will offer little resistance to fire spread noting the large mezzanine opening to the front LH corner of the workshop. We would recommend that an asbestos survey is undertaken and you should budget to strip out the ceiling structure and replace it with adequately sized timbers. New metal ceiling tiles can be fitted suitable for use in workshop areas. A timber specialist should be consulted to assess the concealed structure for timber decay including dry rot.

6. Fibrous cement boarding to ground floor ceiling finish.

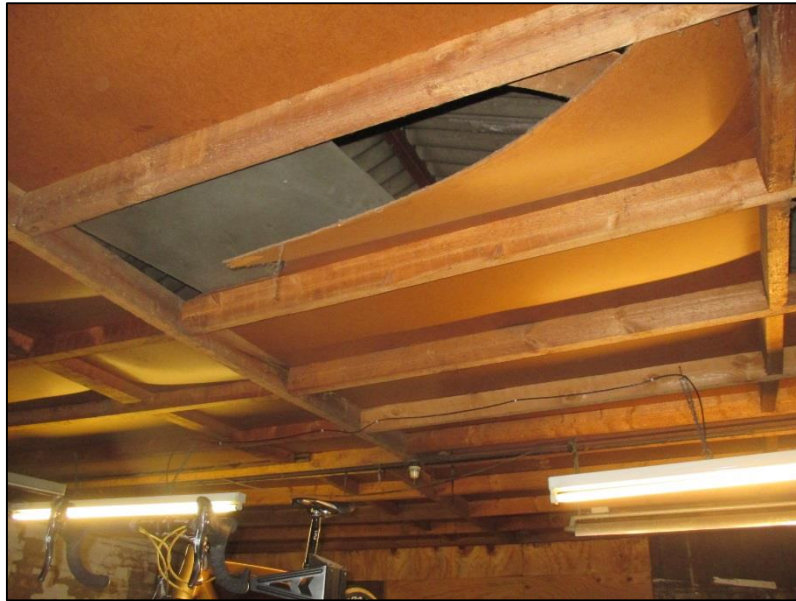
7. Displaced ceiling finish to first floor.

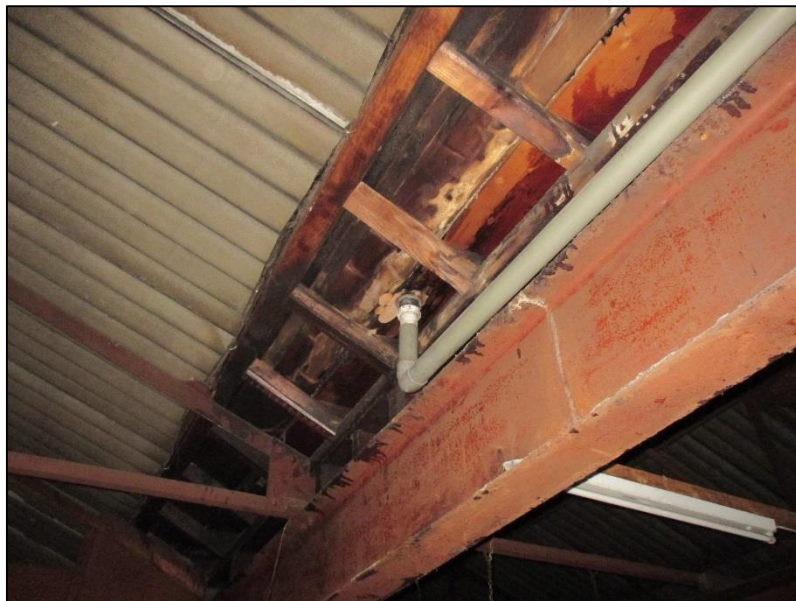
8. Damp staining to underside of central valley gutter with waste pipe connection.

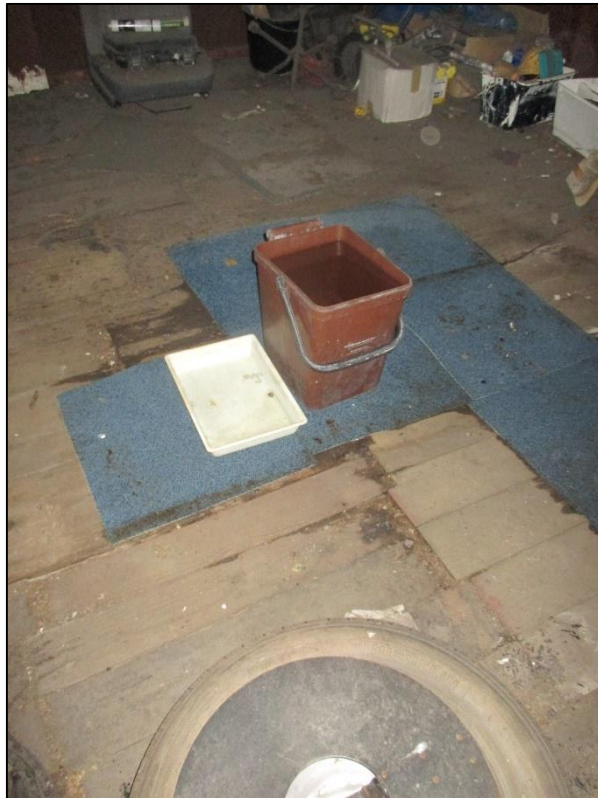
9. Accumulated water below central valley gutter.

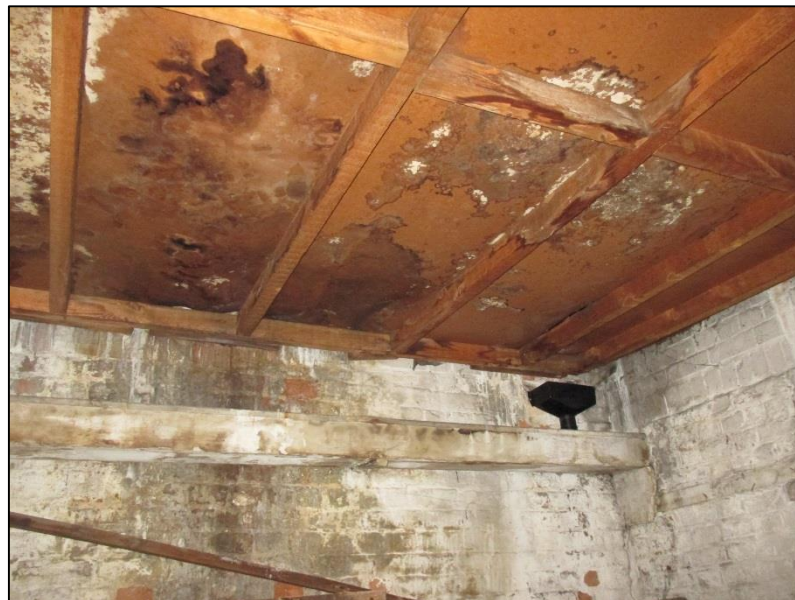
10. Further decay to first floor ceiling surface.

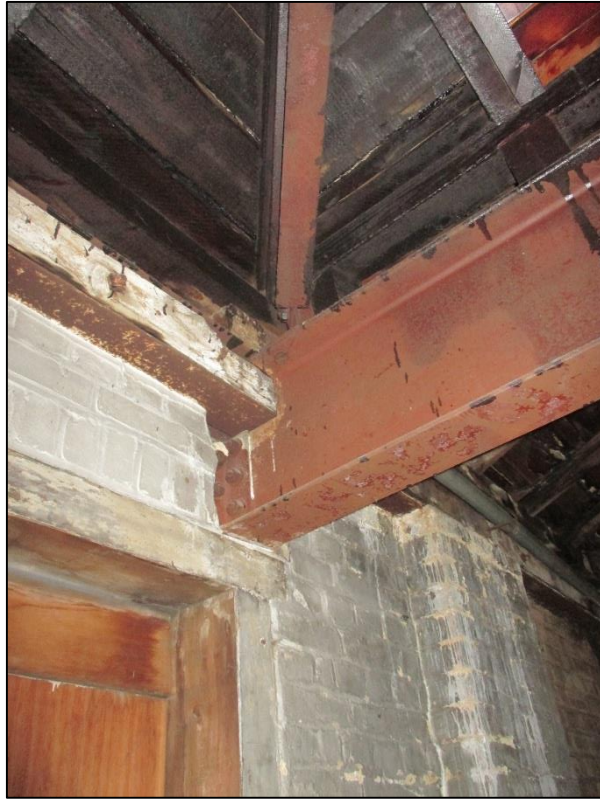
The steel beams at first floor level appear to be supported directly off the brickwork to the rear wall and notched in around the steel lintels to the front elevation supported upon the loading door frame which is not appropriate. The steel beams should be supported off padstones or bearing plates to support the loads. The steel and timber beams in the workshop that span from side to side are built into the party walls supported off steel bearing plates/lintels. The timber beam towards the front of the workshop has suffered from decay to the end bearing with a metal column and plate erected within the last 30 years or so.

11. Steel beam supported upon timber door frame/lintel.

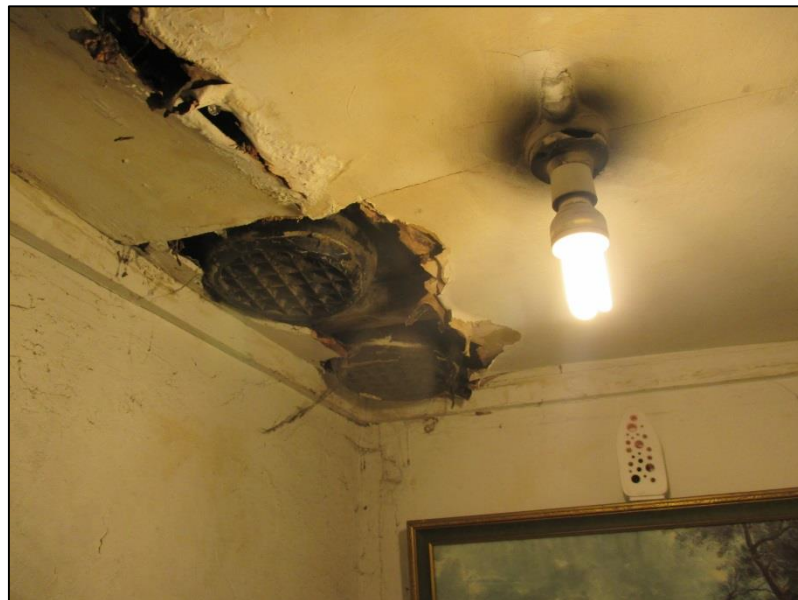
The timber constructed and assumed modern plasterboard ceiling surfaces applied to the office are considered to be in a fair condition however, the plastered ceiling is poor to the WC presumably due to damp ingress from the high level exposed roof which should be stripped out and reinstated. The fibre wool insulation should be removed to the ceilings around the light fittings to avoid overheating and prevent a fire outbreak. Alternatively, smoke hoods can be fitted.

12. Damaged ceiling to WC.

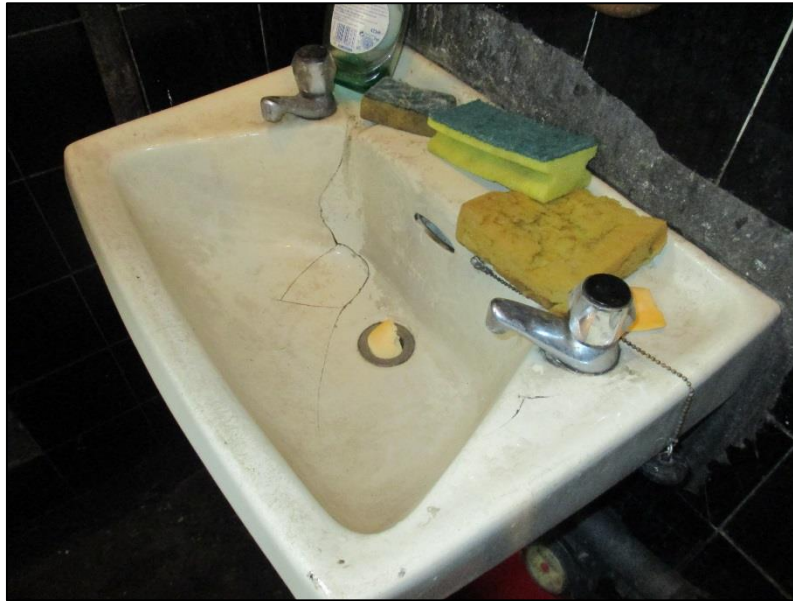
A basic WC vitreous china pan and plastic seat is fitted to the workshop WC enclosure. A vitreous china wall-hung basin is located in the adjacent lobby served by chrome mixer taps. The basin is considered to be approximately 30 years old provided with a Triton water heater which is approximately 10 years old. The basin is cracked and heavily soiled. The WC pan and cistern are considered to be in a fair condition replaced within the last 5 years or so although would benefit from thorough clean. The WC pan is considered adequate although the wall and floor surfaces should be replaced together with the ceiling, basin and associated pipework.

13. Cracked basin to WC lobby.

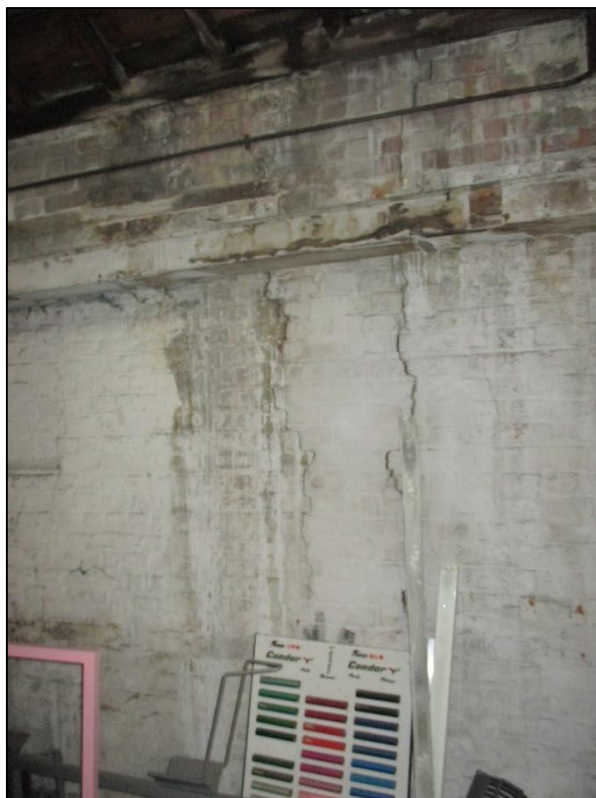
The left hand party wall is built of painted brickwork construction laid English bond when viewed internally over ground and first floor largely obscured by stored items. Rendered plaster and tiles are applied to the WC location. Embedded steel lintels/bearing plates are noted at ground floor level supported the floor beams above. The wall is considered to be plumb however, substantial 8mm wide tramline vertical cracks are generally noted centrally continuing down to ground floor level tapering to 1mm with a third vertical crack adjacent. This is considered to be caused by the lack of movement joints however, the tapered cracks suggests movement may have occurred possibly exacerbated by the construction of No.5 Northington Street. Copies of the discharged Party Wall Awards should be obtained with repairs undertaken accordingly. Noting the extent of the structural cracking, further investigations are required by a structural engineer who may insist upon monitoring works to determine if the movement is progressive. The walls are generally damp stained at high level emanating from the eaves level with frost damaged bricks noted. The damaged brickwork should be cut out and new bricks stitched in when the roof is repaired. Localised repointing works should be budgeted for. The wall is out of plumb to the WC and should be reconstructed and the low level and heavily blown de-bonding render/plaster to the WC walls should be hacked off and reinstated including the wall tiles. We would recommend that you obtain a quotation from a damp proof specialist to install a chemically injected damp proof course and waterproof tanking to the party walls as required. We advise that chemically injected damp proof courses require notification under the Party Wall etc. Act 1996.

14. Vertical cracks to LH party wall at first floor level.

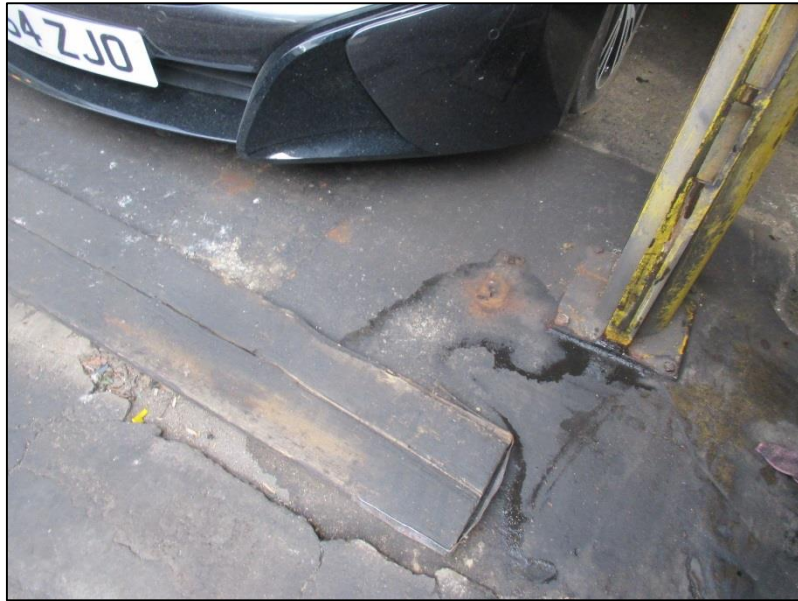
15. Damaged ground floor slab at door threshold location.

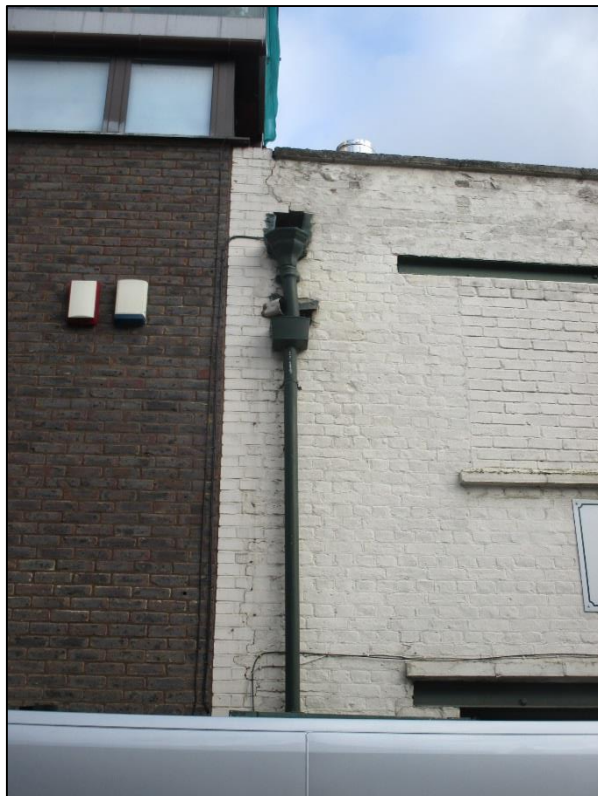
Replacement bricks have been stitched in to the left hand side, we assume, when 5 Northington Street was constructed. Settlement cracking is noted to the pointing throughout. Reinforcement rod repairs should be fixed into the mortar bed joints to retain the brickwork. The pointing is considered to be fair elsewhere although we would recommend you budget to rake out and repoint the brickwork over the bottom four courses or so and allow for localised brickwork repairs.

16. Vertical cracking to brickwork stitching adjacent 5 Northington Street.

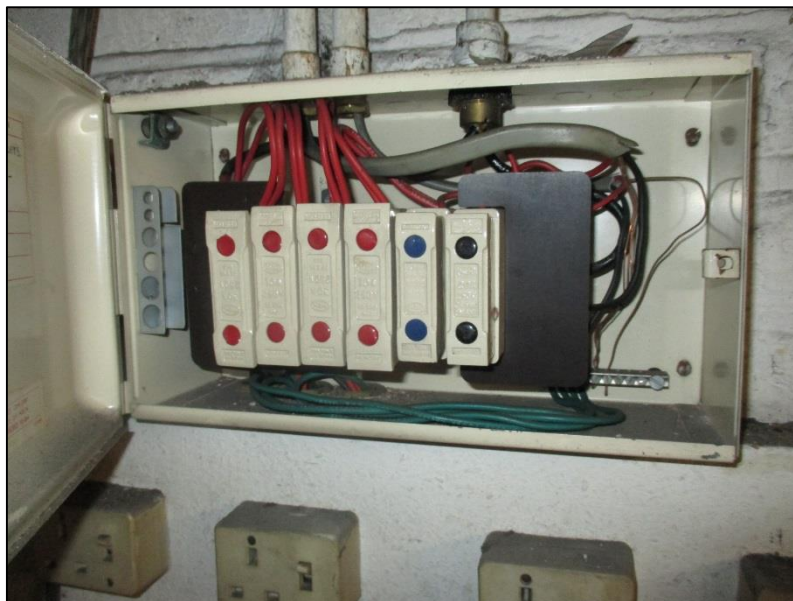
17. Dated electrical fusebox to RH wall at first floor level.

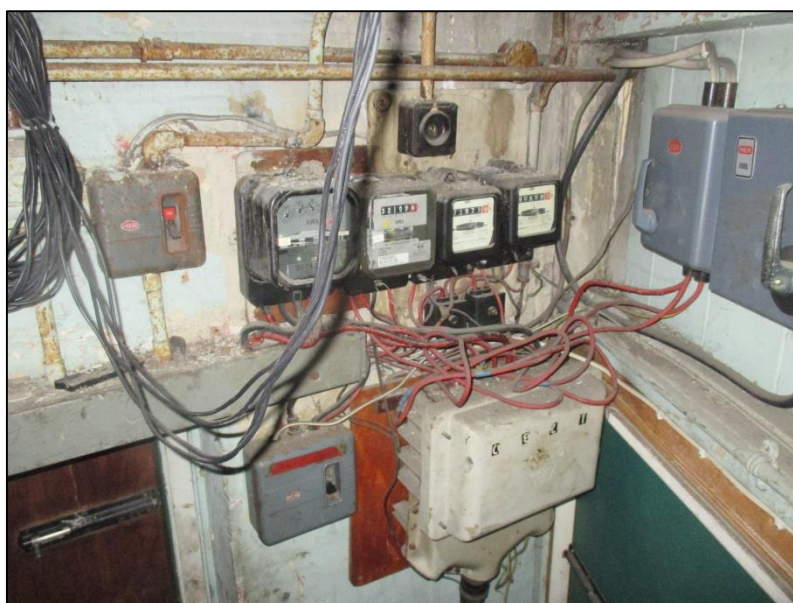
- 8.4 The incoming electrical supply with electrical meters and main switchgear are located within the means of escape stairwell area separating the workshop with a timber partition. The electrical components should be relocated, the timber partition lined with plasterboard and the staircase replaced.

18. Incoming electrical main and electrical meters in stairwell.

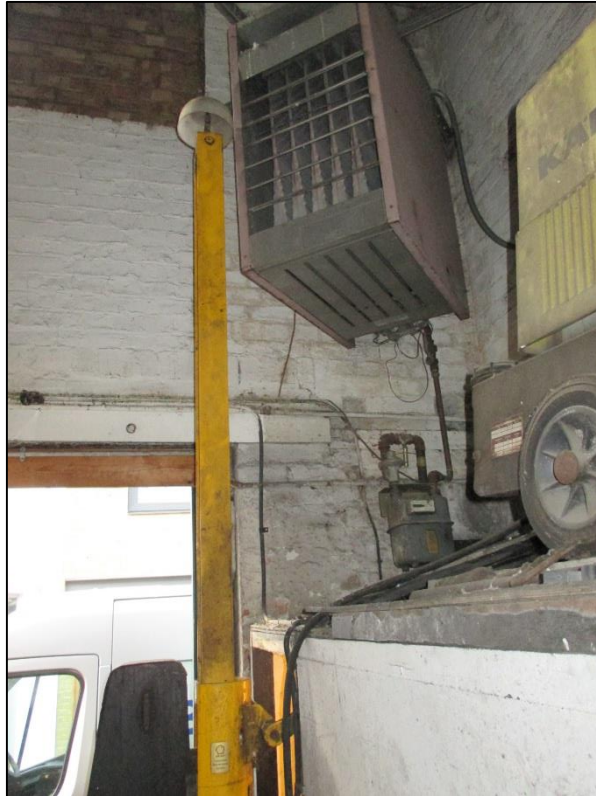
19. Gas heater and gas meter to workshop.

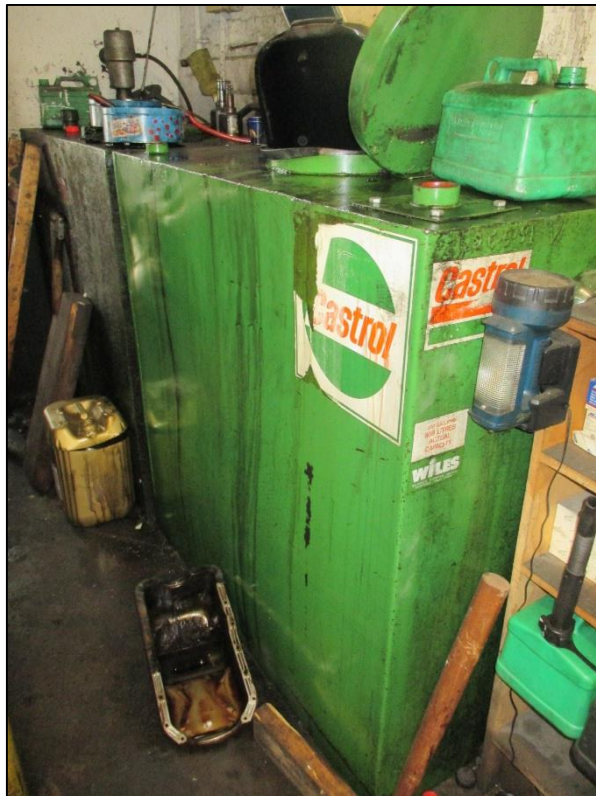
20. Oil/fuel tank to workshop.

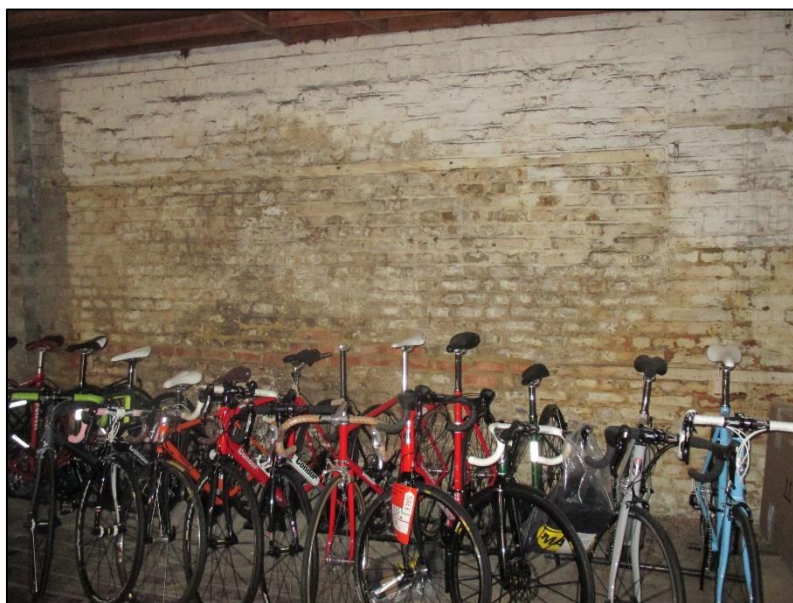
The rear party wall when viewed internally is built of painted brickwork construction laid English bond with embedded timber lintels inserted which, we assume, have been retained following the bricking up of original openings. The lintels can be replaced with concrete. The ground floor section of the wall was additionally supported by brick piers and partly rendered. The rear wall was largely obscured by stored items and, particularly, parked vehicles at ground floor level. A large structural crack is noted to the left hand side of the wall at first floor level adjacent the left hand party wall continuing down to ground floor level with undulations noted to the rendered wall. Further investigations are required by a structural engineer as detailed above. Extensive damp staining is noted throughout the rear wall particularly at first floor level leading to frost damaged bricks caused by a defective roof covering. Frost damaged bricks should be cut out and new bricks stitched in. It would be prudent to assess the roof covering to the rear neighbouring property to determine if similar defects are occurring.

21. Damp staining to rear wall.

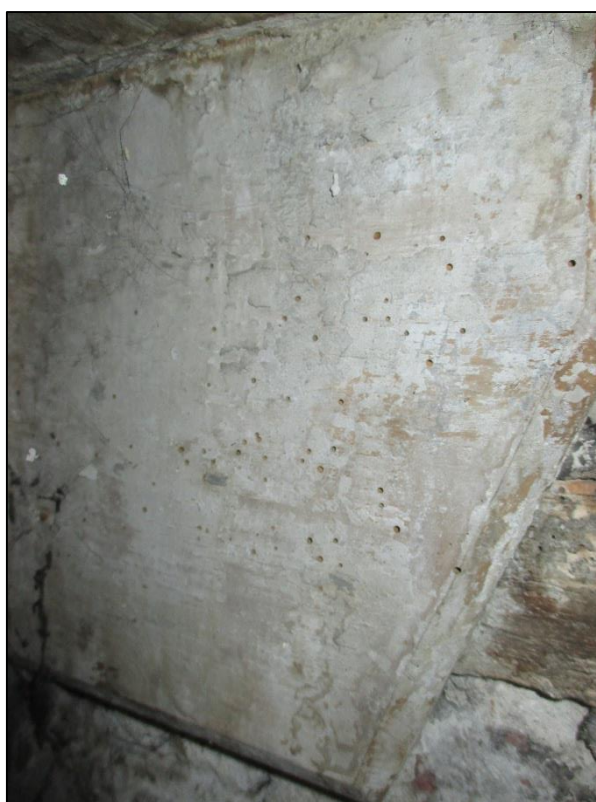
22. Woodboring insect attack to rear wall.
