**FURTHER STRUCTURAL APPRAISAL**

**ONE SEVEN ONE  
171A FINCHLEY ROAD  
LONDON  
NW3 6LB**

**JAMES ANDREWS RSW**

**Project N° 2411  
October 2015**

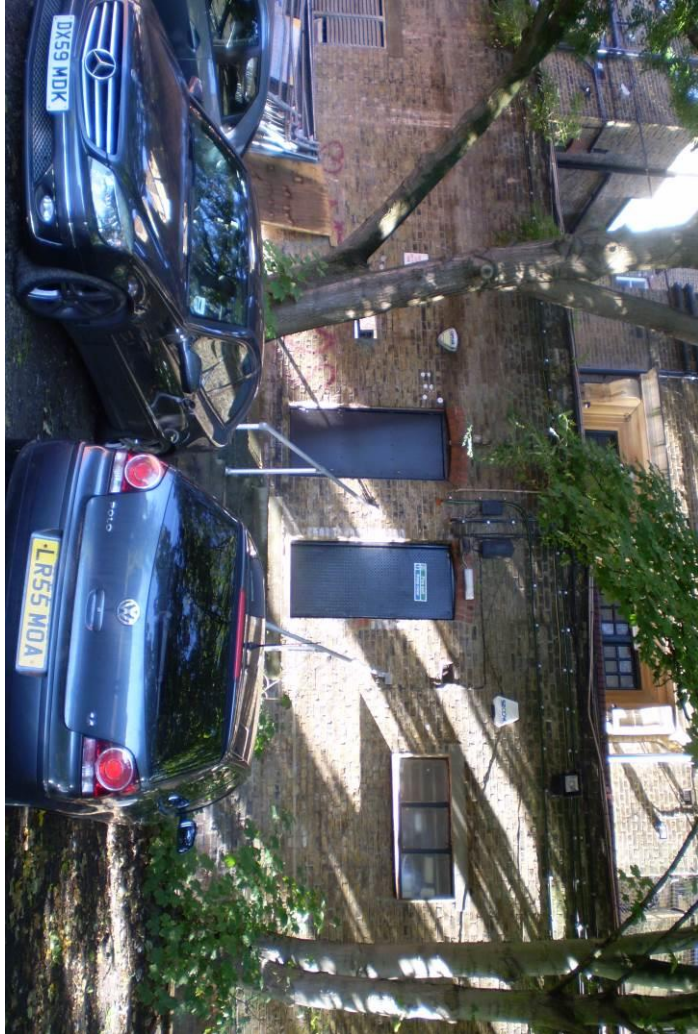
Plate 1 – General view of the rear area of the Basement to N° 171A and adjoining property

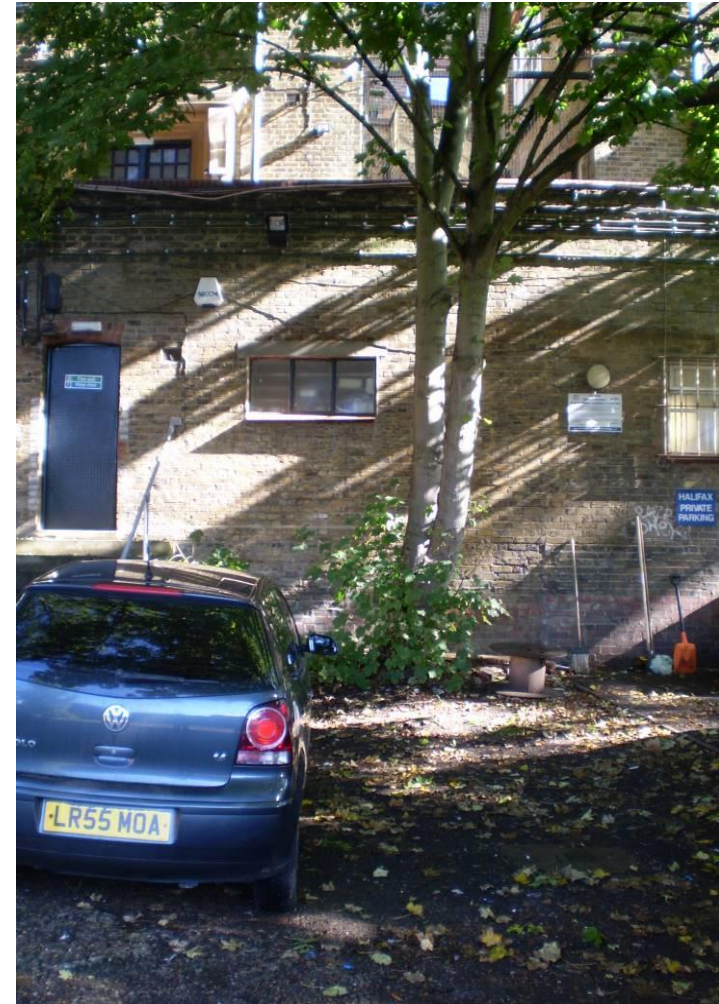
Plate 2 – View of rear elevation to the Basement of adjoining property

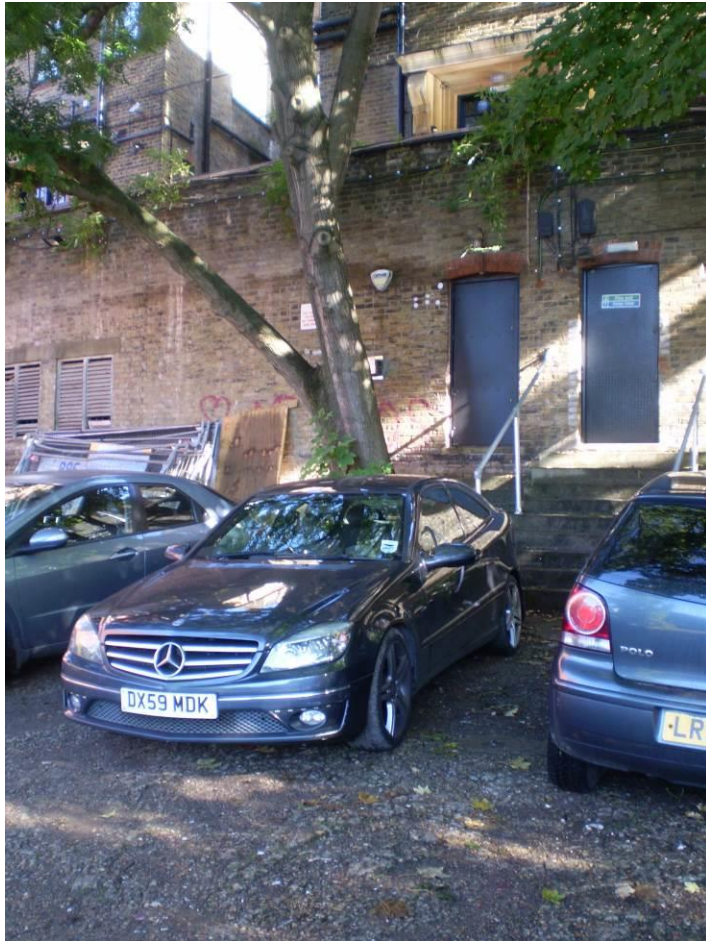
To the rear of 171A Finchley Road, the crack damage is similar to that noted within the original report. Although the toothed vertical crack recorded last time does appear to have increased only very slightly.

Plate 3 – View of elevation to the Basement of N° 171A

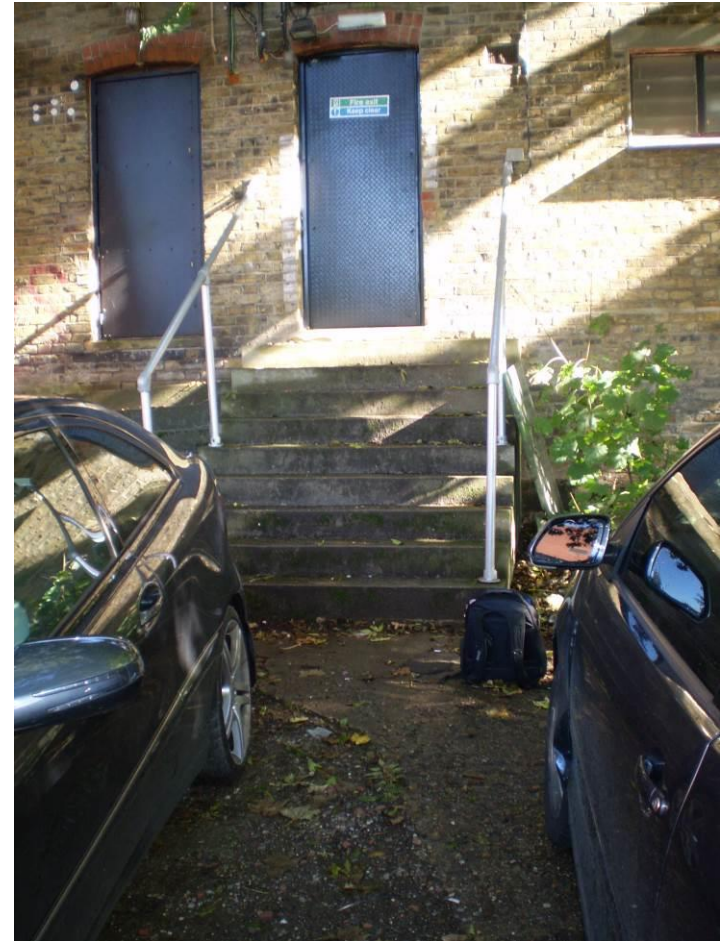
The steps that serve the adjoining property ‘Spec Savers’ however have been completely rebuilt with new handrail. It is noted however that there is some settlement of the concrete steps and a slight movement away from the rear boundary walkway wall although the handrail shows little signs of distortion or movement. It has likely flexed due to the type used.

Plate 4 – View of rear access steps to adjoining property

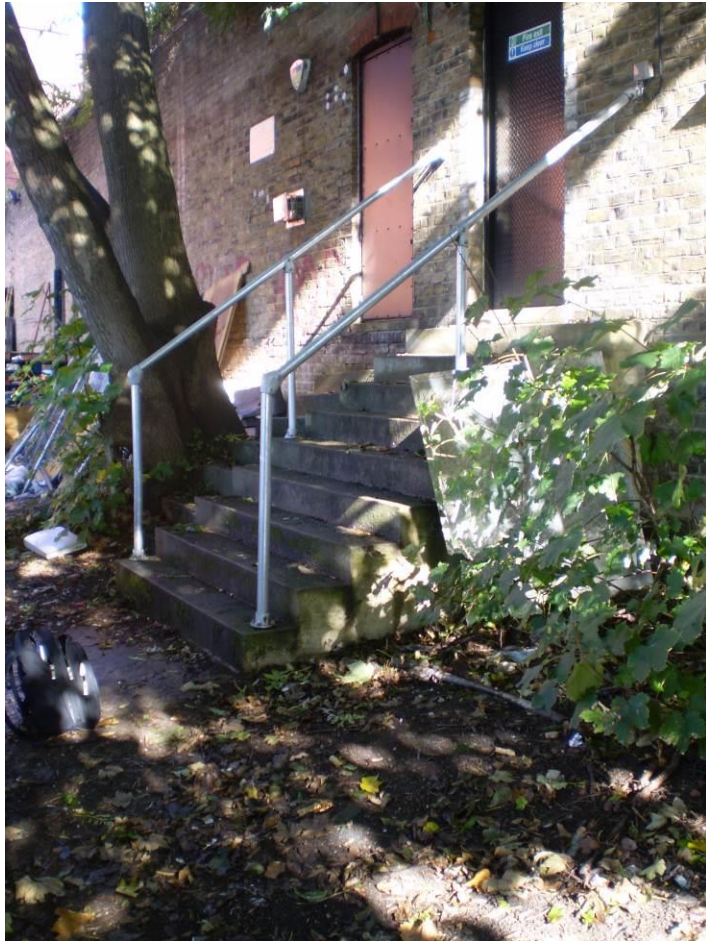
Plate 5 – View of rear access steps to adjoining property

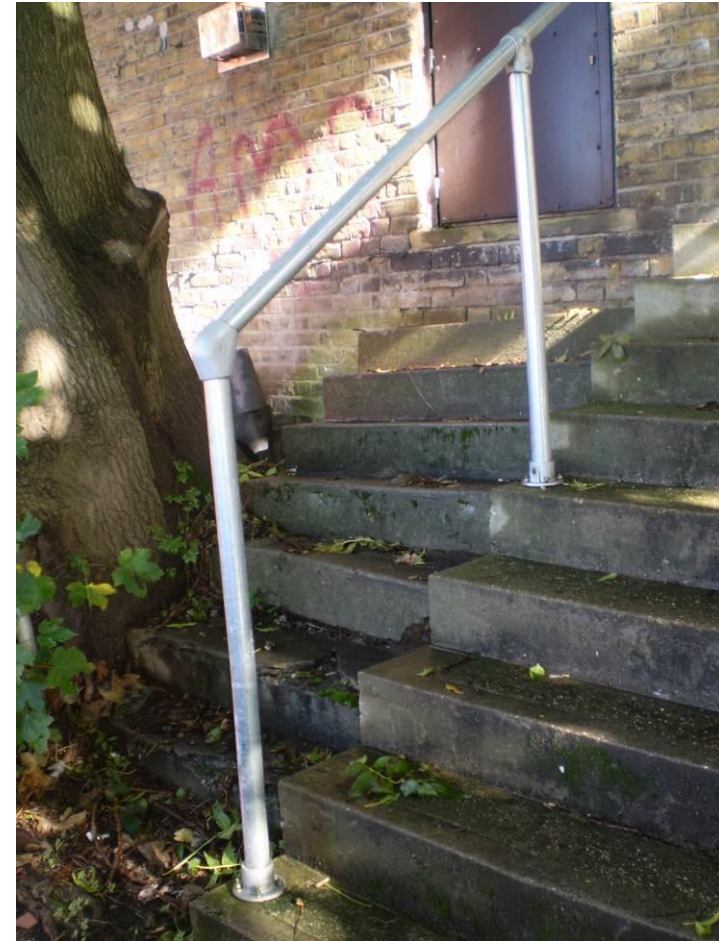
Plate 6 – View of steps to rear adjoining property with steps to N° 171A beyond

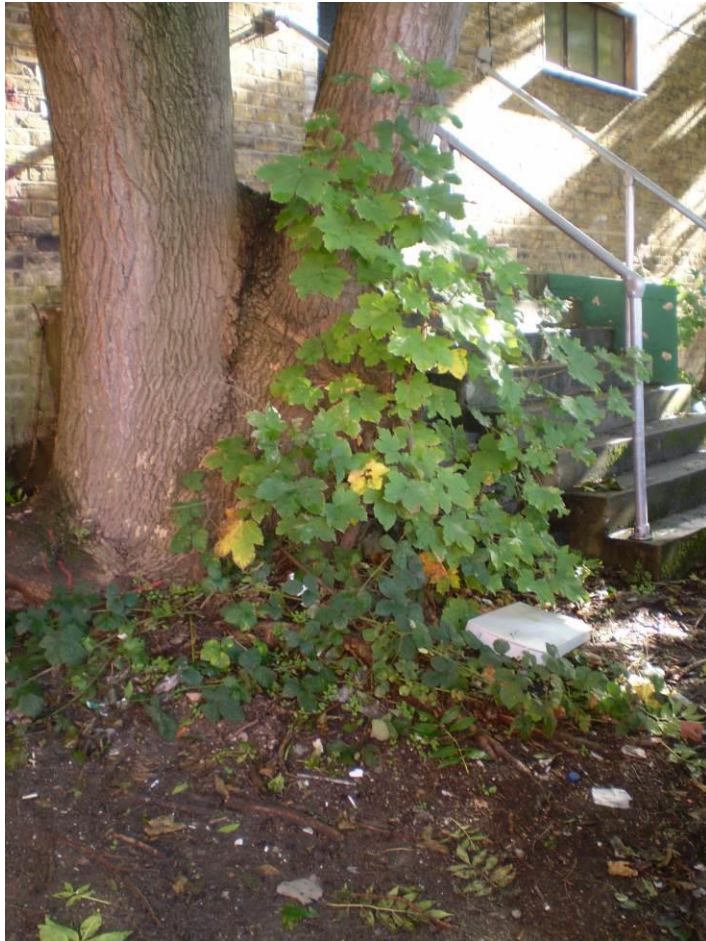
It should be noted and of concern that the trees along the rear of the basement elevation are within 1.0 meter of the wall. Any new foundations constructed in this area with the trees as seen on site would have to be to a minimum depth below ground level of at least 1.5 m (in accordance with NHBC and Building Regulation requirements).

Plate 7 – Base of tree adjacent to the rear steps to N° 171A

The only way to ensure that there is no ongoing issues from the trees, on the assumption that they are the proximate cause of the damage, is to have the trees removed.

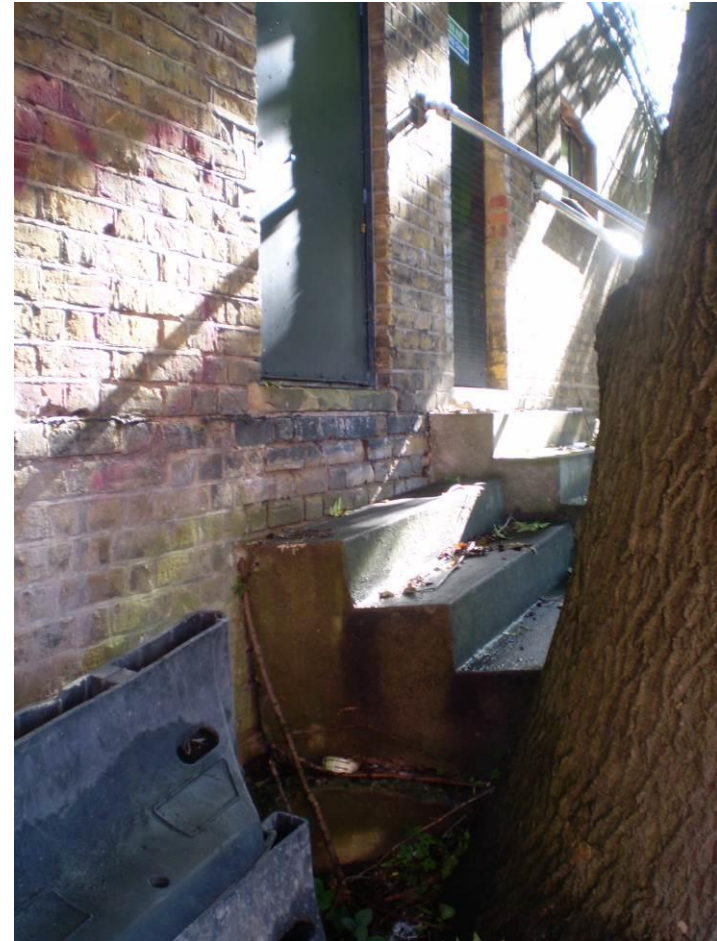
The mass concrete access steps which serve 171A Finchley Road, have major crack damage and have settled and moved away from the rear boundary walkway wall. The gap between the face of the mass concrete is in excess of 100 mm at the worst case. There appears to be a worsening since the previous visit.

As referred to earlier in this report if new foundations were to be constructed with the trees in their present position the foundation level would have to be at least 1.5 m below external ground level. It is very unlikely that this is the case, bearing in mind the age of, and type of footings for this building. Although the stairs and the rear walls have been repaired to the adjoining property of N° 171A. The damage seen does not confirm or otherwise whether the tree roots pass beneath the boundary wall. However the new steps although as a mass block is sound there appears to be a slight separation between the rear wall face and the back face of the block of steps. Whether there is a separation joint between that has disintegrated it is not possible to confirm. But the gap seen is rather larger than a typical separation joint and therefore some form of settlement has occurred. Timing for this is not possible to confirm, but if the trees are an issue with any ground movement then the settlement would commence once the block of steps has been completed.

Plate 8 – Close up view of steps to N° 171A settled and moved away from rear wall

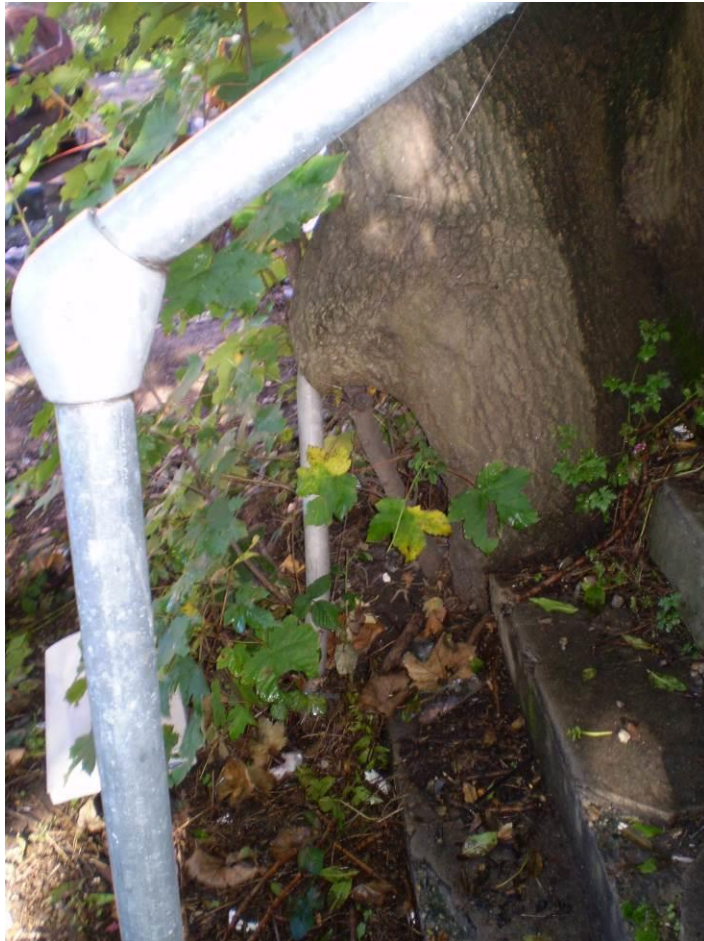
Plate 9 – View of existing hand rail encased by the tree at the steps to 171A

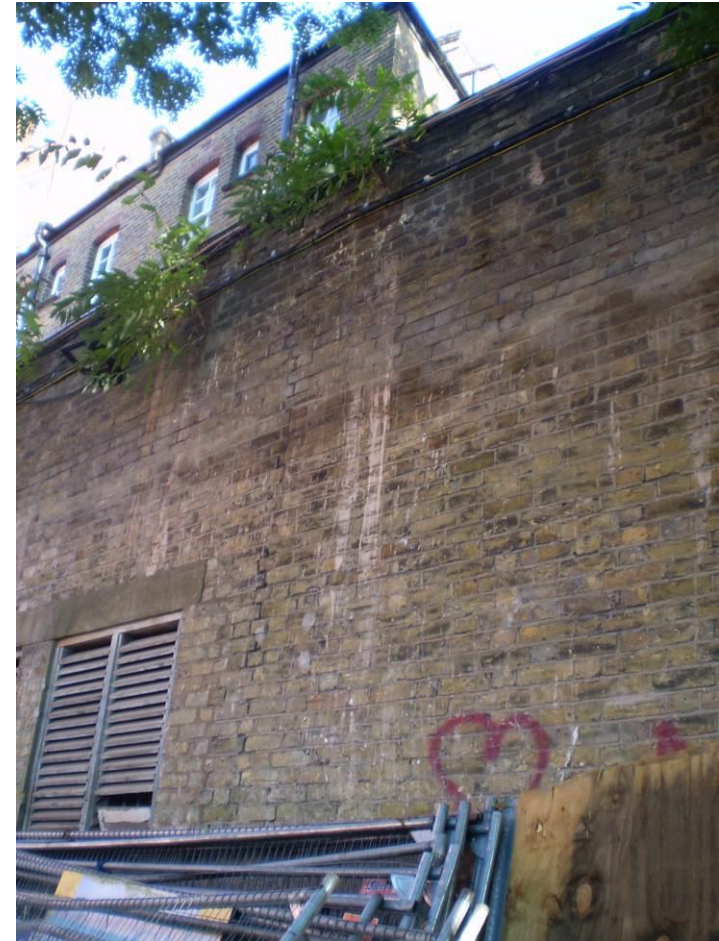
The damage as seen at the rear wall to 171A, when compared with the record photographs from the 2011 report has got worse. The magnitude of this is not possible to gauge as no formal monitoring regime has been set up.

Plate 10 – Vertical crack damage to the rear wall of N° 171A Basement

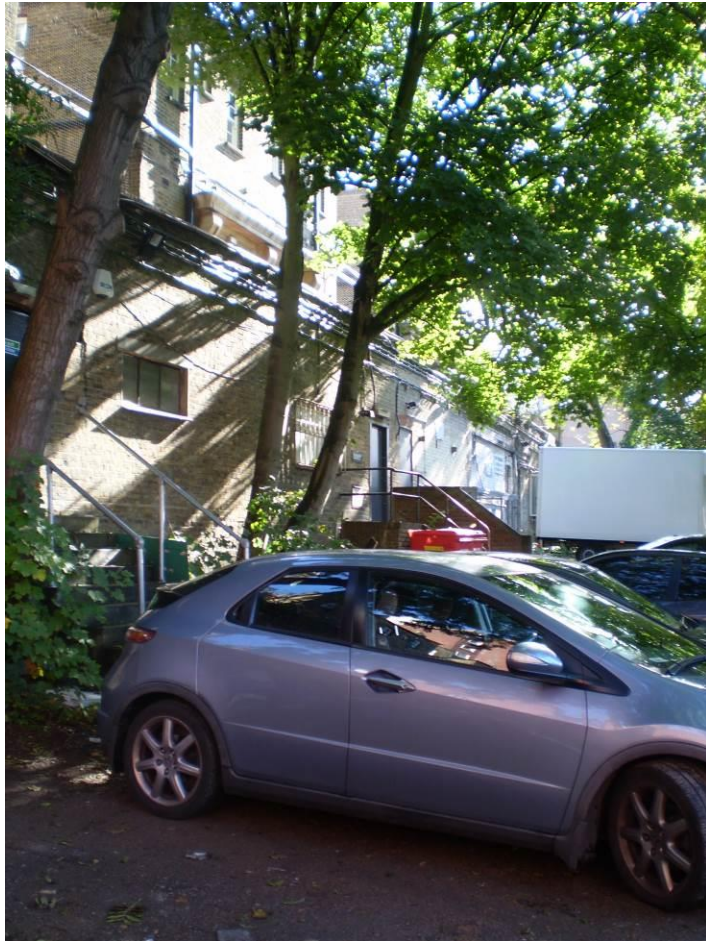
Plate 11 – View of tree adjacent to rear wall to adjoining property

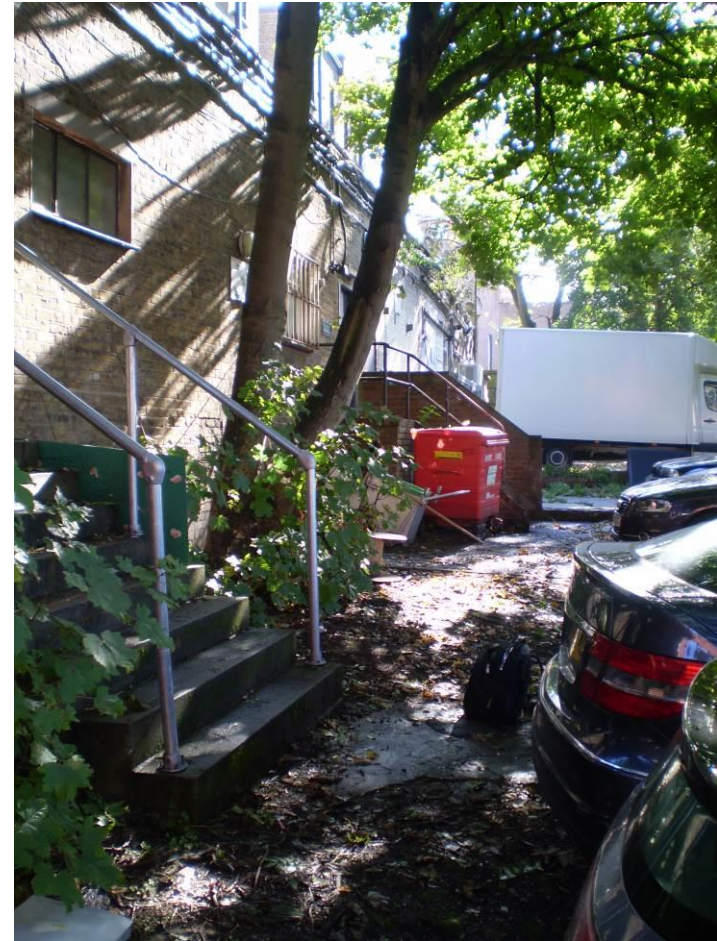
Plate 12 – View of bottom of steps to the adjoining property

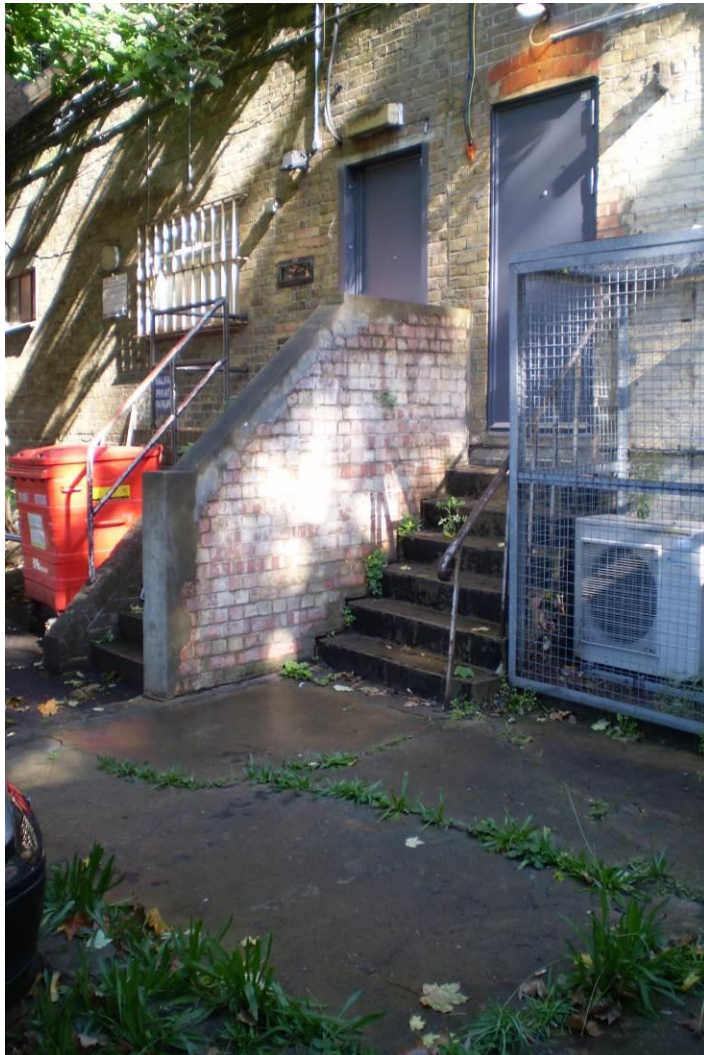
Plate 13 – View of steps to properties beyond the area at the rear of N° 171A

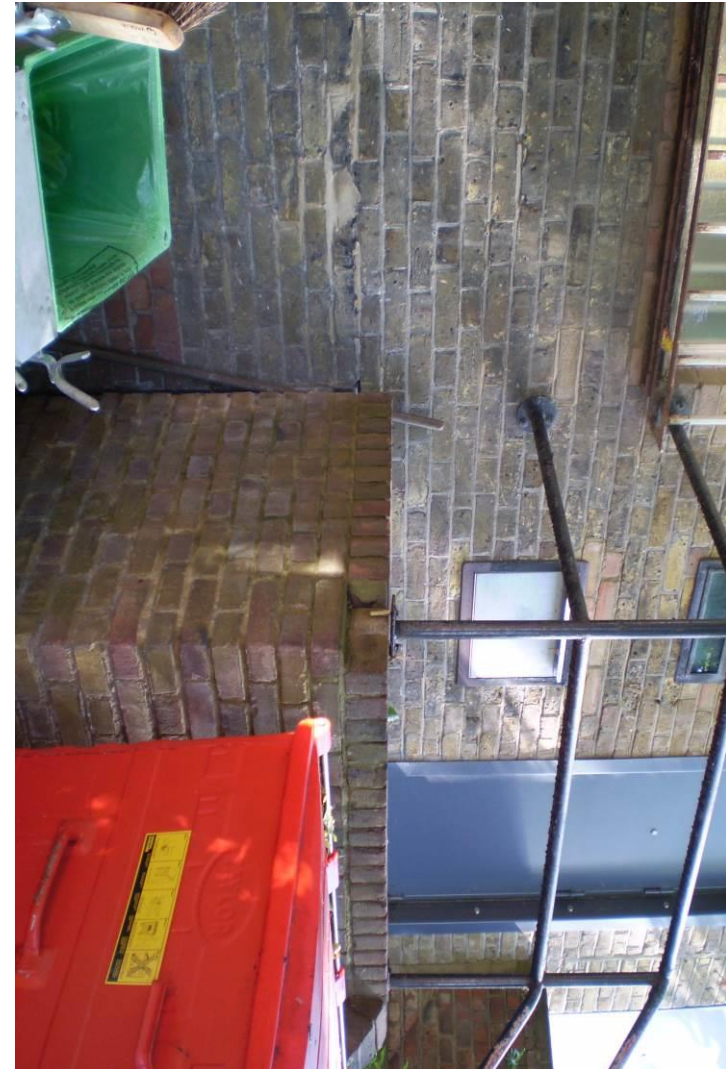
Plate 14 – Crack damage to the step beyond the area of N° 171A (with gap between wall and step structure)

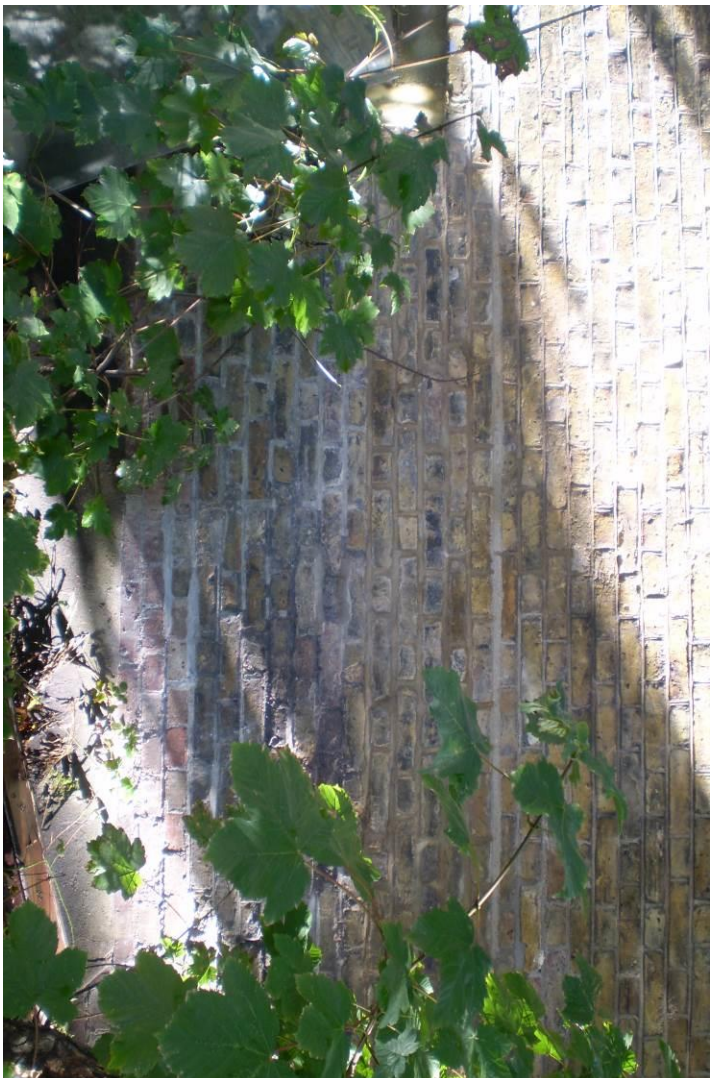
Plate 16 – Further repaint/crack repairs to rear elevation to adjoining property  
below dpc level

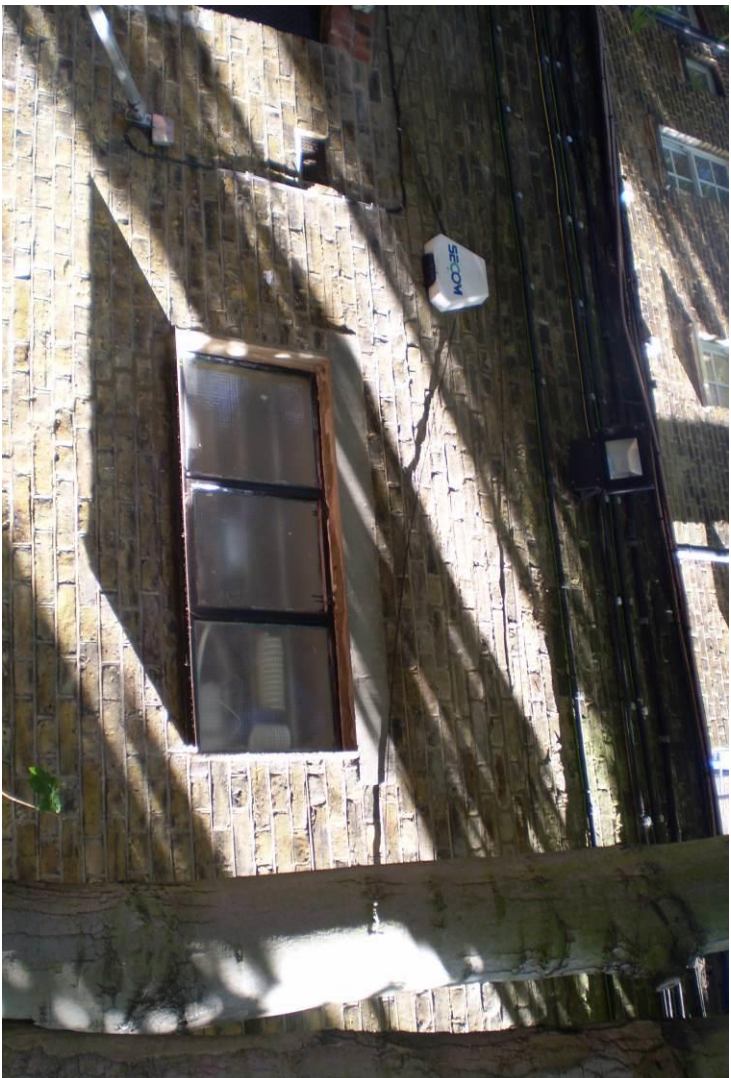
It was noted that the right hand side shop to 171A has been refurbished recently and ‘Spec Savers’ occupy this unit. As part of the refurbishment the rear elevation has been repainted and repaired where crack damage originally occurred. A photographic record of the repairs are included within Appendix A at the end of this report. The timing of the repairs is not known but there appears to be no new crack damage to the rear elevation.

Plate 15 – Repaint to rear elevation of main wall to adjacent property

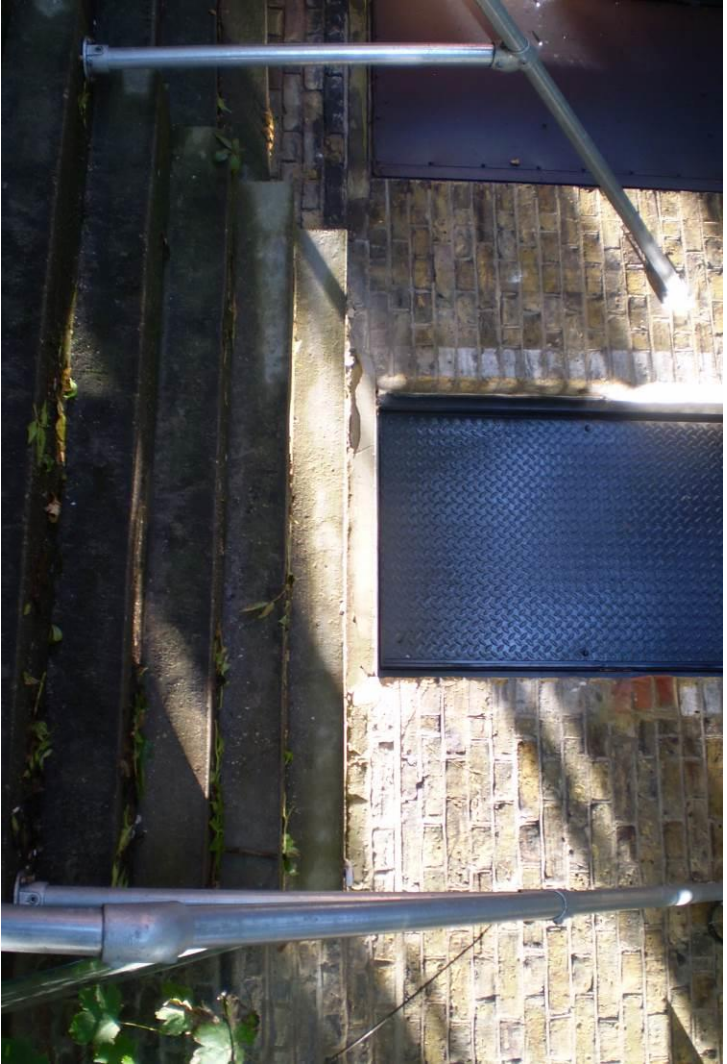
Plate 17 – Damage to threshold at the top of rear steps to adjoining property

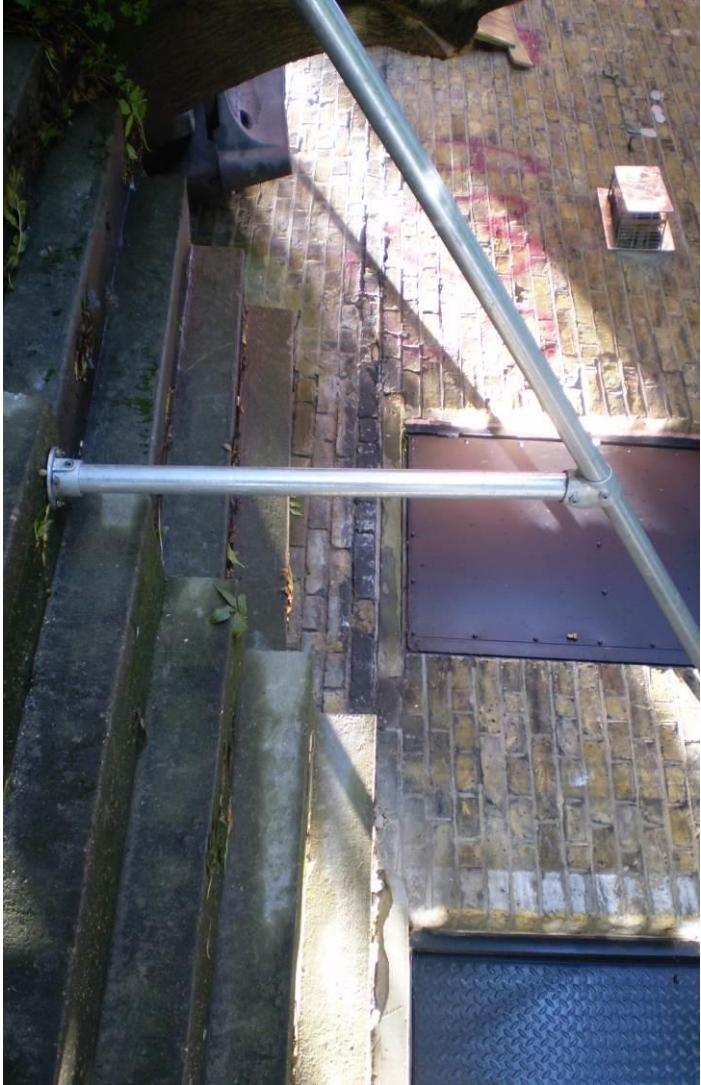
Plate 18 – Comparison view of steps to rear of N° 171A and adjoining property

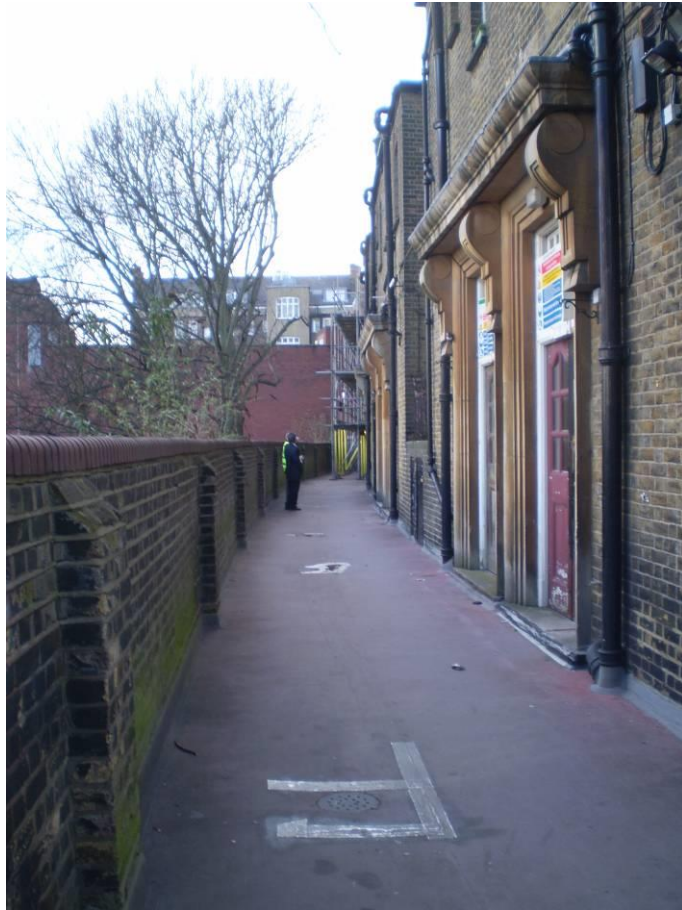
**Plate 2** Rear Open Walkway

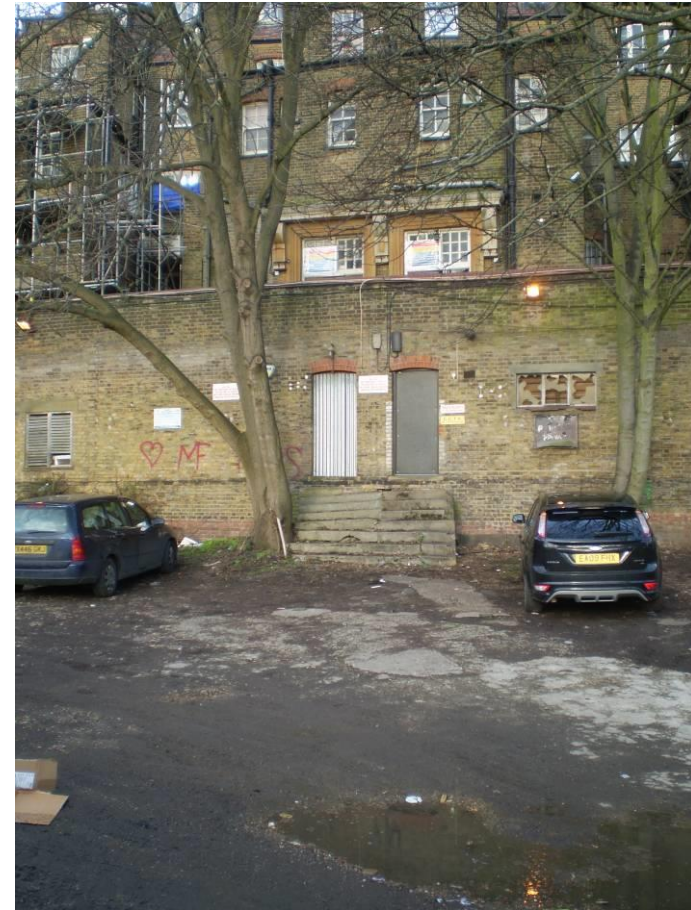
**Plate 1** Typical Rear Elevation

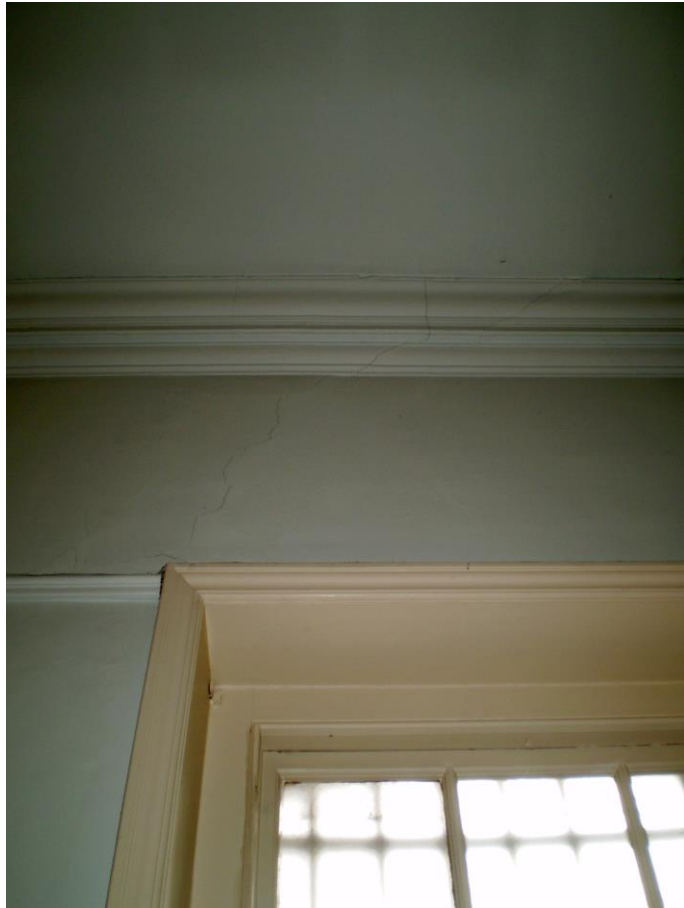
Crack in the rear right hand corner. Crack across the corner extending slightly down the rear wall. Crack less than 1.0mm (Hairline). **Plate 4 refers.**

**Plate 4** Crack in rear wall and ceiling

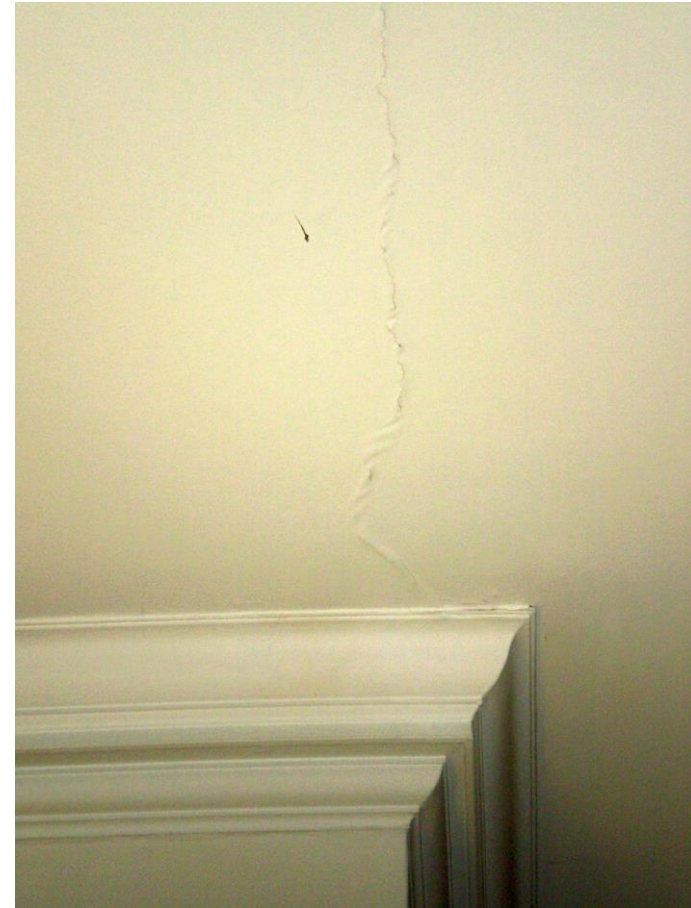
Crack in the ceiling towards the rear left hand corner above the staircase down to basement level. Crack runs parallel to the party wall and away from the bulkhead from the stairs to the flats above. Slight ruckling in the ceiling finishes also. Crack approximately 1.0mm width (Fine). **Plate 3 refers.**

**Plate 3** Ceiling crack to rear of shop

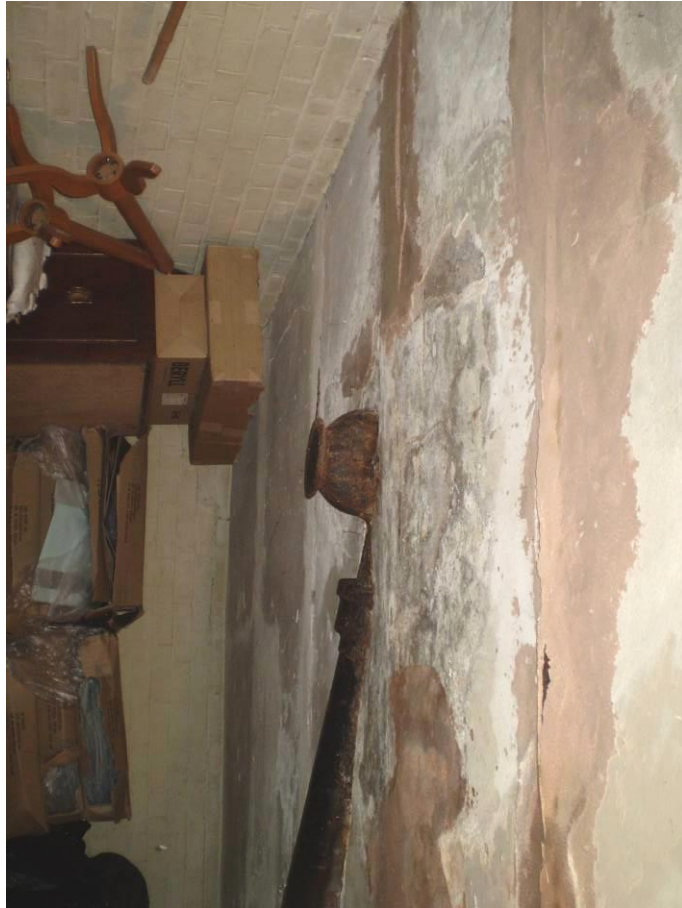
**Plate 6** Ceiling water penetration damage at walkway gully pot location

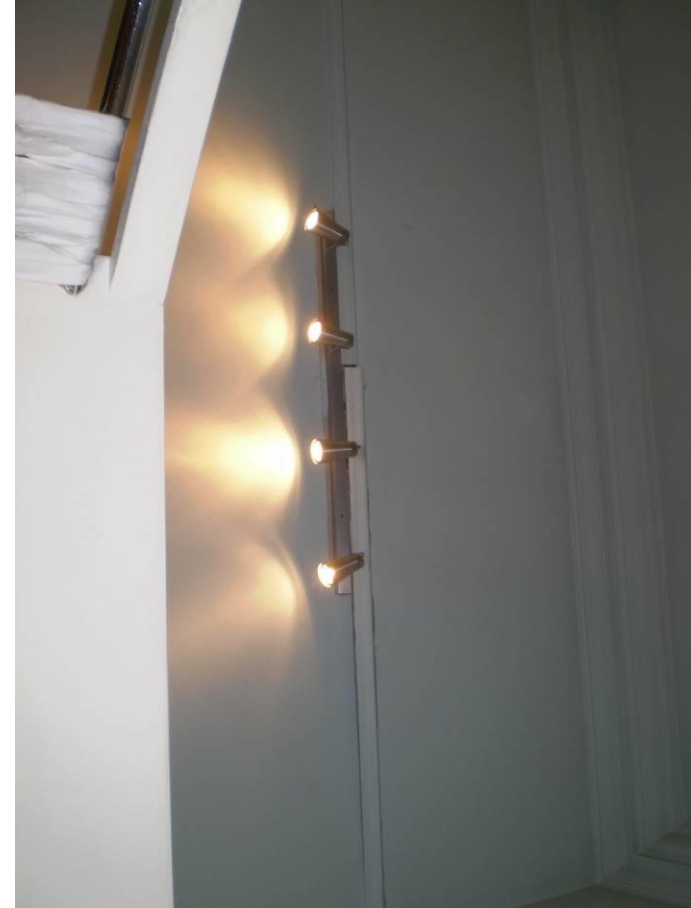
**Plate 5** Picture rail parted from internal wall

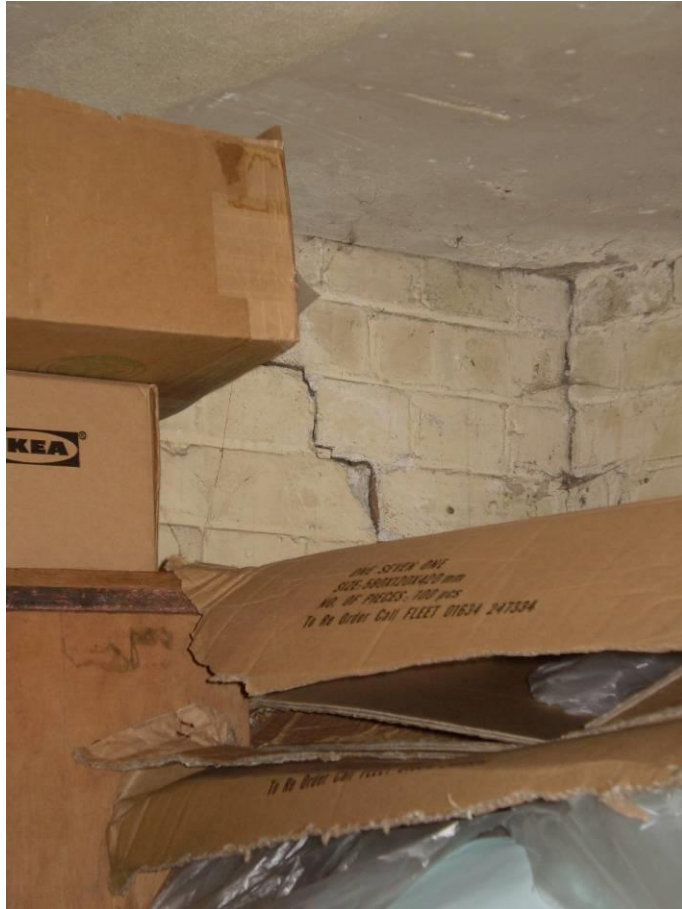
Stepped crack in the external boundary wall close to the junction with the party wall line. Crack measures 1mm - 2mm width (Slight). **Plate 8 refers.**

**Plate 8** Stepped crack in rear boundary wall

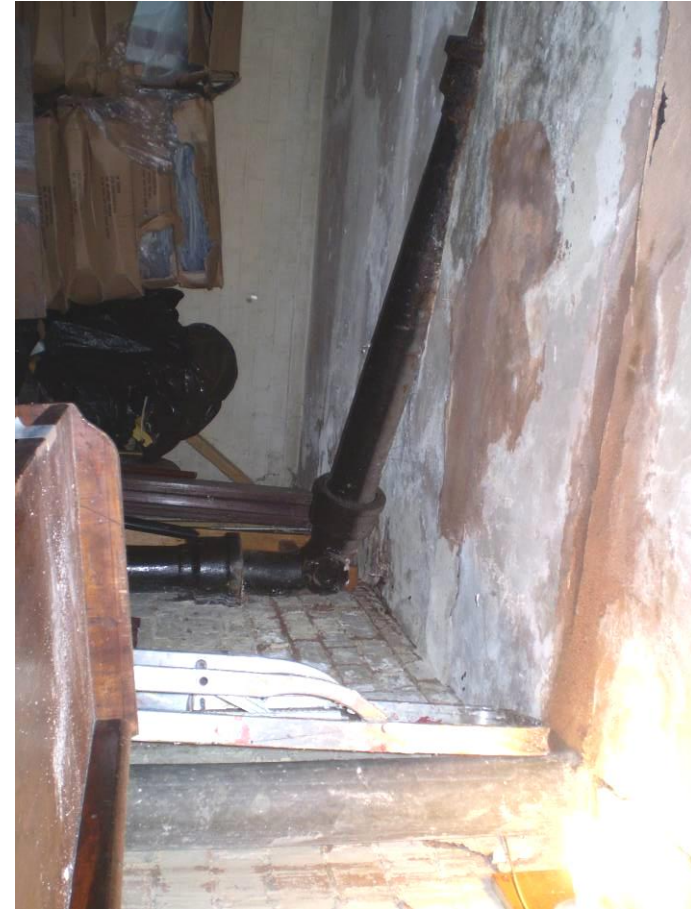
**Plate 7** Drain run to vertical down pipe with water penetration damage to ceiling

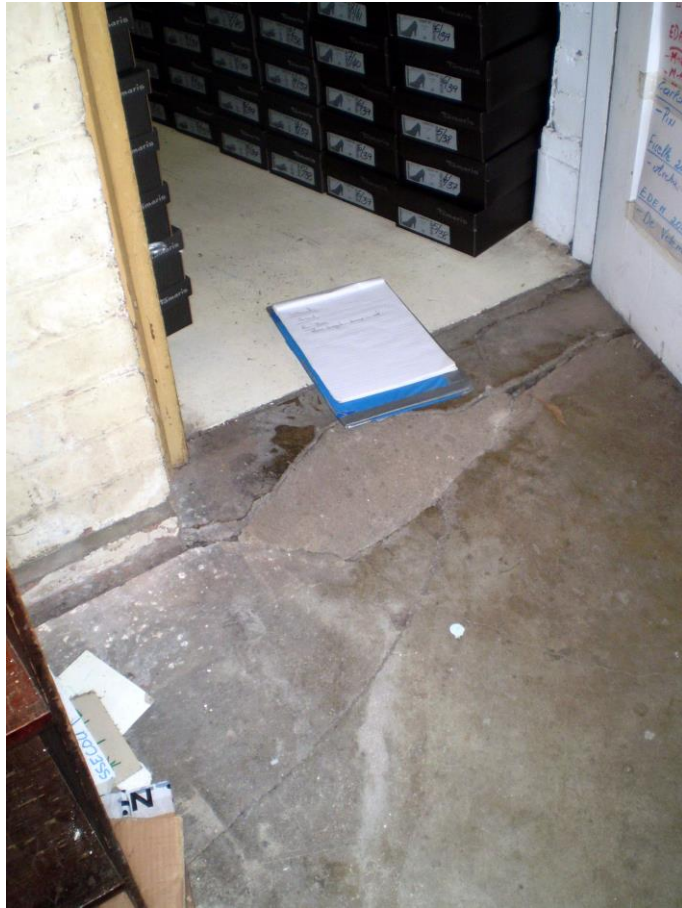
**Plate 10** Cracks in Basement floor at door threshold to rear stack/store room

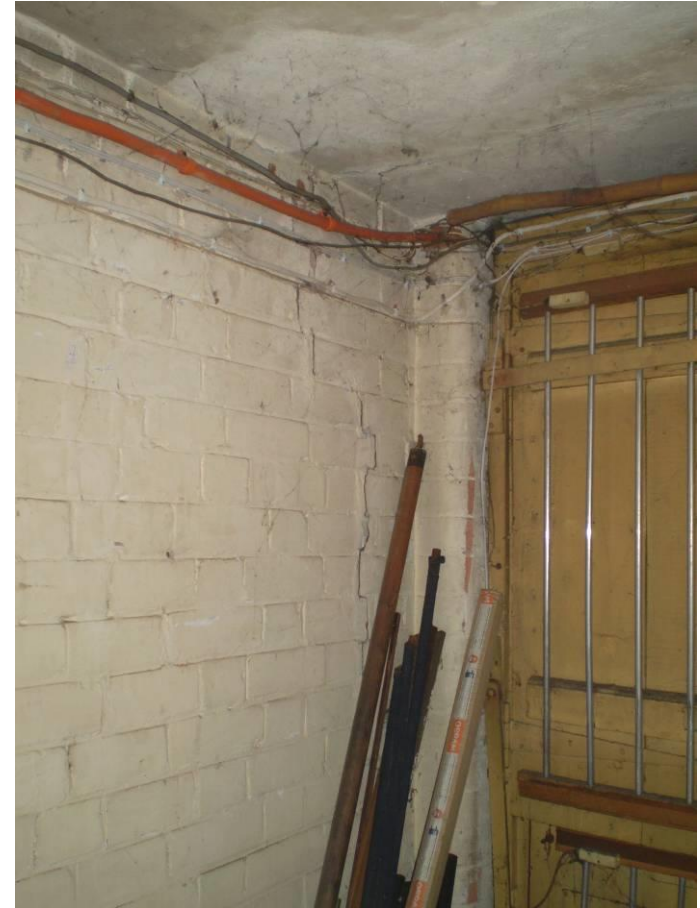
**Plate 9** Stepped crack in Party Wall to left hand side

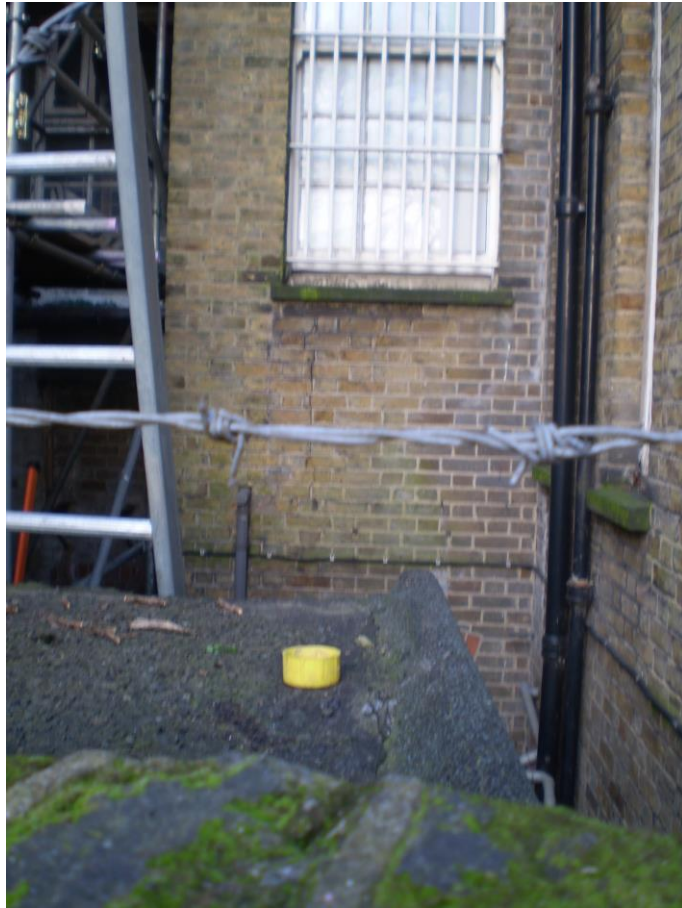
**Plate 12** Rear ground floor level window to shop

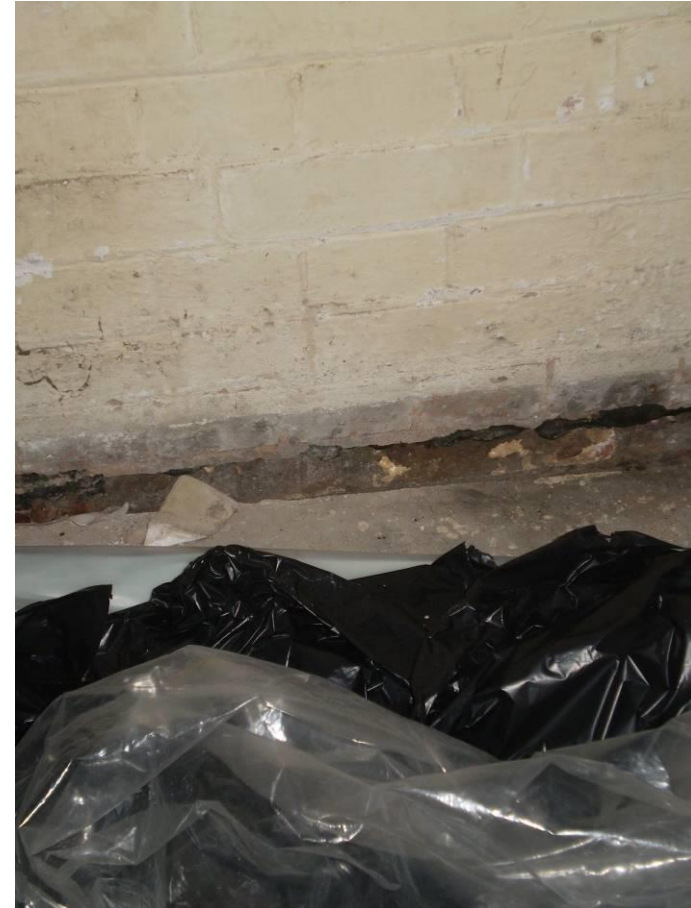
Floor had major settlement with the worst recorded settlement of 120 mm vertically. Also crack damage measuring 1.0 mm – 2.0 mm width.

**Plate 11** Settlement in floor slab at centre span adjacent to the rear boundary wall

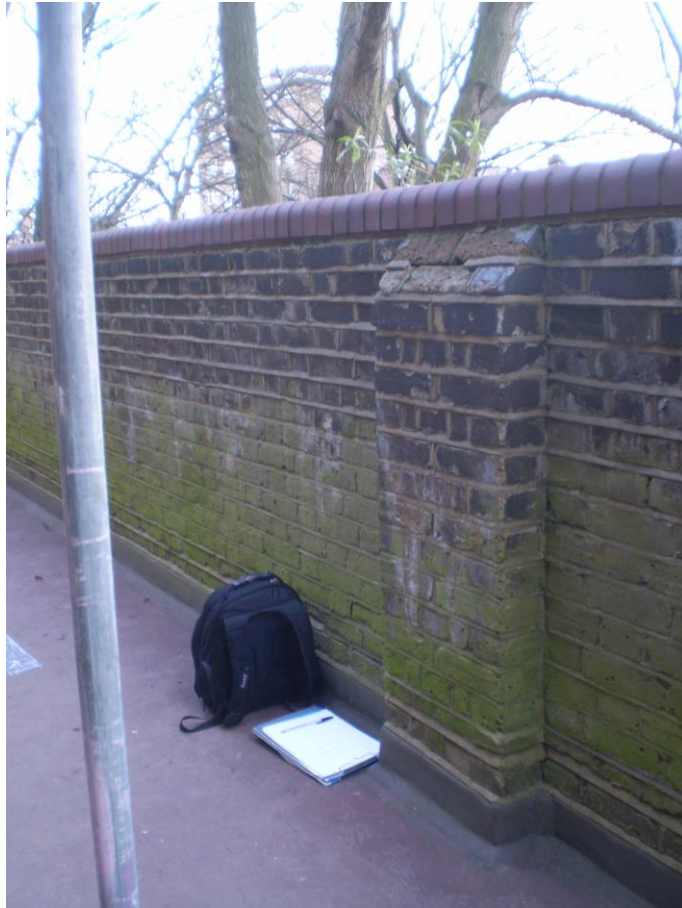
**Plate 14** Typical upstand boundary wall detail to the rear open walkway area

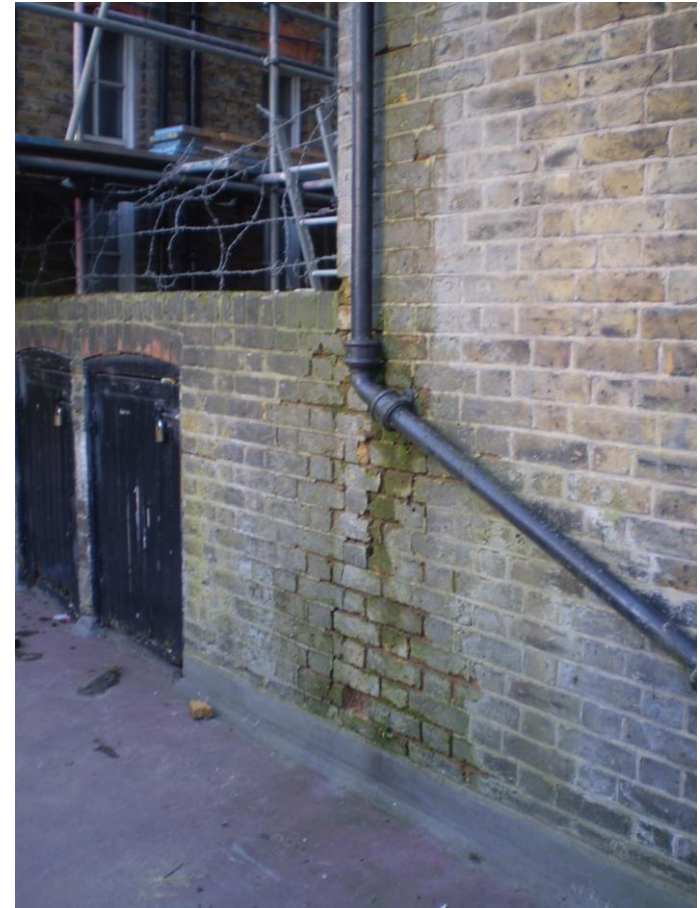
**Plate 13** Mortar washed out of perpendicular and bed mortar joints
