**FURTHER STRUCTURAL APPRAISAL**

**ONE SEVEN ONE  
171A FINCHLEY ROAD  
LONDON  
NW3 6LB**

**JAMES ANDREWS RSW**

**Project N° 2411  
October 2015**

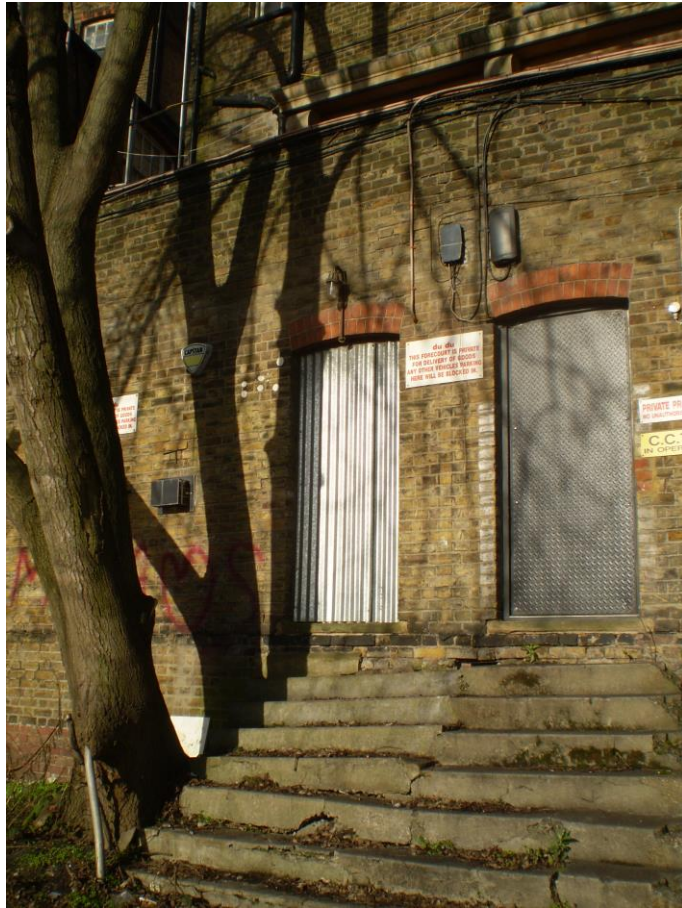
**Plate 16** Typical view rear access stairs

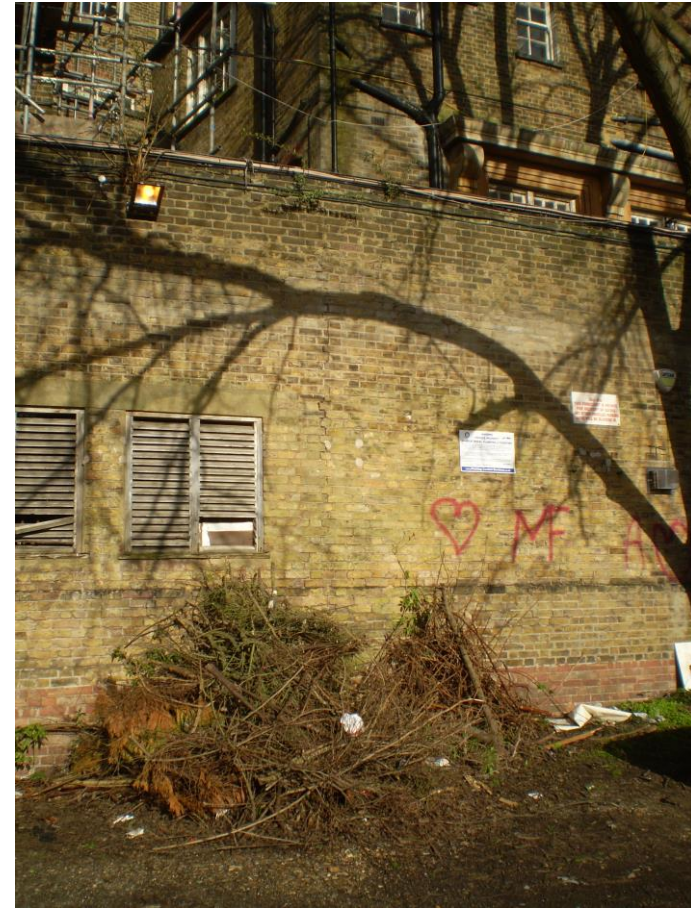
**Plate 15** Toothed vertical crack at approximate party wall location

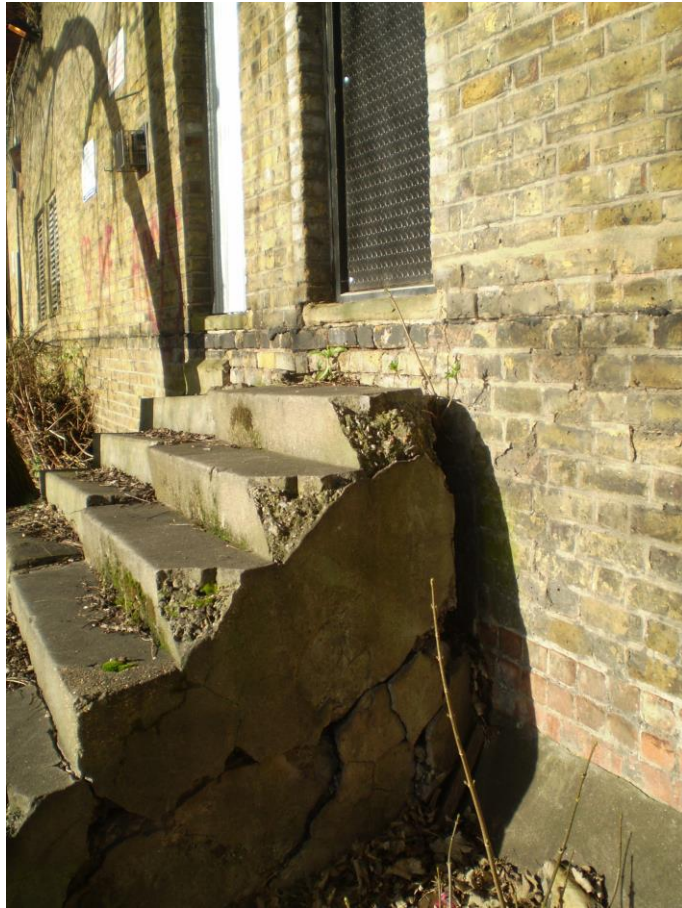
**Plate 18** Gap between steps and rear boundary wall

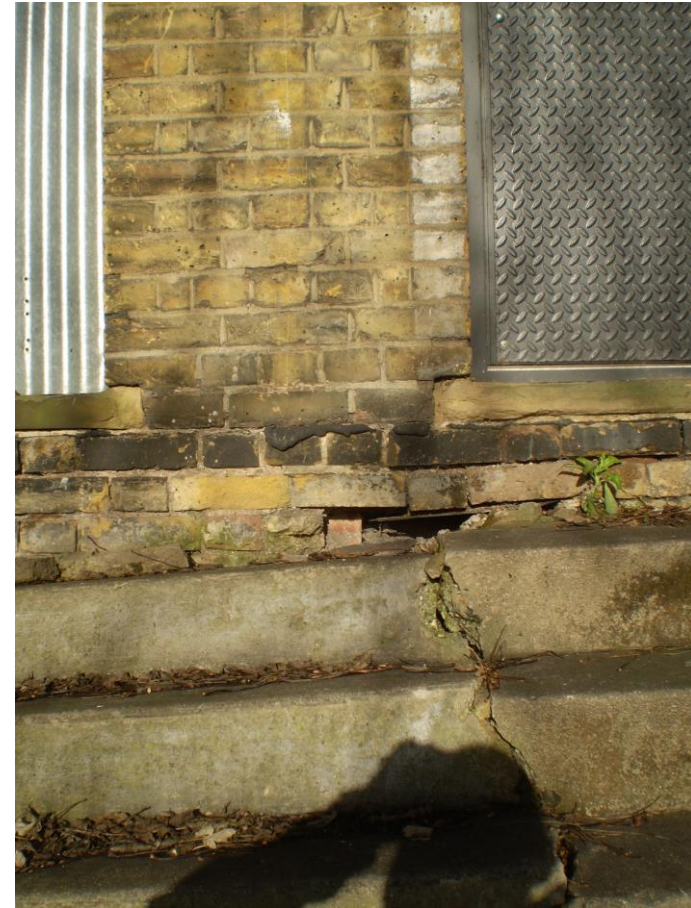
**Plate 17** Major crack in mid section of the mass concrete rear access steps

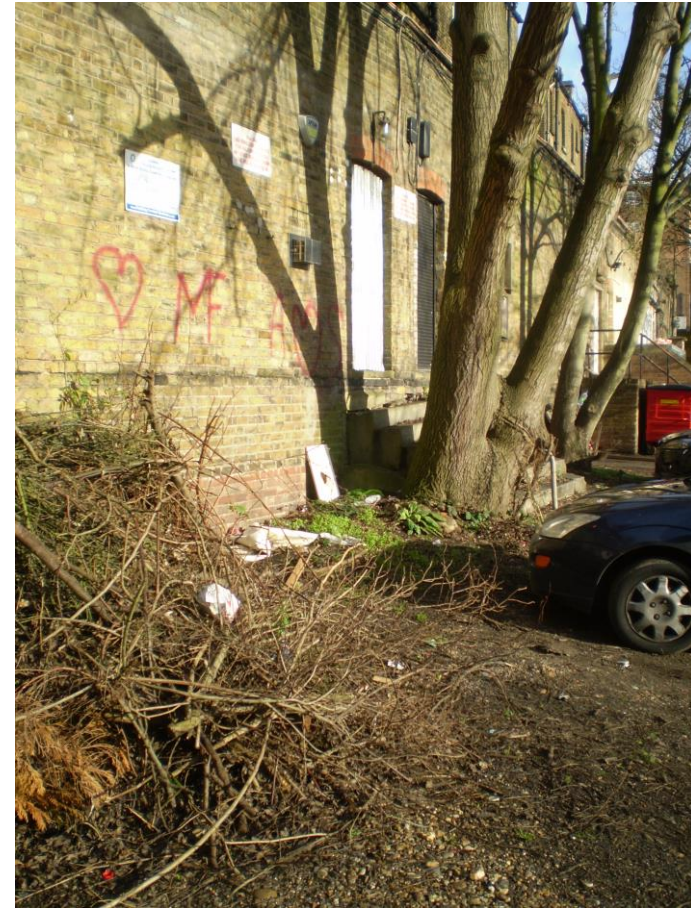
**Plate 19** Tree adjacent to rear boundary wall
