Arboricultural Appraisal Report

Subsidence Damage Investigation at:

37 Greville Road
London
NW6 5JB

CLIENT:	Crawford & Company
CLIENT REF:	SU1504550
MWA REF:	SUB160216-556
MWA CONSULTANT:	David Williams (N.D.Arb MArborA)
REPORT DATE:	07-03-2016

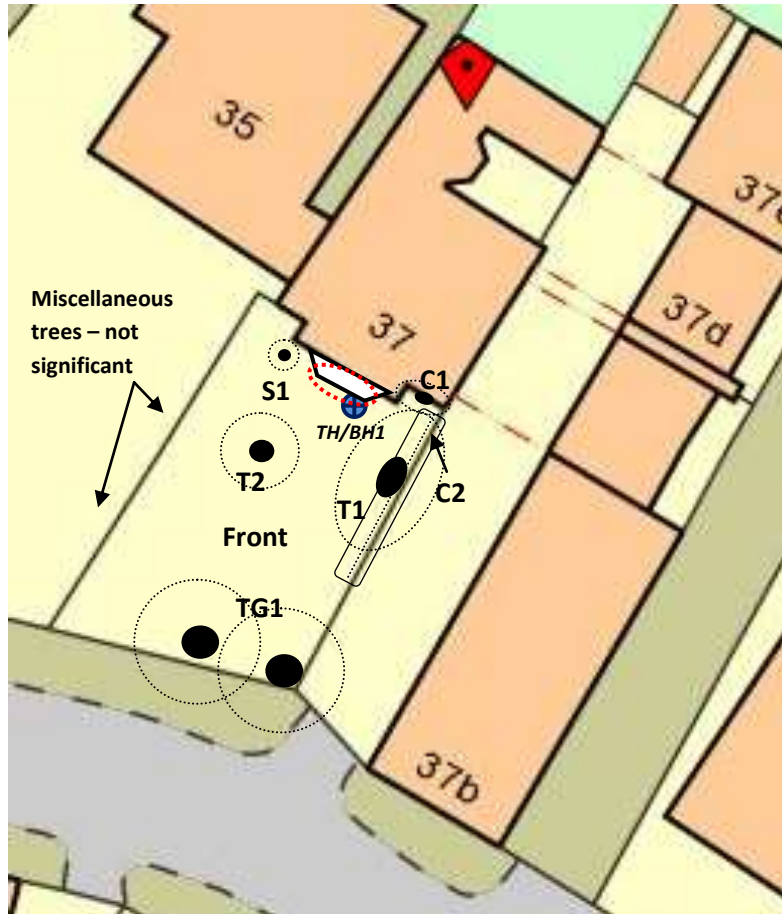
SITE PLAN

Approximate areas of damage

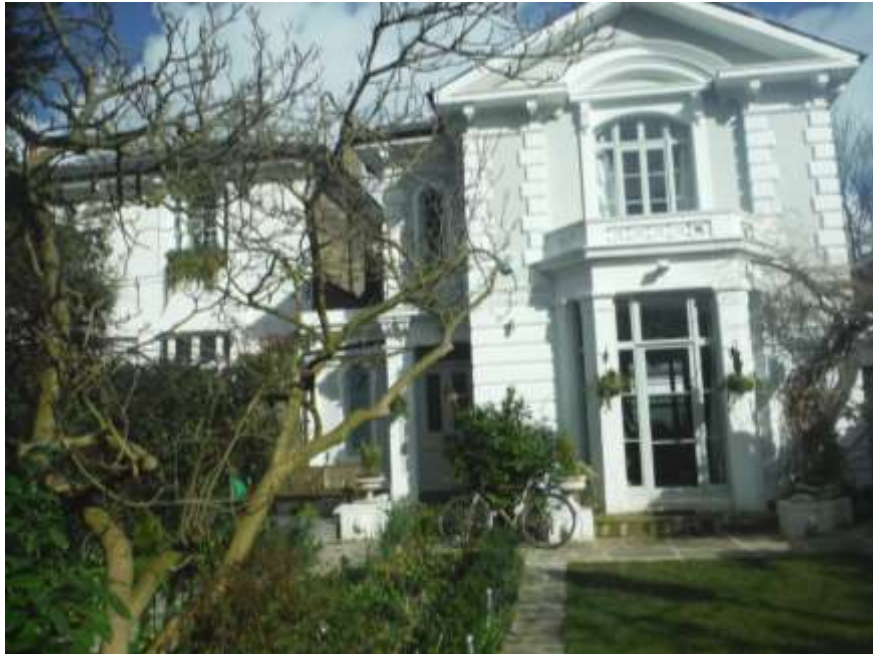
The current damage affects the front bay only where cracking is focused externally at the junction with the main body of the dwelling.

View of Front elevation

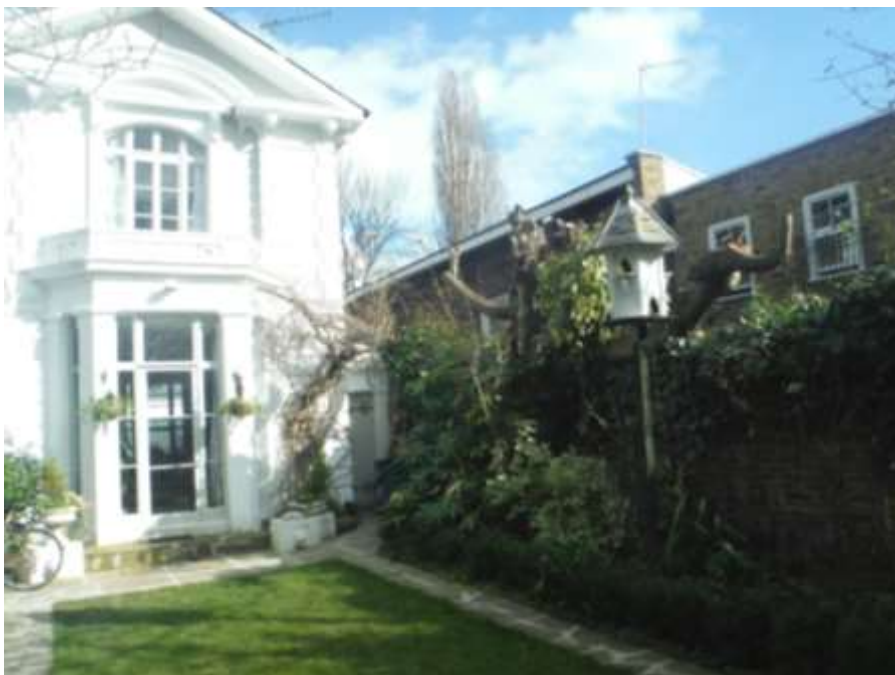
Based on the technical reports currently available, engineering opinion and our own site assessment we conclude the damage is consistent with shrinkage of the clay subsoil, the dominant cause of which is judged to be the drying action of T1 with C1 exerting a secondary influence.

The influence of C2 is thought to be minimal and we do not consider removal of this element to be justified unless monitoring indicates that movement persists after the removal of T1 and C1.

View of C1, T1 and C2

Tree No.	Species	Ht (m)	Dia (cm)	Crown Spread (m)	Dist. to building (m)	Age Classification	Ownership
T1	Sycamore	4.0	50*	7.0	3.0-4.0	Younger than property	Policy Holder
Management history		Recently pollarded to current dimensions					
Recommendation		Remove and treat stump to inhibit regrowth					
C1	Wisteria	3.3	M/S	2.0	0.0	Younger than property	Policy Holder
Recommendation		Remove and treat stump to inhibit regrowth
