TECHNICAL REPORT ON A SUBSIDENCE CLAIM

Crawford Reference: SU1504550

37 Greville Road
London
NW6 5JB

SUBSIDENCE CLAIM

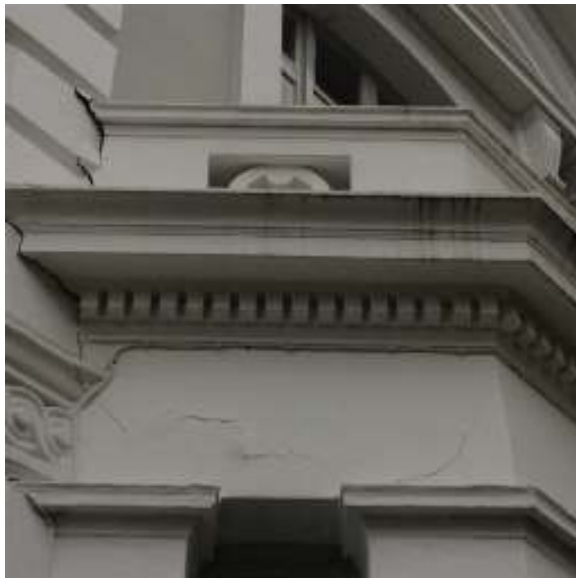
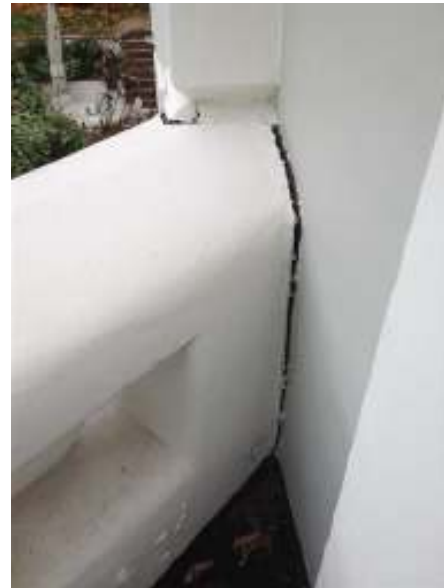
Front Bay

Vertical tapering crack at either side of abutment up to 15mm wide.
 Separation between right hand bay pier and window frames up to 2mm wide.
 Various 1mm diagonal cracks above left hand window head.

In structural terms the damage falls into Category 3 of Table 1, Building Research Establishment⁶ Digest 251, which describes it as **“moderate”**.

The pattern and nature of the cracks is indicative of an episode of subsidence. The cause of movement appears to be clay shrinkage.

The timing of the event, the presence of shrinkable clay beneath the foundations and the proximity of vegetation where there is damage indicates the shrinkage to be root induced. This is a commonly encountered problem and probably accounts for around 70% of subsidence claims notified to insurers.

Although the cause of the movement needs to be dealt with, we note the vegetation is subject to a Preservation Order. Unfortunately, current legislation requires certain investigations to be carried out to support an application for the tree works.

Typically, these investigations would involve trial pit(s) to determine the depth and type of footings, boreholes to determine the nature of the subsoil/influence of any roots and monitoring to establish the rate and pattern of movement. The monitoring data provided must be sufficient to show a pattern of movement consistent with the influence of the vegetation and therefore it may be necessary to carry out the monitoring for up to a 12 month period.

It will also be necessary to obtain a specialist Arboricultural Report.
