ARBORICULTURAL ASSESSMENT REPORT

For:	Client:	Oriel Services Limited
	Insurer:	[REDACTED]
Site:	Policyholder:	[REDACTED]
	Risk Address:	57 Aberdare Gardens, London, NW6 3AL
Refs:	OCA Ref:	58215
	Client Ref:	7885746
	Insurer Ref:	[REDACTED]

Report By:	James Allnutt		
Title:	Arborist	Date:	31 March 2015

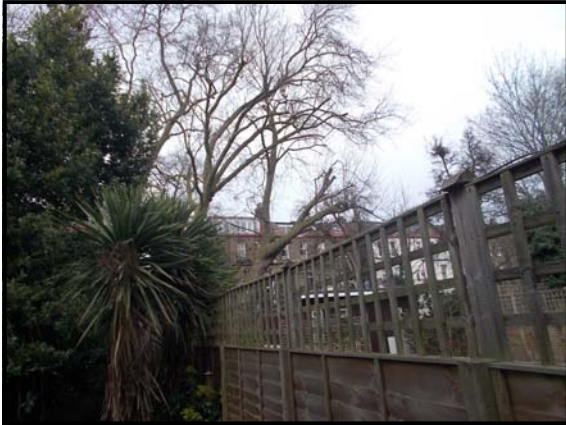
Roots have been recovered from TP1 and have been formally identified as *Platanus*. Given the size, species, and proximity to the location of the trial pit/borehole we consider that these roots have emanated from London Planes T1/ T2, & T9/T10.

1. T1 right, T2 left behind the policyholder's garden.

Tree No:	Species	Works Required
T1	London Plane	Fell as close to ground level as practicable and treat stump
T2	London Plane	Fell as close to ground level as practicable and treat stump
T3	Willow	Fell as close to ground level as practicable and treat stump
T4	Willow	Fell as close to ground level as practicable and treat stump
T8	Laurel	Fell as close to ground level as practicable and treat stump
T9	London Plane	Fell as close to ground level as practicable and treat stump
T10	London Plane	Fell as close to ground level as practicable and treat stump

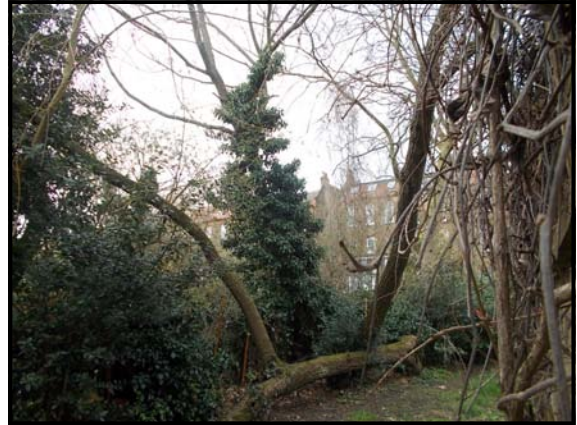
No roots relating to Willow or Laurel were recovered during investigations. However, given its size and proximity to the insured property we consider that it is likely that roots from Willows T3 & T4 as well as Laurel T8 have also extended beneath the depth of foundations.

2. T3 stem laying horizontally with T4 showing ivy on stem.

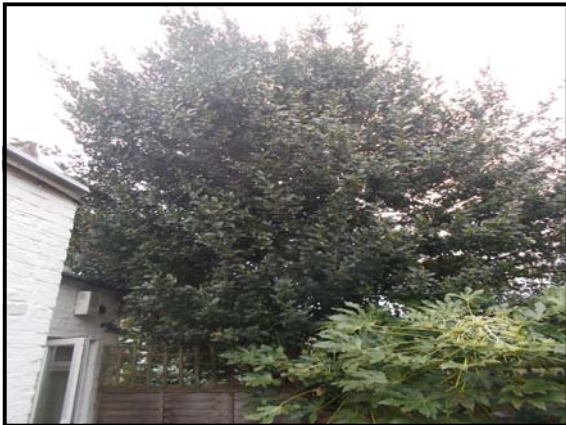
3. View showing T8.

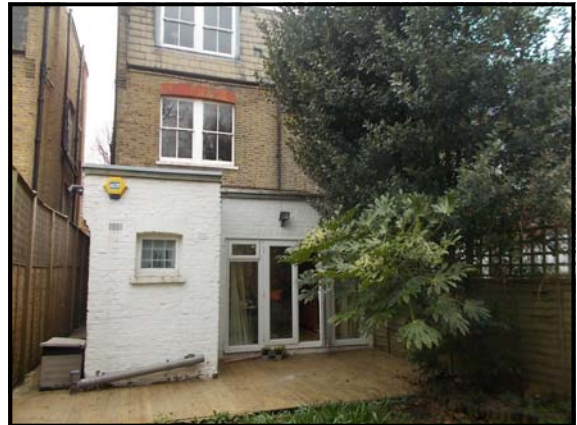
4. Rear of the property showing S1 and T8.

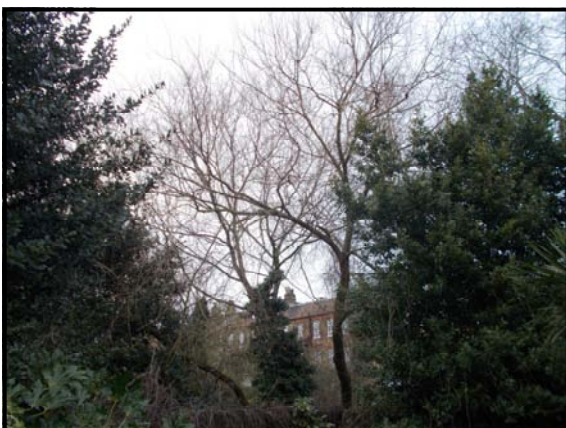
5. T4 left of centre and T3 right of centre.
