SITE INVESTIGATION FACTUAL REPORT

Report No: 246035
Client: Cunningham Lindsey - Maidstone
Site: 57, Aberdare Gardens
London
Client Ref: 7851572-Aberdare Gardens Ltd
Date of Visit: 13/01/2015

Investigation Layout Plan

Site: 57 Aberdare Gardens, NW6 3AL

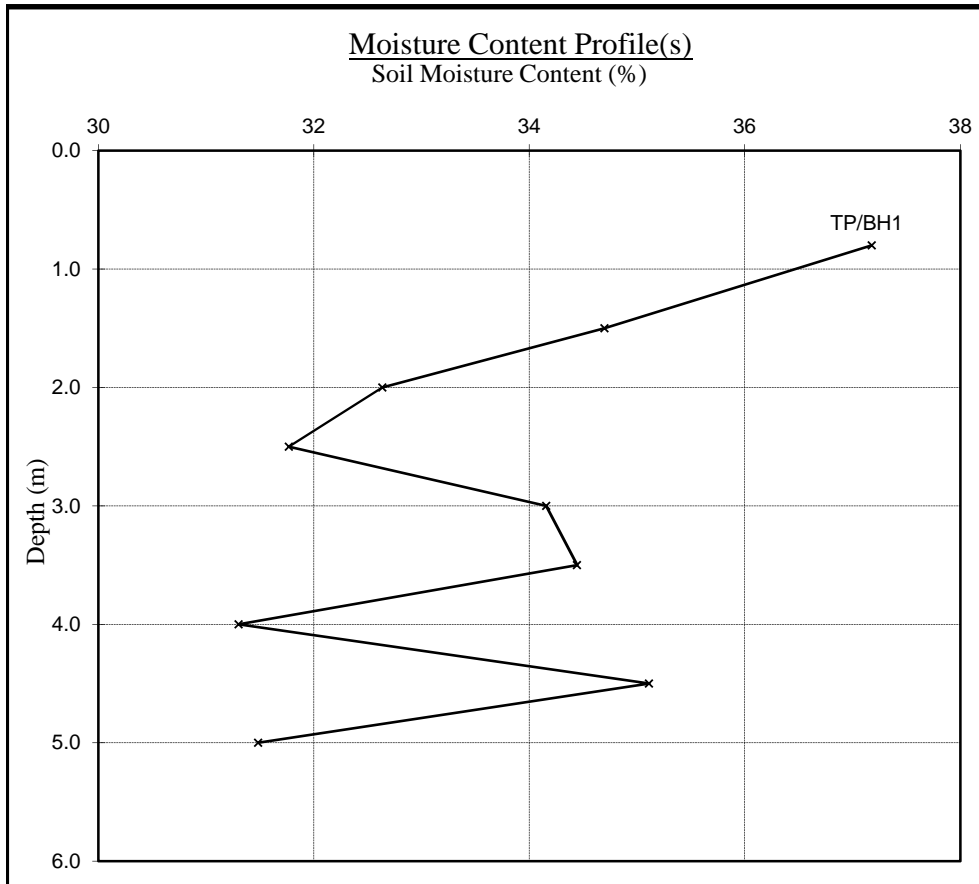
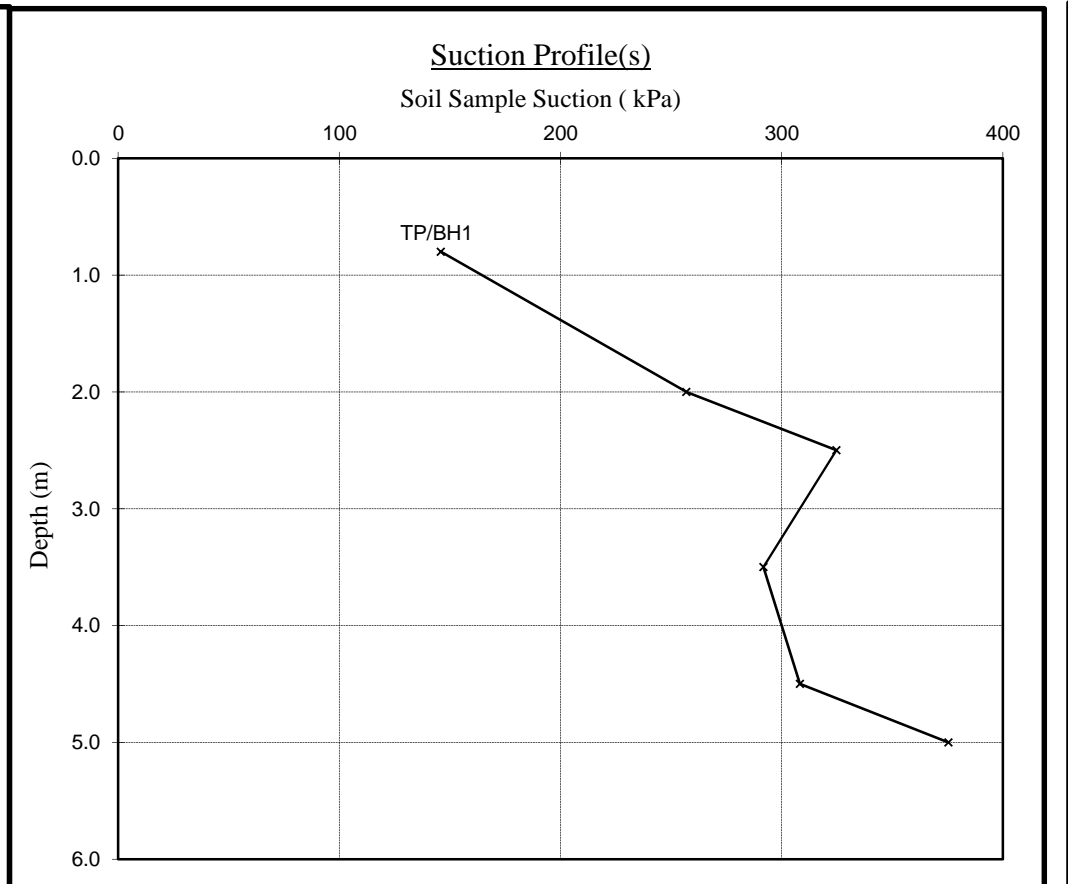
Moisture Content and Suction Profiles

When shown, the theoretical equilibrium suction profiles are based on conventional assumptions associated with London Clay (and similarly overconsolidated clays) at shallow depths. Note that the sample disturbance component is dependant on the method of sampling and any subsequent recompaction. The above plots show this to be 100kPa which is the value suggested by the BRE on the basis of their limited number of tests on recompacted samples. This may or may not be appropriate in this instance and judgement should be exercised.

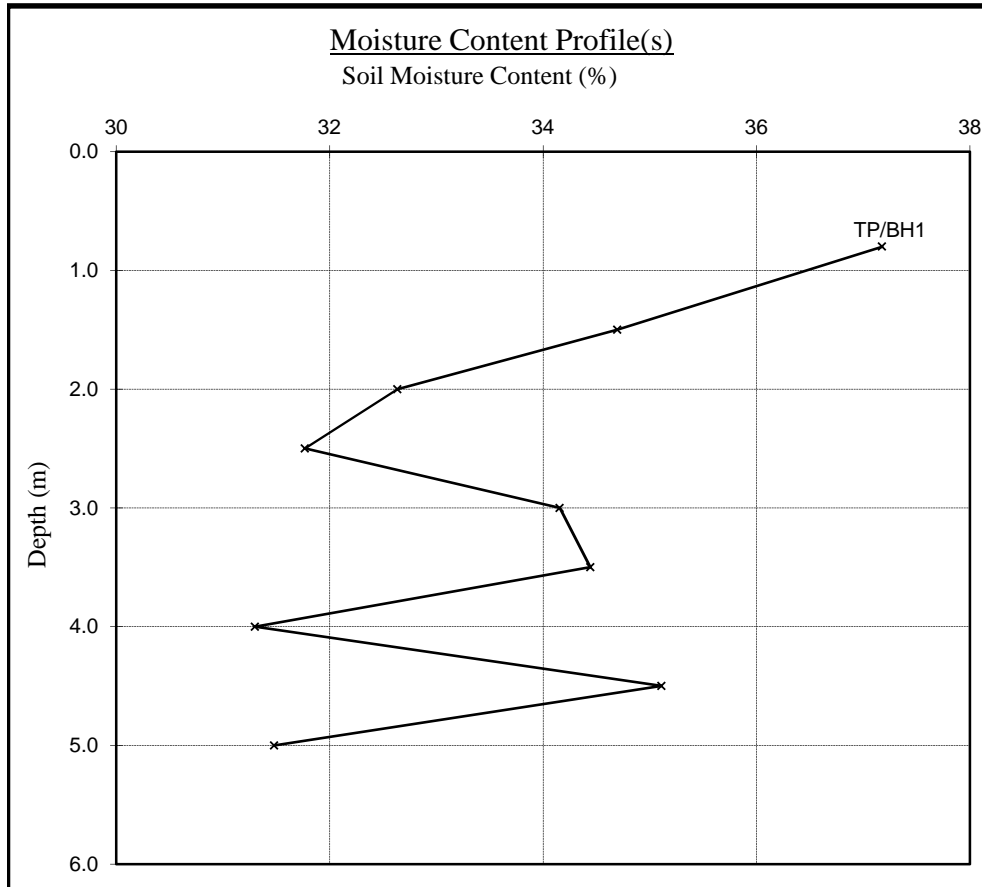
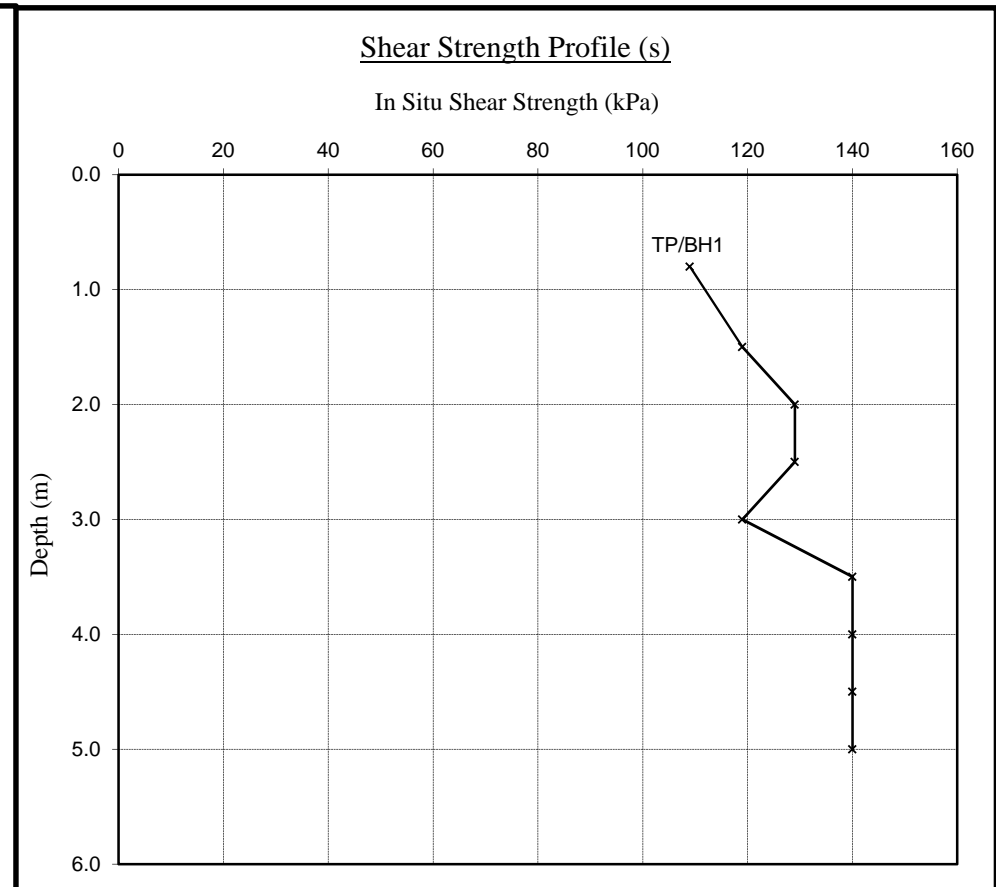
Moisture Content and Shear Strength Profiles

Unless otherwise stated, values of Shear Strength were determined in situ by CET using a Pilcon Hand Vane the calibration of which is limited to a maximum reading of 140 kPa.

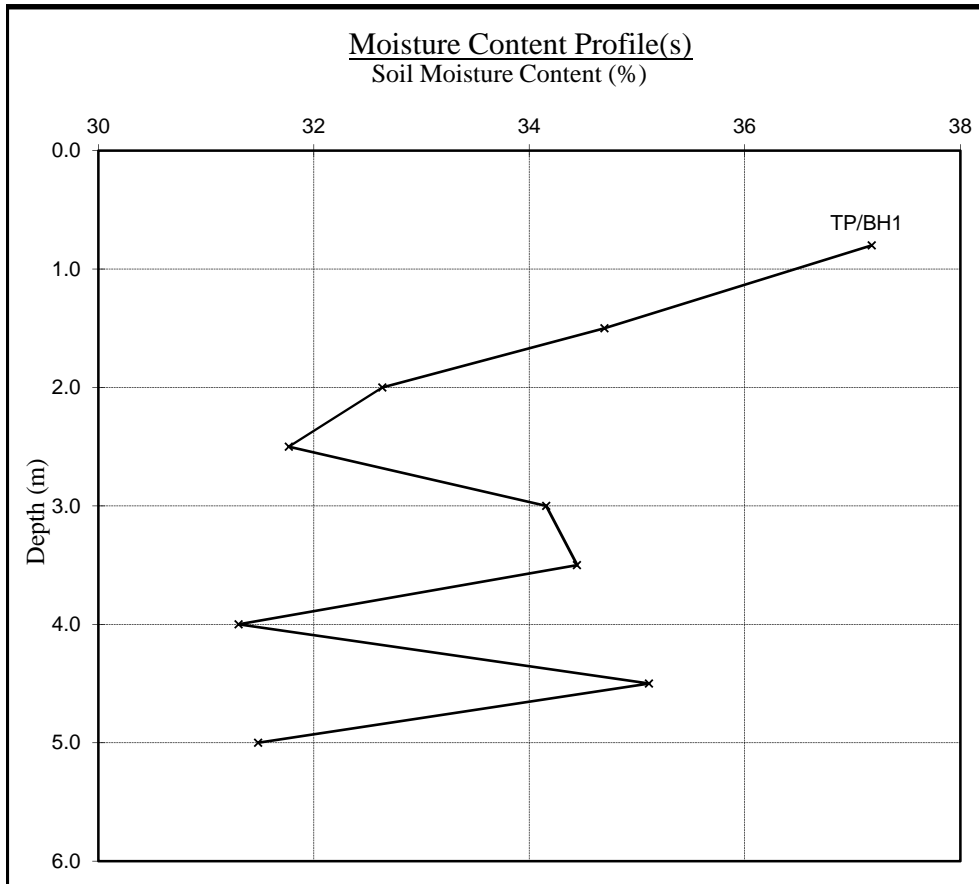
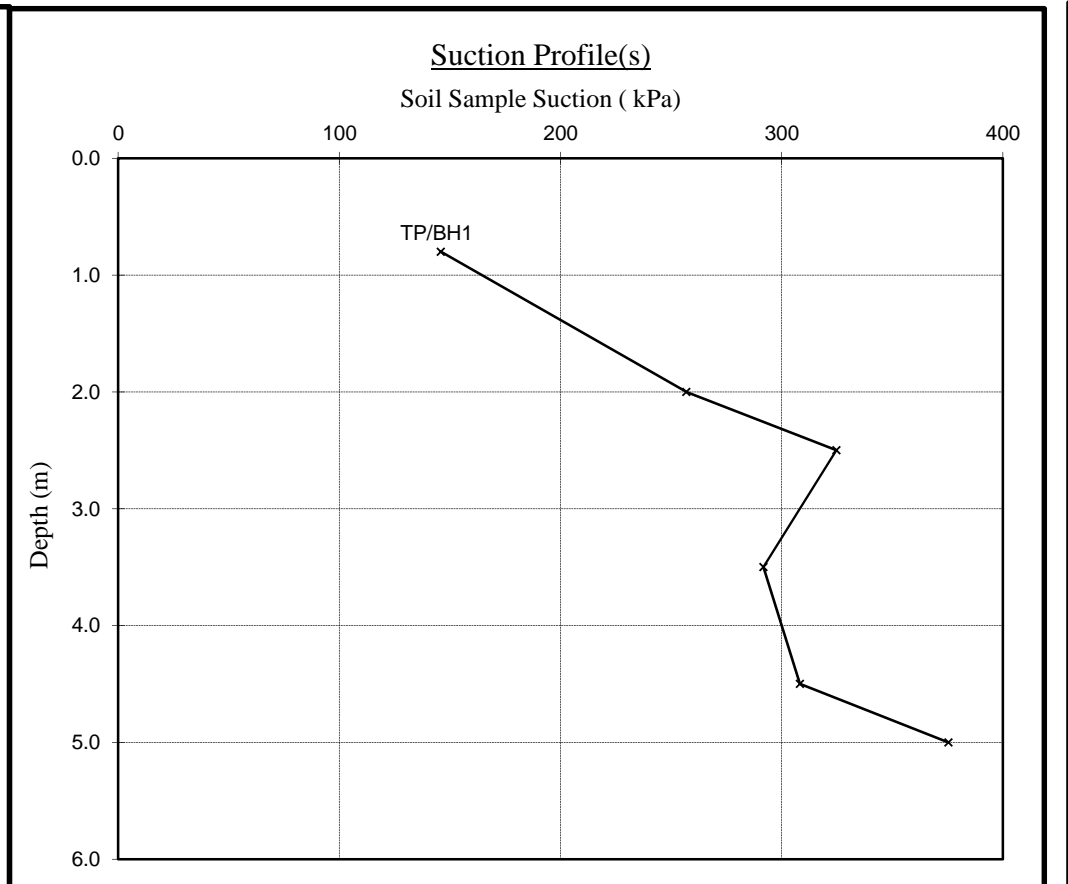
Moisture Content and Suction Profiles

When shown, the theoretical equilibrium suction profiles are based on conventional assumptions associated with London Clay (and similarly overconsolidated clays) at shallow depths. Note that the sample disturbance component is dependant on the method of sampling and any subsequent recompaction. The above plots show this to be 100kPa which is the value suggested by the BRE on the basis of their limited number of tests on recompacted samples. This may or may not be appropriate in this instance and judgement should be exercised.
