Appendix 2 Tree Photos

Appendix 3 Tree Survey Table

Appendix 4 Tree Constraints Plan

PROJECT
77 LAWN ROAD, CAMDEN

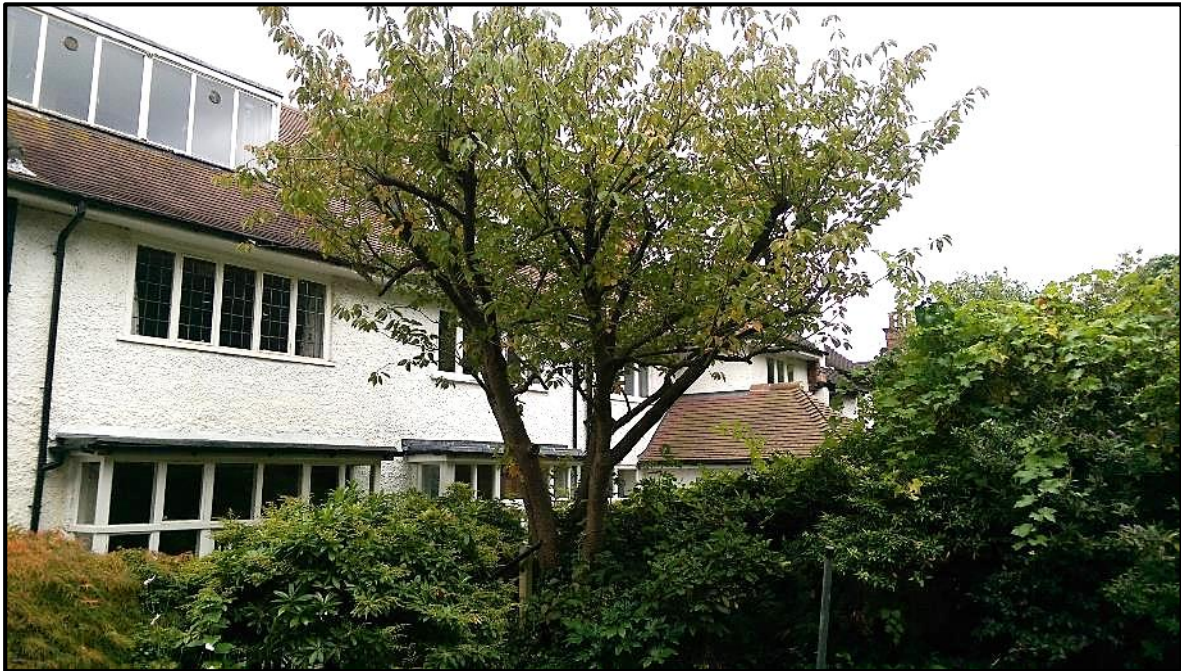
Plate 1 (above). T1, cherry, looking south with past pruning points visible.

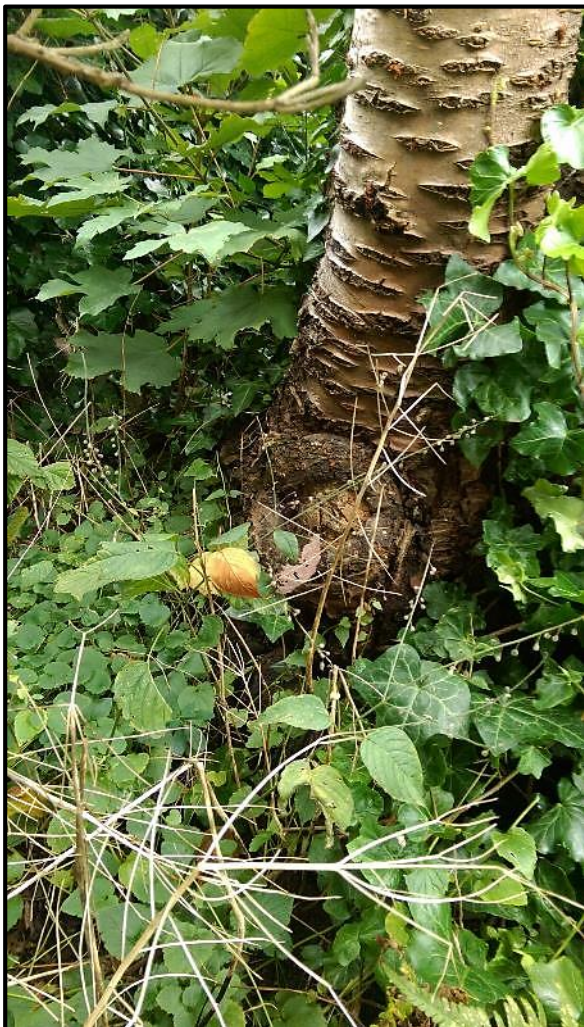
Plate 2 (left). The unoccluded wound close to the base of T1, with decay commencing.

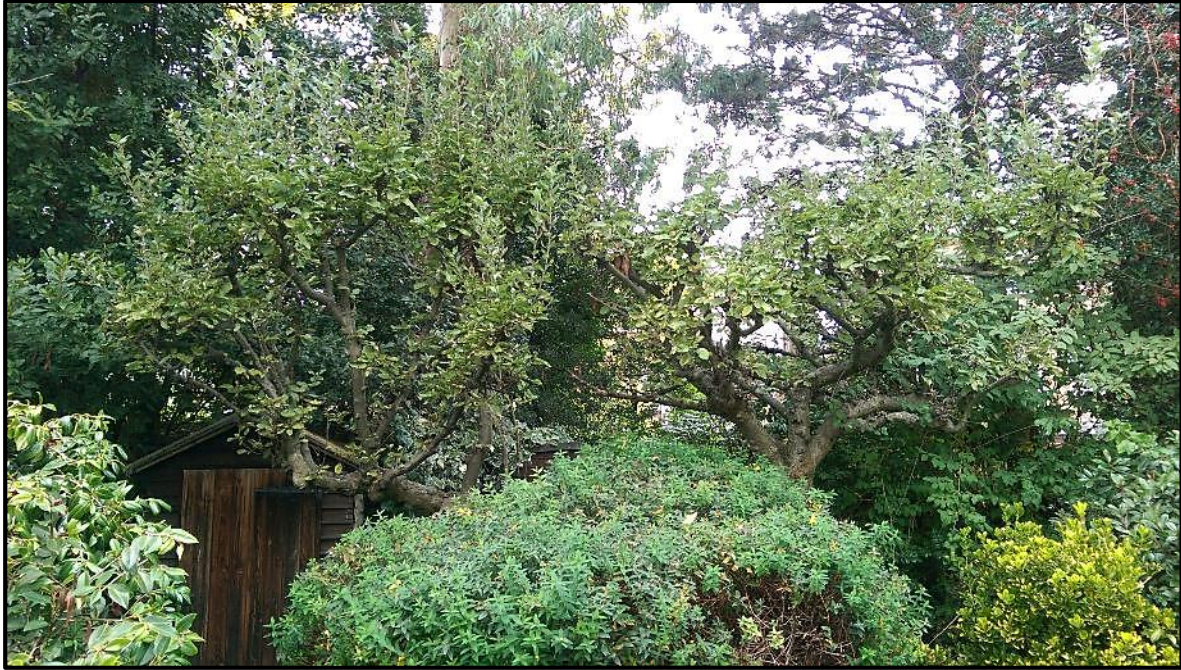
Plate 3 (above). T2, apple, looking west, showing small size.

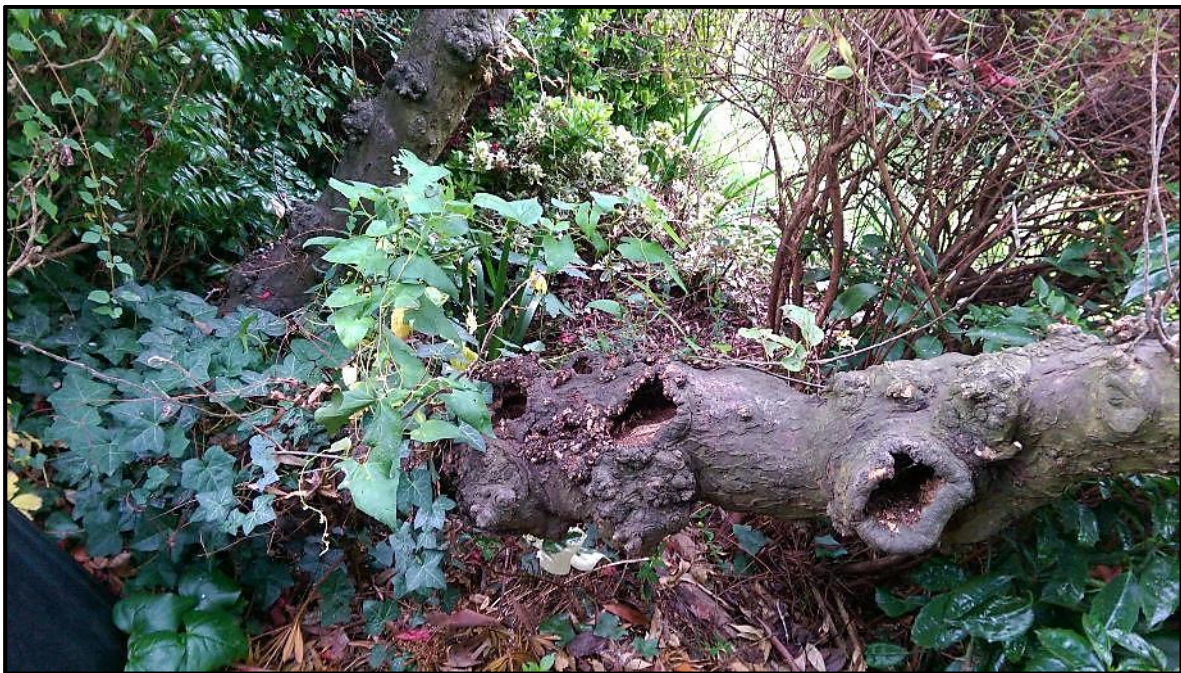
Plate 4. The southern trunk of T2, showing horizontal growth and extensive cavity development.

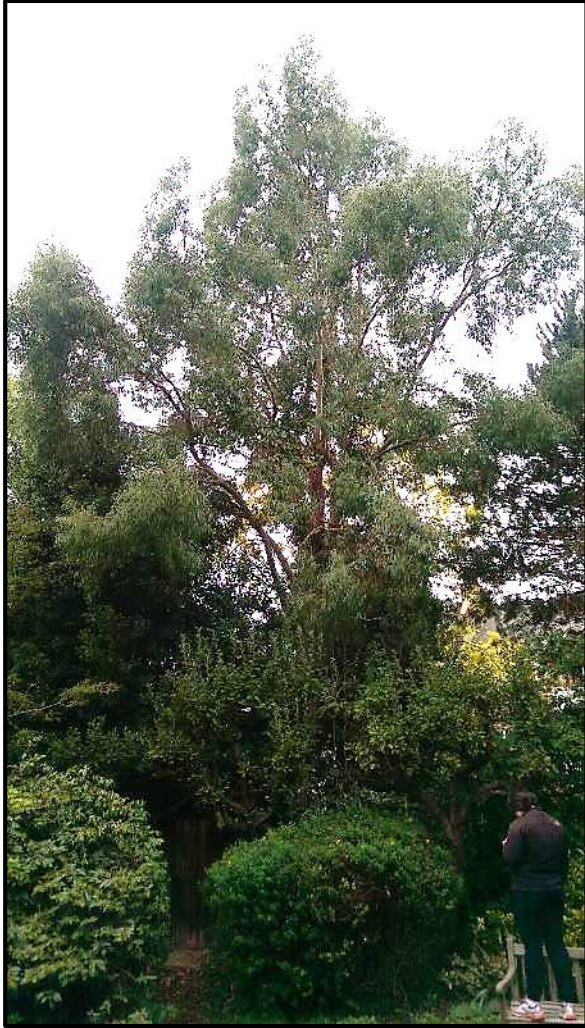
Plate 5. T3, off-site Eucalyptus, looking west.

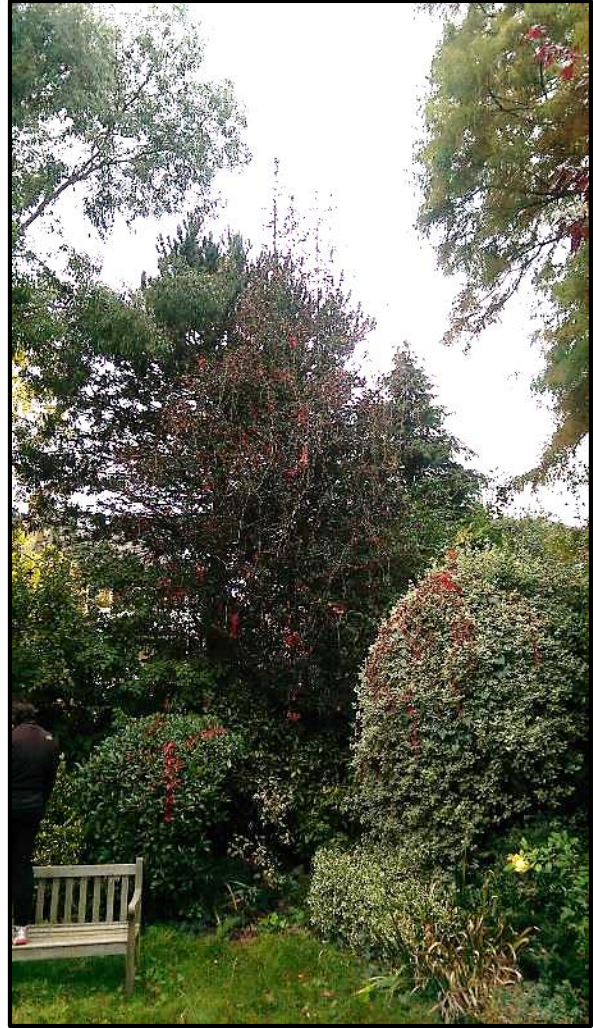
Plate 6. T4, holly (centre), growing within dense vegetation preventing direct access to the trunk, as viewed looking west.

T4	Holly <i>Ilex aquifolium</i>	M	Fair	10	3	3	3	3	0.5	100 100 120*	A medium sized tree of typical form but with a sparse crown. Triple-stemmed from the base, but access to inspect this was prevented by dense foliage form surrounding shrubs.	No work.	B1,3	20-40	2.23
T5	Dawn Redwood <i>Metasequoia glyptostroboides</i>	M	Fair	20	4*	5*	6*	4.5*	3.5	750*	A large, impressive off-site tree, visible from Lawn Road.	No work.	A1	40+	9.00

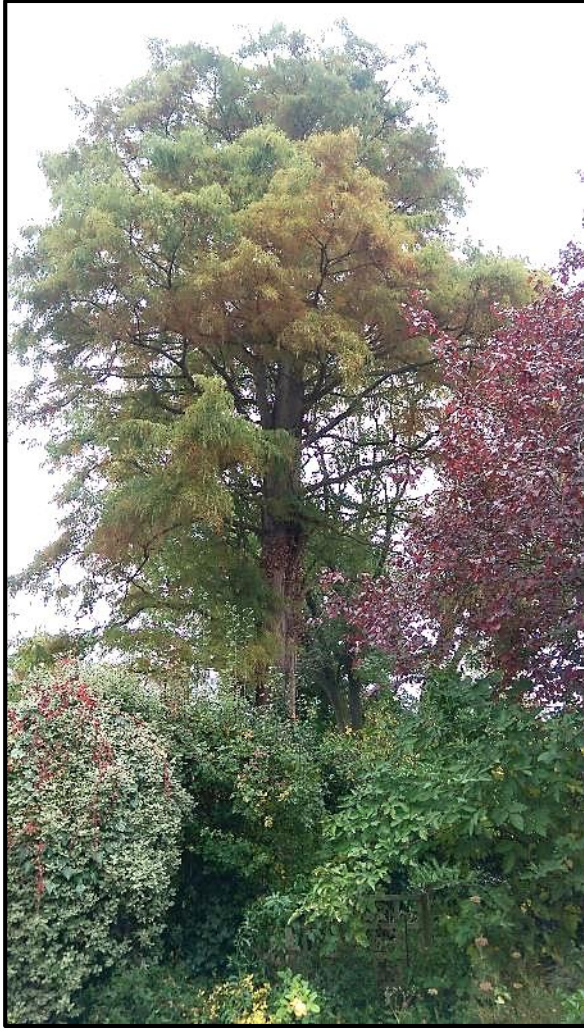
Plate 7 (left). T5, off-site Dawn Redwood, looking north and showing the tree's good form and impressive size.

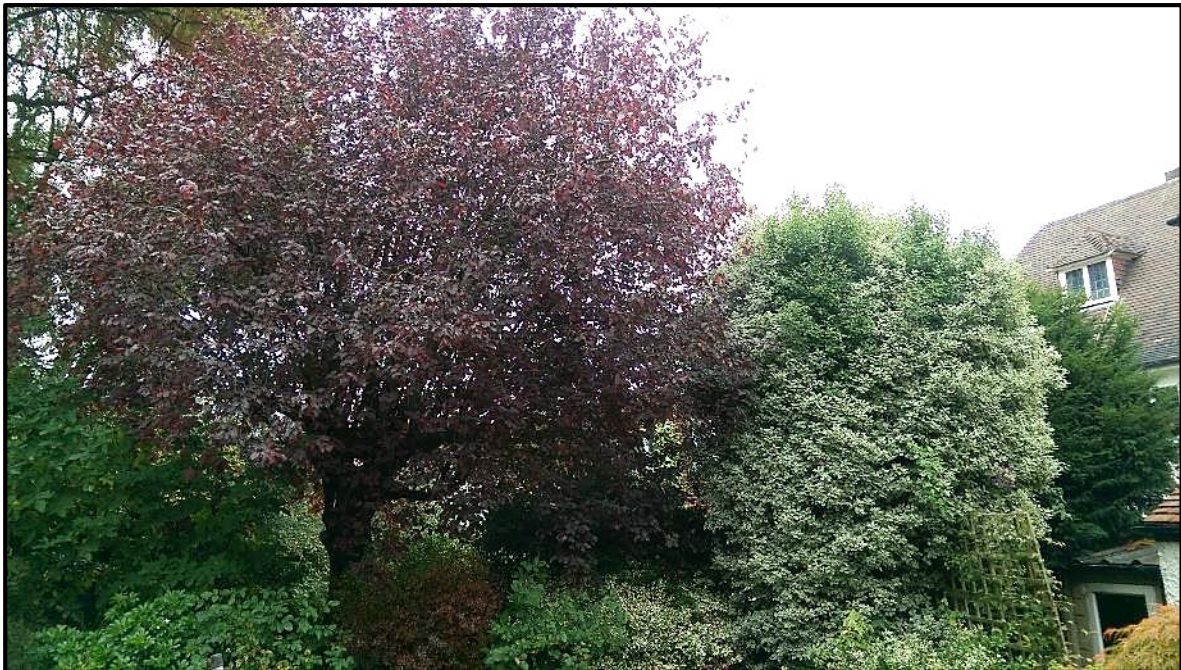
Plate 8 (below). T6, Pissard plum (left), T7, pittosporum (centre right) and T8, yew (far right), looking north-west and showing the small size of all three trees.

Tree No.	Species	Age	Condition	Height (m)	Spread (m)				Crown Clearance (m)	DBH (mm)	Comments	Recommendations	BS 5837 Category	Remaining Contribution (est.)	RPA Radius (m)
					N	S	E	W							
T6	Pissard plum <i>Prunus cerasifera</i> 'Pissardi'	M	Fair	7.0	3	3*	3.5	3.5	1.5	350*	Medium-sized off-site tree pollarded at 2.5m, with regrowth of good vitality arising from the pruning points.	No work.	B1	20-40	4.20
T7	<i>Pittosporum</i> spp.	M	Good	5.0	1.5	1.5	1.5	1.5	0	120 @ 1m	A small, unremarkable shrub of typical form for the species.	No work.	C1	10-20	2.44
T8	Yew <i>Taxus baccata</i>	M	Fair	4.5	2	2	2	1.5	1.0	180*	Small, off-site tree subject to regular trimming to control its size and shape.	No work.	C1	40+	2.16
T10	Ash <i>Fraxinus excelsior</i>	M	Fair	11	1.5	4	4	4	3.0	350*	Off-site tree standing within the front garden of the adjacent property to the south. The crown contained typical amounts of minor dead wood and showed evidence of past reduction to 3m radial crown spread.	No work.	B1	20-40	4.20

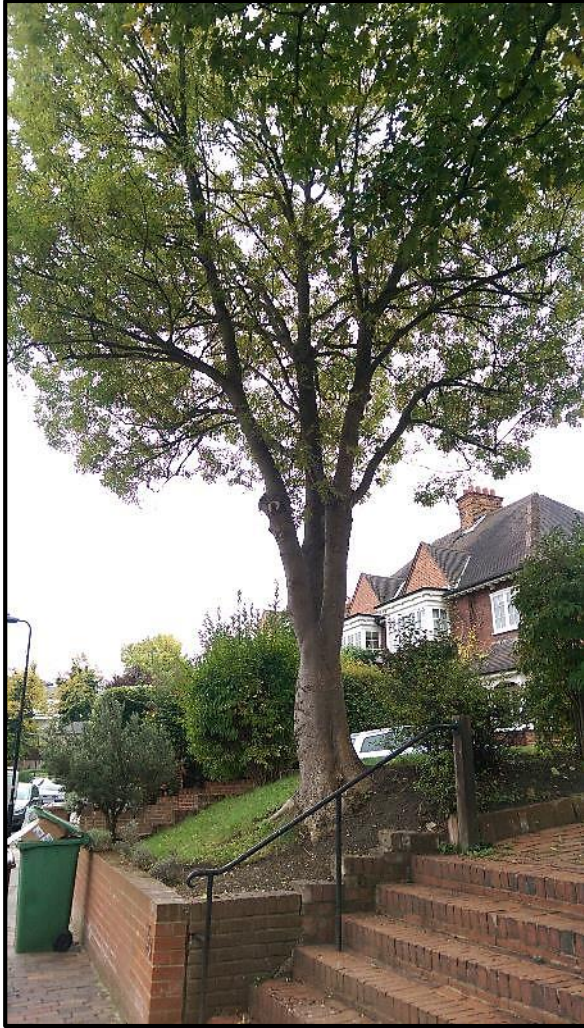
Plate 9. T9, off-site ash, viewed from Lawn Road looking south.

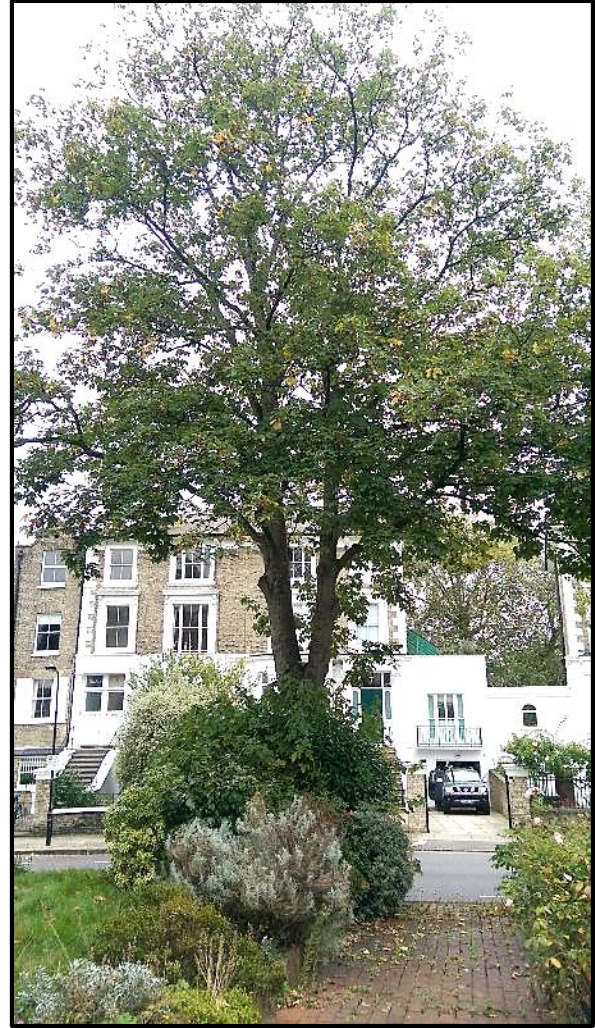
Plate 10. T10, sycamore, looking est from within the front garden, showing the dense sucker growth round the base.

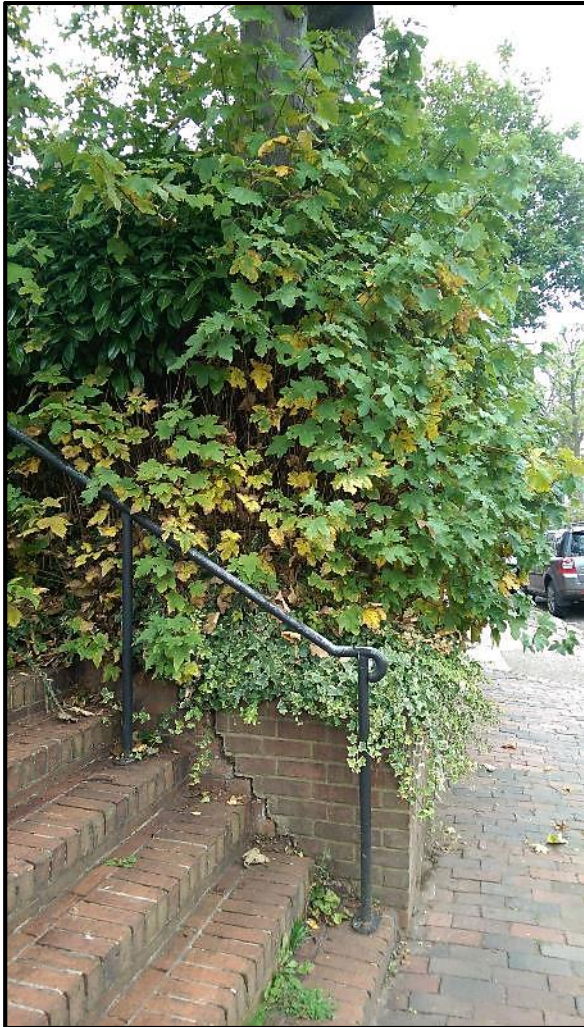
Plate 11. The base of T10 as viewed from Lawn Road, looking north. The dense sucker growth is visible, together with the diagonal crack in the retaining wall next to the steps.

T11	Sycamore <i>Acer pseudoplatanus</i>	M	Fair	15	7	6.5	6	6.5	5.0	600*	Large tree with the base surrounded by dense suckers, preventing access to the trunk. Extension growth within the crown was poor. The tree stood at the top of a retaining wall along the road frontage, with diagonal cracking observed in the wall adjacent to the steps.	Clear suckers to allow inspection of the trunk.	B1	20-40	7.20
T12	Sycamore <i>Acer pseudoplatanus</i>	M	Fair	13	6	5	5	5.5*	2.5	450*	Off-site tree standing within the front garden of the adjacent property to the north. The tree has previously been reduced to 5m and 9m.	No work.	B1	20-40	5.40

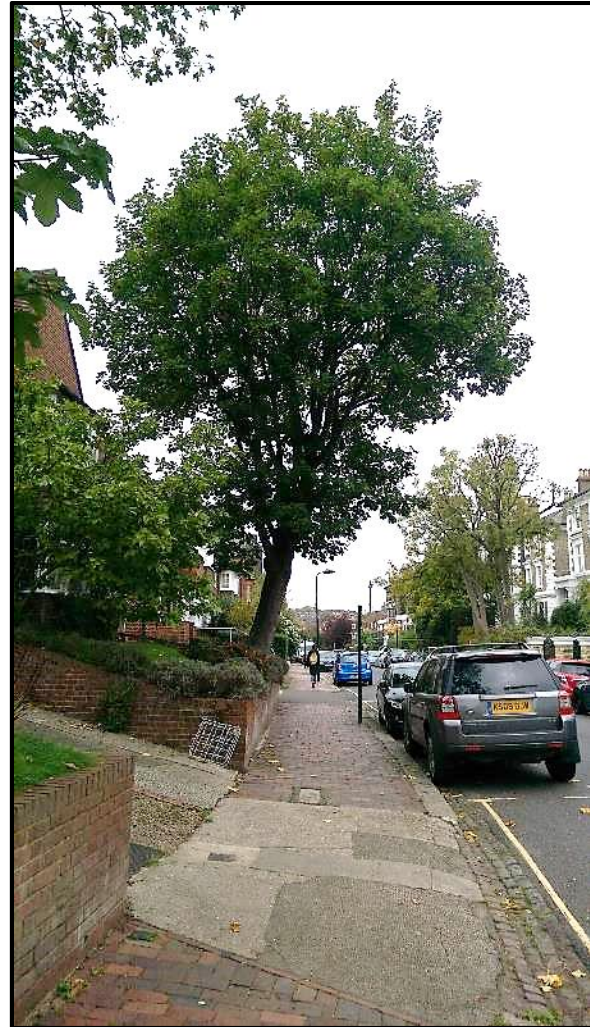
Plate 12. T11, off-site sycamore, looking north from Lawn Road. The driveway serving the property is to the left.
