# 4 The Grove, Highgate

Visual Structural Inspection

**This report describes the findings of the Visual Structural Inspection conducted at 4 The Grove, Highgate on behalf of Jamie Oliver Holdings Limited**

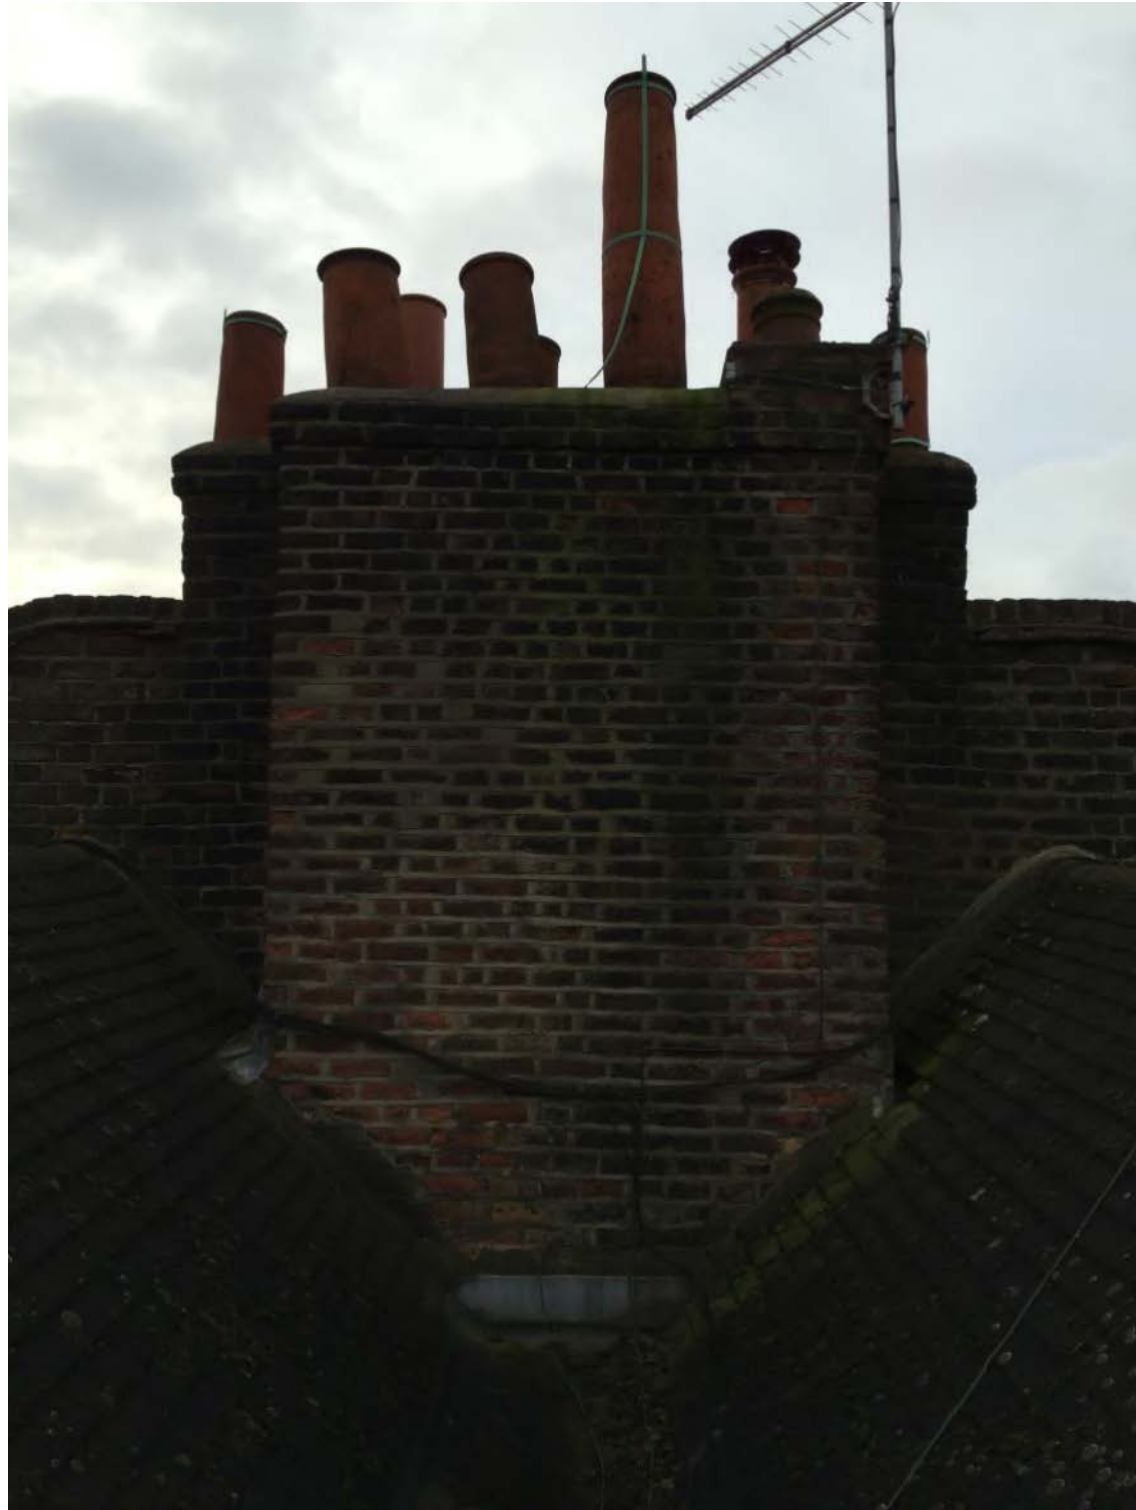
| Reference | Visible Symptom of Distress | Possible Cause(s) | Further Investigation Required | Principal of Repair | Likely Consequence of Not Repair | Photo References |
|---|---|--|---|--|--|---|
| R-1 | Vertical cracking in face of stack | Thermal fluctuations | None | Rake-out bed joint of every 4 <sup>th</sup> course and insert 6mm diameter stainless steel Helibar placed in helibond grout as bonding agent. For cracks up to 6mm, use Nitokit TH by Fosroc. For cracks over 6mm, ram in tight 1:2 dry pack with non-shrink additive. All as per manufacturers recommendations. | Progressive increase in crack width and potential destabilization of stack over time. | 1 / 2 / 3 |

Photo 1 – Looking South to North elevation of southern chimney stack

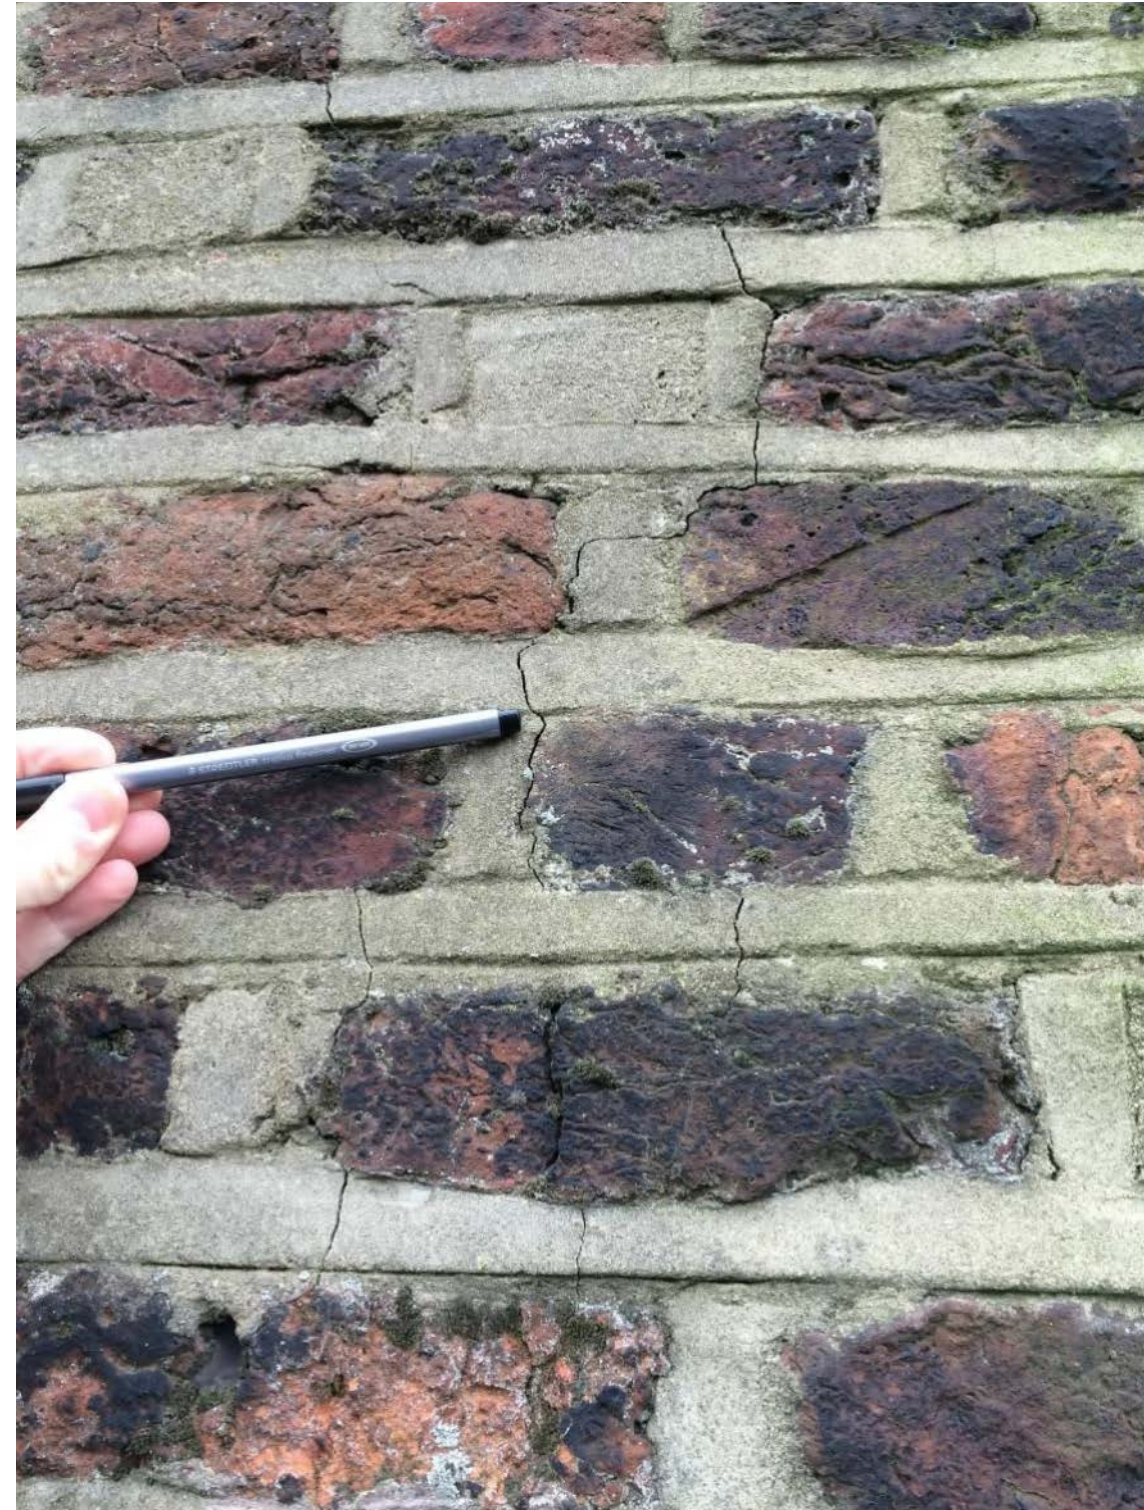
Photo 2 – Vertical crack in face of southern stack

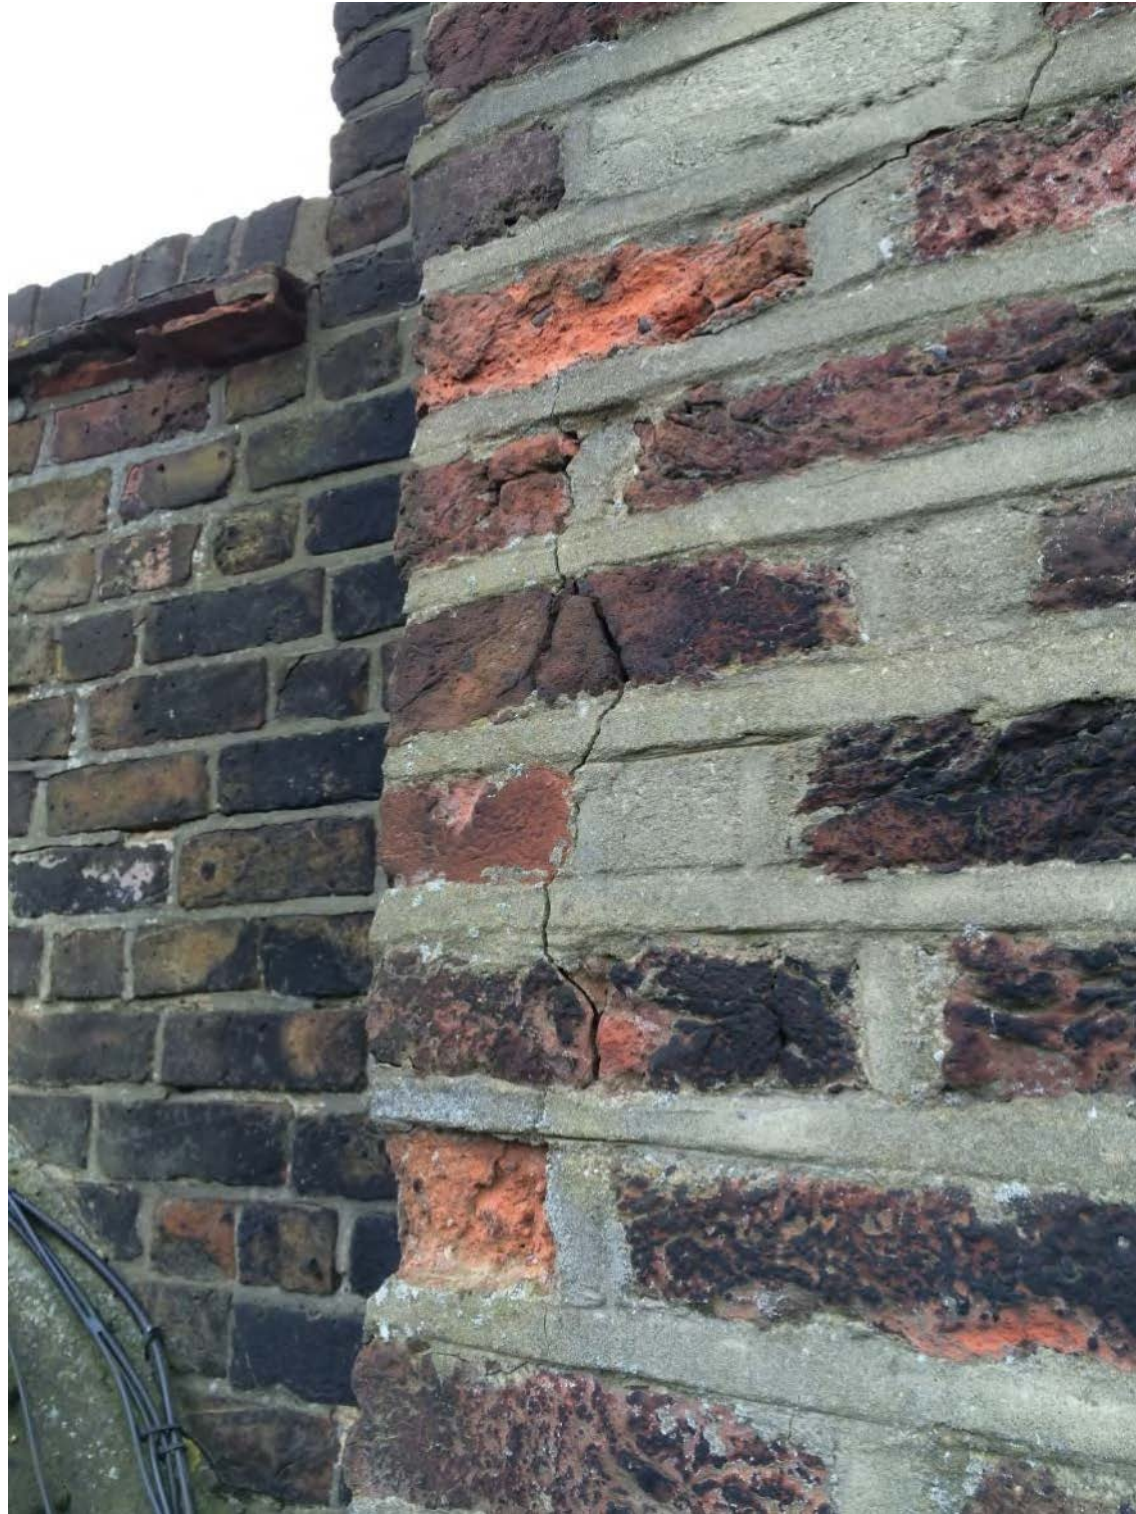
| Reference | Visible Symptom of Distress | Possible Cause(s) | Further Investigation Required | Principal of Repair | Likely Consequence of Not Repair | Photo References |
|---|---|--|---|--|--|---|
| R-2 | Blown brick faces | Crypto florescence. Hidden salt crystallisation occurring within the pores below the masonry surface. Fine pores cannot accommodate the increasing accumulations of salts and are eventually broken apart by the expansive forces of the crystal growth, causing the surface to decay. | None | Loss of section minimal. No repair presently required. | - | 3 |

*Photo 3 – Blown face of brickwork and vertical cracking to northern face of southern stack*

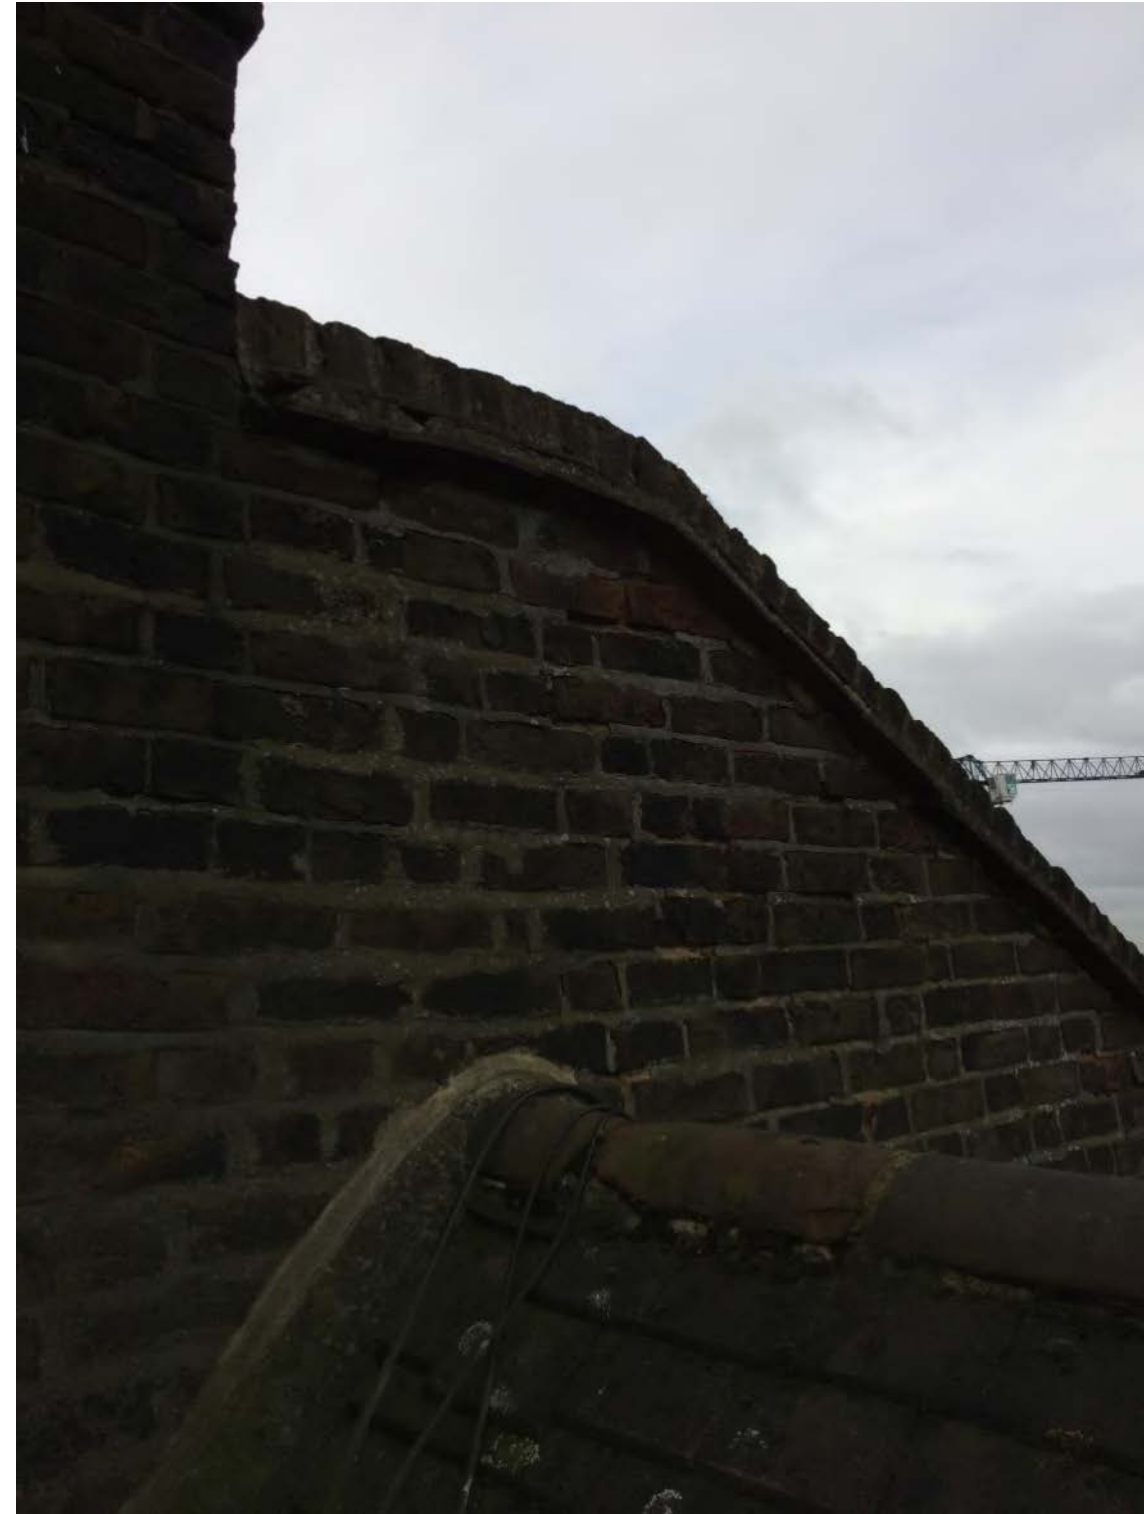
| Reference | Visible Symptom of Distress | Possible Cause(s) | Further Investigation Required | Principal of Repair | Likely Consequence of Not Repair | Photo References |
|---|---|--|---|--|--|---|
| R-3 | Pointing missing to parapet | Freeze thaw action | None | Rake out any loose pointing encountered and re-point. | Further loss of pointing in adjacent beds. | 4 |

*Photo 4 – Missing pointing on Party Wall parapet*

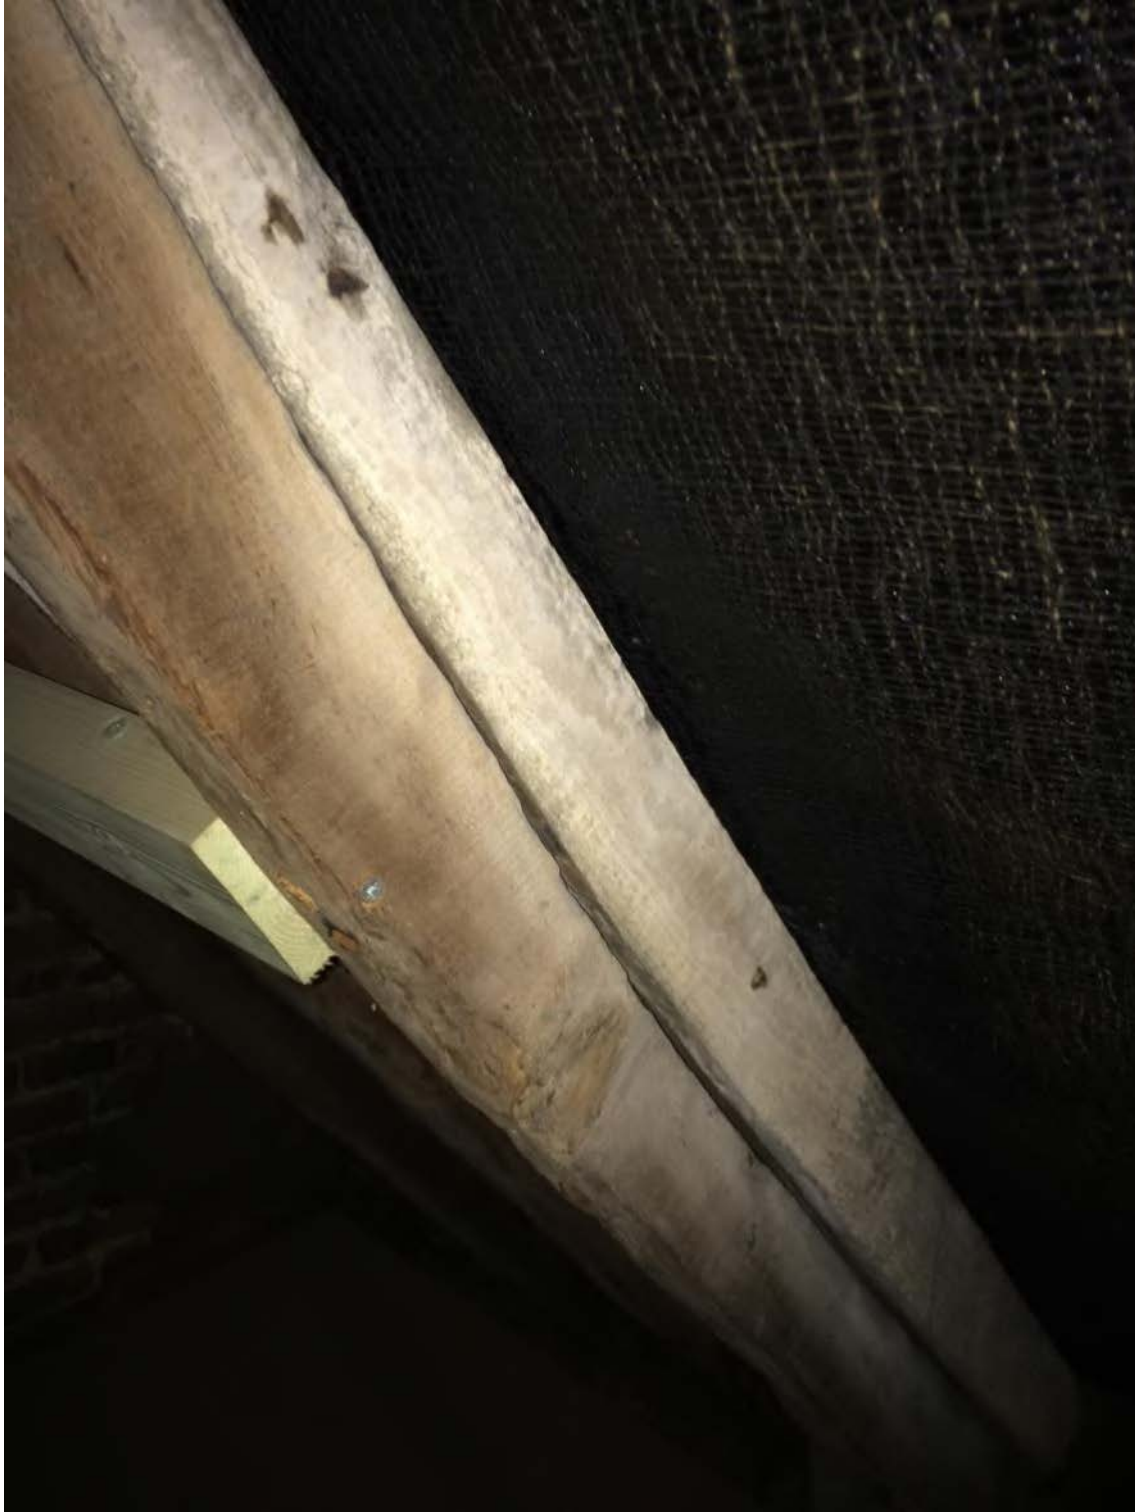
| Reference | Visible Symptom of Distress | Possible Cause(s) | Further Investigation Required | Principal of Repair | Likely Consequence of Not Repair | Photo References |
|---|---|--|---|--|--|---|
| R-4 | Bowing rafters to interior roof pitches | Non-original concrete tiles on interior pitches | None | Replace heavy concrete tiles with traditional clay tiles to match front and rear pitches. Install collar strut to act as compression member and prevent further deflection. | Rafters remain overloaded and cause rafters to deflect further overstress purlins and potentially exacerbate roof spread at 2 <sup>nd</sup> floor level. | 5 |

*Photo 5 – Significant firrings to correct sagging rafters*

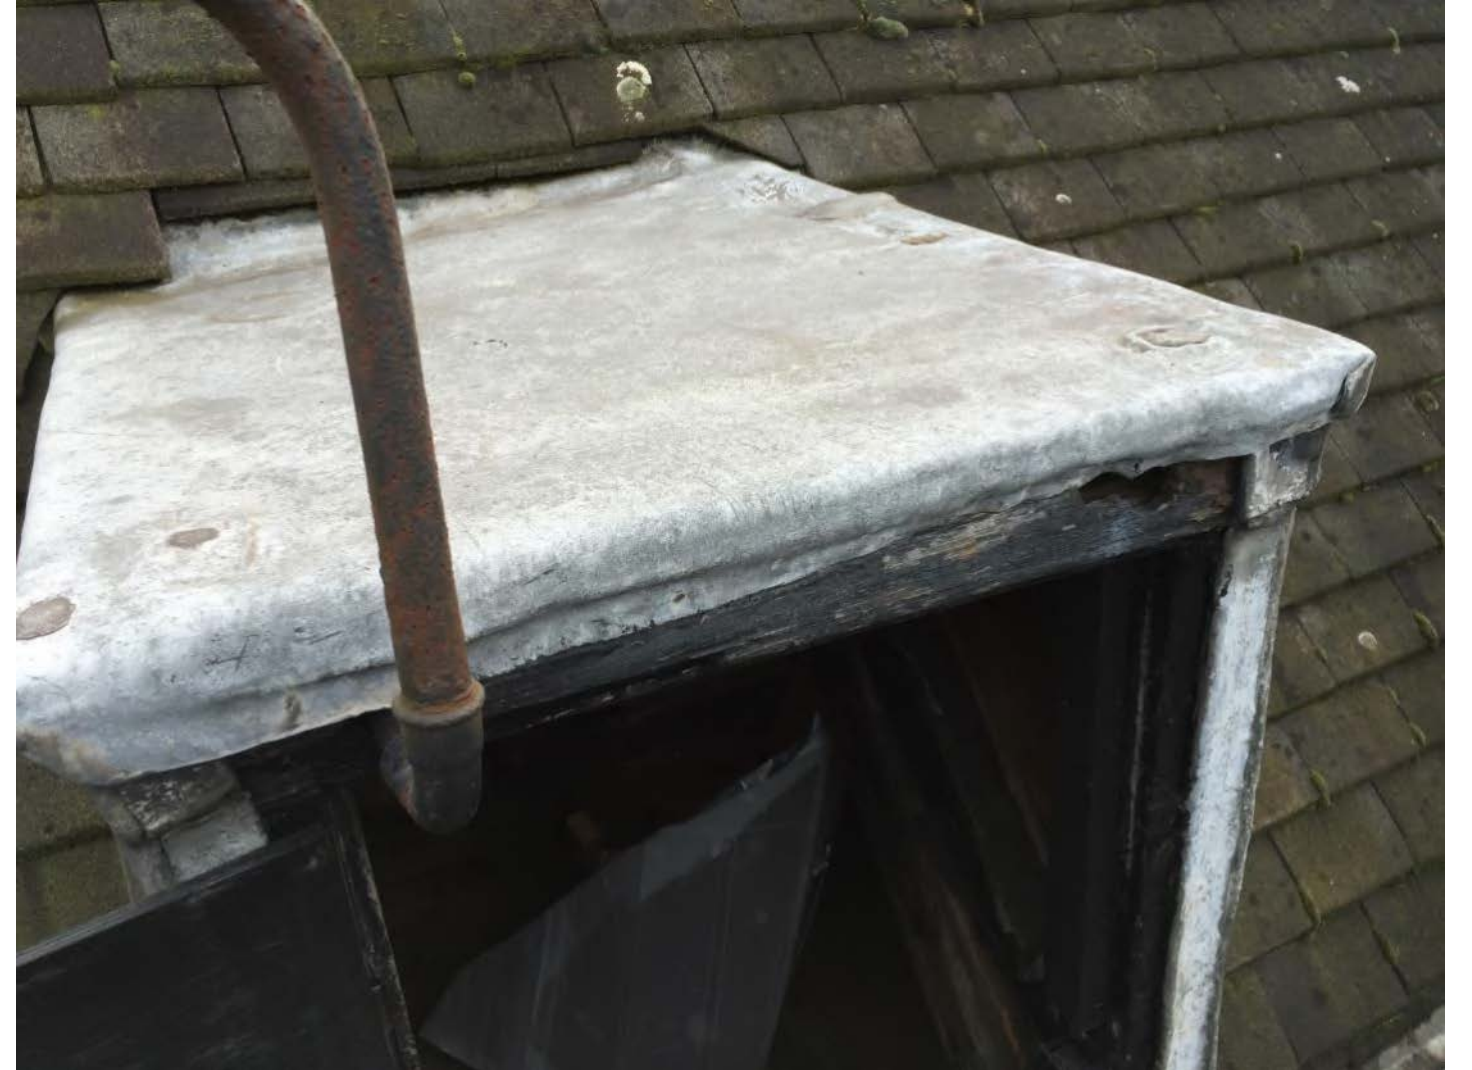
| Reference | Visible Symptom of Distress | Possible Cause(s) | Further Investigation Required | Principal of Repair | Likely Consequence of Not Repair | Photo References |
|---|---|--|---|--|--|---|
| R-5 | Hatch enclosure timbers rotten | Poor flashing detail allowing water ingress | None | Reconstruct roof access hatch and enclosure in timber carcassing and improve waterproofing detail using lead work to Architects details and recommendation. | Continued decay of enclosure timbers and water ingress to roof space. | 6 |

*Photo 6 – Decaying timber surround to roof hatch*

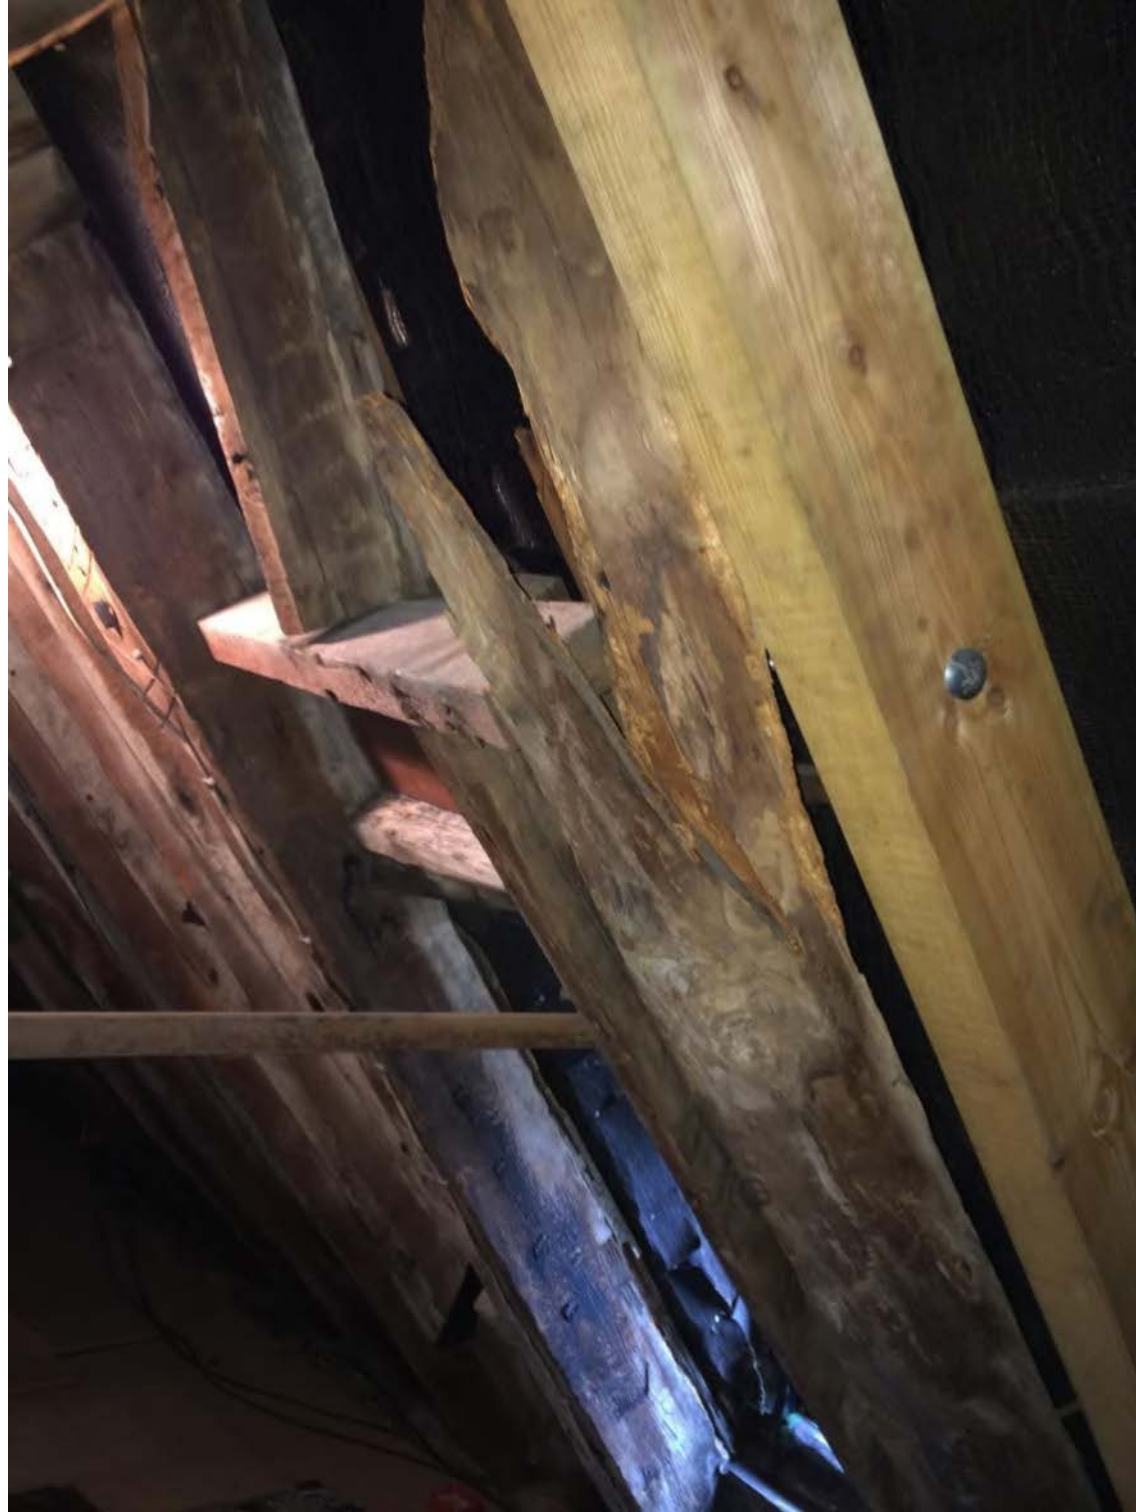
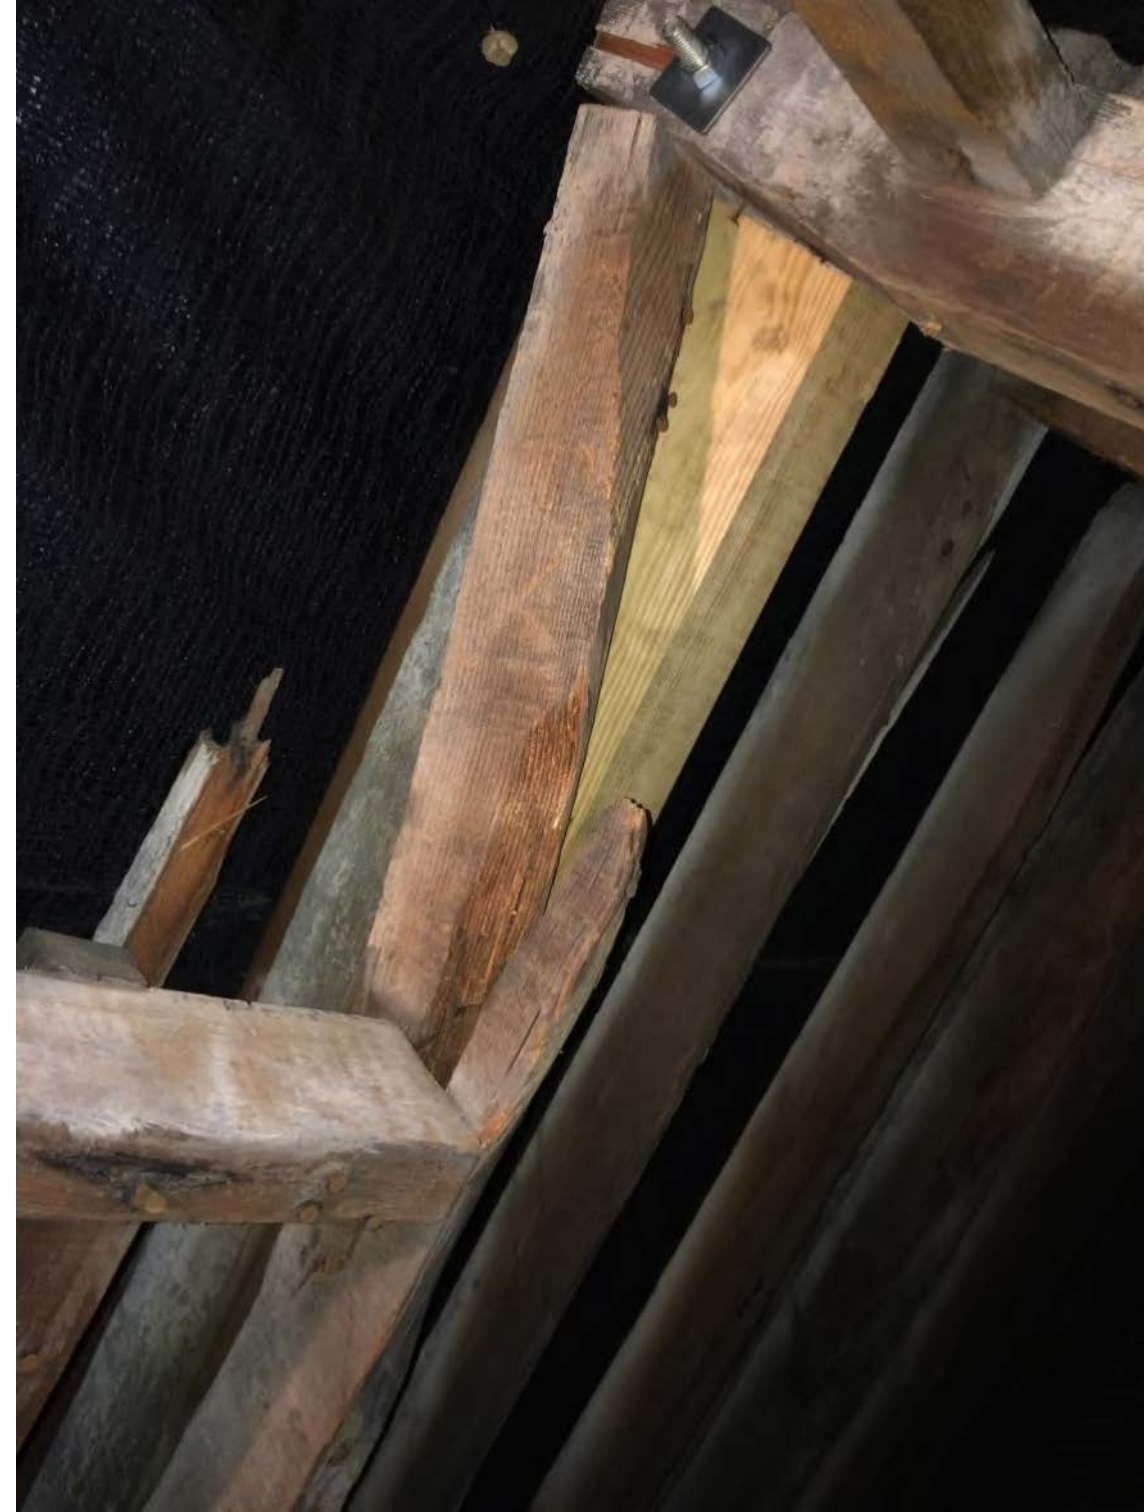
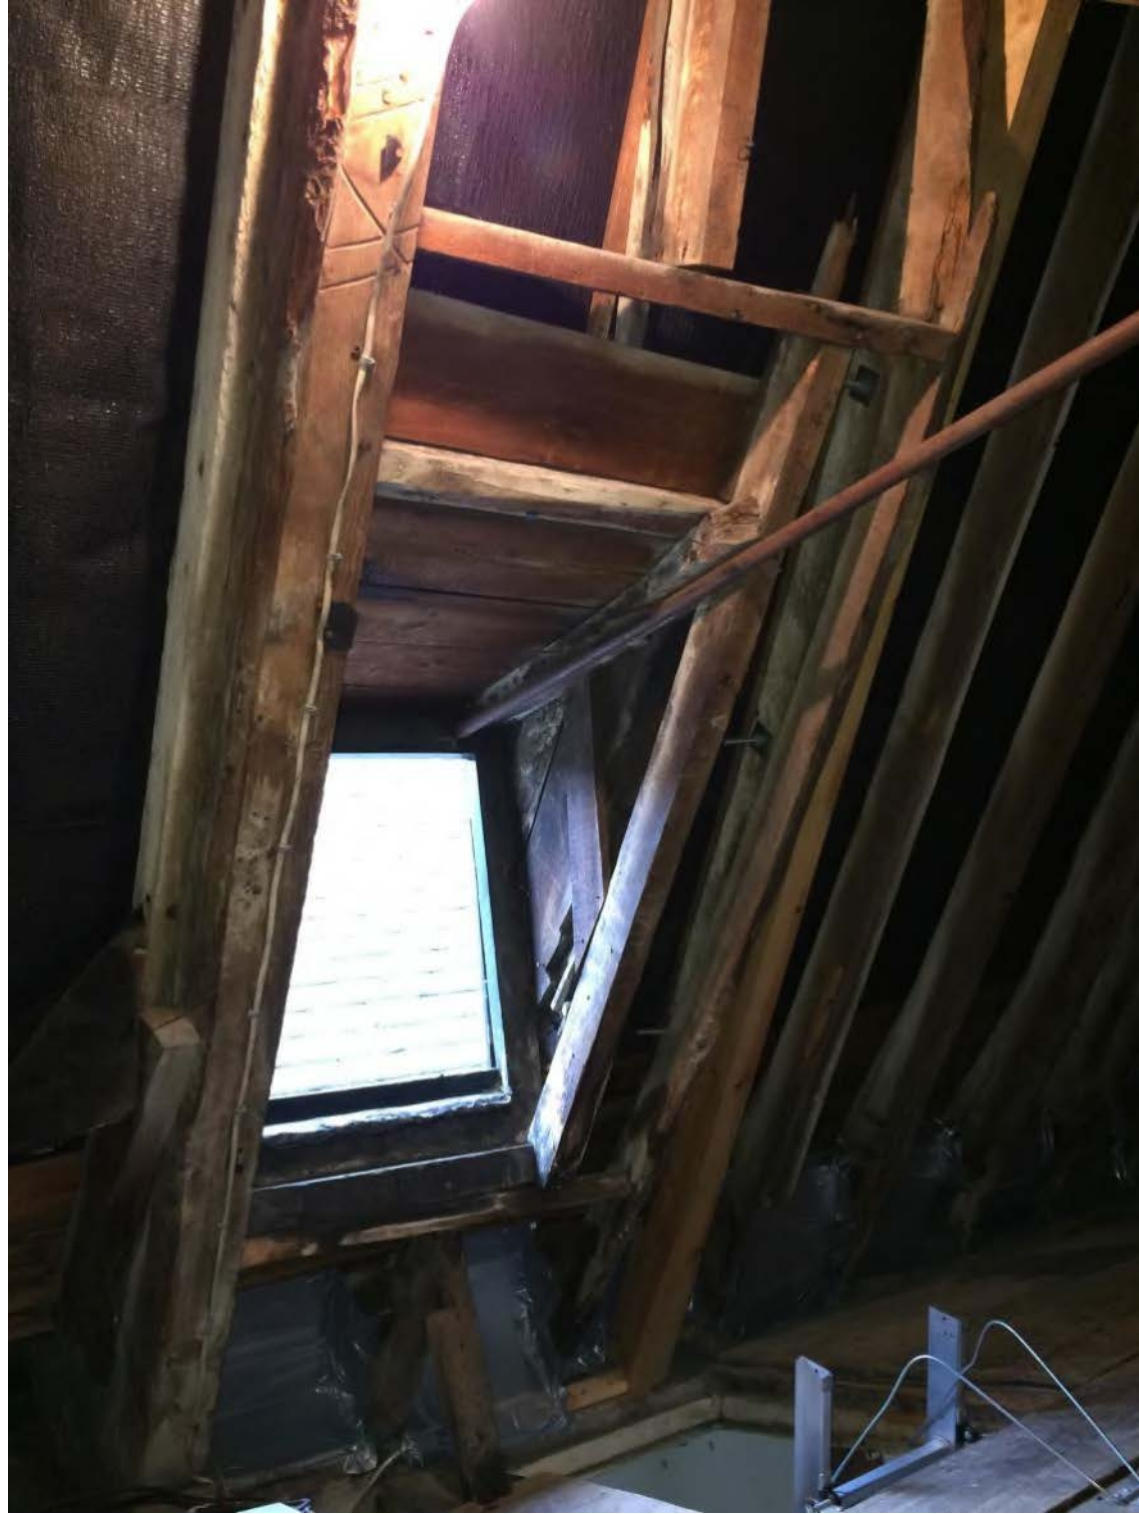
| Reference | Visible Symptom of Distress | Possible Cause(s) | Further Investigation Required | Principal of Repair | Likely Consequence of Not Repair | Photo References |
|---|---|--|---|--|--|---|
| R-6 | Fractured hatch timber | Inadequate design and detailing of trimming timbers during historic modification | None | Remove roof access enclosure and rebuild with doubled-up trimming rafters either side of opening to avoid overstressing of individual rafters. | Potential collapse of roof access hatch enclosure. | 7 / 8 / 9 |

*Photo 7 – Fracture to roof hatch trimming timber*

*Photo 8 – Fracture to roof hatch trimming timber*

Photo 9 – Fracture to roof hatch trimming timber on right hand side

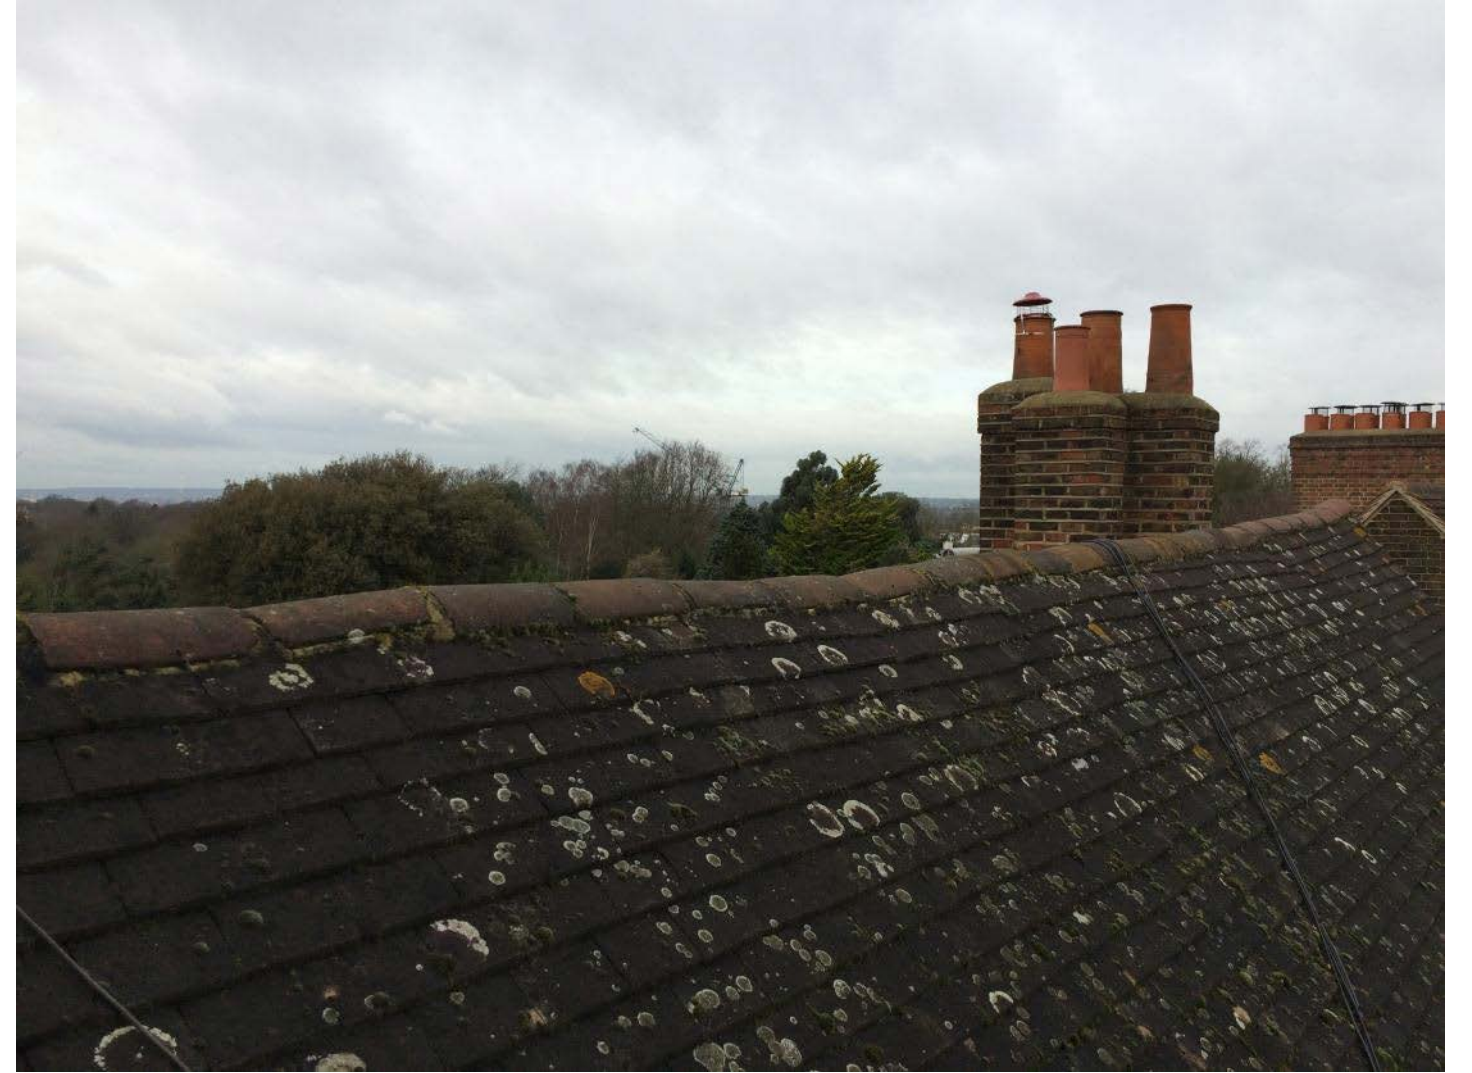
| Reference | Visible Symptom of Distress | Possible Cause(s) | Further Investigation Required | Principal of Repair | Likely Consequence of Not Repair | Photo References |
|---|---|--|---|--|--|---|
| R-7 | Minor ridge sagging | Overloading of interior pitches and historical creep | None | Reduce load by replacing heavy concrete tiles with traditional clay tiles to match front and rear pitches. Improve connectivity of 2 <sup>nd</sup> floor joists with rafter feet to prevent further roof spread. | Continued distortion of roof structure and potentially exacerbate roof spread at 2 <sup>nd</sup> floor level. | 10 |

Photo 10 – Minor sagging of roof pitch

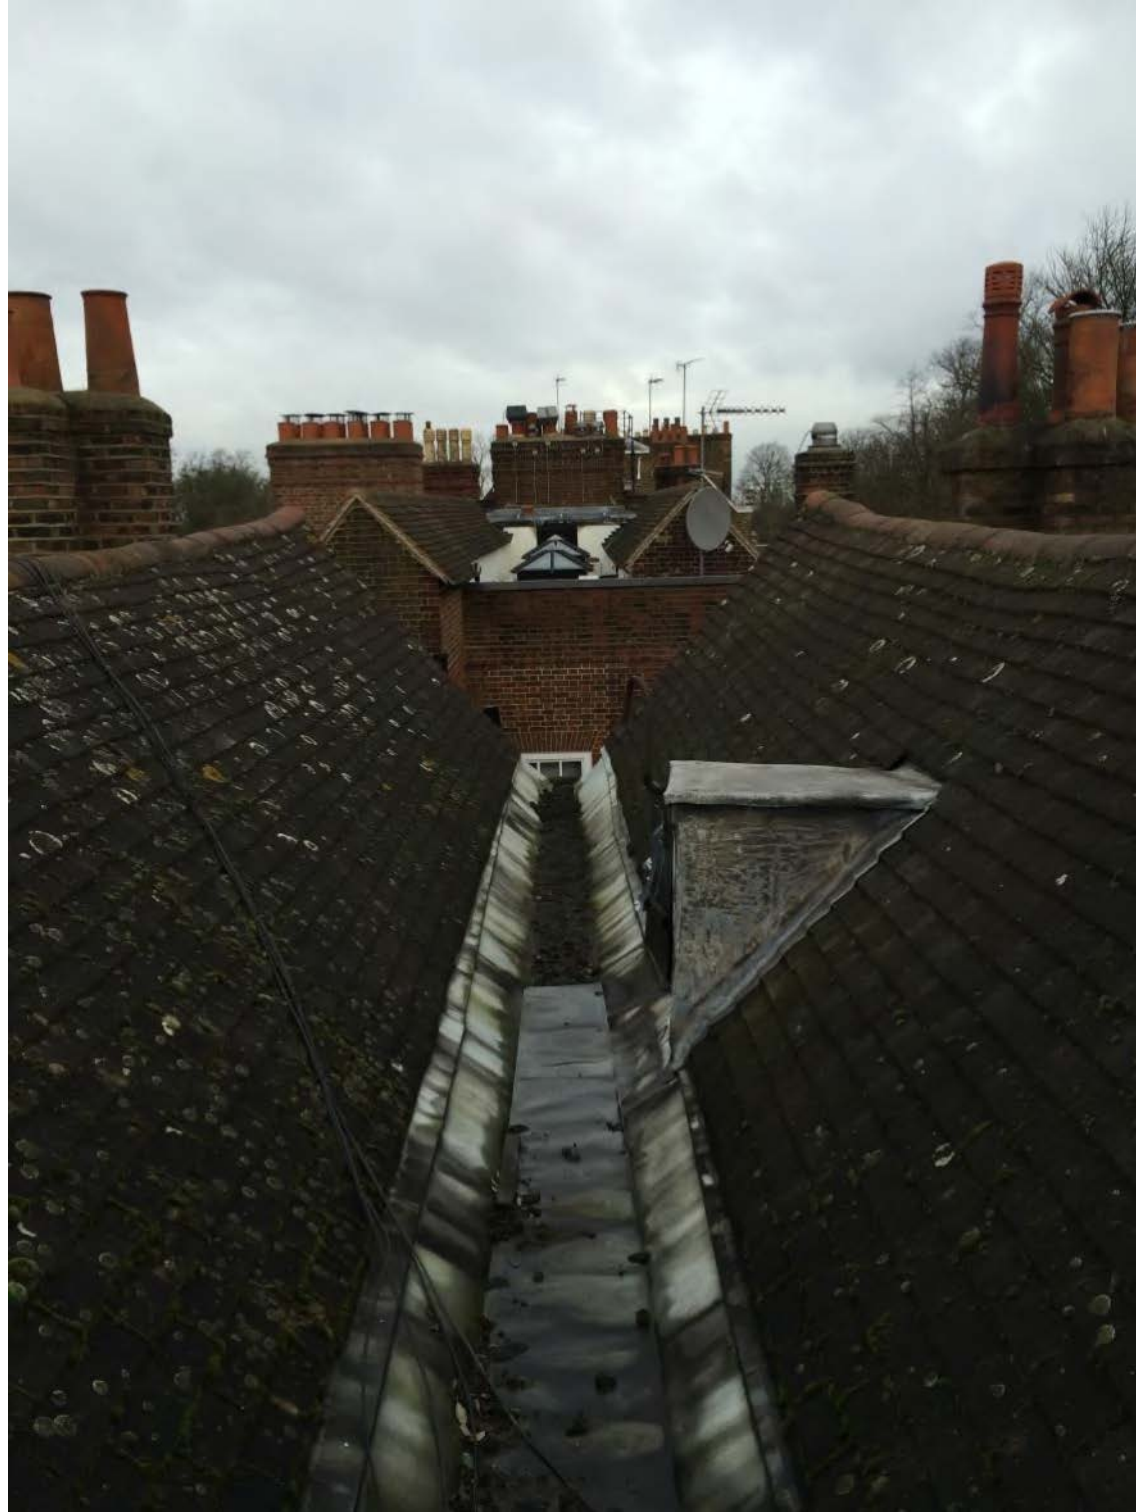
| Reference | Visible Symptom of Distress | Possible Cause(s) | Further Investigation Required | Principal of Repair | Likely Consequence of Not Repair | Photo References |
|---|---|--|---|--|--|---|
| R-8 | Silting in valley gutter | Insufficient fall in valley gutter | None | Increase fall of valley gutter. | Continued build-up of sediment preventing water from draining. Encouraging ponding and water ingress to roof structure. | 11 |

Photo 11 – Silting of valley gutter

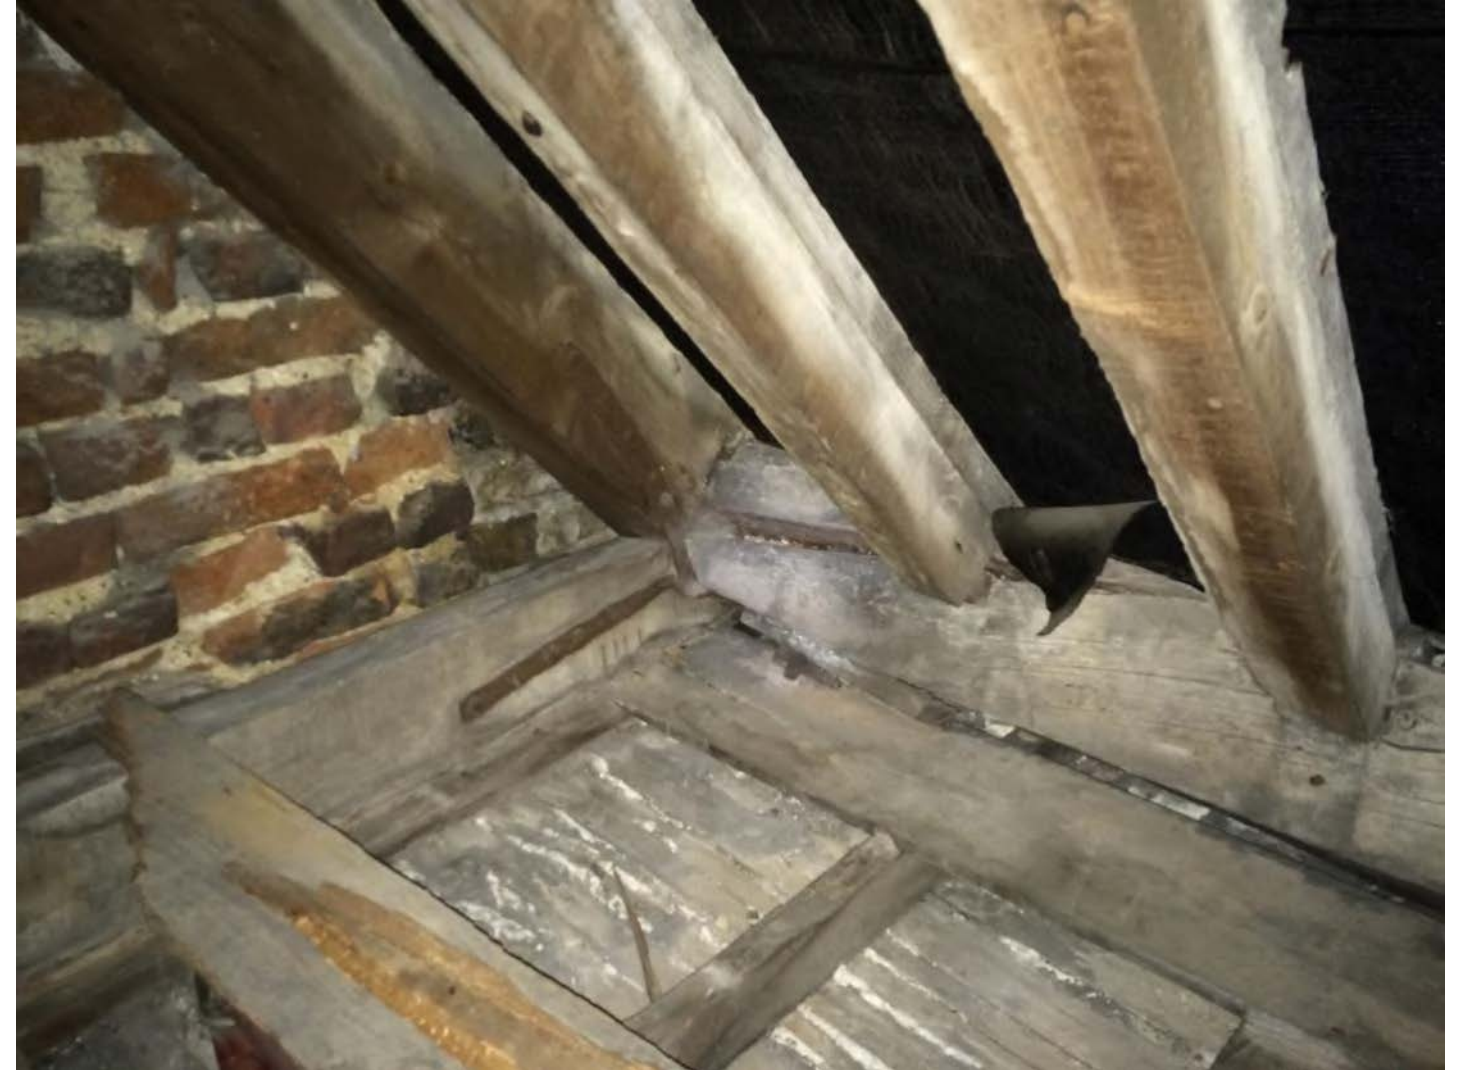
| Reference | Visible Symptom of Distress | Possible Cause(s) | Further Investigation Required | Principal of Repair | Likely Consequence of Not Repair | Photo References |
|---|---|--|---|--|--|---|
| R-9 | Major fracture in purlin | Overloading and rotation of purlin causing failure of tenon connection | None | Horizontal through bolting of purlin with resin infill to reform section modulus. Steel brackets to improve connection of purlin in to principal truss. | Partial collapse of roof possible should the connection fail entirely. | 12 |

Photo 12 – Fractured purlin at tenon connection with northern principal truss

The North-East purlin was found to have a major fracture at its tenon connection with the northern principal truss. We recommend horizontal through bolting of purlin with resin infill to reform the section modulus. Steel brackets should then be installed to improve connection of the purlin in to the principal truss.
