# 4 The Grove, Highgate

Visual Structural Inspection

**This report describes the findings of the Visual Structural Inspection conducted at 4 The Grove, Highgate on behalf of Jamie Oliver Holdings Limited**

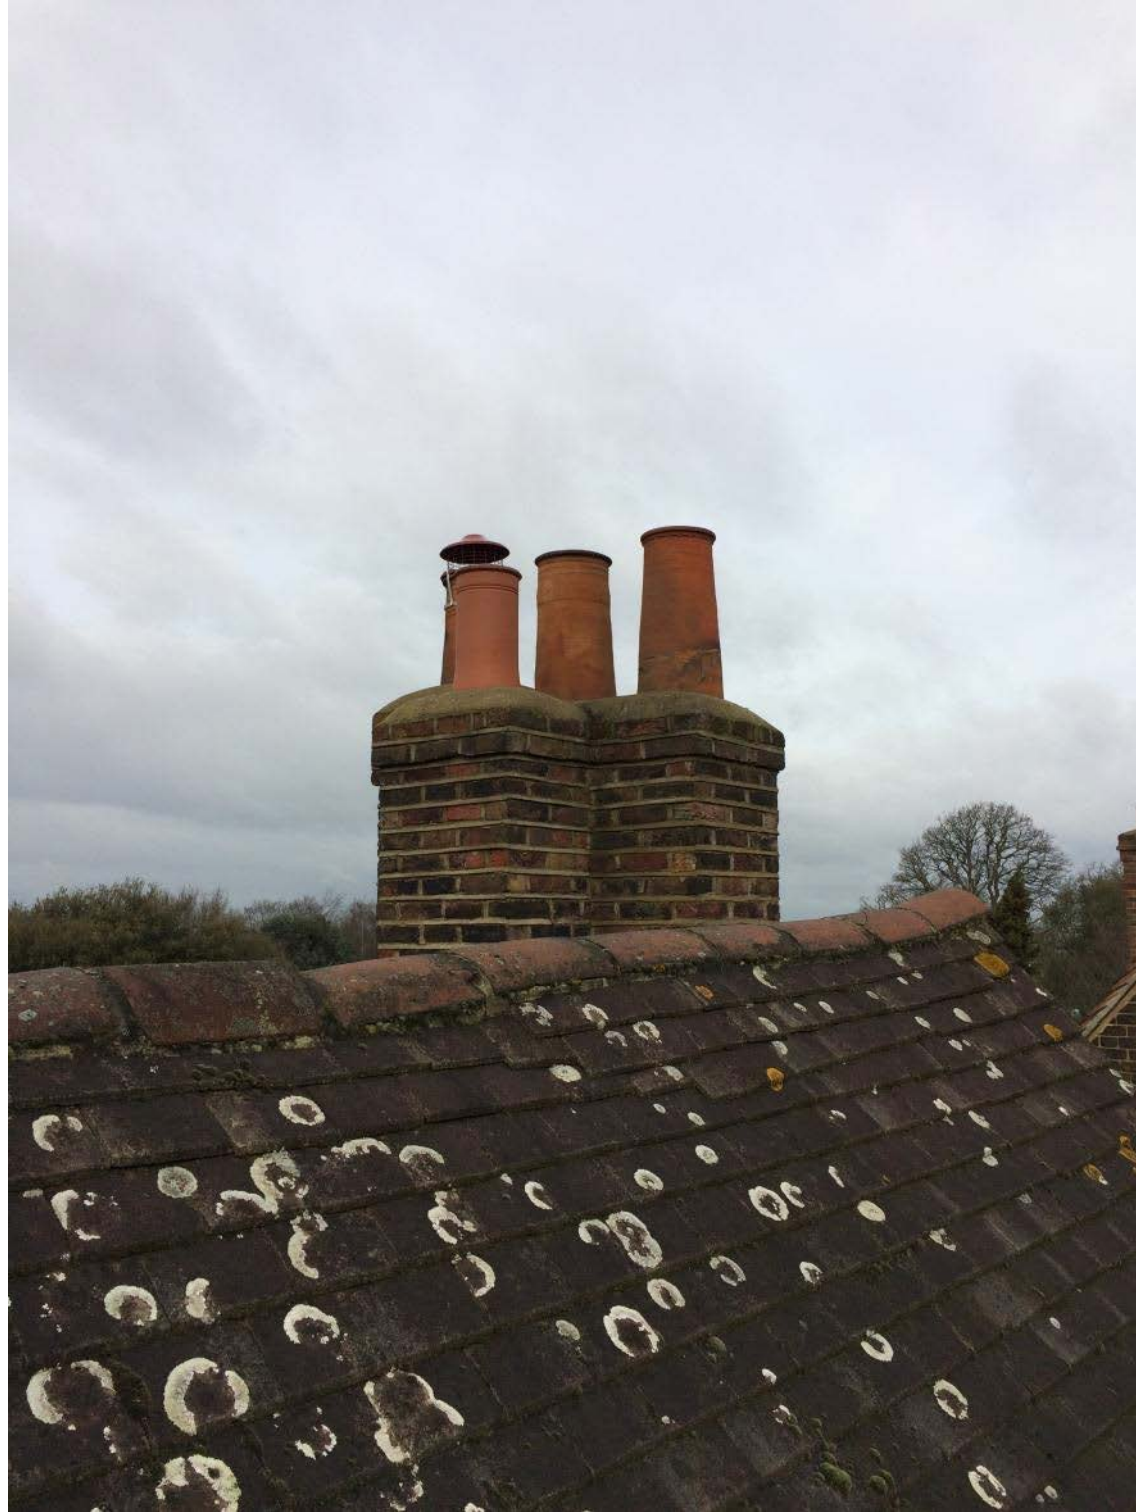
| Reference | Visible Symptom of Distress | Possible Cause(s) | Further Investigation Required | Principal of Repair | Likely Consequence of Not Repair | Photo References |
|---|---|--|---|--|--|---|
| R-11 | Flaking chimney pot | Freeze thaw | None | None currently required. | Surface of pot may continue to erode. | 13 |

Photo 13 – Flaking surface to clay pot

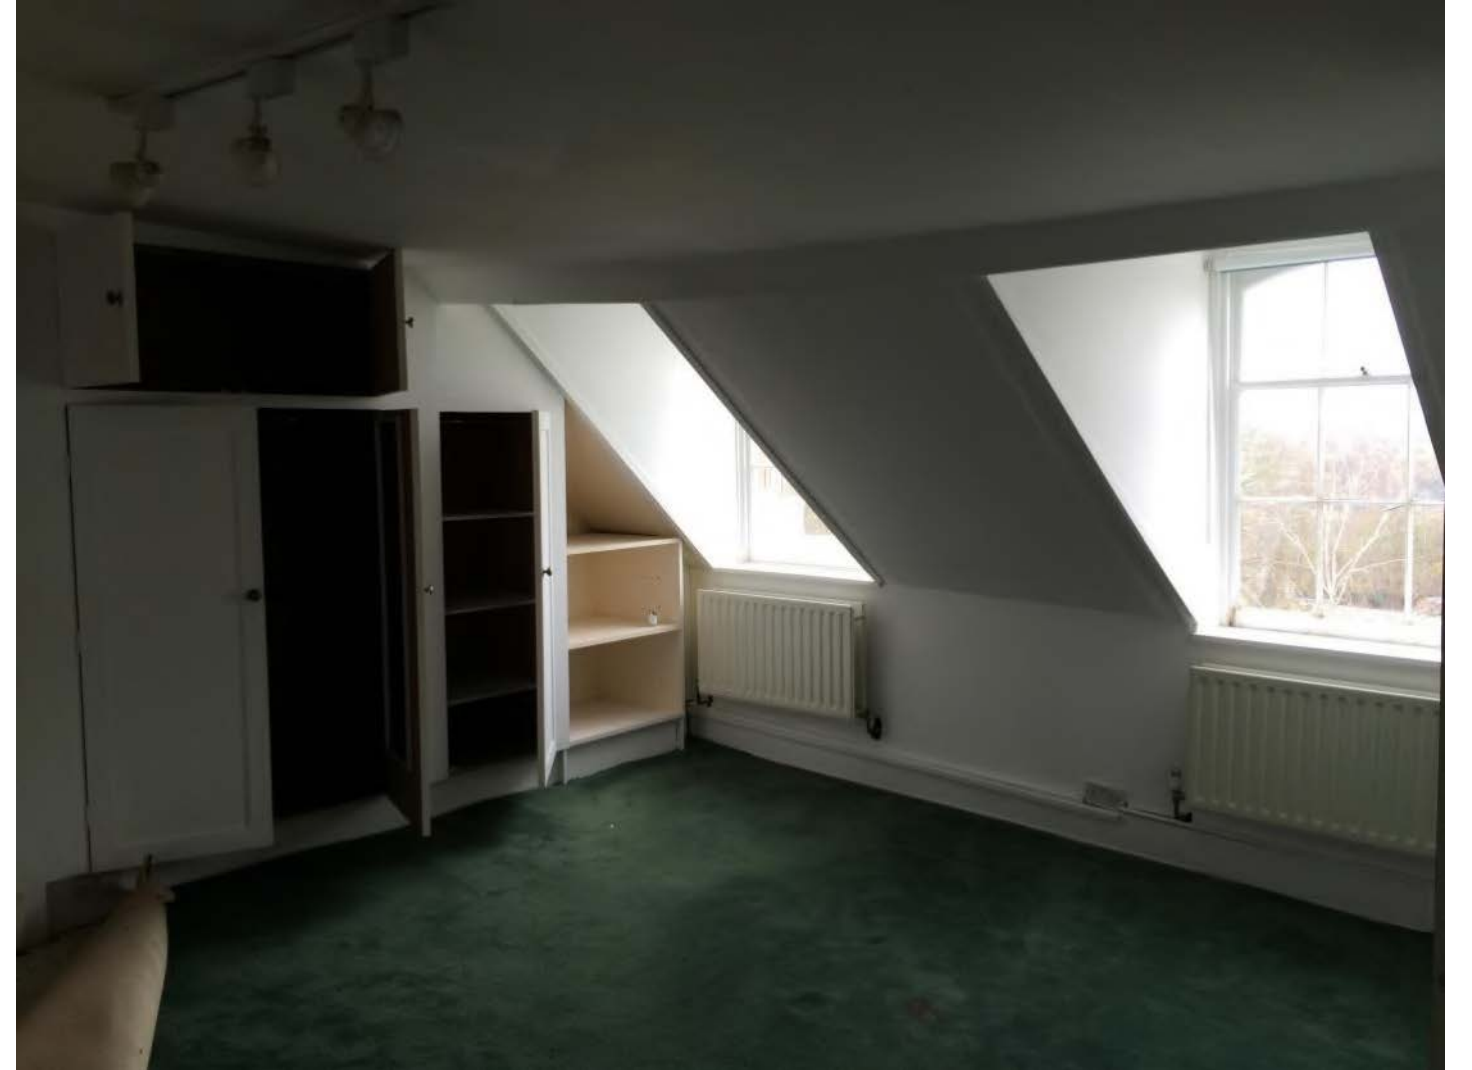
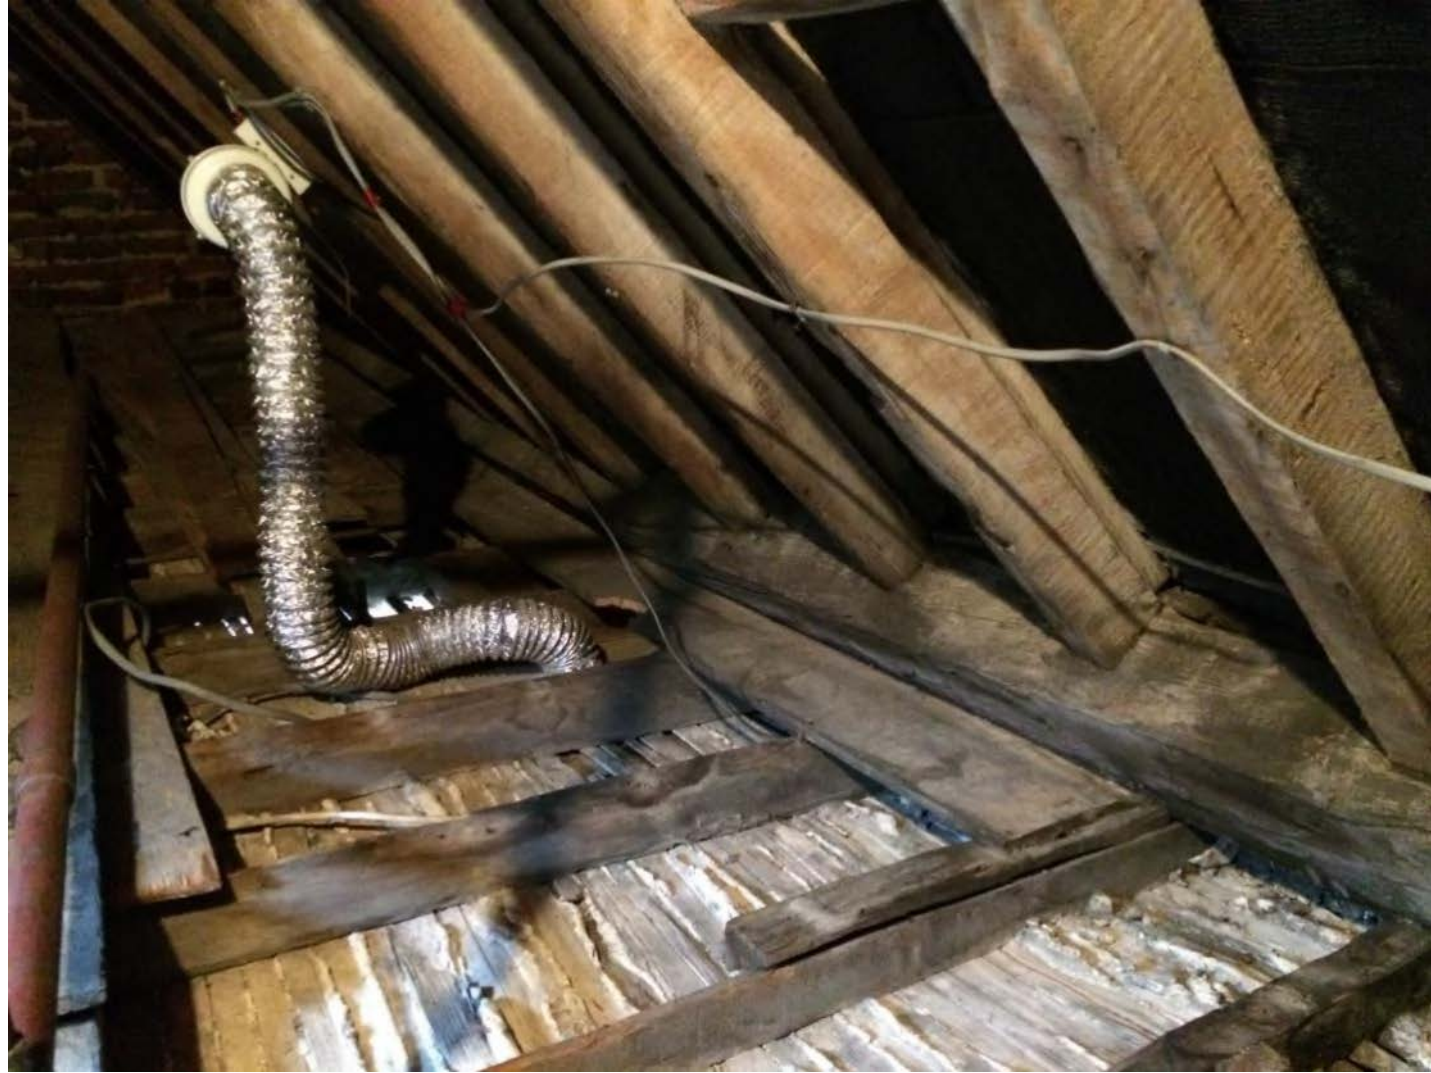
| Reference | Visible Symptom of Distress | Possible Cause(s) | Further Investigation Required | Principal of Repair | Likely Consequence of Not Repair | Photo References |
|---|---|--|---|--|--|---|
| R-12 | Deflected purlins | Overloading and roof spread | None | Reduce load by replacing heavy concrete tiles with traditional clay tiles to match front and rear pitches. Install compression members between purlins to prevent any further deflection. Improve connectivity of 2 <sup>nd</sup> floor joists with rafter feet to prevent further roof spread. | Partial collapse of roof possible should the deflection cause the tenon connections to fail and the rafters become unsupported. | 14 / 15 |

Photo 14 - Significant deflection of South-West purlin

*Photo 15 - Significant deflection of North-East purlin*

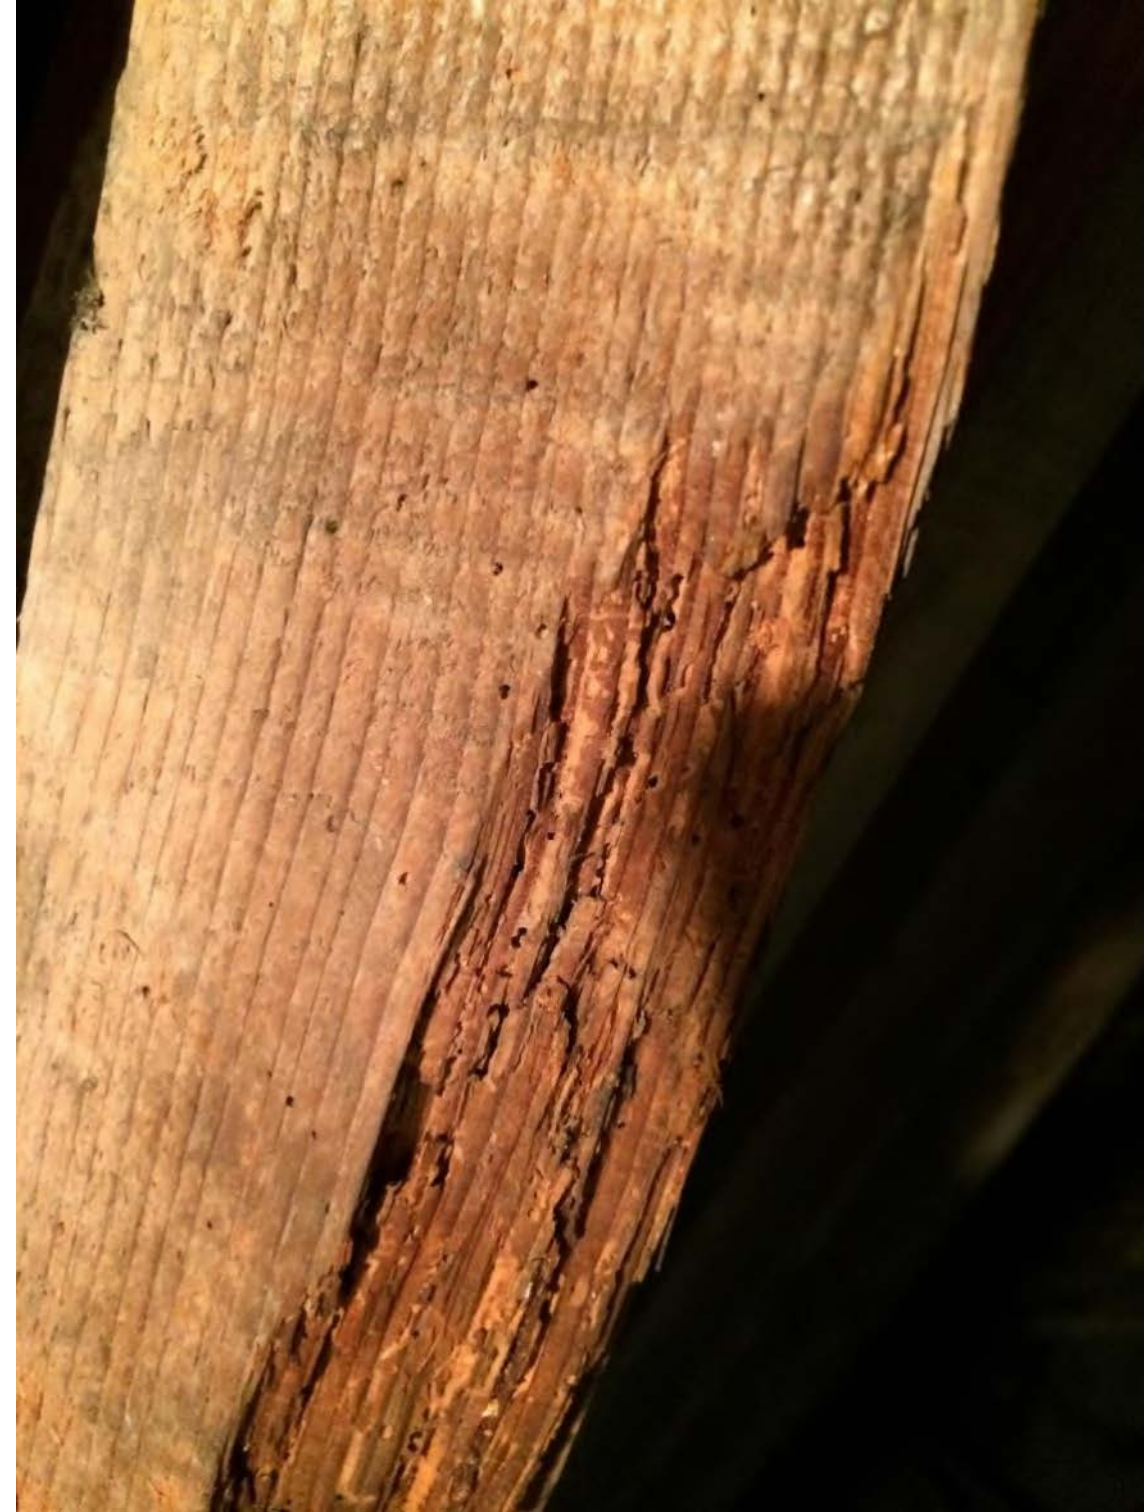
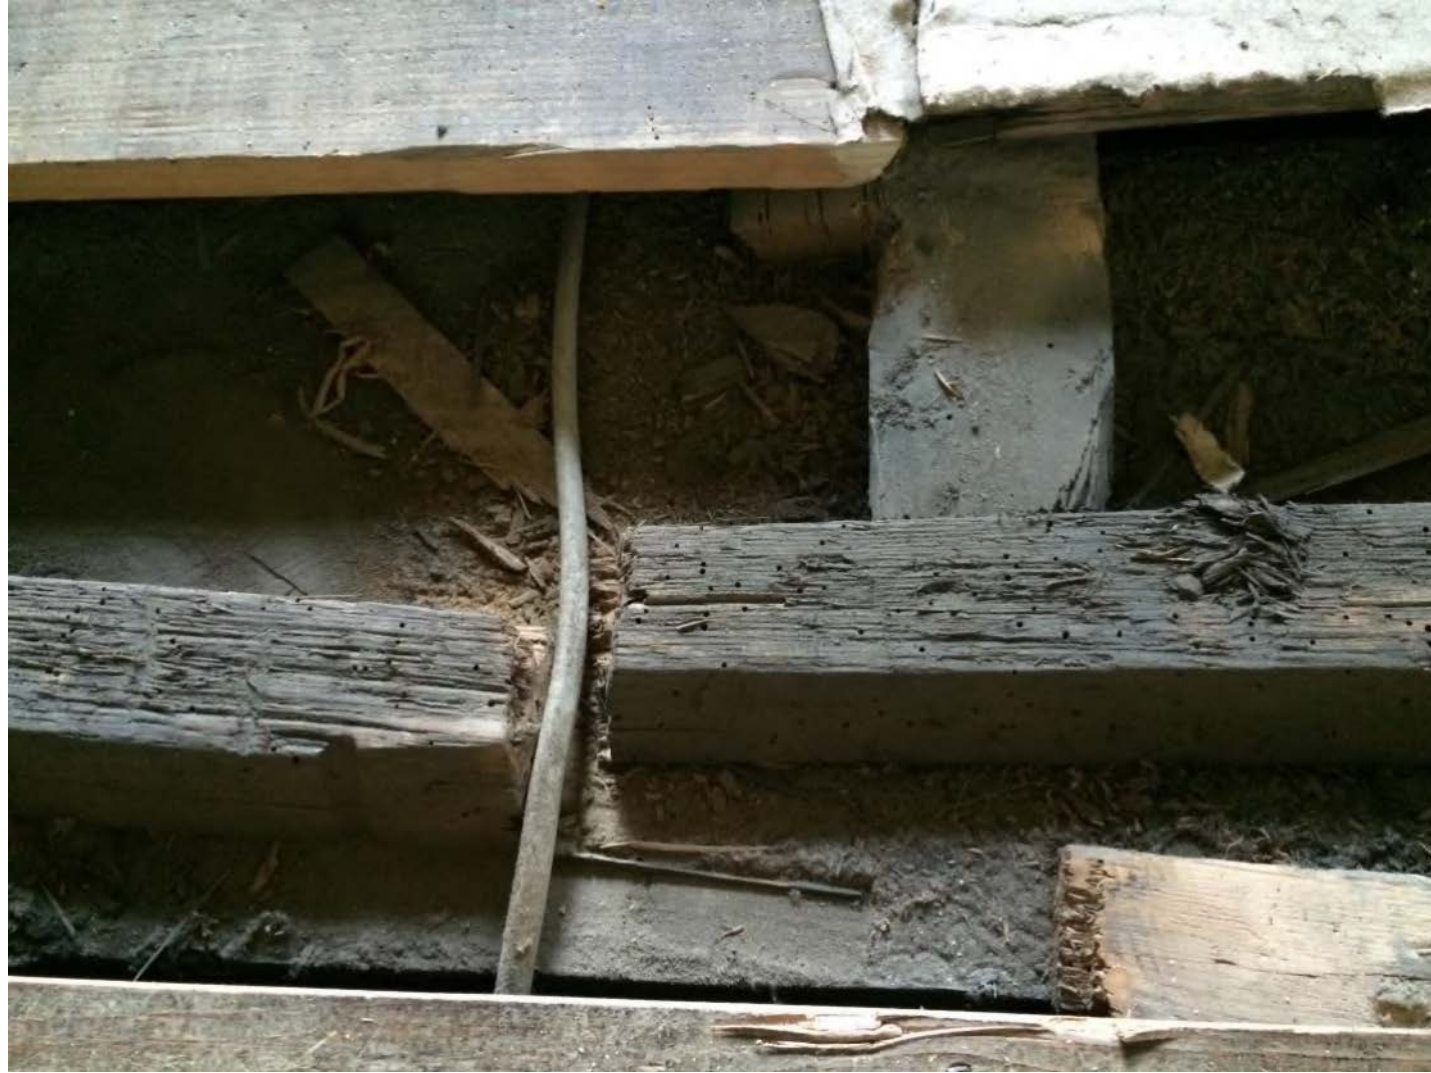
| Reference | Visible Symptom of Distress | Possible Cause(s) | Further Investigation Required | Principal of Repair | Likely Consequence of Not Repair | Photo References |
|---|---|--|---|--|--|---|
| R-13 | Insect bores in timber | Insect attack | Specialist timber survey may be beneficial to mitigate risk. No insect bore dust or frass visible so insect attack may be historical. | Timber specialist to advise of appropriate cause and treatment. As a precaution, we would recommend having the roof sprayed with insecticide as a matter of course. | If active, insect attack could reduce the capacity of individual elements and cause them to fail in extreme circumstances. | 16 / 17 |

*Photo 16 – Insect bores to timber rafter*

*Photo 17 – Insect bores to timber floor joist and heavy notching of battens*

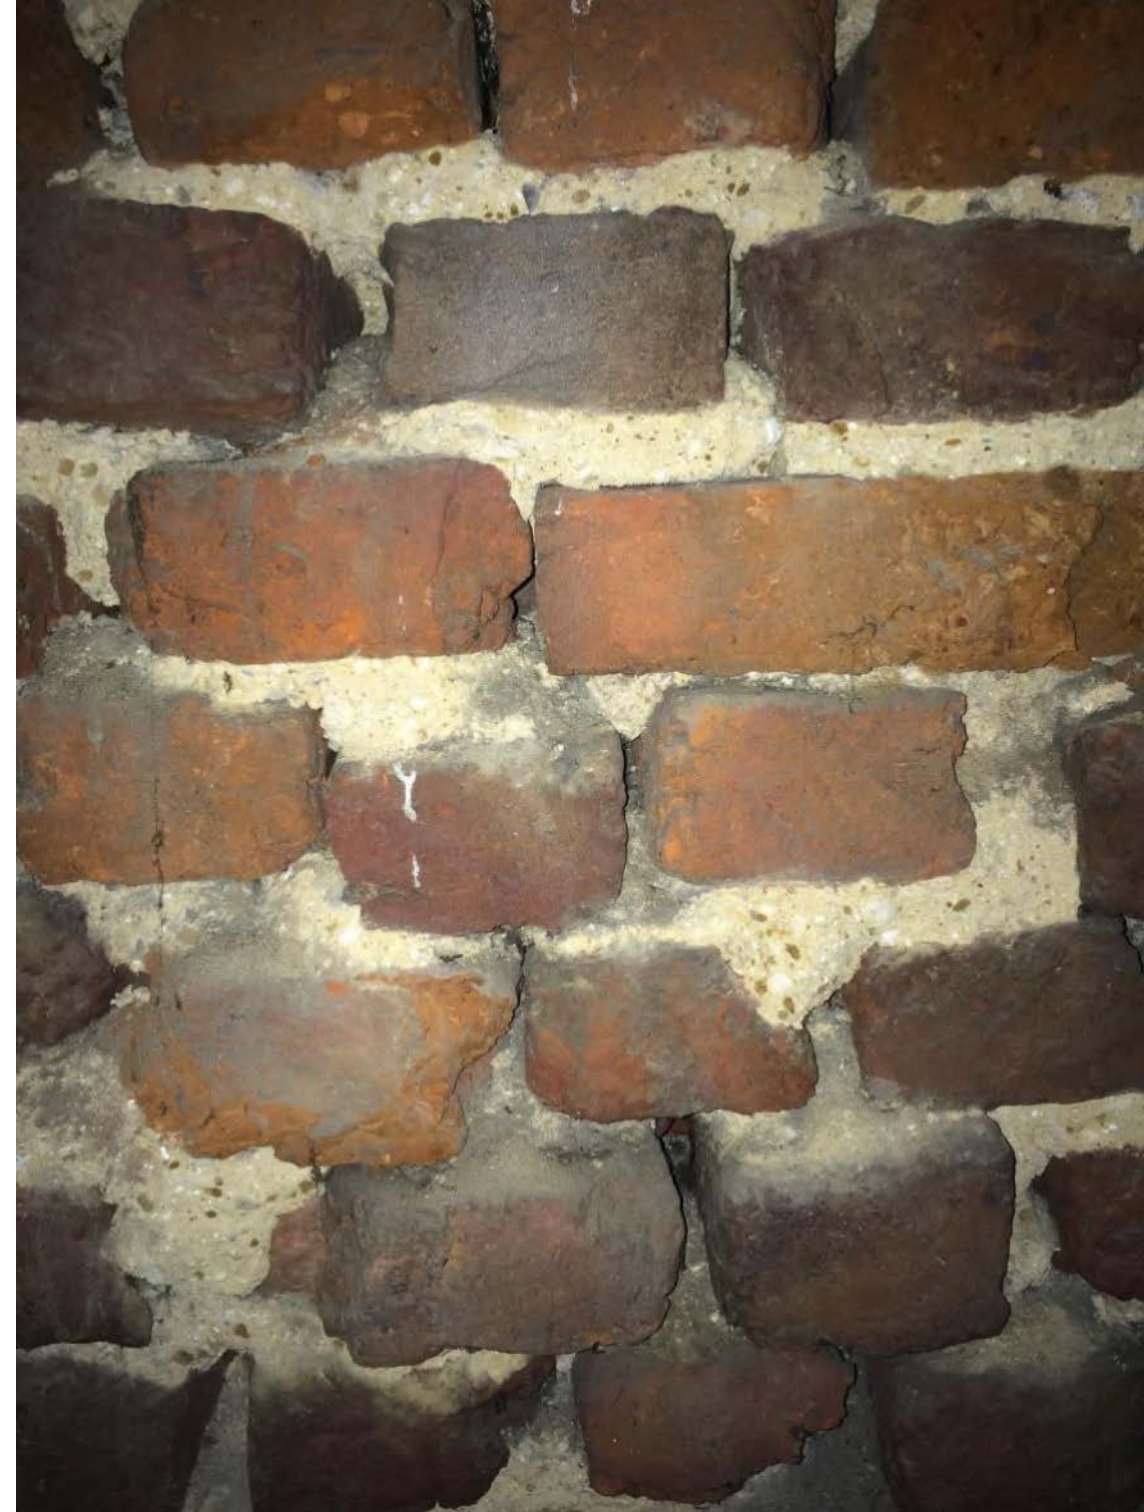
| Reference | Visible Symptom of Distress | Possible Cause(s) | Further Investigation Required | Principal of Repair | Likely Consequence of Not Repair | Photo References |
|---|---|--|---|--|--|---|
| R-14 | Missing pointing from inside face of North gable wall within roof space | Historical water ingress washing out mortar | None | Repoint with lime based mortar. | Continued loss of mortar could make the gable wall unstable. | 18 |

*Photo 18 – Missing pointing to inside face of North gable wall within roof space*

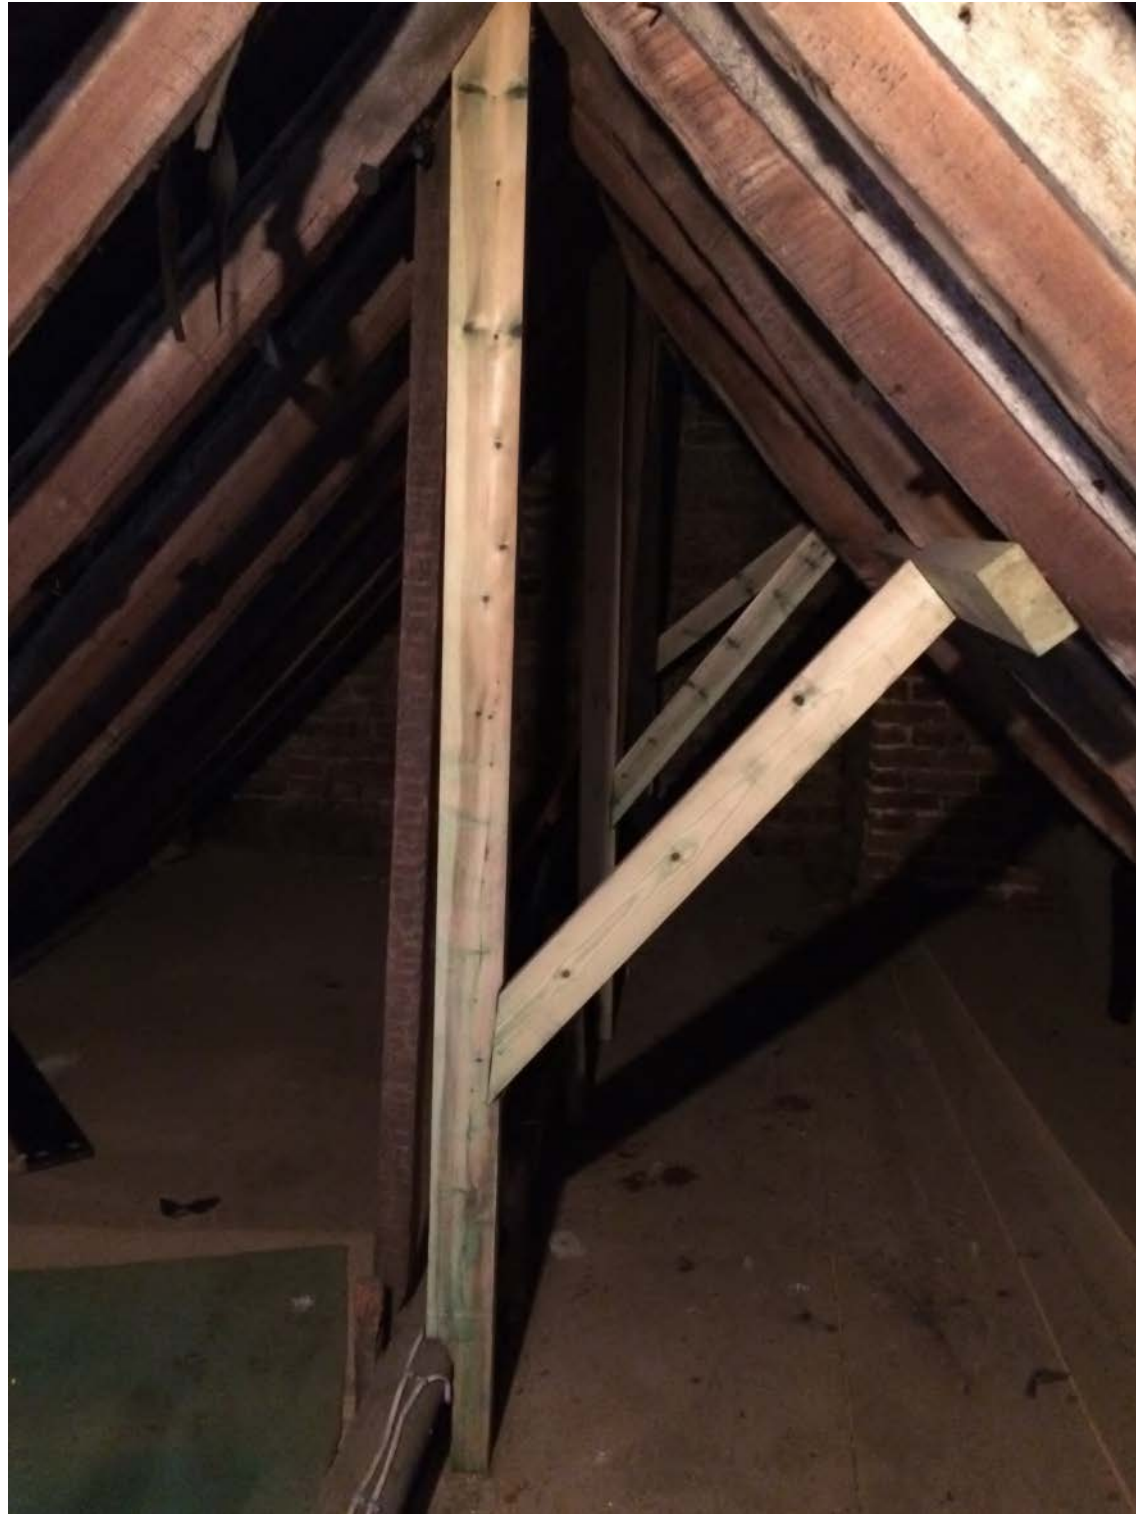
| Reference | Visible Symptom of Distress | Possible Cause(s) | Further Investigation Required | Principal of Repair | Likely Consequence of Not Repair | Photo References |
|---|---|--|---|--|--|---|
| R-15 | Modern diagonal prop to interior pitch within front roof space | Attempt to prevent further rafter deflection. Props down to ceiling joist binder which is structurally inadequate to prop against. | None | Replace heavy concrete tiles with traditional clay tiles to match front and rear pitches. Install collar strut to act as compression member and prevent further deflection. | Rafters remain overloaded and cause rafters to deflect further overstress 2 <sup>nd</sup> floor ceiling joists. | 19 |

*Photo 19 – Modern Repairs within roof space*

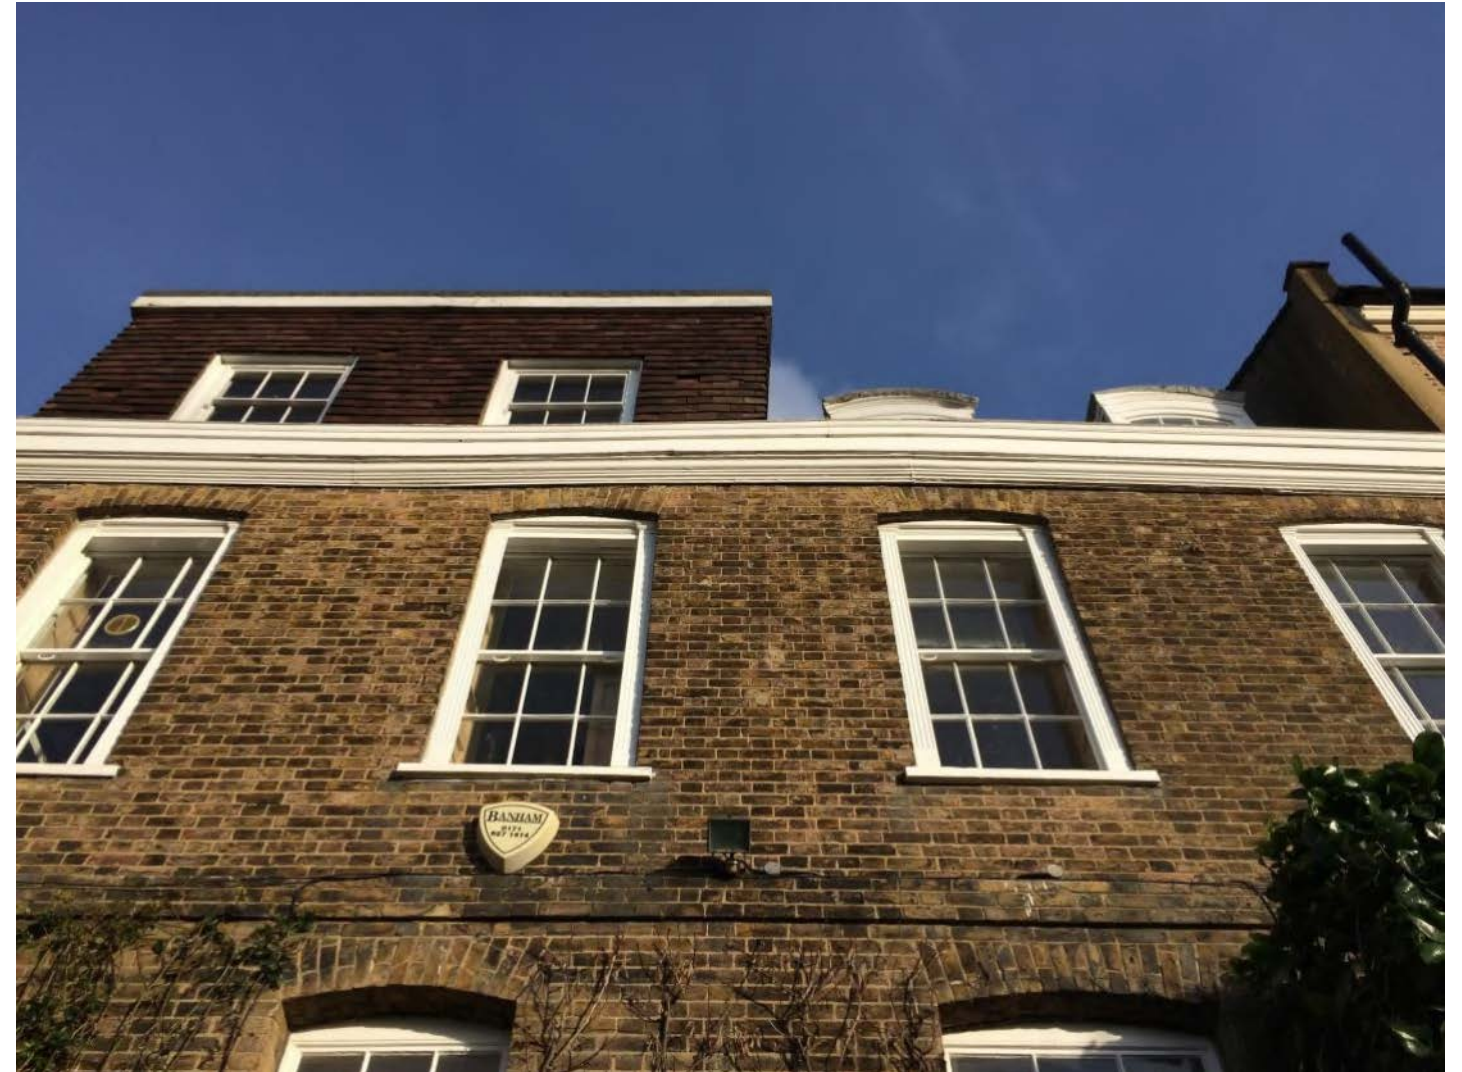
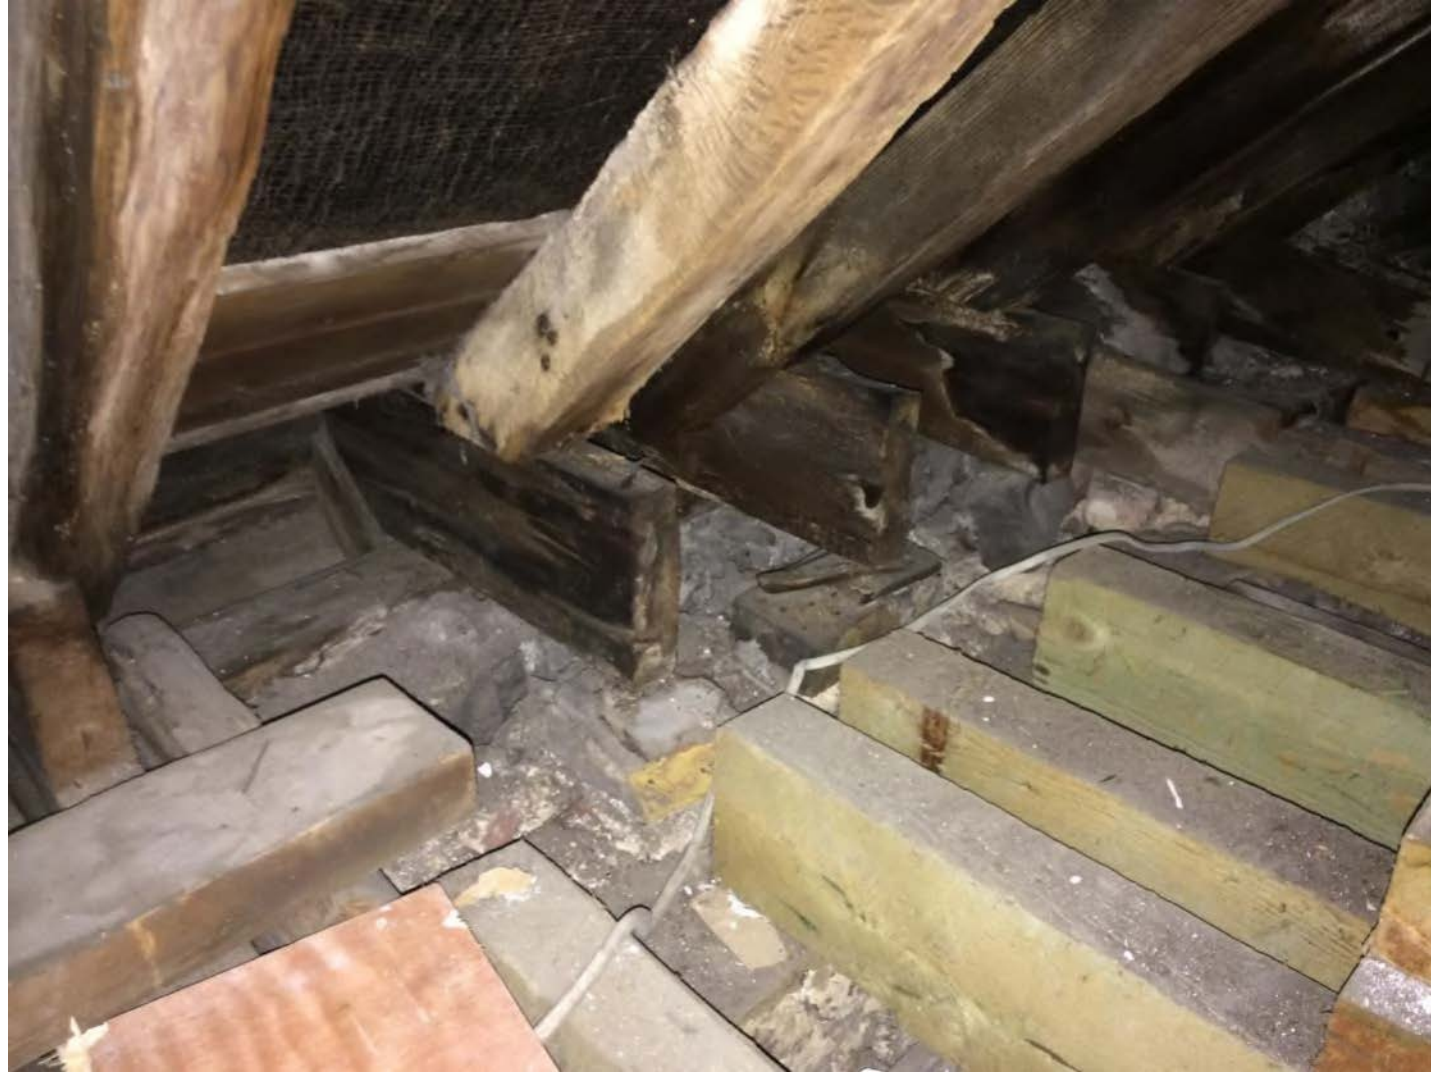
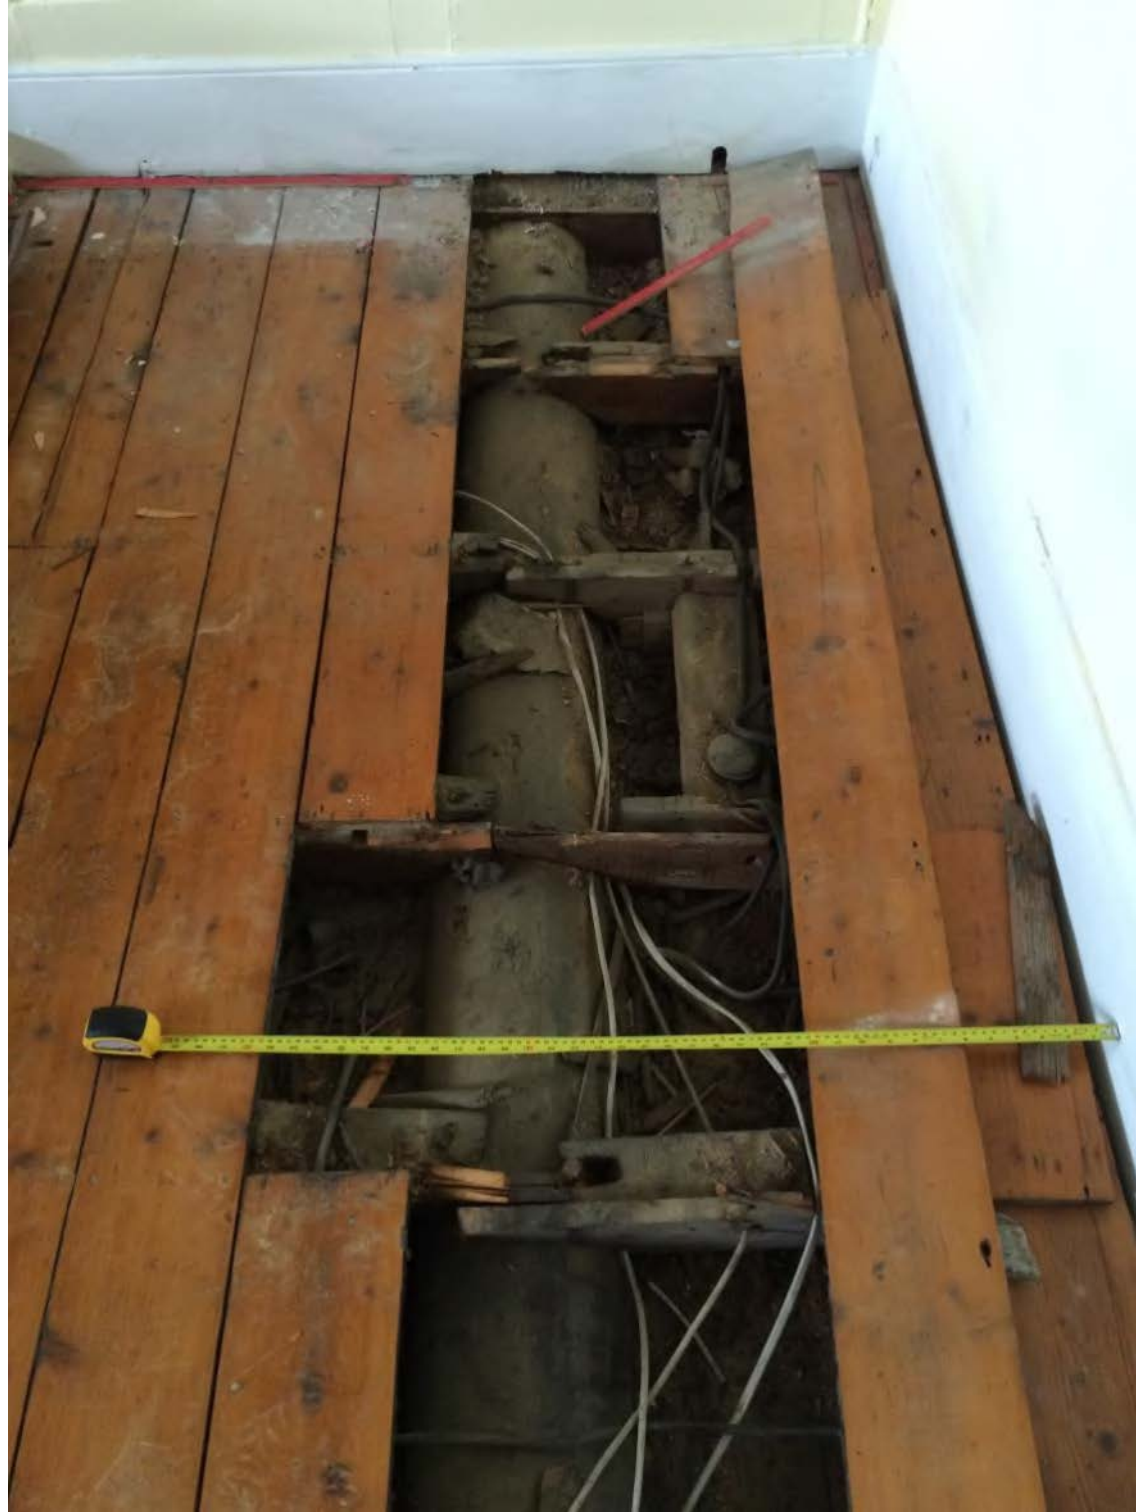
| Reference | Visible Symptom of Distress | Possible Cause(s) | Further Investigation Required | Principal of Repair | Likely Consequence of Not Repair | Photo References |
|---|---|---|---|--|--|---|
| 2-1 | Roof spread | Overloading of interior pitches causing excessive purlin deflection and resultant outward force through rafter feet. Cut bottom chord and lack of connectivity between rafter ends and 2 <sup>nd</sup> floor joists resulting in no floor restraint and parapet able to push out. | Remove dwarf stud walls and clear eaves to enable engineers to inspect wall plate and rafter end relationship with second floor joists. Also open-up joist to bressummer connection within 2 <sup>nd</sup> floor plate. | Insert timber rafter collar and purlin struts to prevent further deflection. Replace lost connectivity between rafter ends and 2 <sup>nd</sup> floor joists. Tie joists over supporting bressummers to ensure 2 <sup>nd</sup> floor can act as a diaphragm in tension. | Ultimately, collapse of rear elevation and associated structure. It is essential this is repaired immediately. | 20 / 21 / 25 |

*Photo 20 – Bowing of rear elevation at mid-point of 2<sup>nd</sup> floor level*

*Photo 21 – Loss of connectivity between rafter ends and second floor joists. Existing joists appear to have been severed.*

Photo 25 – Poor connection of joists on to North-West 2<sup>nd</sup> floor bressummer

Defects R-4 / R-7 / R-12 / R-15 / 2-1 / 2-2 / 2-3 can all be addressed through the installation of collar struts and compression members between purlins used in conjunction with a tying details at the interface of the second floor joists with the rafter ends and the supporting bresssummers.

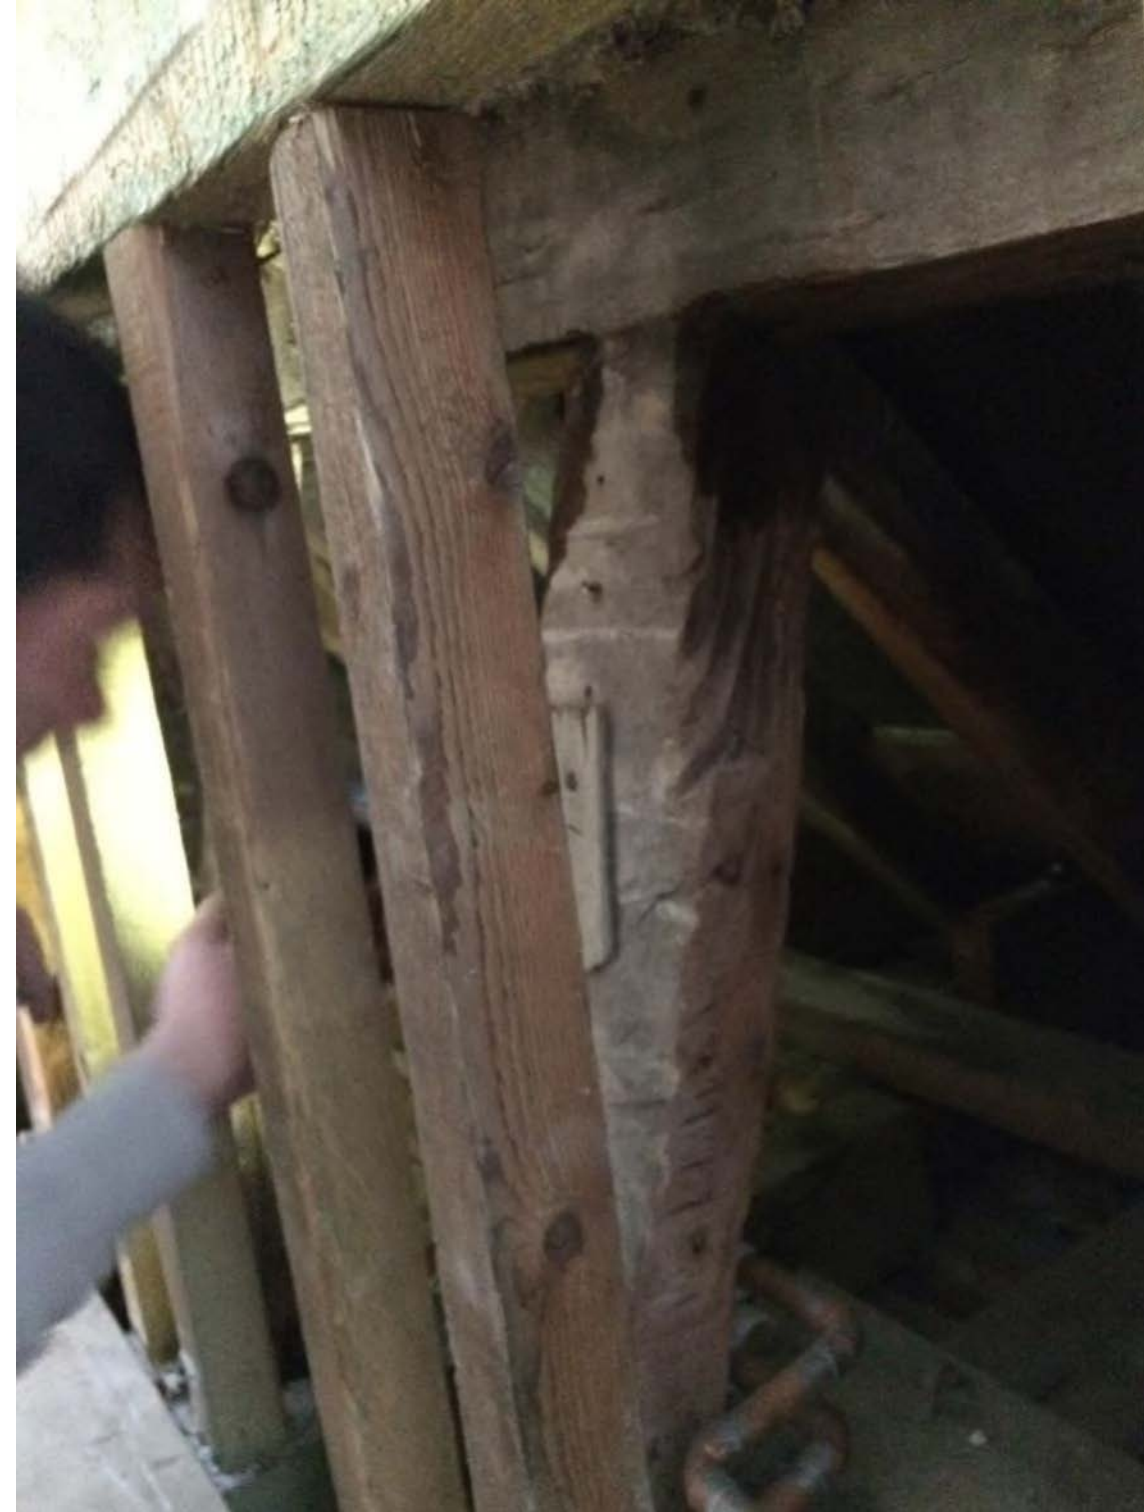
| Reference | Visible Symptom of Distress | Possible Cause(s) | Further Investigation Required | Principal of Repair | Likely Consequence of Not Repair | Photo References |
|---|---|---|---|--|--|---|
| 2-2 | Leaning dwarf stud walls | Overloading of interior pitches causing excessive purlin deflection and resultant outward force through rafter feet. Cut bottom chord and lack of connectivity between rafter ends and 2 <sup>nd</sup> floor joists resulting in no floor restraint and parapet able to push out. | Remove dwarf stud walls and clear eaves to enable engineers to inspect wall plate and rafter end relationship with second floor joists. Also open-up joist to bressummer connection within 2 <sup>nd</sup> floor plate. | Insert timber rafter collar and purlin struts to prevent further deflection. Replace lost connectivity between rafter ends and 2 <sup>nd</sup> floor joists. Tie joists over supporting bressummers to ensure 2 <sup>nd</sup> floor can act as a diaphragm in tension. | Ultimately, collapse of rear elevation and associated structure. It is essential this is repaired immediately. | 22 |

*Photo 22 – Original dwarf stud walls leaning to rear elevation behind modern corrected wall line*

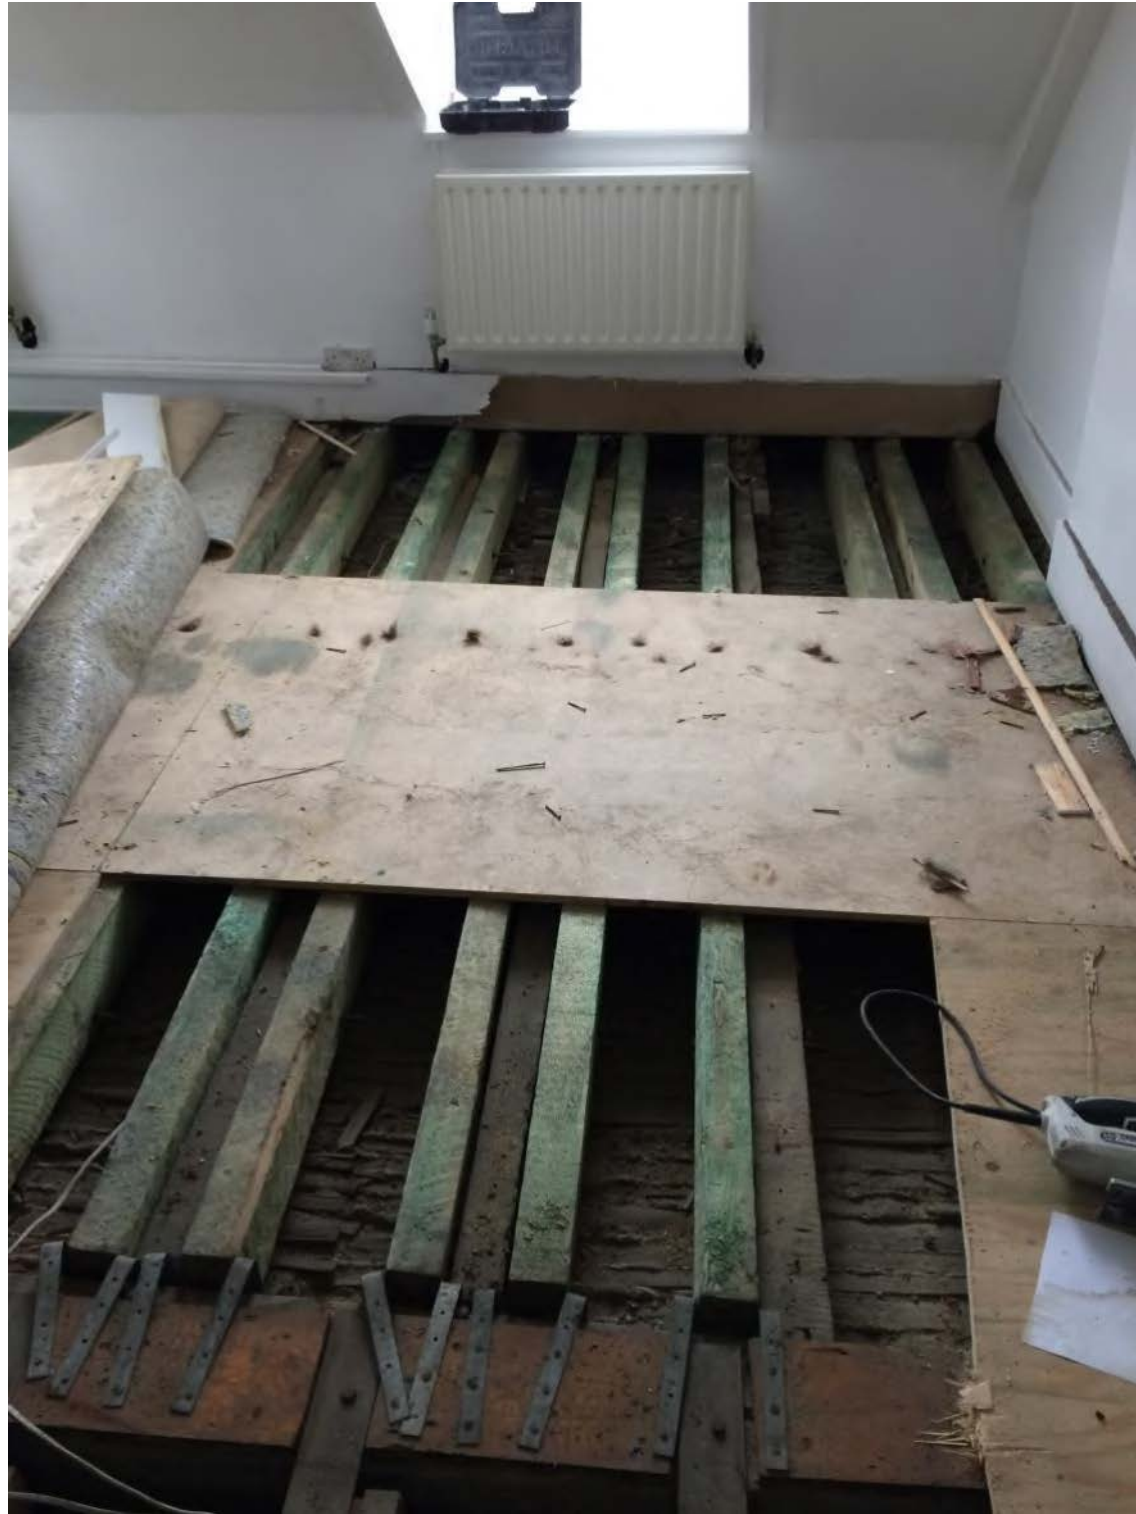
| Reference | Visible Symptom of Distress | Possible Cause(s) | Further Investigation Required | Principal of Repair | Likely Consequence of Not Repair | Photo References |
|---|---|---|---|--|--|---|
| 2-3 | New joists installed to level sloping floor | An poor attempt to control roof spread and correct the level of the floor | None | In addition to recommendations made in '2-1'. Replace lost connectivity between rafter ends and 2 <sup>nd</sup> floor joists. Tie joists over supporting bressummers to ensure 2 <sup>nd</sup> floor can act as a diaphragm in tension. Ensure boards are suitably screwed down into new joists to maintain diaphragm action of 2 <sup>nd</sup> floor plate. | - | 23 |

Photo 23 – Supplementary modern timbers installed either side of existing joists and poor detail over bressummer
