# 4 The Grove, Highgate

Visual Structural Inspection

**This report describes the findings of the Visual Structural Inspection conducted at 4 The Grove, Highgate on behalf of Jamie Oliver Holdings Limited**

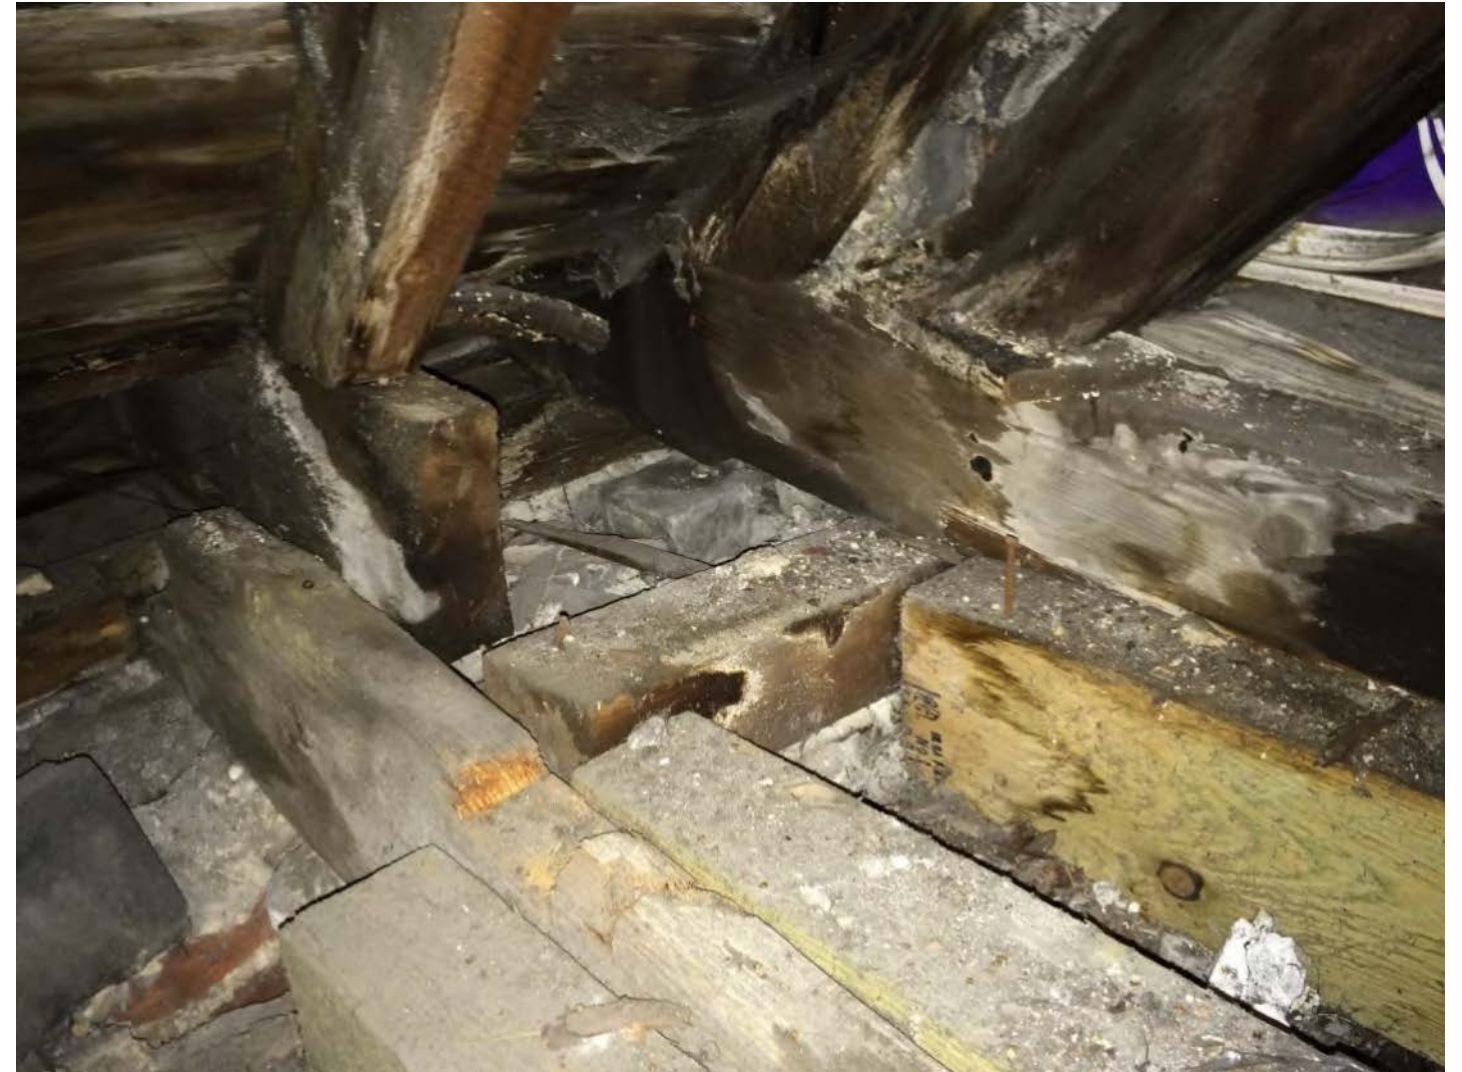
| Reference | Visible Symptom of Distress | Possible Cause(s) | Further Investigation Required | Principal of Repair | Likely Consequence of Not Repair | Photo References |
|---|---|---|---|--|--|---|
| 2-4 | Water staining on timbers | Water ingress through failed box gutter | Remove dwarf stud walls and clear eaves to enable engineers to inspect damage to wall plate and rafter ends. Specialist timber survey may be beneficial to mitigate risk. | Replace/strengthen elements of decayed timber.<br><br>Rot survey to establish full extent of decay. | Decayed timber may be structurally inadequate. | 24 |

Photo 24 – Significant water staining to rafter ends within rear eaves. Cut truss chord.

As noted in the Defects Analysis, historical water staining was observed in the rear roof eaves behind the dwarf walls at second floor level. We recommend this is investigated further to determine the extent of water ingress and if any of the structural timbers have decayed to an extent that may necessitate replacement.

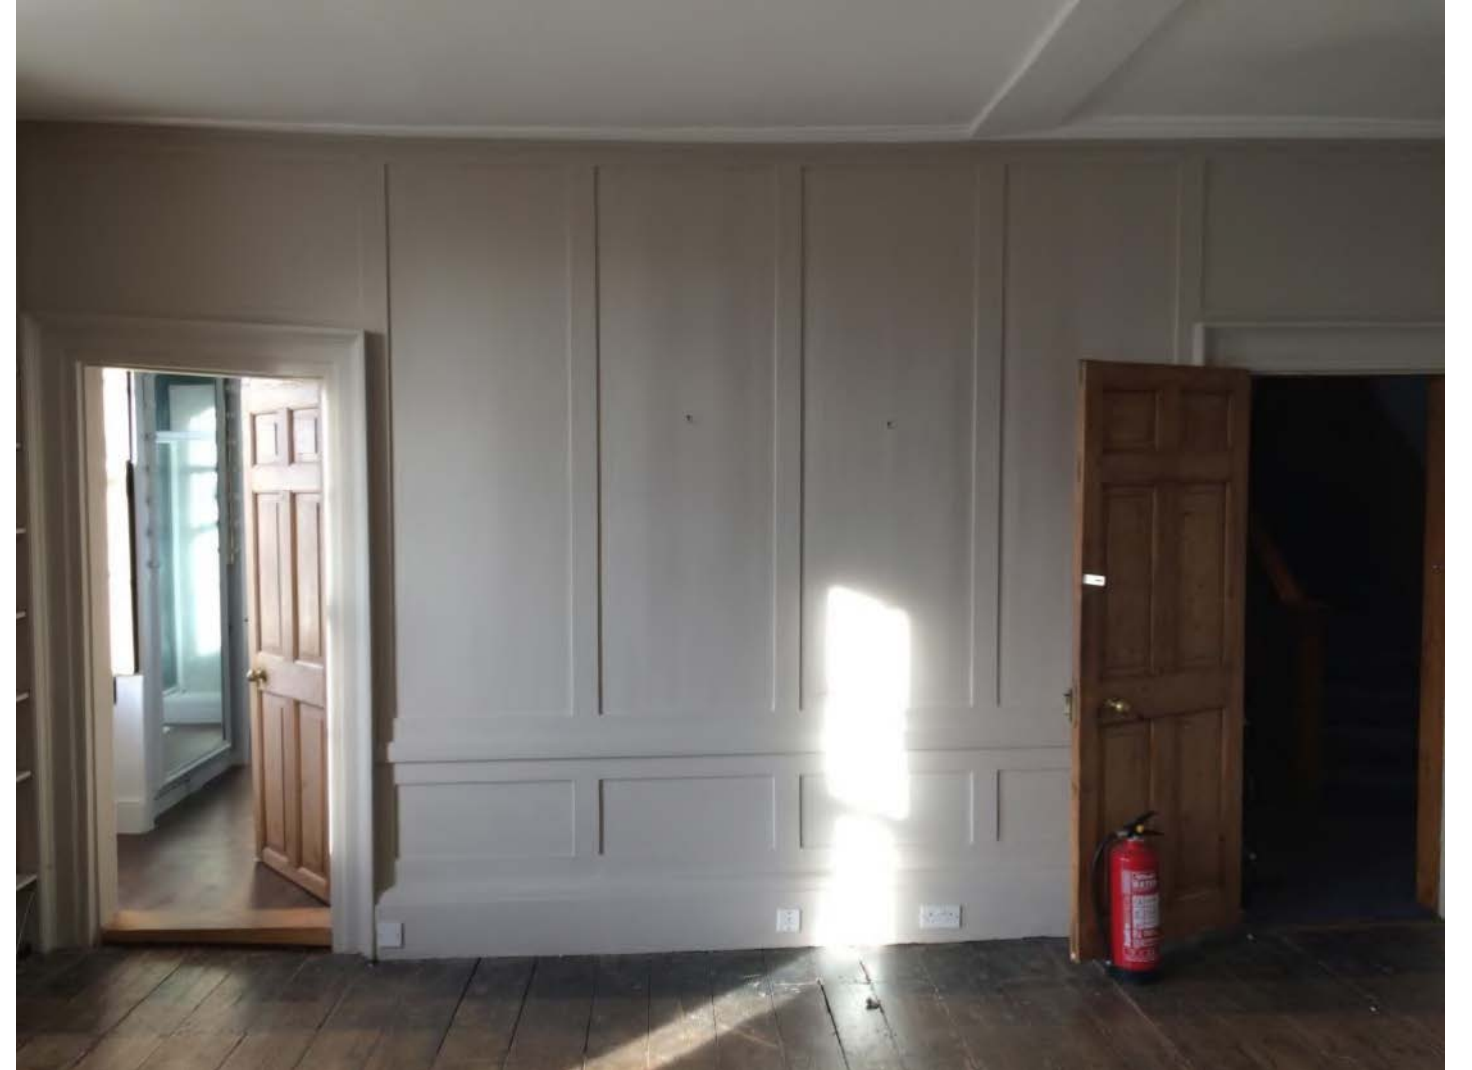
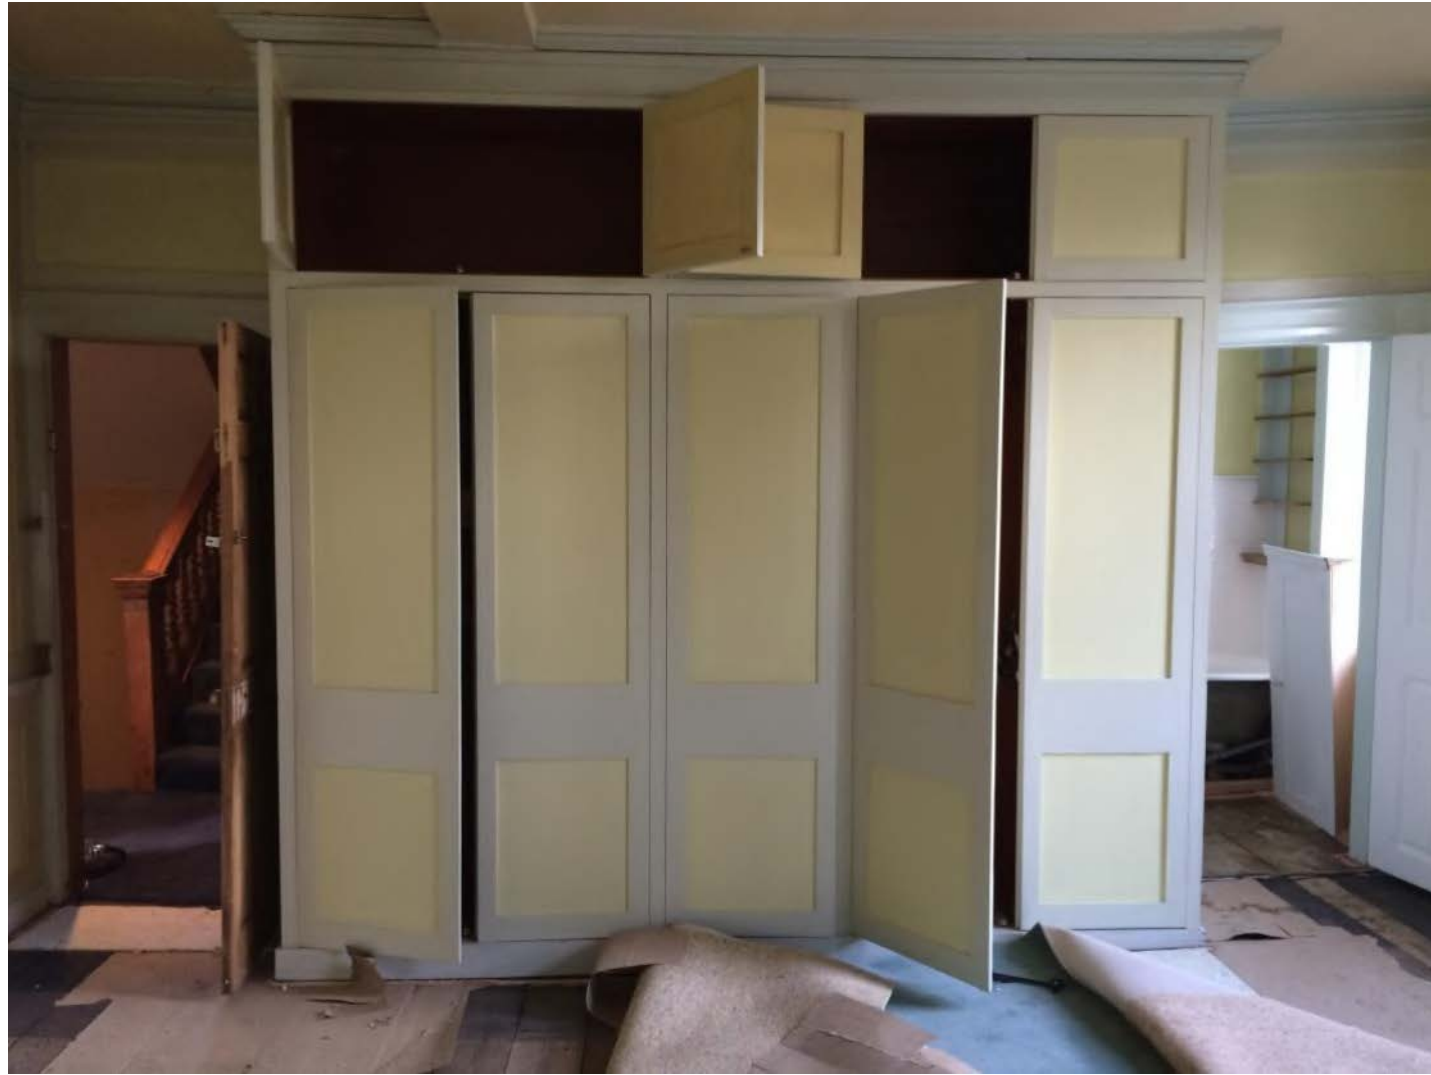
| Reference | Visible Symptom of Distress | Possible Cause(s) | Further Investigation Required | Principal of Repair | Likely Consequence of Not Repair | Photo References |
|---|---|---|---|--|--|---|
| 1-1 | Sloping floors and lozenge doors | Overloading of central East-West timber spine wall | None | Relieve load wherever possible. Replace concrete roof tiles with clay alternatives. Avoid areas of heavy storage. No dense modern materials. | Continued over stressing of spine wall will lead to further cracking and rotation of door openings. | 26 / 27 |

Photo 26 – Sloping floor and lozenging of doors in Bedroom 1 at 1<sup>st</sup> floor level

Photo 27 – Sloping floor and lozenge of doors in Bedroom 2 at 1<sup>st</sup> floor level

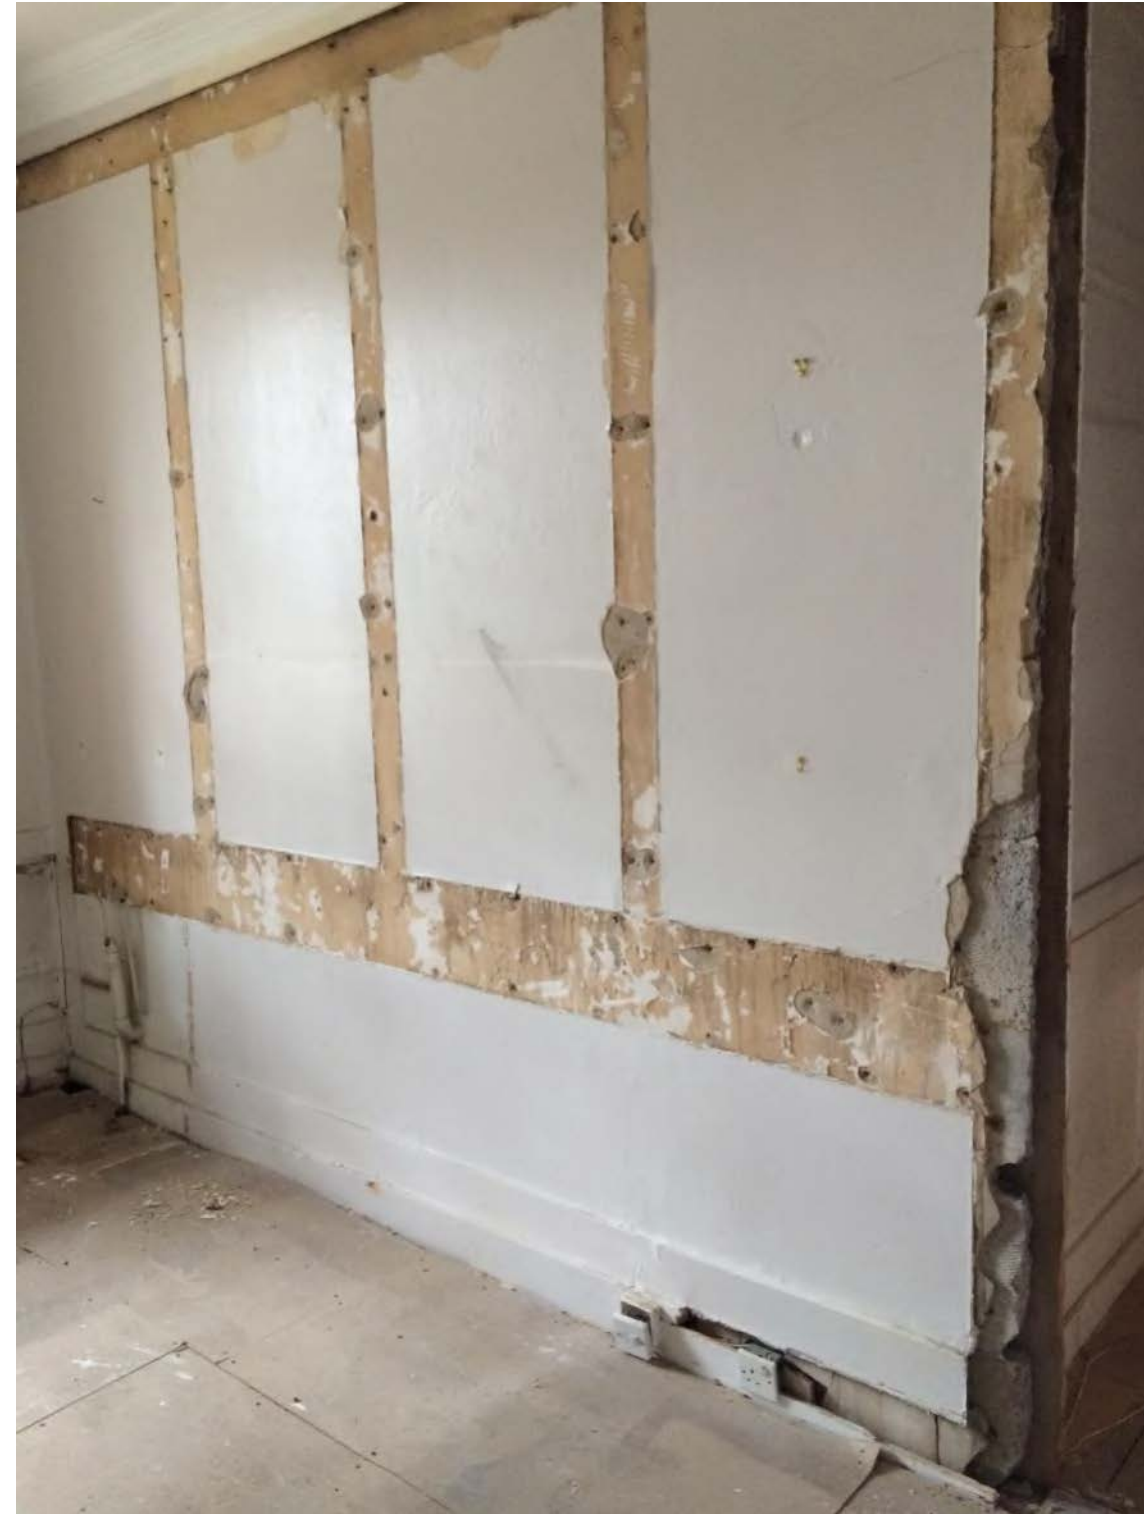
| Reference | Visible Symptom of Distress | Possible Cause(s) | Further Investigation Required | Principal of Repair | Likely Consequence of Not Repair | Photo References |
|---|---|---|---|--|--|---|
| 1-2 | Sloping floor and deflection of bressummers | Heavy modern concrete block partition supported on single joist. Non-original timber trussed walls under. | None | Remove existing blockwork wall and reconstruct using timber stud on doubled-up joist below. | Continued over stressing of floor plate and potential for further movement. | 28 |

Photo 28 – Sloping floor to modern blockwork partition

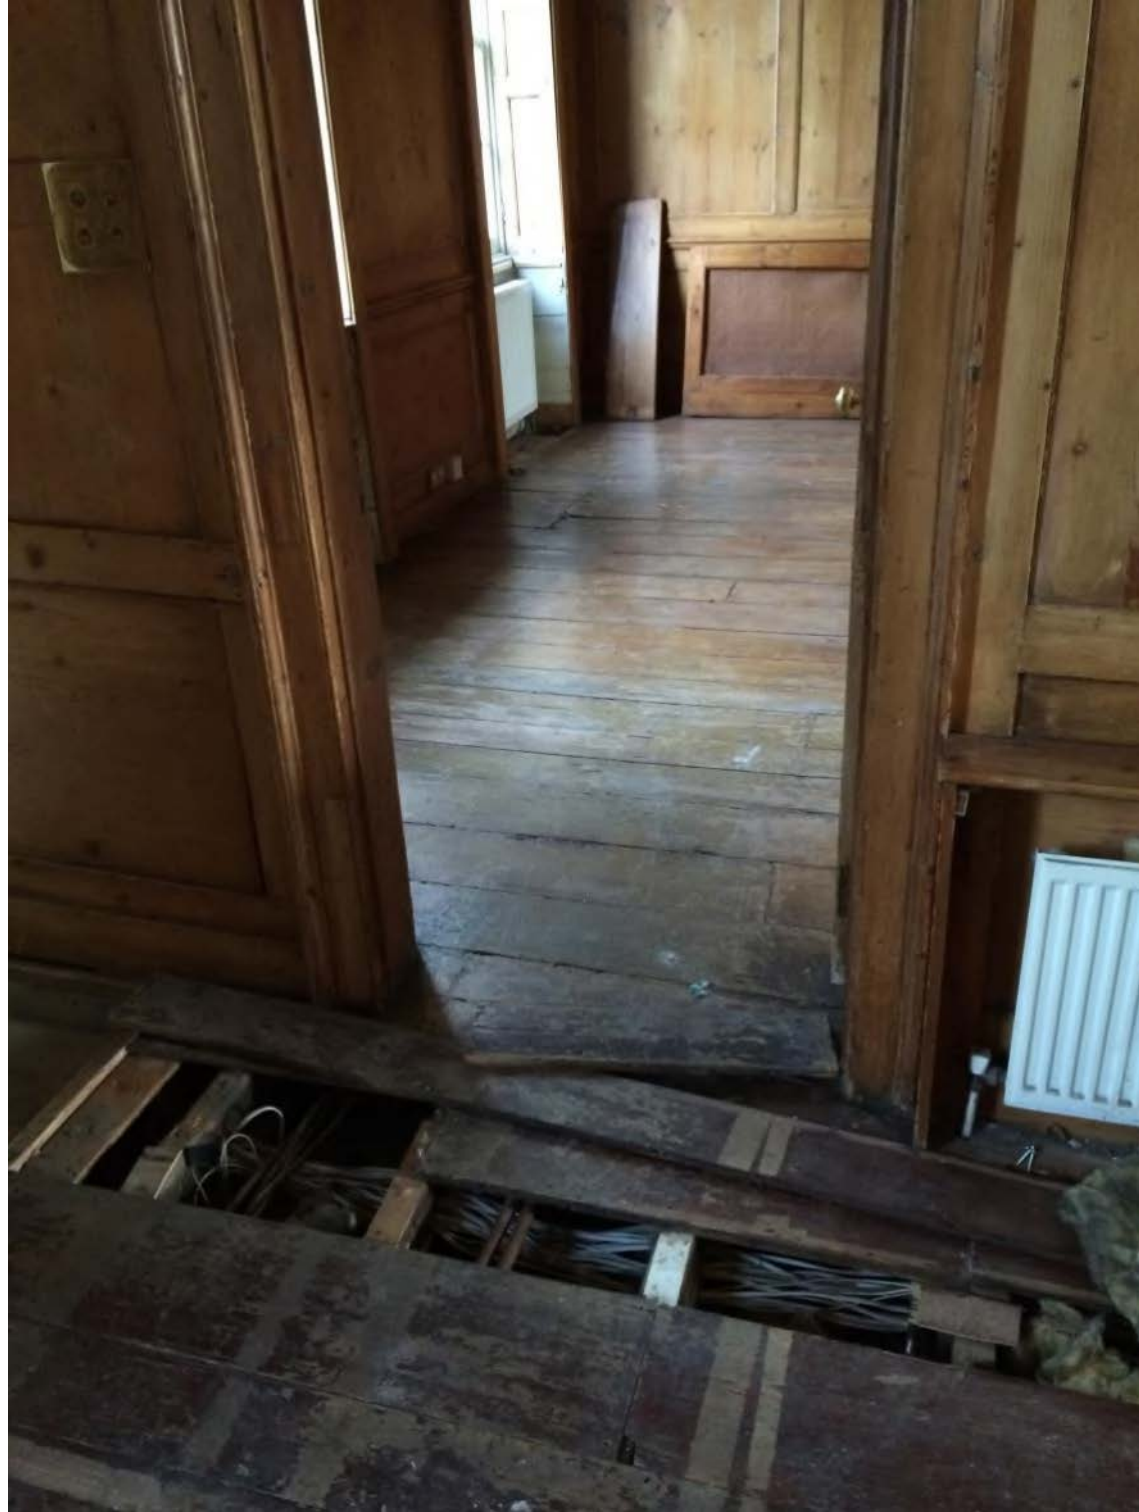
| Reference | Visible Symptom of Distress | Possible Cause(s) | Further Investigation Required | Principal of Repair | Likely Consequence of Not Repair | Photo References |
|---|---|---|---|--|--|---|
| UGF-1 | Sloping floor to East-West spine wall | Also, large non-original opening in East-West spine wall severing ties in timber trussed walls.<br><br>East half of central East-West and stair enclosure do not continue down to LGF and therefore transfer load directly on to UGF joists causing them to be overstressed. | None | Add additional floor joists between existing under transferred walls to stiffen floor and prevent further deflection. Reduce loading wherever possible. | Continued over stressing of floor plate and potential for further movement. | 29 |

Photo 29 – Sloping floor to East-West central spine wall at upper ground floor level

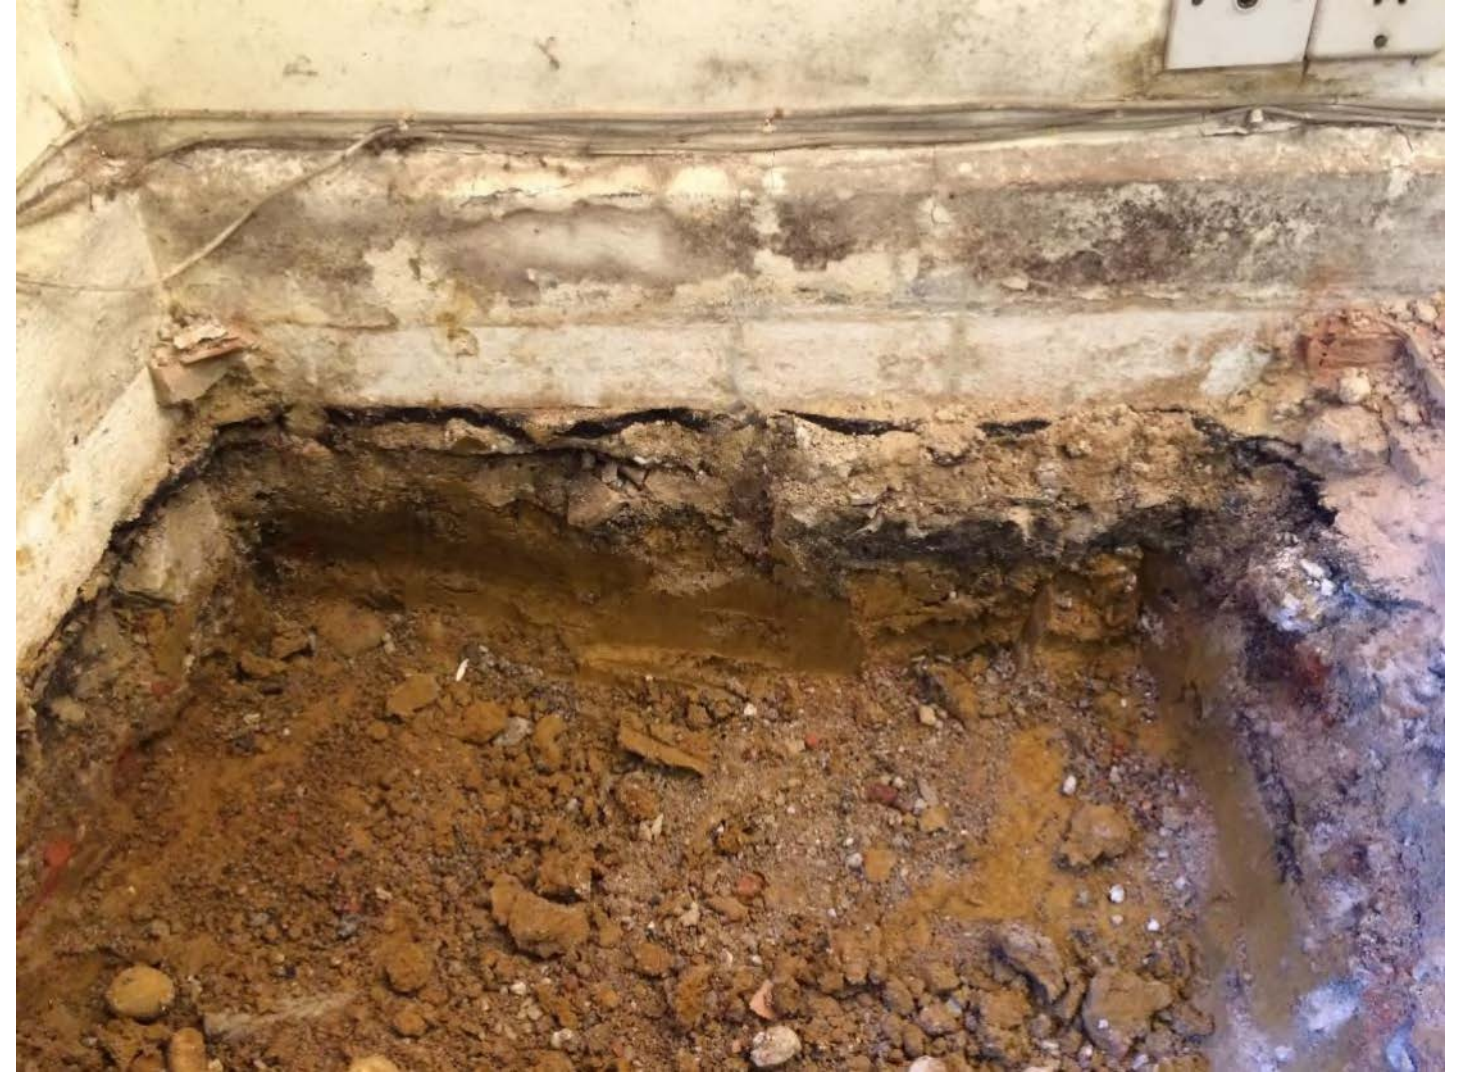
| Reference | Visible Symptom of Distress | Possible Cause(s) | Further Investigation Required | Principal of Repair | Likely Consequence of Not Repair | Photo References |
|---|---|---|---|--|--|---|
| LGF-1 | Shallow footing level | Floor previously lowered to below originally intended. | Compete remaining trial pits | Ensure any lowering of the existing lower ground floor does not undermine the existing footing. | None, assuming that the footing is not undermined. | 30 |

Photo 30 – Shallow foundations at lower ground floor level
