REFURBISHMENT / DEMOLITION
ASBESTOS SURVEY REPORT

1 RANULF ROAD
HAMPSTEAD
LONDON

Reference: 14.879
Issuing Office: London

Survey Date: 6 January 2015
Report Date: 12 January 2015

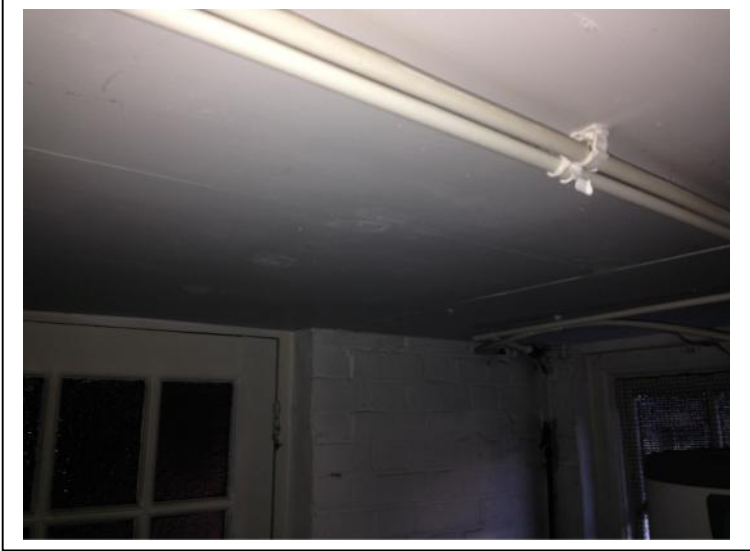
ASBESTOS RECORD SHEET		
LOCATION: Boiler / Utility Room		LOCATION ID: 01

Sample No.:	Location	Material Description	Material Type	Asbestos Content
01	Basement Utility Room	Ceiling Lining	NAD	NAD

GENERAL INFORMATION		
Survey Date: 6 January 2015	Element: Ceiling Lining	
Floor: Basement	Surface Treatment: Decorated	
Area: Boiler / Utility Room	Quantity: 8m ²	
SAMPLING		
Sample Number: 01	Asbestos Type: NAD	
MATERIAL ASSESSMENT SCORE		MAS
Product Type: N/A	Surface Treatment: N/A	N/A
Extent of Damage: N/A	Asbestos Type: N/A	
PRIORITY ASSESSMENT RATING		PRIORITY
Accessibility: N/A	Location: N/A	N/A
RECOMMENDATIONS		
No further works required.
