### Arboricultural Survey (BS5837:2012) & Impact Assessment Report

La Sainte Union School  
La Sainte Union Convent  
Highgate Road  
London  
NW5 1RP

12th April 2016

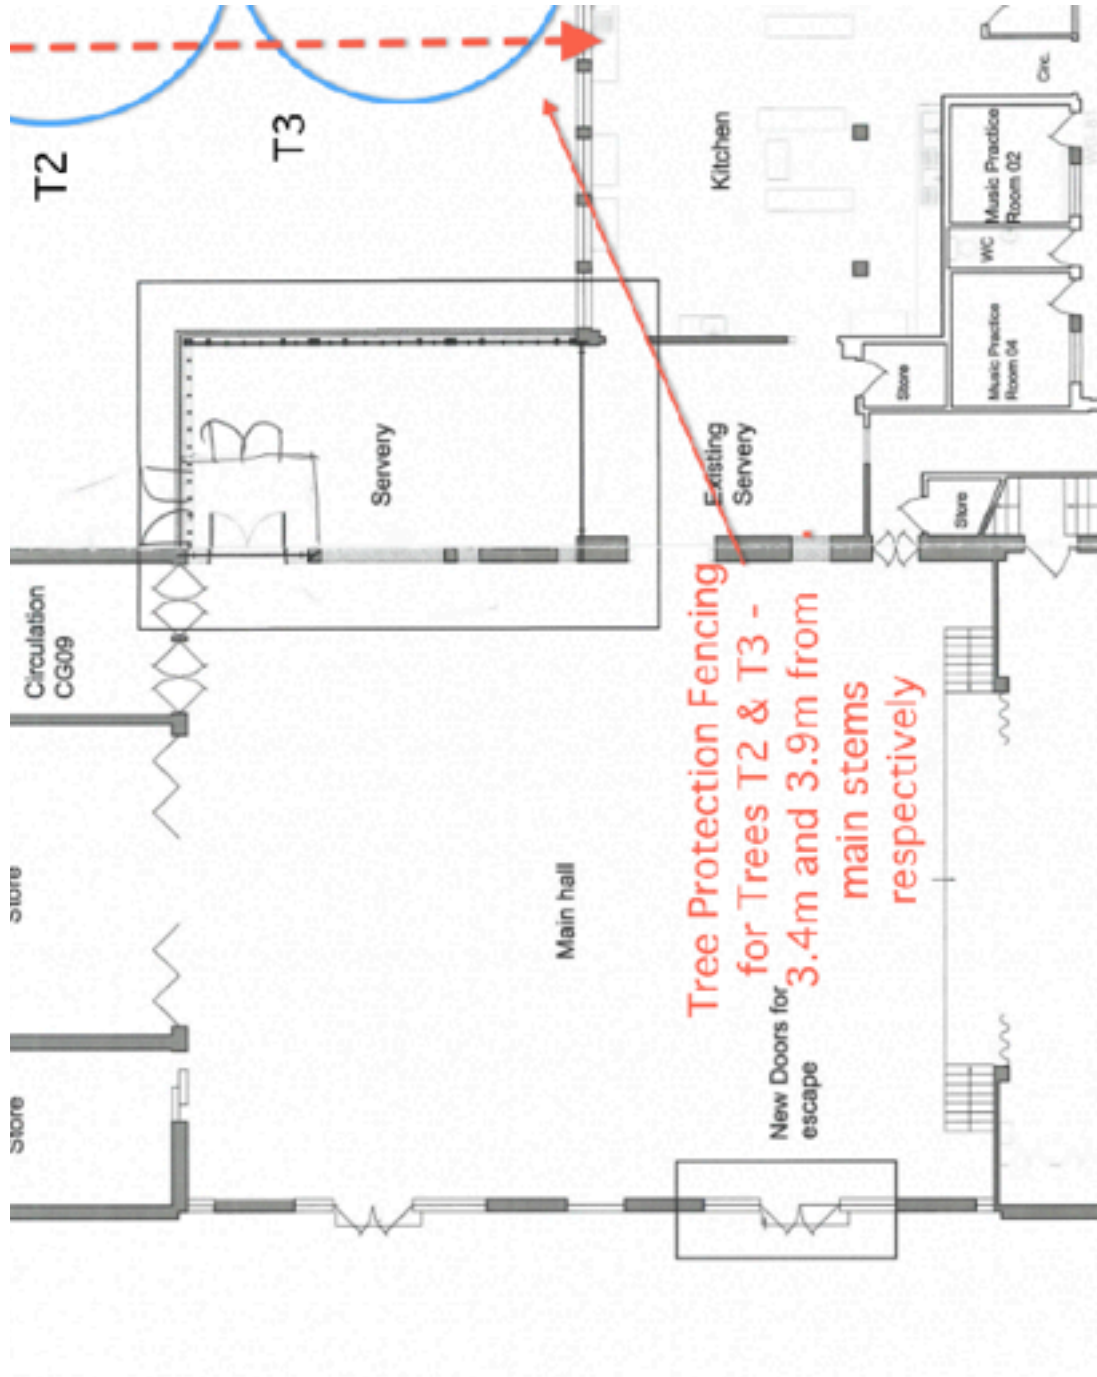
Appendix B.3: Site Plan of Tree Protection:  
La Sainte Union School, Highgate Road, London, NW5 1RP

1. Red line denotes Tree Protection Fencing to offer protection to soft landscaped area and also incorporating full protection for trees T2 and T3

4.17 The protection fencing that is specified for trees T2 and T3 is therefore recommended to extend across the width of the area for both of these trees (see *Appendix B.3*) ensuring that full protection is provided for the entire rear garden area for this development site and a Construction Exclusion Zone (CEZ) is provided.

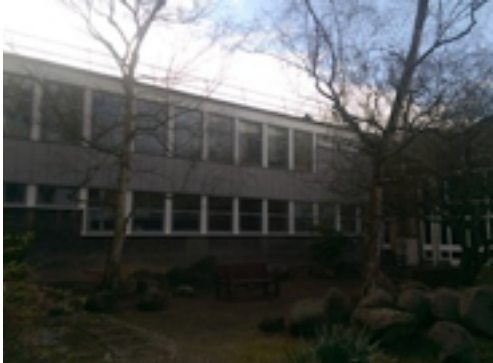
C.1 Photograph of trees T1- T3, La Sainte Union School, Highgate Road, London, NW5 1RP as viewed in a south westerly direction

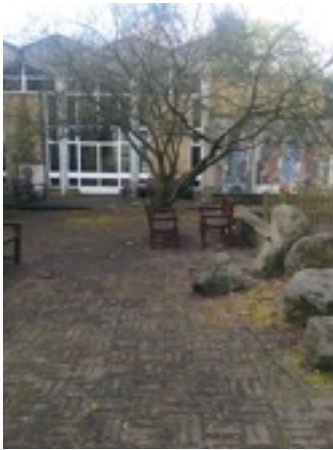
4.10 Tree T1 is a mature Goat Willow (*Salix caprea*) tree located within the courtyard area of the main school grounds. The tree is generally structurally sound with good root flare compensating for a slight lean to the north east at the base. The main union at 800mm has some tight unions where 3 main stems develop to form a low and spreading canopy. With a relatively light pruning history for species the tree has a balanced canopy lightly encroaching towards the property to the west and the to the playground and soft landscape area for the remainder. The tree is rated as a 'C.1' category tree (BS5837: 2012) due to the limited amenity value provided within the wider landscape.

La Sainte Union School, London, NW5 1RP BS 5837:2012 Tree Schedule – April 2016												
Tree No	Species	Ht (m)	DBH (mm)	Sprd (m)	Age	Visual Cond	Vigour	BS5837 Cat. Rating (2012)	Remaining (years)	Comments / Structural Condition	Managem. Recomms	RPA (m)
T1	Goat Willow	6	m/s 210	N: 6 E: 6 S: 4 W:4	M	F	G	C.1	10-15 years	Tree has a lean to the north east at the base - multi-stem at 800mm with 3 main stems developing and 7 branches forming a compact and broad low spreading canopy. Tree has very tight unions at the base taking account of playground location.	Fell to ground level and provide replacement tree planting to implement proposed development	N/A
T2	Birch	11	280	N: 5 E: 3 S: 3 W:3	M	F	G	B.1	15-20 years	Tree is structurally sound at the base growing from soft landscape area. Leans to the west - main union at 3m sound. Tree has been selectively crown reduced but has responded well. Relative broad canopy for species.	No action required at present	3.4

C.2 Photograph of tree T1, La Sainte Union School, Highgate Road, London, NW5 1RP as viewed in a westerly direction

4.11 The tree's location within very close proximity of the proposed extended building area means that the tree cannot be retained taking account of both the implementation of the proposed development and its associated construction site activities. Therefore the tree is proposed for removal and a replacement provided as specified below and in *Section 5.4*.

T1 Goat Willow

*Fell to ground level and grind out stump*

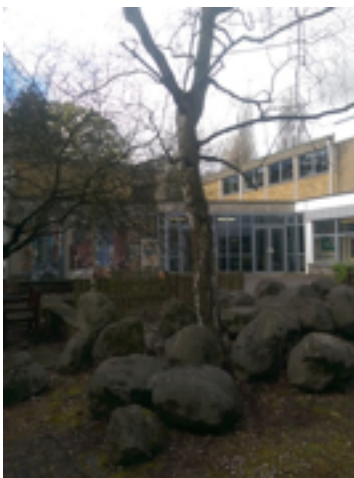
4.14 Tree T2 is a mature Birch tree (*Betula pendula*) which is located within the central area of the Servedy courtyard area alongside tree T2. The tree provides good amenity value to this area and is generally structurally sound. The tree is rated as 'B.1' (BS5837:2012) taking into account the above factors and its visibility within the wider landscape.

4.15 This tree is at its closest point is sited in excess of 10.0 metres from the proposed development and taking into account its recommended root protection distance of 3.4m, its comprehensive protection is fully achievable.

C.3 Photograph of tree T2, La Sainte Union School, Highgate Road, London, NW5 1RP as viewed in a north westerly direction

T2 Birch

*No action required at present*

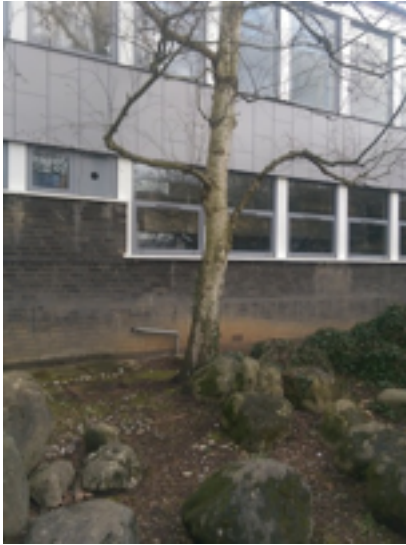
4.16 Tree T3 is also a mature Birch tree (*Betula pendula*) which is located on the southern boundary of the courtyard area approximately 2.0m distance from the building; and provides good amenity value for the area. The tree is generally structurally sound with some overhanging growth to the building. The tree is rated as 'B.1' (BS5837:2012) taking into account the location and its context within the wider landscape. As with tree T2, this tree is at its closest point is sited in excess of 10 metres from the proposed development and taking into account its recommended root protection distance of 3.9m, its comprehensive protection is fully achievable; the protection fencing is specified a significant distance from the main stem of this tree (3.9m minimum but achievable at a greater distance).

T3	Birch	12	320	N: 4 E: 3 S: 3 W:5	M	G	G	B.1	15-20 years	Tree is a structurally sound at base - good root flare and leans to the north west. Canopy in upper crown slightly unbalanced to the west with some deadwood throughout - tree has grown to the light against building which is approx 2m distance from base.	No action required at present	3.9

Photograph of tree T3, La Sainte Union School, Highgate Road, London, NW5 1RP as viewed in a southerly direction

T3 Birch

*No action required at present*
