Window Schedule

Refurbishment of Grade II* Listed Office Building

6 Bloomsbury Square

Revision C for Planning Conditions: 18th April 2016

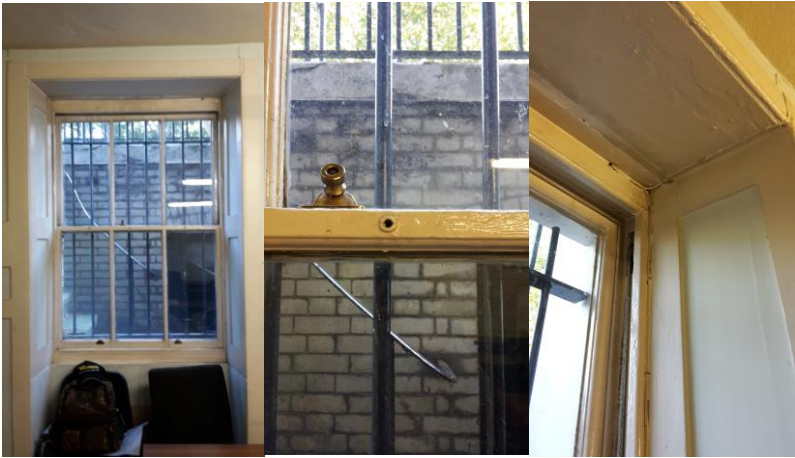
W.B.1

Opens top and bottom. Glass and putty in good condition. Top needs easing. Remove security bolts. Damage to top sash bottom rail and sill frame. Sand frames and fill damaged sections. Repaint.
W.B.2	E		Double Hung Sash	Timber	PTS-131

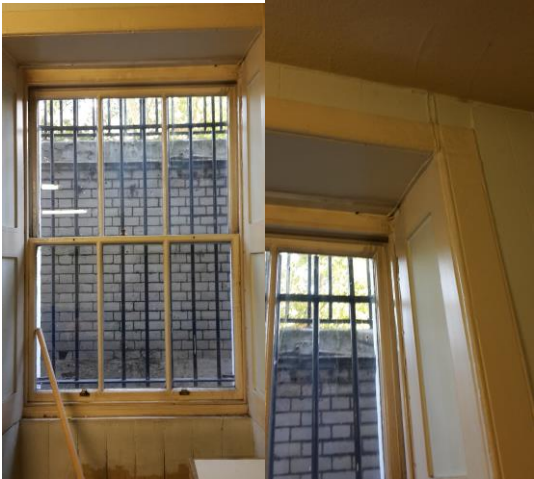
W.B.2

Opens top and bottom. Glass and putty in good condition. Top needs easing. Remove security bolts. Damage to top sash bottom rail and sill frame. Sand frames and fill damaged sections. Repaint.
W.B.3	E		BLOCK	Timber	-		
W.B.3.A	E		BLOCK	Timber	-		
W.B.4	E		REMOVE	Timber	-

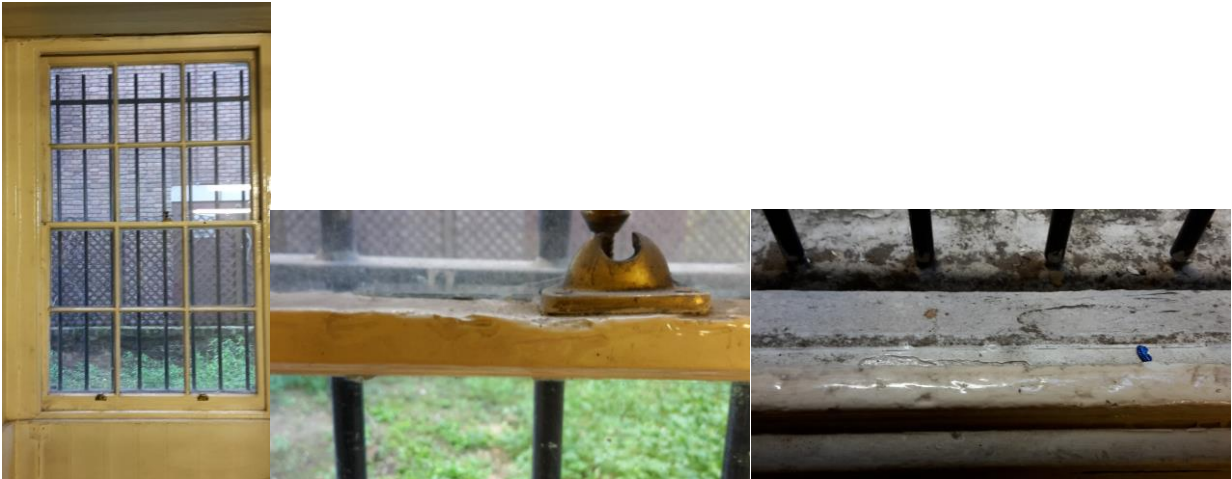
W.B.6

Opens bottom only. Glass and putty in good condition. Damage to top sash bottom rail and sill frame. Sand frames and fill damaged sections. Repaint.

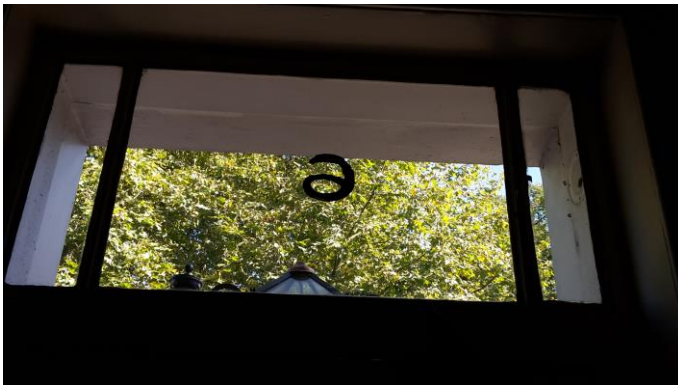
W.0.2A

Non original steel frame with opening light one side, within timber frame. Fix shut opening light, sand, prime and repaint. Re-paint numeral on glass.
W.0.2.B	E	Elliptical, fixed light under stair	Timber	PTS-131

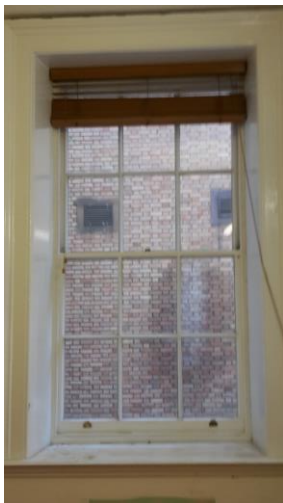
Good condition. Sand and repaint.
W.0.3	E	Double Hung Sash	Timber	PTS-131

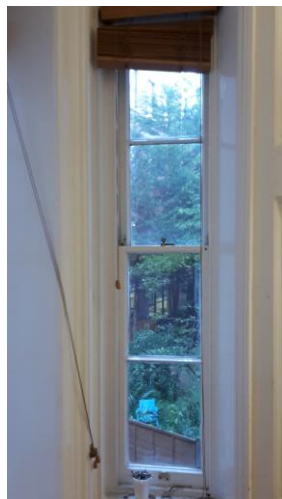
Non original timber sash window in good condition. Sand and repaint.
W.0.4	E	Small Double Hung Sash	Timber	PTS-131

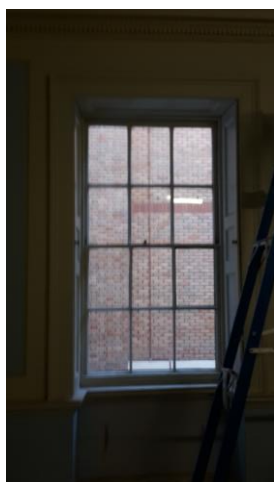
Opens bottom only. Adjust to open top and bottom. Sand and repaint.
W.0.5	E	Double Hung Sash	Timber	PTS-131

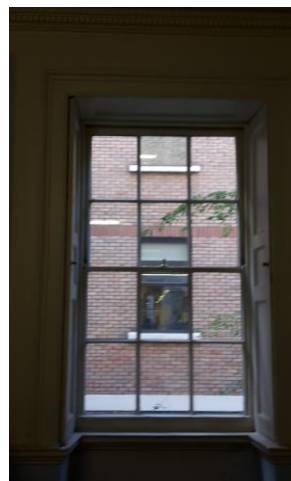
W.0.6

Glass, shutters, closing bar and hinges in good condition. Top and bottom open. Damage to top sash bottom rail and sill frame. Sand frames and fill damaged sections. Repaint.

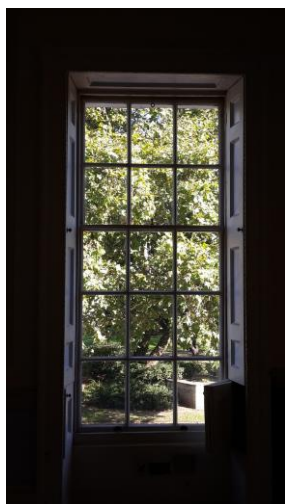
W.1.1	E	Large Double Hung Sash	Timber	PTS-131

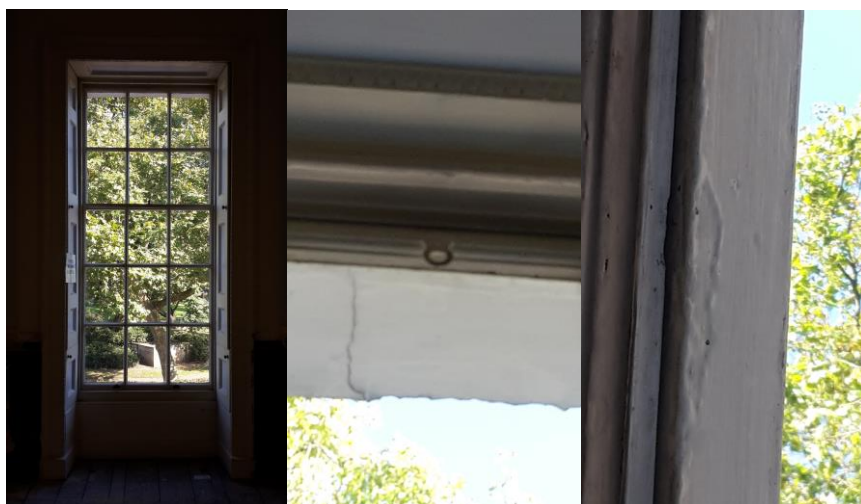
Shutters in good condition. Sashes open top and bottom. Easing required to top sash. Damage to top sash bottom rail and sill frame. Sand frames and fill damaged sections. Repaint. New eye required for hook operation of upper sash.
W.1.2	E	Large Double Hung Sash	Timber	PTS-131

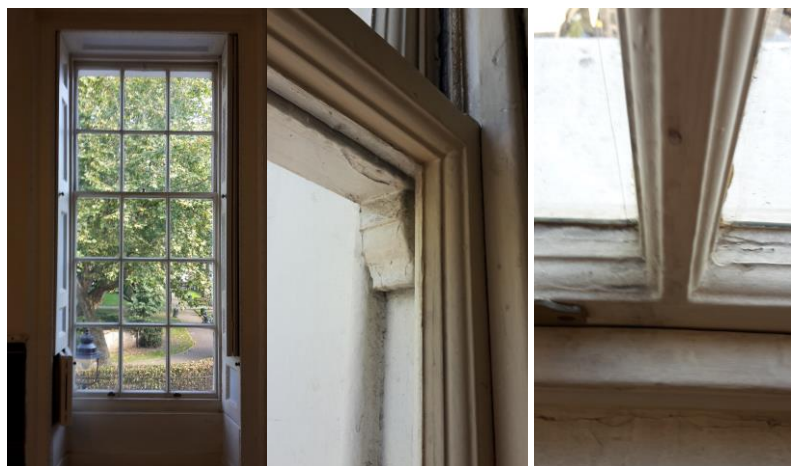
Left shutter does not open. Re-hinge. Sashes open top and bottom. Damage to top sash bottom rail, sill frame and side frame. Sand frames and fill damaged sections. Repaint. New eye required for hook operation of upper sash.
W.1.3	E	Large Double Hung Sash	Timber	PTS-131

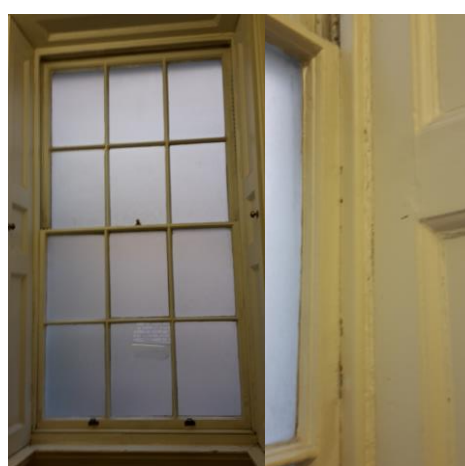
Left shutter does not open. Re-hinge. Sashes open top and bottom. Damage to top sash bottom rail and sill frame. Sand frames and fill damaged sections. Repaint. New eye required for hook operation of upper sash.
W.1.4	E	Double Hung Sash	Timber	PTS-131

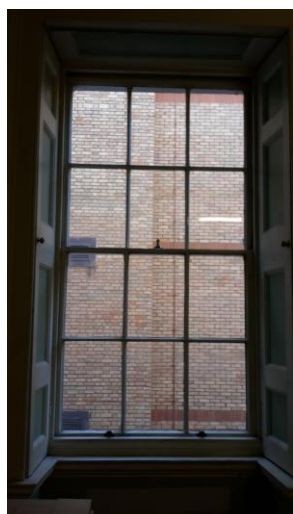
W.1.5

Shutters in good condition. No closing bar. Top sash won't open. Damage to top sash bottom rail and sill frame. Sand frames and fill damaged sections. Repaint. Remove opaque film from glass.

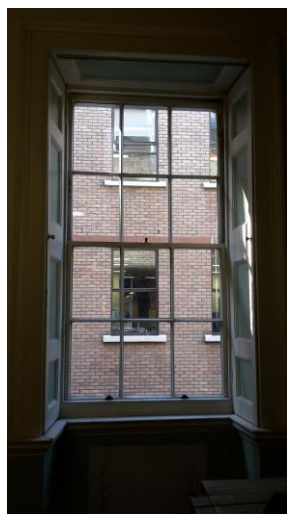
Shutters do not open. Sashes working. Damage to top sash bottom rail and sill frame. Sand frames and fill damaged sections. Repaint. Retain iron hoop brackets outside. Remove curtain track from inside.
W.1.6	E	Double Hung Sash	Timber	PTS-131

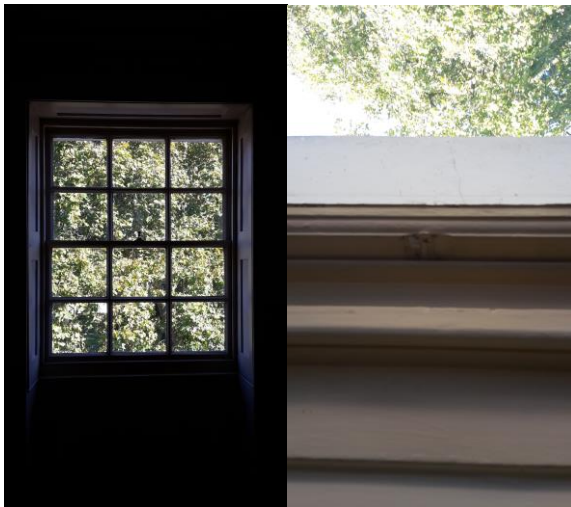
W.2.1

Shutters need easing to open properly. Sashes work top and bottom. No need to re-rope. Minor damage to top sash rail centre. Sand frames and fill damaged sections. Repaint.
W.2.2	E	Double Hung Sash	Timber	PTS-131

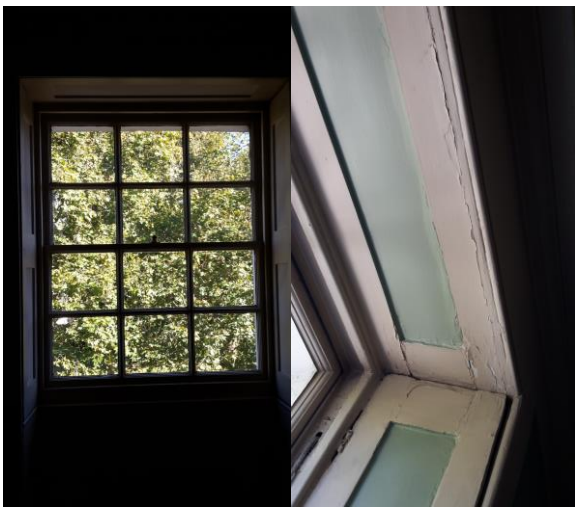
W.2.2

Shutters need easing to open properly. Sashes need easing. No need to re-rope. Significant damage to timber frame. Sand frames and repair damaged sections. Repaint. Damaged film on one glass pane to be replaced.
W.2.3	E	Double Hung Sash	Timber	PTS-131

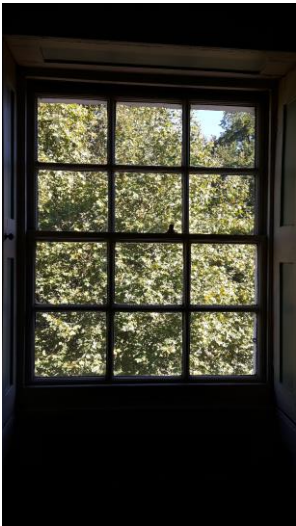
W.2.3

Shutters working. Top sash needs adjusting. No need to re-rope. Water damage to top lining panel and frame head. Sand panels and frames and repair damaged sections. Repaint.
W.2.4	E	Double Hung Sash	Timber	PTS-131

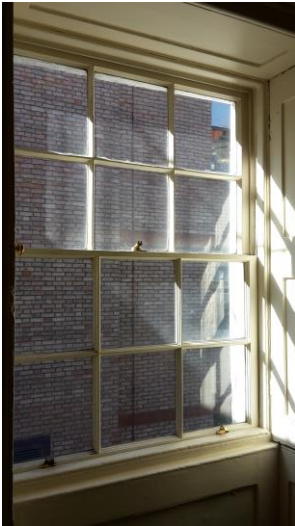
W.2.4

Shutters are working. Sashes work top and bottom. Infill panels to access weights are missing. Sand frames and replace missing sections. Repaint.
W.2.5	E	Double Hung Sash	Timber	PTS-131

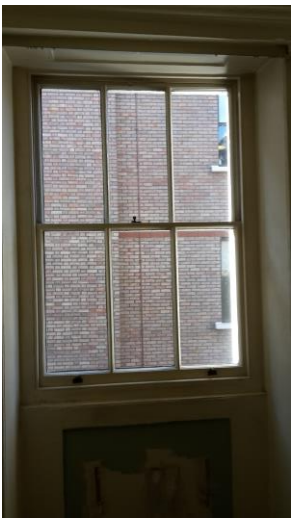
W.2.5

No shutters. Sashes work top and bottom. No need to re-rope. Good condition. Sand frames and repaint.

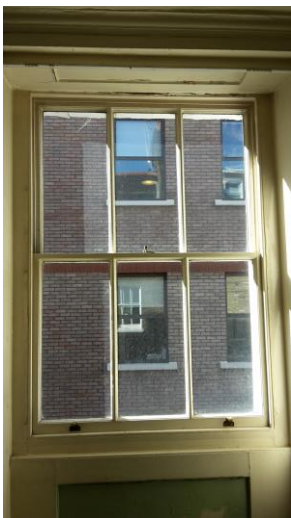
W.2.6

No shutters. Water damage to top lining panel. Sashes work top and bottom. No need to re-rope. Remove curtain rail. Sand panels and frames and repair damaged sections. Repaint.
W.2.7	N	Internal Sash	Timber	PTS-131

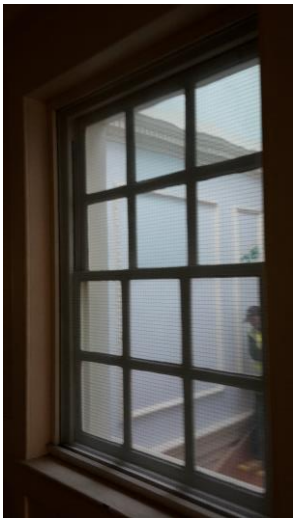
W.2.7

Remove additional single wired glass pane and fixing frame from existing window. For safety purposes fix sashes in shut position. Frame and glass in good condition. Sand and repaint. Additional 60 min fire resistant window kitchen side etched glass see A-30-707-A
W.3.1	E	Double Hung	Timber	PTS-131

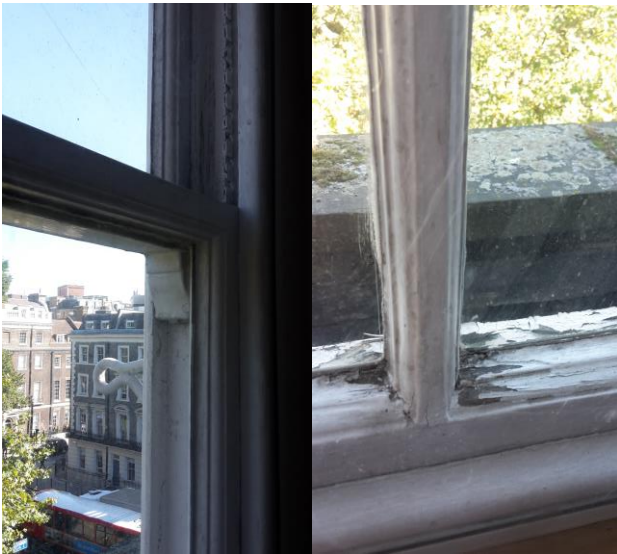
W.3.1

Sashes need adjusting. Sashes on chains. Remove Perspex panel with magnetic frame. Water damage to frame. Sand panels and frames and repair damaged sections. Repaint.

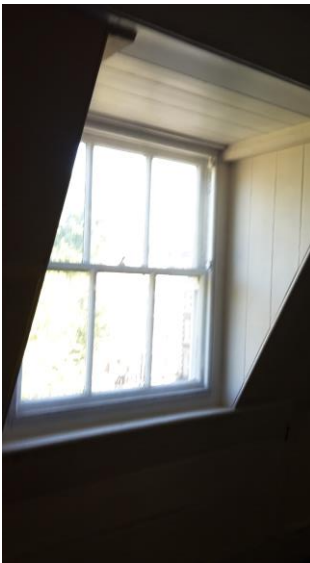
W.3.2	E	Double Hung	Timber	PTS-131	 	Sashes do not open. Broken chain. Replace chain. Water damage to frame. Remove small pulleys for previous blind. Sand panels and frames and repair damaged sections. Repaint.
W.3.3	E	Double Hung	Timber	PTS-131

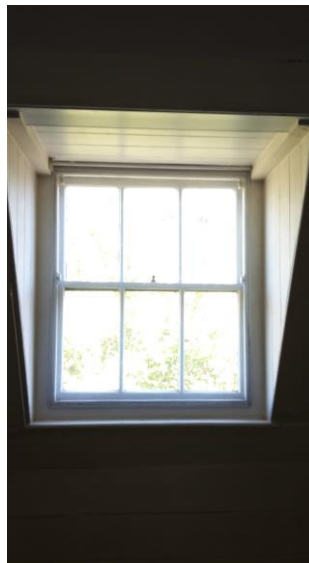
W.3.3

Top sash does not open. Ease to open. Water damage to frame. Sand panels and frames and repair damaged sections. Repaint.
W.3.4	N	Internal Porthole	Timber	PTS-131

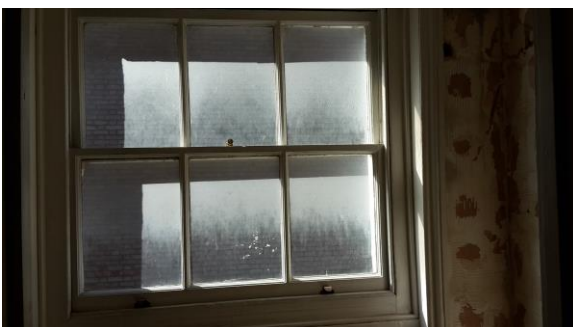
W.3.5

Sash window does not open. Ease to open. Frame and glass in good condition. Sand and repaint.
W.3.6	E	Double Hung Sash	Timber	PTS-131

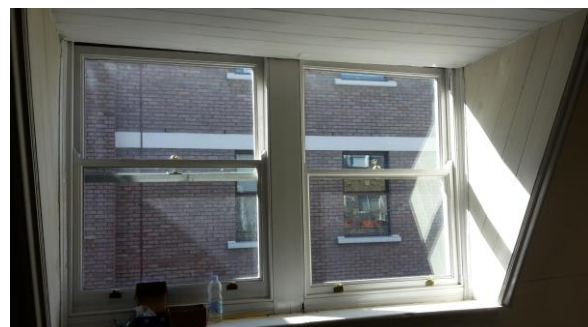
W.3.6

New window but not in good condition. Top sash does not open. Ease to allow opening. Repair rotten timber sill and bottom frame. Sand and repaint.

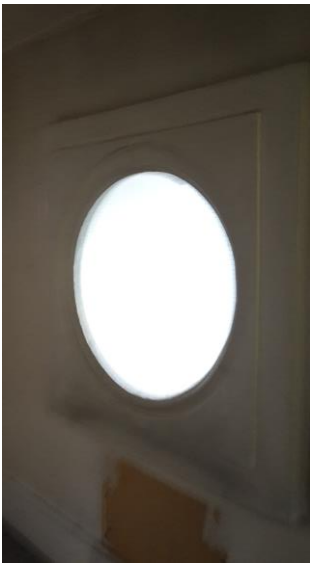
W.3.4

Remove non- original single pane porthole window and rectangular hardboard surround. Replace with new window to match W.3.8 in light well lantern. See Dwg. No. A-30-706 - A Add new 60 minute fire resistant window on room side
W.3.5	E	Double Hung Sash	Timber	PTS-131

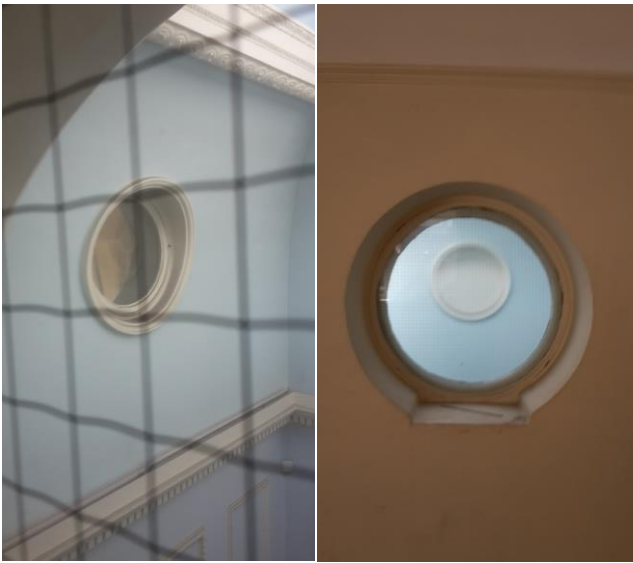
W.3.7

Remove non- original single pane porthole window . Replace with new window to match W.3.8 in light well lantern. See Dwg. No. A-30-706 - A Add new 60 minute fire resistant window on room side
W.3.8	N	Internal Porthole Pivot	Timber	PTS-131

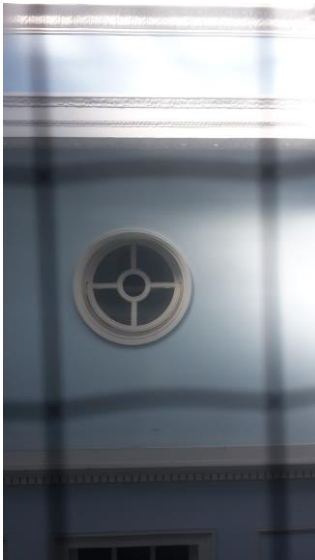
W.3.8

New porthole window to match existing with clear glass. Add new 60 minute fire resistant window on kitchen side see A-30-706 - A
W.3.9	OMITTED			-		Window has been bricked up and only the frame exists on the staircase side. There is no depth available to install a false window, therefore the new false window has been omitted.
