Express Drainage Solutions

CCTV Survey Report

Foul & Surface Water

**Re: CCTV Survey Foul & Surface Water Systems
Site: Premier Basements, 12 Elsworthy Road, London, NW3 3DJ**

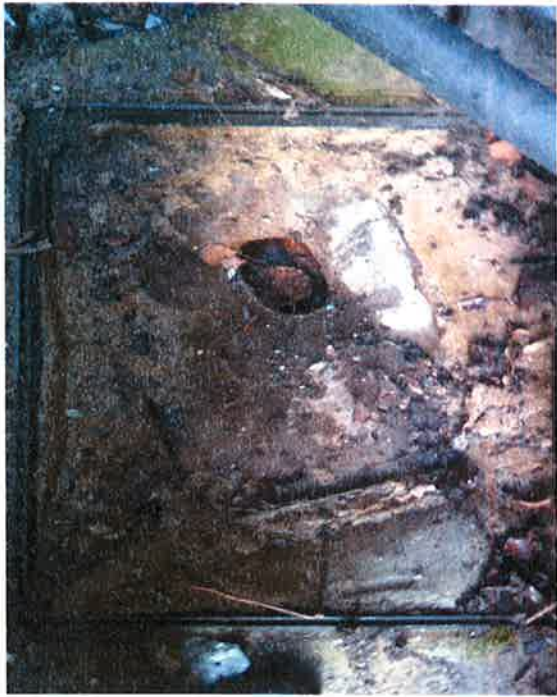
Inspection Chamber Information		Photo
Inspection Chamber No: IC 1	Invert Level: 300mm

Cover Size: 450 x 600mm	Chamber Size: 450 x 600mm	
Composition: Brick		
Condition: No Significant structural defects within inspection chamber 1		
Inspection Chamber Lateral Connections: Inspection Chamber 1 contains an open access hole within the chamber. Which allows access for upstream & downstream drainage runs?		
See CCTV Survey Report for Recommendations

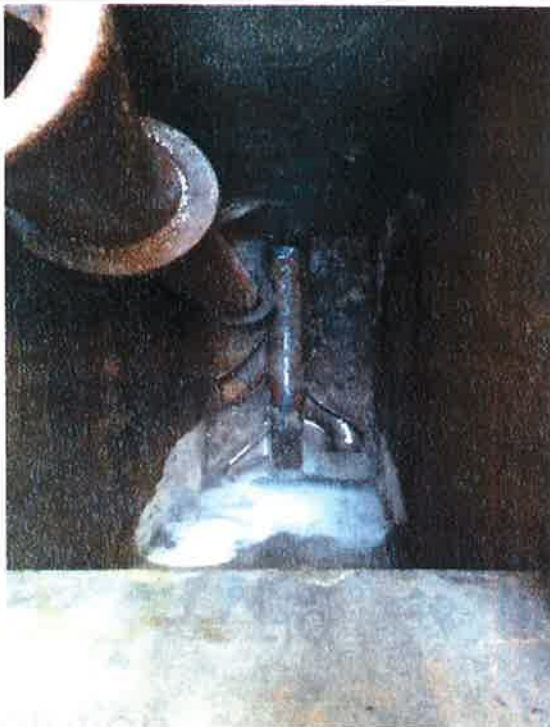
Inspection Chamber Information		Photo
Inspection Chamber No: IC 2	Invert Level: 2300 mm

Cover Size: 450 x 650mm	Chamber Size: 500 x 650mm	
Composition: Brick		
Condition: No Significant structural defects within inspection chamber 2		
Inspection Chamber Lateral Connections: IC 2 contains 3 laterals, 1 high level lateral, upstream & downstream drainage runs.		
See CCTV Survey Report for Recommendations

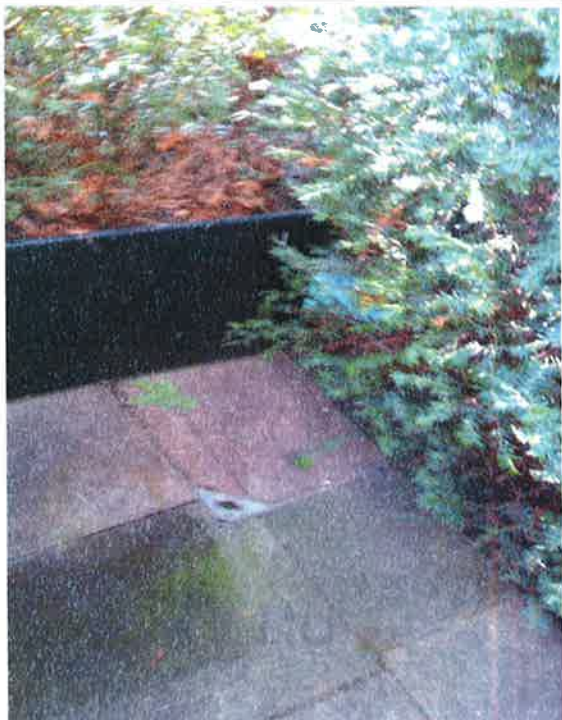
Inspection Chamber Information		Photo
Inspection Chamber No: IC 3	Invert Level: Unable to Confirm

Cover Size: Unable to Confirm	Chamber Size: Unable to Confirm	
Composition: Unable to Confirm		
Condition: Unable to gain access to inspection chamber, due to roots growing over inspection chamber cover.

Inspection Chamber Lateral Connections: Unable to confirm		
See quote attached for recommendations

Sheet:	Inspection Chamber Report Page
Location:		Inspection Chamber 3	
Recommendations	<p>Our recommendation are:</p> <p>1) Remove all roots from Cover & Frame</p> <p>2) Expose Inspection Chamber, Then Re-CCTV any additional lateral connections. (Any further work will be quoted for accordingly)</p> <p>This will reinstate structural Integrity and create a Free Flowing drainage run</p> <p>All works undertaken by EDS, is carried out by fully qualified operatives to the highest standard</p>		
Works Guarantee	All lining works undertaken is guaranteed for 10 years & excavations 5 years		
Are there any Health & Safety issues	No		
Risk & Method Statement supplied	Will be supplied upon undertaking of works		
Any Special Site Requirements or Conditions	Will be supplied upon undertaking of works		
Specialist Plant Requirement	Will be supplied upon undertaking of works		
Repair Quotation Cost£	£250.00+ VAT

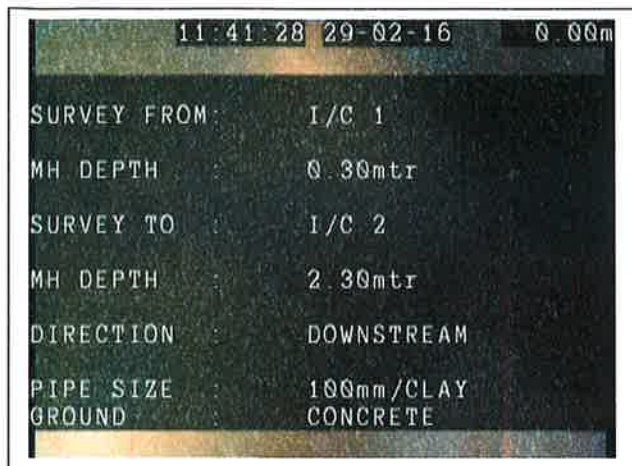
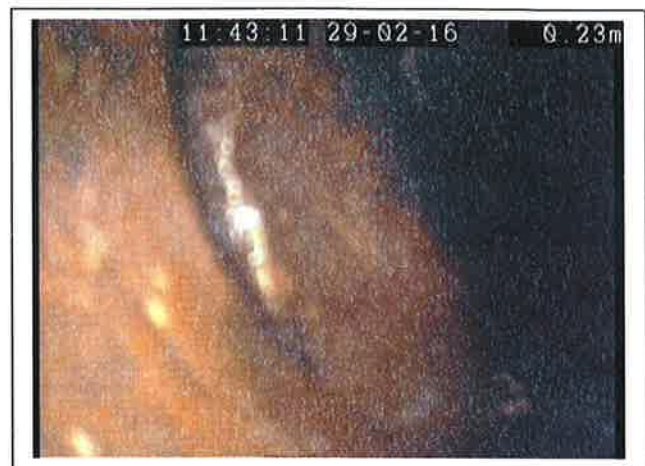
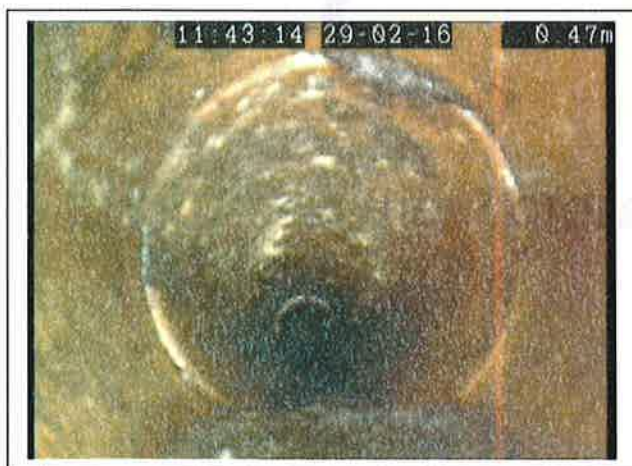
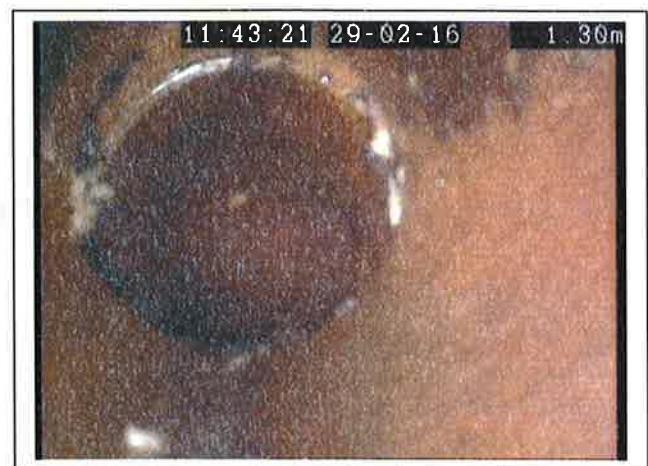
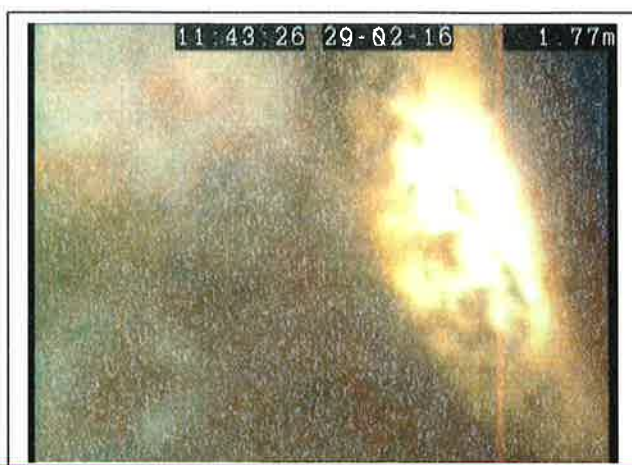
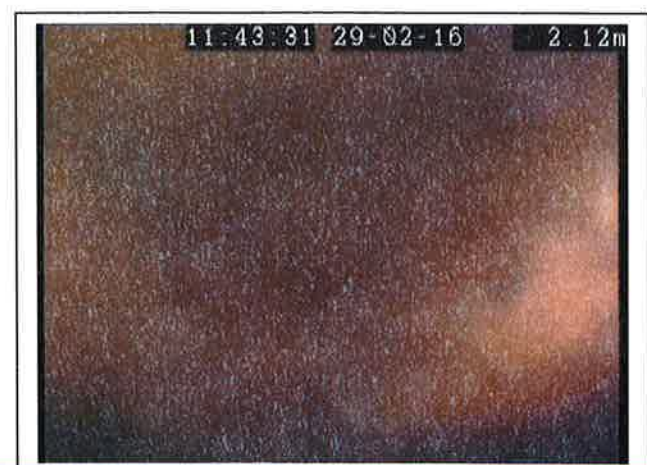
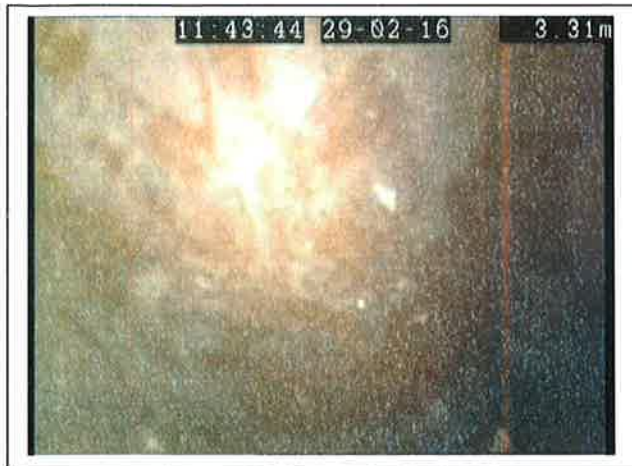
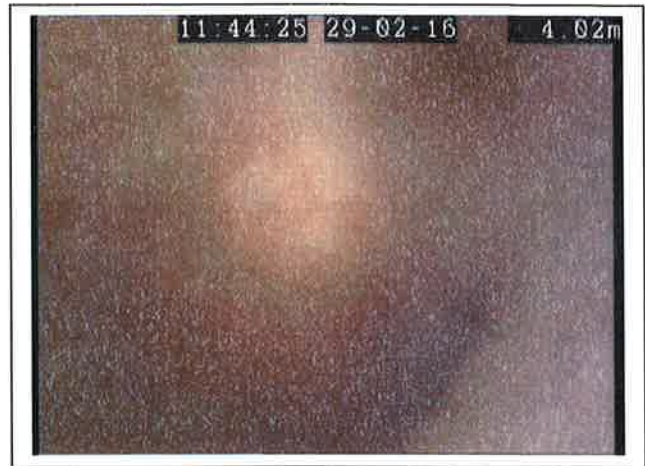
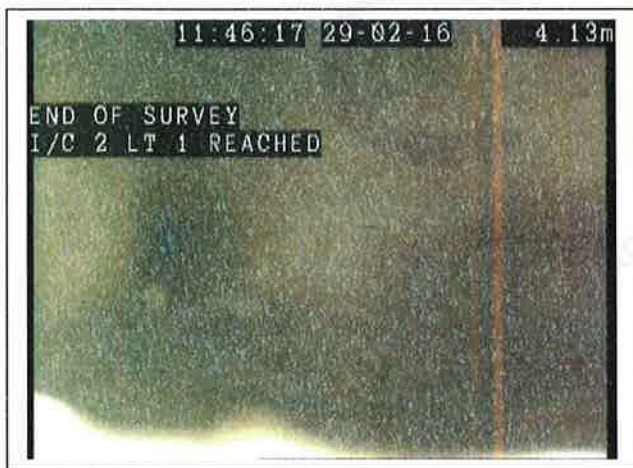
**Images of CCTV Survey for Drainage Run:
IC 1 – IC 2**

0.00m			Start of Survey		Yes
0.23m	DJ	Slight	Displaced Joint, Pipe Soundness?		Yes
0.47m	DJ	Slight	Displaced Joint, Pipe Soundness?		Yes
1.30m	DJ	Large	Displaced Joint, Pipe Soundness?		Yes

1.77m	DJ	Slight	Displaced Joint, Pipe Soundness?		Yes
2.12m			Vertical 90 Degree bend in drainage run		Yes
3.31m			Bend in drainage run		Yes
4.02m			Vertical 90 degree bend in drainage run		Yes

4.13m			Reached Inspection Chamber 2 (Poor connection into Inspection Chamber 2) & End of Survey		Yes
Is the Drain Run in a serviceable condition?		No			
If No / Reason		<p>The survey revealed that the drainage run enters through a poorly installed connection into inspection chamber 2 & displaced joints/pipe soundness? (Large-Slight), within the drainage run.</p> <p>The defects are having a detrimental effect on the full drainage system which could deteriorate further if remedial repairs are not undertaken.</p> <p>If you have any further queries or questions in relation to any of the above noted defects please don't hesitate to contact the office on the number supplied on the covering letter.</p>

Sheet:	1
Start Position	Inspection Chamber 1	End Position	Inspection Chamber 2		
Recommendations		Our recommendation are: 1) Excavate & Replace Approx 4m of Drainage Run & Connection into Inspection Chamber 2. Changing connection to a dropper within inspection chamber 2. Using New UPVC Pipe Work (To correct alignment & fall) This will reinstate structural Integrity and create a Free Flowing drainage run All works undertaken by EDS, is carried out by fully qualified operatives to the highest standard			
Works Guarantee		All lining works undertaken is guaranteed for 10 years & excavations 5 years			
Are there any Health & Safety issues		No			
Risk & Method Statement supplied		Will be supplied upon undertaking of works			
Any Special Site Requirements or Conditions		Will be supplied upon undertaking of works			
Specialist Plant Requirement		Will be supplied upon undertaking of works			
Repair Quotation Cost£		£1,650.00+ VAT

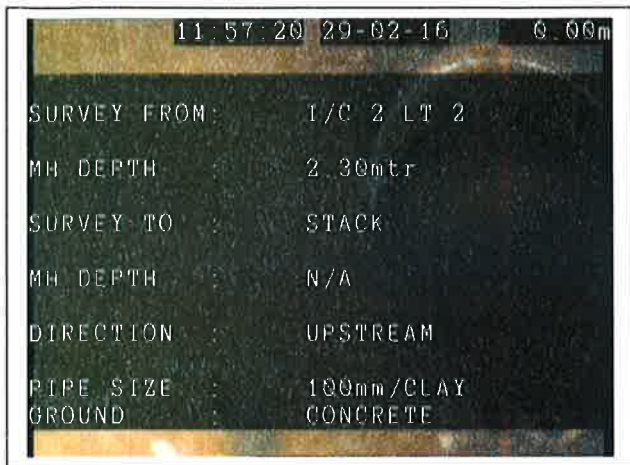
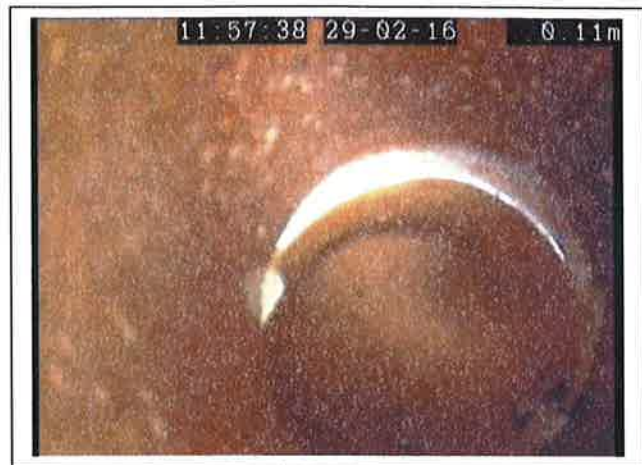
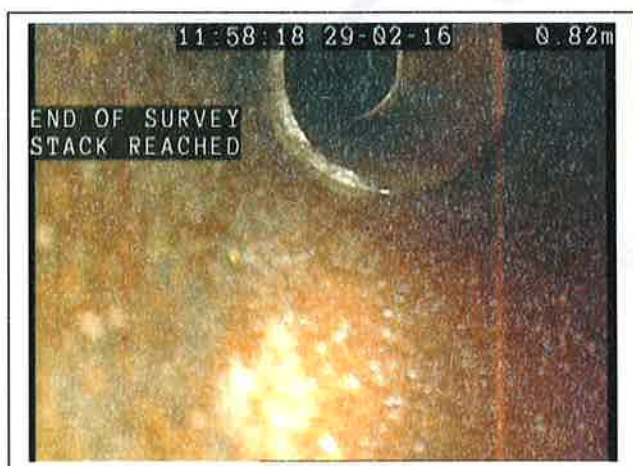
**Images of CCTV Survey for Drainage Run:
IC 2 – Lateral 2 (Stack)**

0.00m			Start of Survey		Yes
0.11m	DJ	Medium	Displaced Joint, Pipe Soundness?		Yes
0.82m			Reached Stack & End of Survey		Yes
Is the Drain Run in a serviceable condition?		No			
If No / Reason		<p>The survey revealed displaced joints/pipe soundness? (Medium) within the drainage run.</p> <p>The defects are having a detrimental effect on the full drainage system which could deteriorate further if remedial repairs are not undertaken.</p> <p>If you have any further queries or questions in relation to any of the above noted defects please don't hesitate to contact the office on the number supplied on the covering letter.</p>

Sheet:	2
Start Position	Inspection Chamber 2	End Position	Lateral 2 (Stack)		
Recommendations		Our recommendation are: 1) HPWJ to remove any scale/residual Debris 2) Insertion of a fibre resin linear liner (super sleeve) for approx 1m. This will reinstate structural Integrity and create a Free Flowing drainage run All works undertaken by EDS, is carried out by fully qualified operatives to the highest standard			
Works Guarantee		All lining works undertaken is guaranteed for 10 years & excavations 5 years			
Are there any Health & Safety issues		No			
Risk & Method Statement supplied		Will be supplied upon undertaking of works			
Any Special Site Requirements or Conditions		Will be supplied upon undertaking of works			
Specialist Plant Requirement		Will be supplied upon undertaking of works			
Repair Quotation Cost£		£750.00+ VAT

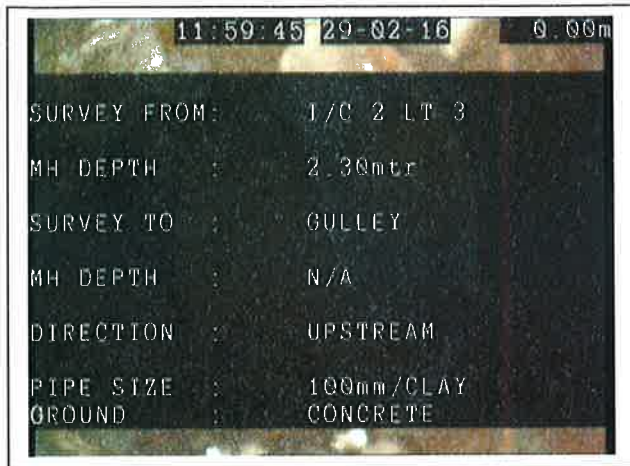
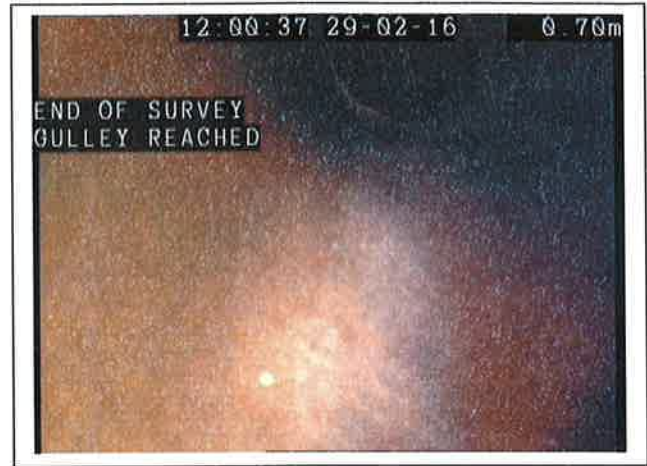
**Images of CCTV Survey for Drainage Run:
IC 2 Lateral 3 - Gully**

Invoice Address: Premier Basements, Unit 21, Tims Boartyard Timsway, Stains upon Thames TW18 3JY		Site: Premier Basements 12 Elsworthy Road London NW3 3DJ		Job No: 28842		Eng No: NH559	
				Date: 04/03/2016		Sheet: 3	
Reason for Survey		CCTV Fully Comprehensive Survey				Survey Recorded Yes	
Pipe Dia	100mm	Run Length	0.70m	Foul / Surface	Combined	Composition Clay	
Start Position		Inspection Chamber 2		End Position		Lateral 3 (Gully)	
Invert Level		2300mm		Invert Level		Not Confirmed	
Direction of Flow		Upstream		Surface Area		Concrete	
Meterage	Code	%	Remark / Note			Image Supplied Y/N	
0.00m			Start of Survey			Yes	
0.70m			Reached Gully & End of Survey			Yes	
Is the Drain Run in a serviceable condition?			Yes				
If No / Reason			The survey revealed no significant structural defects within the drainage run.

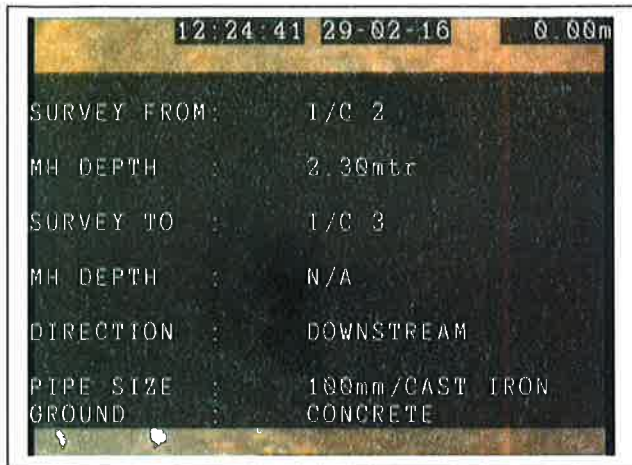
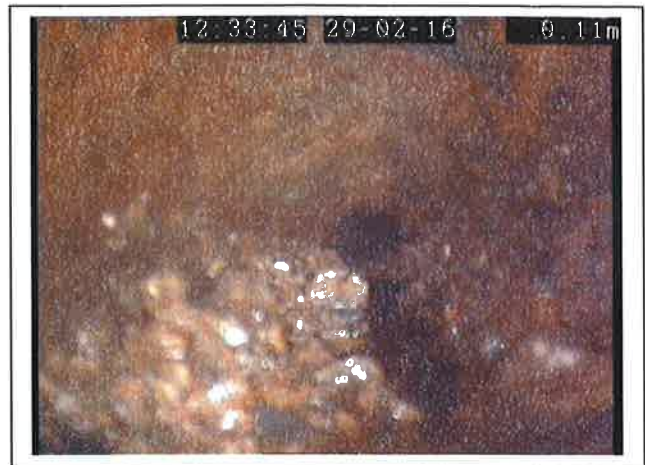
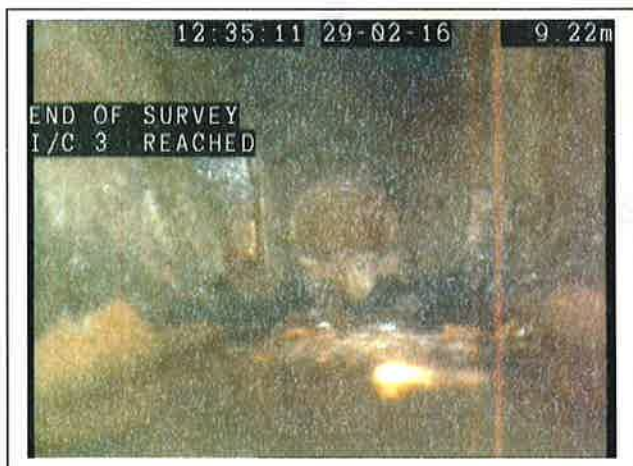
**Images of CCTV Survey for Drainage Run:
IC 2 – IC 3**

0.00m			Start of Survey		Yes
0.11m	SRD		Scale/Residual Debris (Showing Signs of Previous Blockages)		Yes
9.22m			Reached Inspection Chamber 3 Defective Interceptor & End of Survey		Yes
Is the Drain Run in a serviceable condition?			No		
If No / Reason			<p>The survey revealed a defective interceptor within inspection chamber 3 & scale/residual debris within the drainage run.</p> <p>The defects are having a detrimental effect on the full drainage system which could deteriorate further if remedial repairs are not undertaken.</p> <p>If you have any further queries or questions in relation to any of the above noted defects please don't hesitate to contact the office on the number supplied on the covering letter.</p>

Sheet:	4
Start Position	Inspection Chamber 2	End Position	Inspection Chamber 3		
Recommendations		Our recommendation are: 1) HPWJ to remove any scale/residual Debris 2) Excavate & Remove Interceptor (By means of Internal excavation) using approx 1m of New UPVC Pipe Work to Correct Alignment & Fall. 3) Insertion of a fibre resin linear liner (super sleeve) for approx 1m. 4) Install 4 Inch Stainless Steel Rat Blocker This will reinstate structural Integrity and create a Free Flowing drainage run All works undertaken by EDS, is carried out by fully qualified operatives to the highest standard			
Works Guarantee		All lining works undertaken is guaranteed for 10 years & excavations 5 years			
Are there any Health & Safety issues		No			
Risk & Method Statement supplied		Will be supplied upon undertaking of works			
Any Special Site Requirements or Conditions		Will be supplied upon undertaking of works

Specialist Plant Requirement		Will be supplied upon undertaking of works			
Repair Quotation Cost£		£1,700.00+ VAT

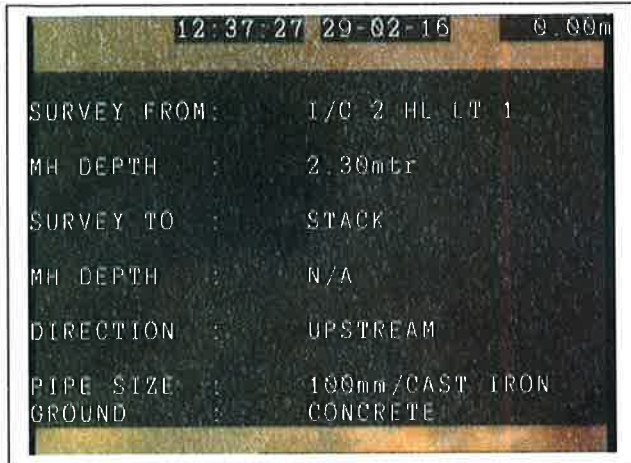
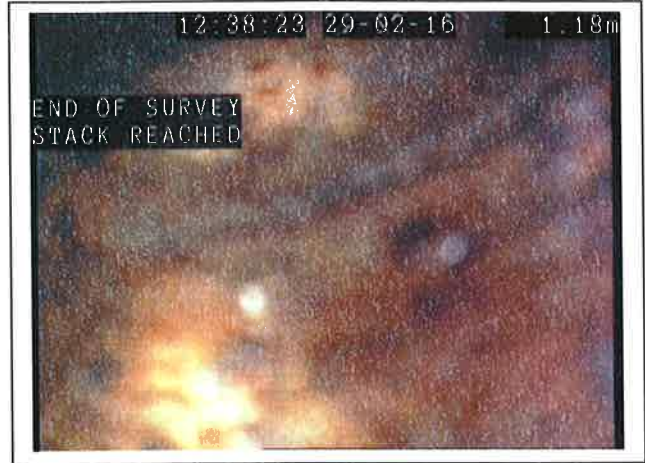
**Images of CCTV Survey for Drainage Run:
IC 2 – High Level Lateral 1 (Stack)**

Invoice Address: Premier Basements, Unit 21, Tims Boartyard Timsway, Stains upon Thames TW18 3JY		Site: Premier Basements 12 Elsworthy Road London NW3 3DJ		Job No:	28842		
				Eng No:	NH559		
				Date:	04/03/2016		
				Sheet:	5		
Reason for Survey		CCTV Fully Comprehensive Survey			Survey Recorded	Yes	
Pipe Dia	100mm	Run Length	1.18m	Foul / Surface	Combined	Composition	Cast Iron
Start Position		Inspection Chamber 2		End Position		High Level Lateral 1 (Stack)	
Invert Level		2300mm		Invert Level		Not Confirmed	
Direction of Flow		Upstream		Surface Area		Concrete	
Meterage	Code	%	Remark / Note			Image Supplied Y/N	
0.00m			Start of Survey			Yes	
1.18m			Reached Stack & End of Survey			Yes	
Is the Drain Run in a serviceable condition?			Yes				
If No / Reason			The survey revealed no significant structural defects within the drainage run.

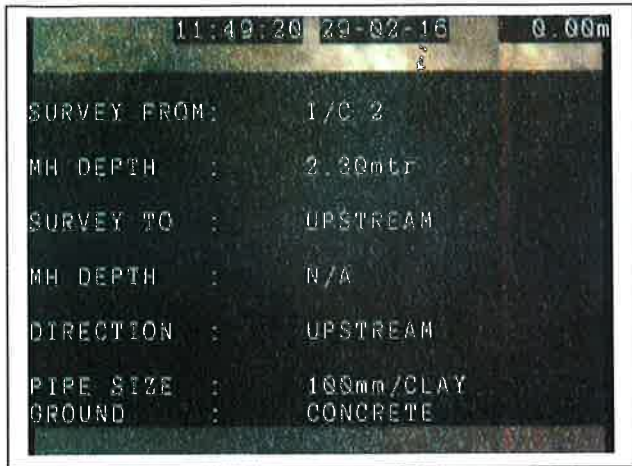
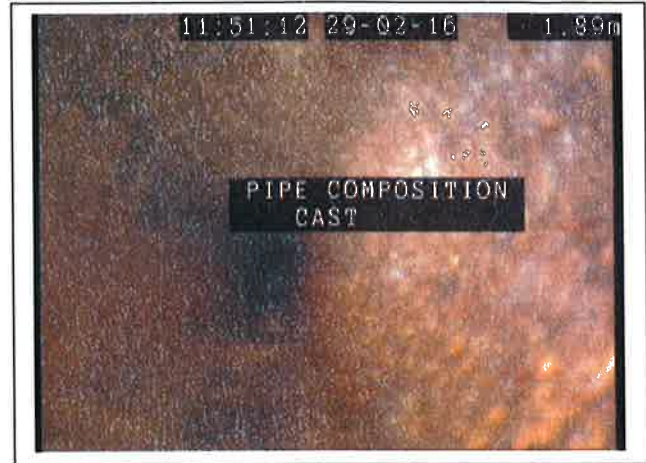
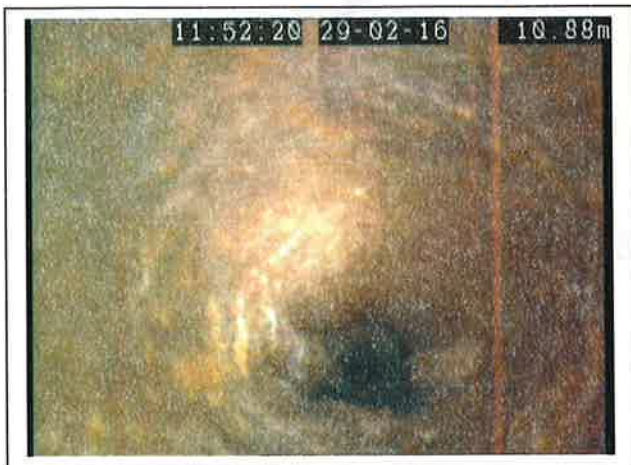
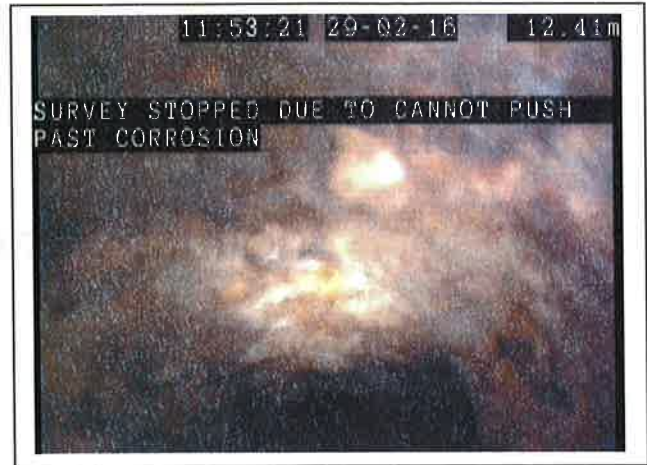
**Images of CCTV Survey for Drainage Run:
IC 2 - Upstream**

0.00m			Start of Survey			Yes	
1.89m	MC		Pipe Composition Changes to Cast Iron			Yes	
10.88m	EC		Encrustation & Corrosion			Yes	
12.41m	SA/EC	Severe	Survey Abandoned due to Encrustation & Corrosion			Yes	
Is the Drain Run in a serviceable condition?							
If No / Reason			<p>The survey was abandoned due to severe encrustation/corrosion @ 12.41m within the drainage run.</p> <p>The defects are having a detrimental effect on the full drainage system which could deteriorate further if remedial repairs are not undertaken.</p> <p>If you have any further queries or questions in relation to any of the above noted defects please don't hesitate to contact the office on the number supplied on the covering letter.</p>

Sheet:	6
Start Position	Inspection Chamber 2	End Position	Upstream		
Recommendations		Our recommendation are: 1) HPWJ with industrial chain flail to remove any encrustation/corrosion, then Re-CCTV to identify true remaining condition of the drainage run. (Any further work will be quoted accordingly) All works undertaken by EDS, is carried out by fully qualified operatives to the highest standard			
Works Guarantee		All lining works undertaken is guaranteed for 10 years & excavations 5 years			
Are there any Health & Safety issues		No			
Risk & Method Statement supplied		Will be supplied upon undertaking of works			
Any Special Site Requirements or Conditions		Will be supplied upon undertaking of works			
Specialist Plant Requirement		Will be supplied upon undertaking of works			
Repair Quotation Cost£		£225.00+ VAT
