Site Details: 35 Camden Mews, London, Nw1 9BY

Prepared for: Threefold Architects

Title: TA_35CM_AIA_001

Published Date: 21st April 2016

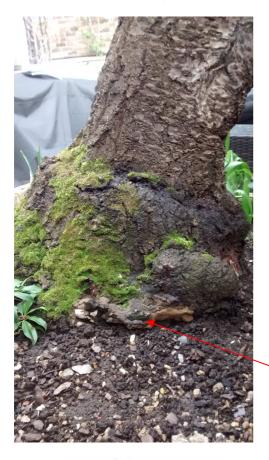
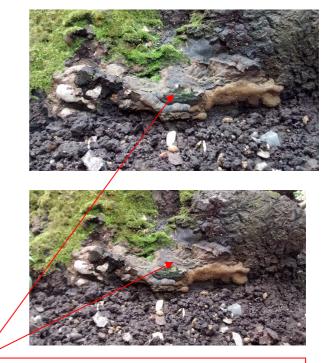
The tree survey identified that T1 is host to suspected *Ganoderma pfeifferi* disease, a parasitic, fungus which destroys both Lignin and Cellulose in wood tissue and can lead to stem failure.

The fruiting body observed at the stem base on the south side of the tree appears to be old, however, the fungus mycelium are likely to be active beyond what can be seen externally.

Sounding hammer testing around the bracket and stem base suggested that the underlying heartwood is intact; however, this is not a guarantee of the integrity of the heartwood.

A fruiting body of suspected *Ganoderma pfeifferi* fungus was observed at the stem base on the southern side of the tree.

The tree is considered to be in a high target area and may cause property damage or personal injury should the tree fail.

It is recommended to have the tree removed due to the presence of *Ganoderma pfeifferi* fungus and have a replacement tree planted.

Following the removal of T1, it will need to be replaced with another tree which will be detailed further in terms of size and species by planning condition.
