ref: 14/1454/JRS
your ref:

date: 31-07-2014

Report on Structural Inspection
on the property known as
54 Bloomsbury Street
London

The following report presents and discusses the findings of a structural inspection of Flat 4, 54 Bloomsbury Street, London.

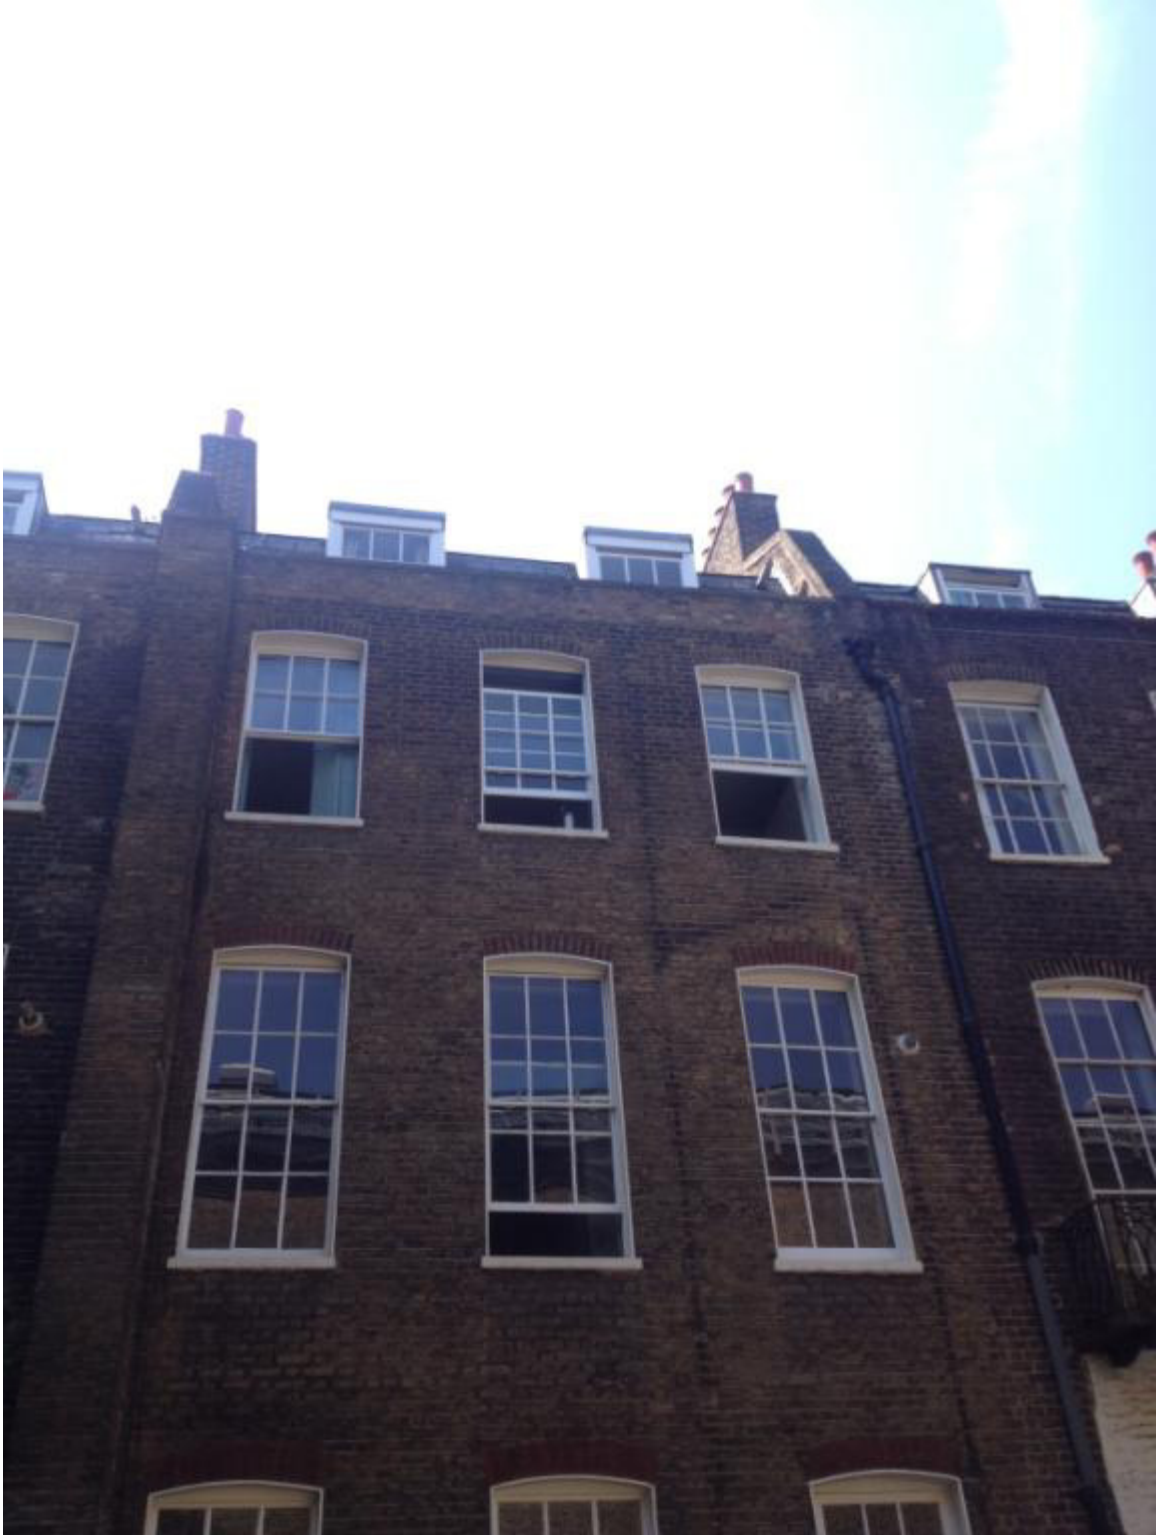
PI General view of rear elevation

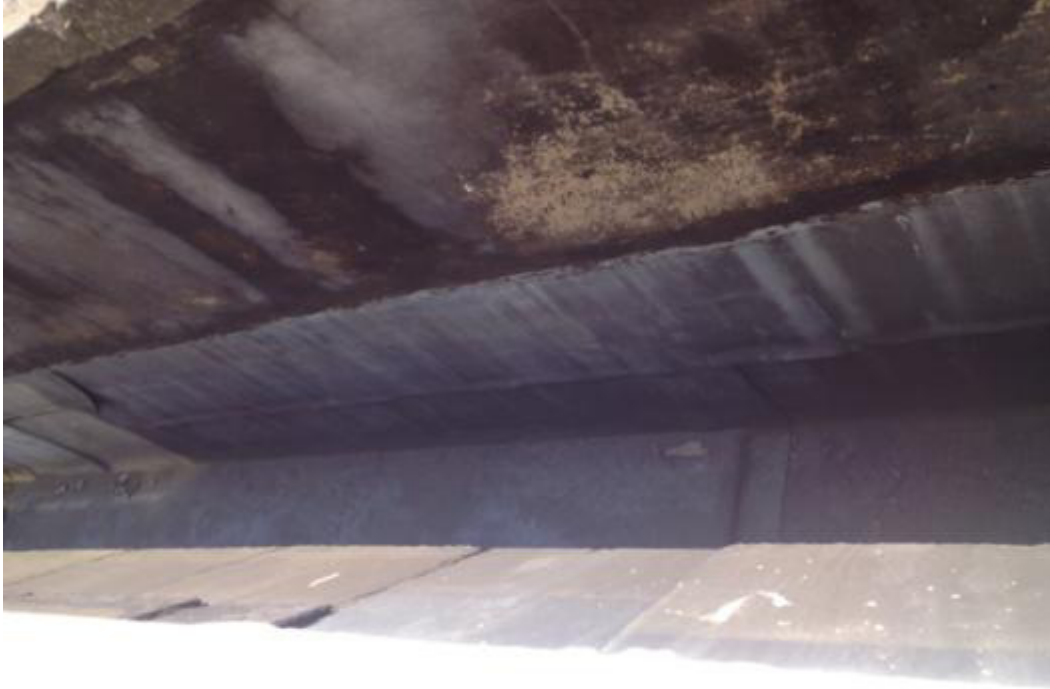
The moisture ingress to flat 4 is likely as a result of a defect in the lead concealed gutter.

P2 General view of front concealed gutter

The gutter should be re-lined preferably with a glass fibre system and the decorations made good to the flat below.

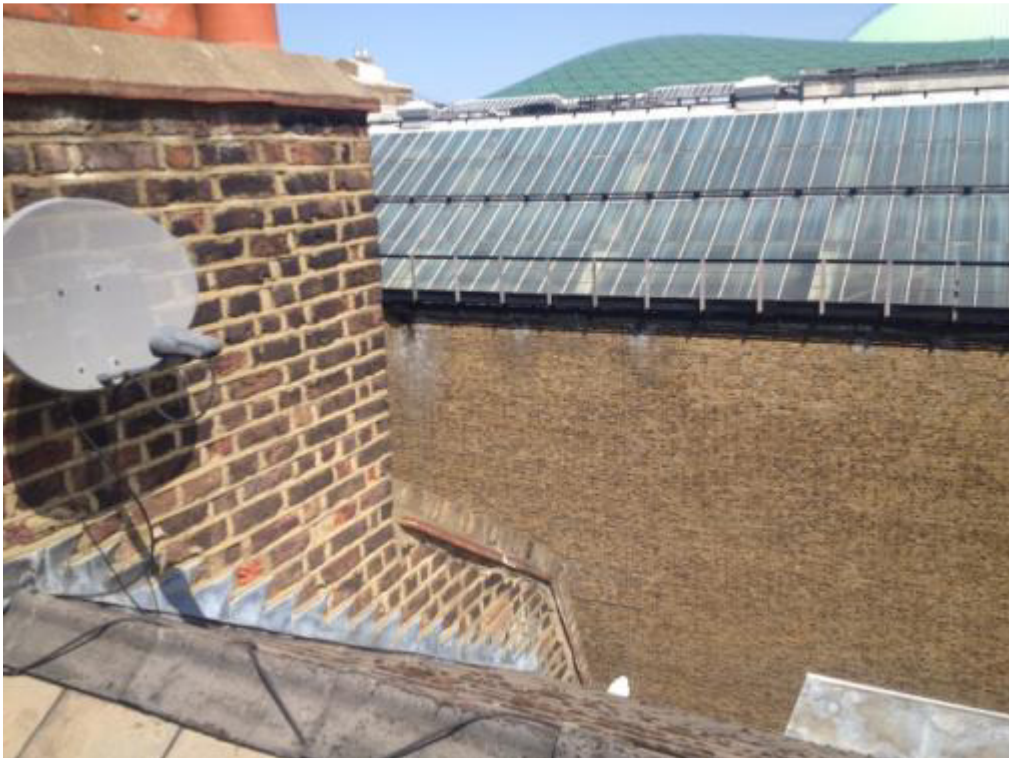
There is no evidence of any structural distress externally which would indicate a potential point of water ingress into flat 4.

P3 General view of flank wall

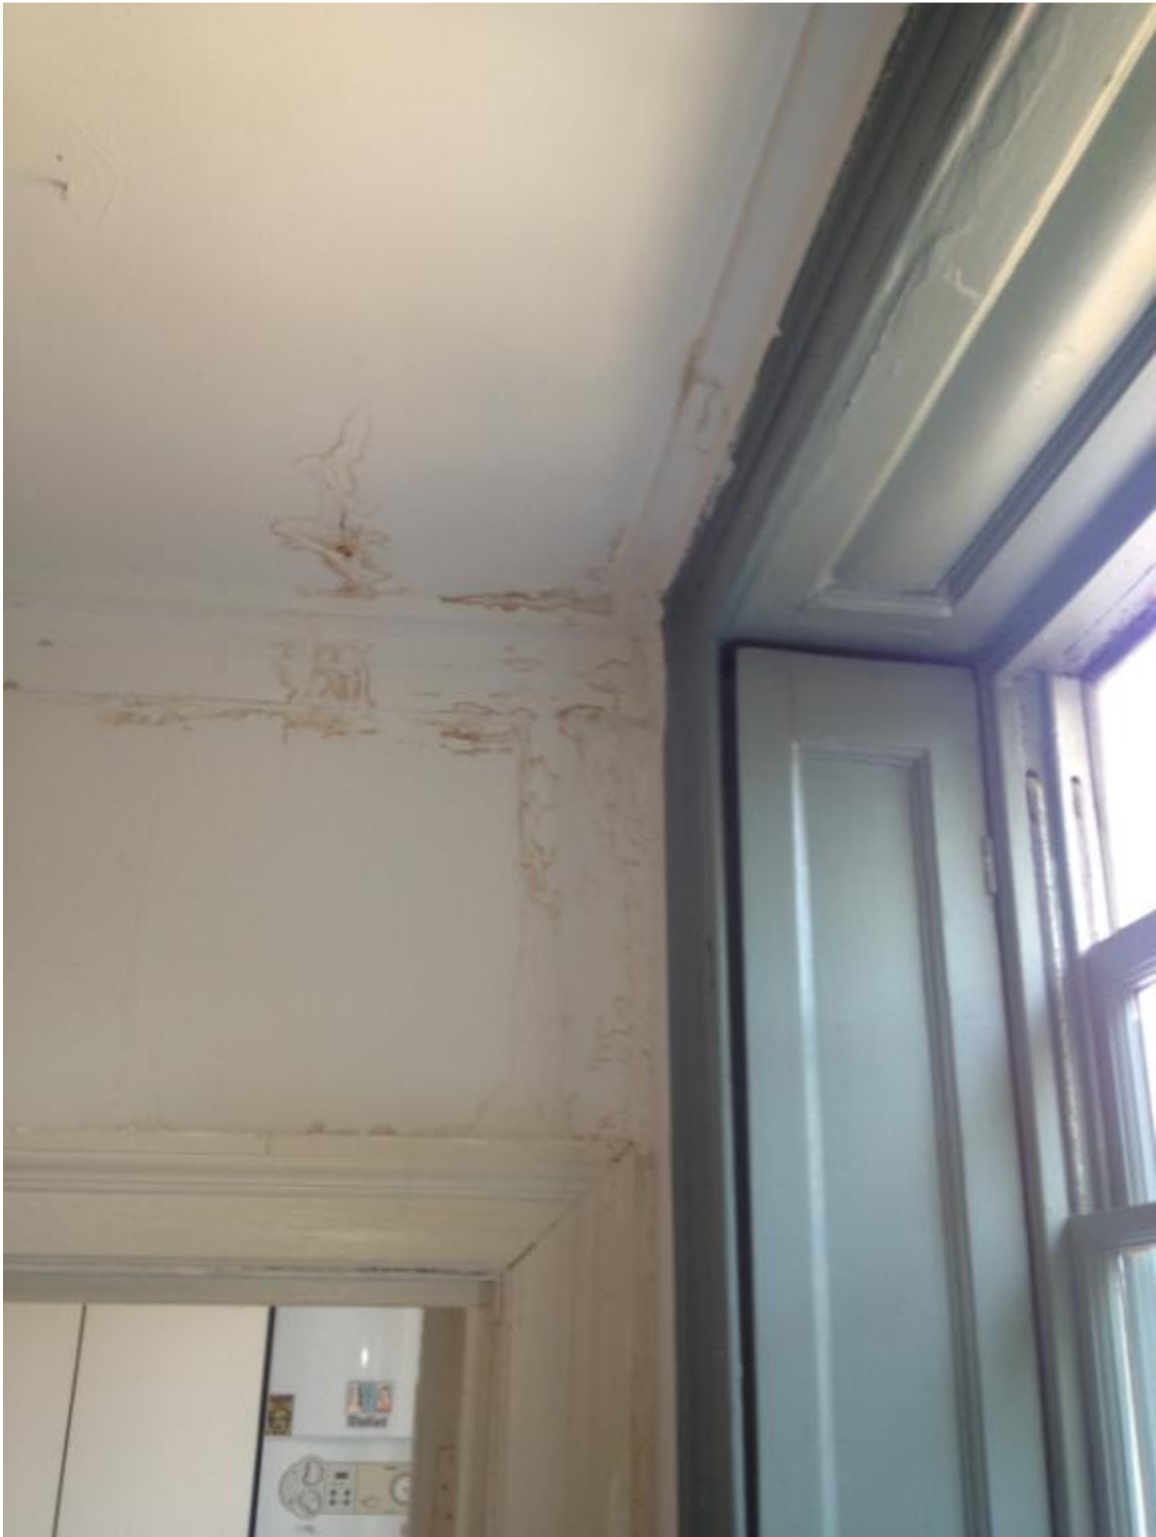
There is evidence of prolonged water ingress to the left hand side of the rear central window. This is directly below the concealed gutter. It is likely that there is a poor joint in the leadwork or similar allowing water to enter the flat below.

P4 Damp above rear window

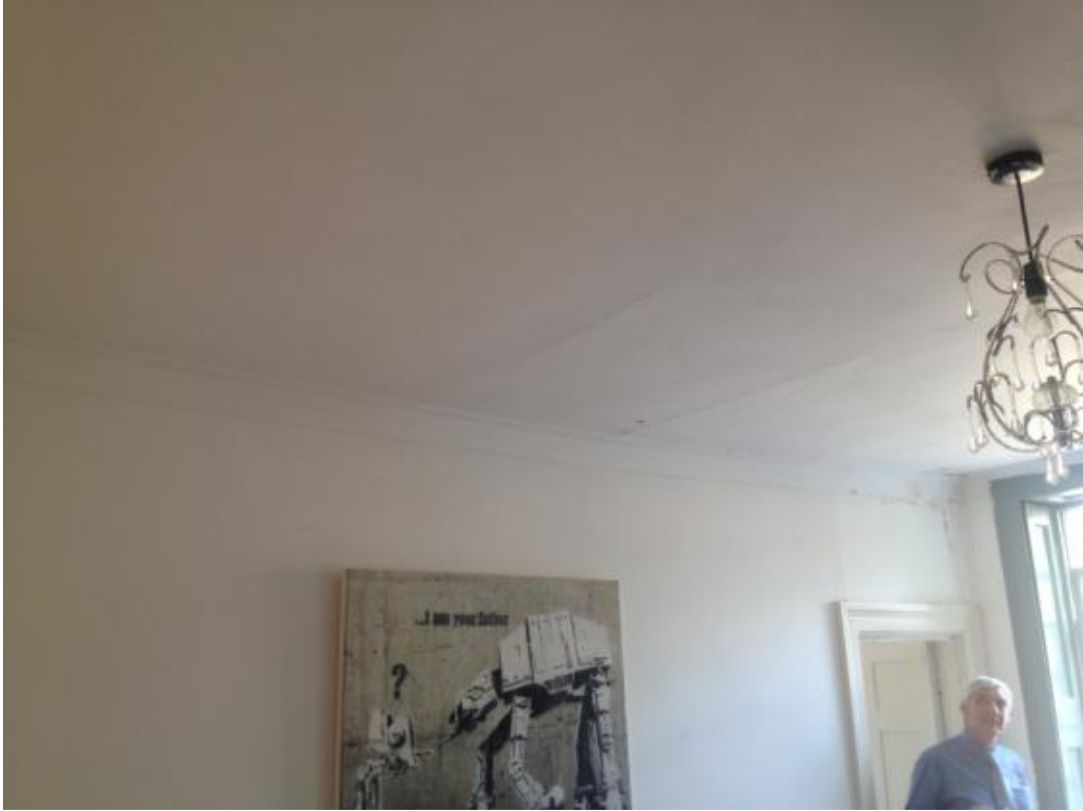
There is evidence of historical sagging of the 4th floor joists. This is evidenced by ceiling cracking and bowing of the covings. These walls are non-loadbearing studs and it is likely that the floor joists above are over-spanned as is common with this type of dwelling.

The sagging ceiling is aesthetically dis-pleasing but is not structurally unsound. It would be very difficult to strengthen the floor due to the structural configuration. If

P5 Cracking to ceiling and bowing of cornice

anything were to be done it would involve removing the ceiling, doubling up joists and reinstatement as necessary.

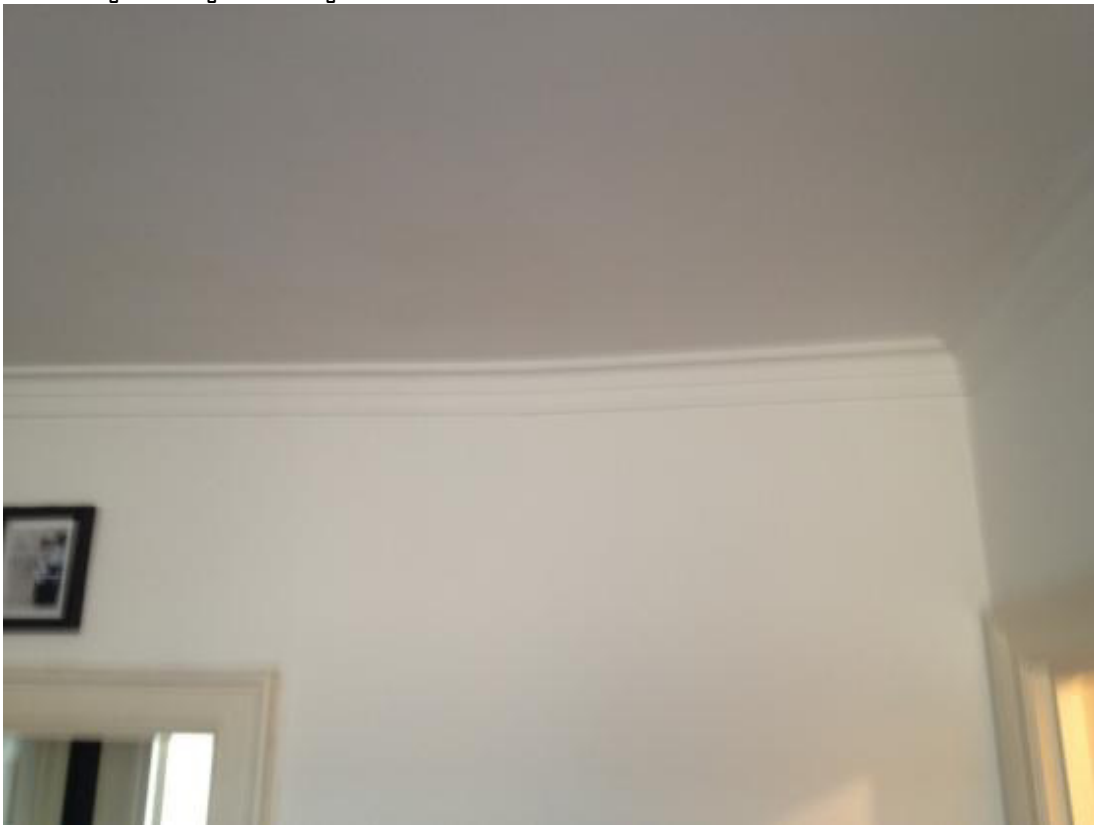
P6 Bowing of coving
