LIGHTHOUSE BLOCK KINGS CROSS

FAÇADE CONDITION SURVEY REPORT

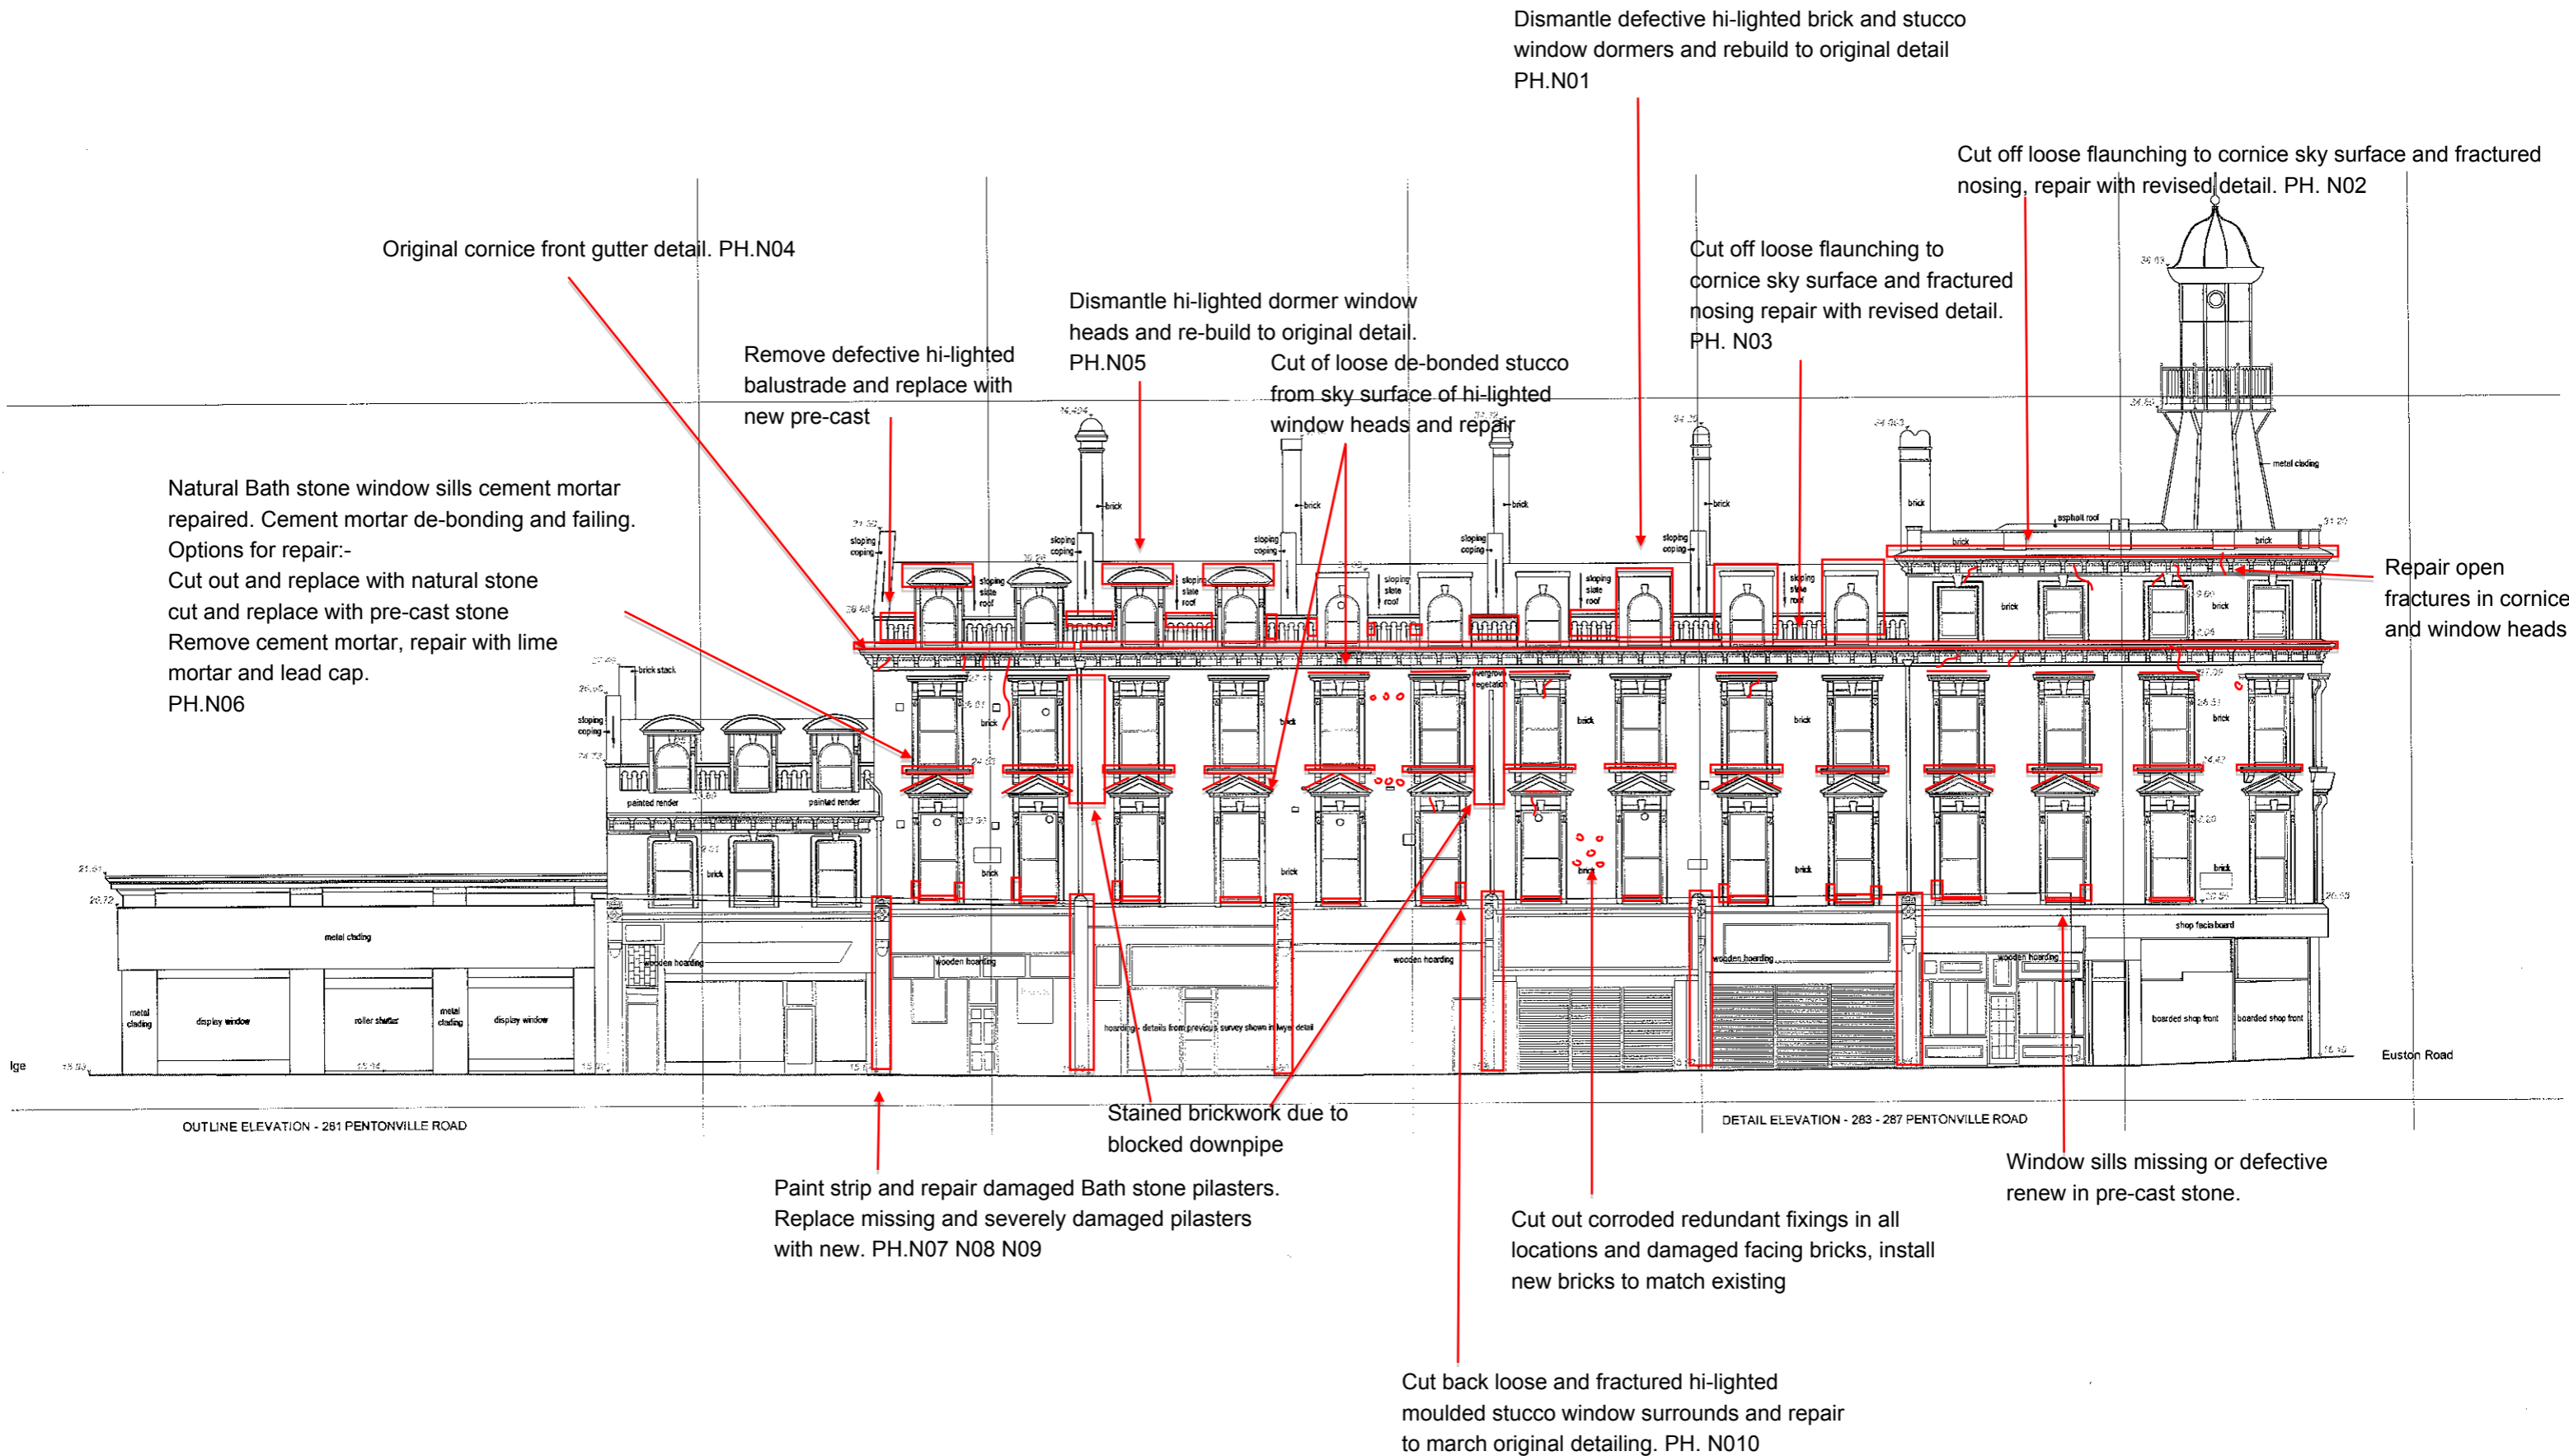
THE LIGHTHOUSE BLOCK KINGS CROSS FACADE CONDITION SURVEY SOUTH ELEVATION

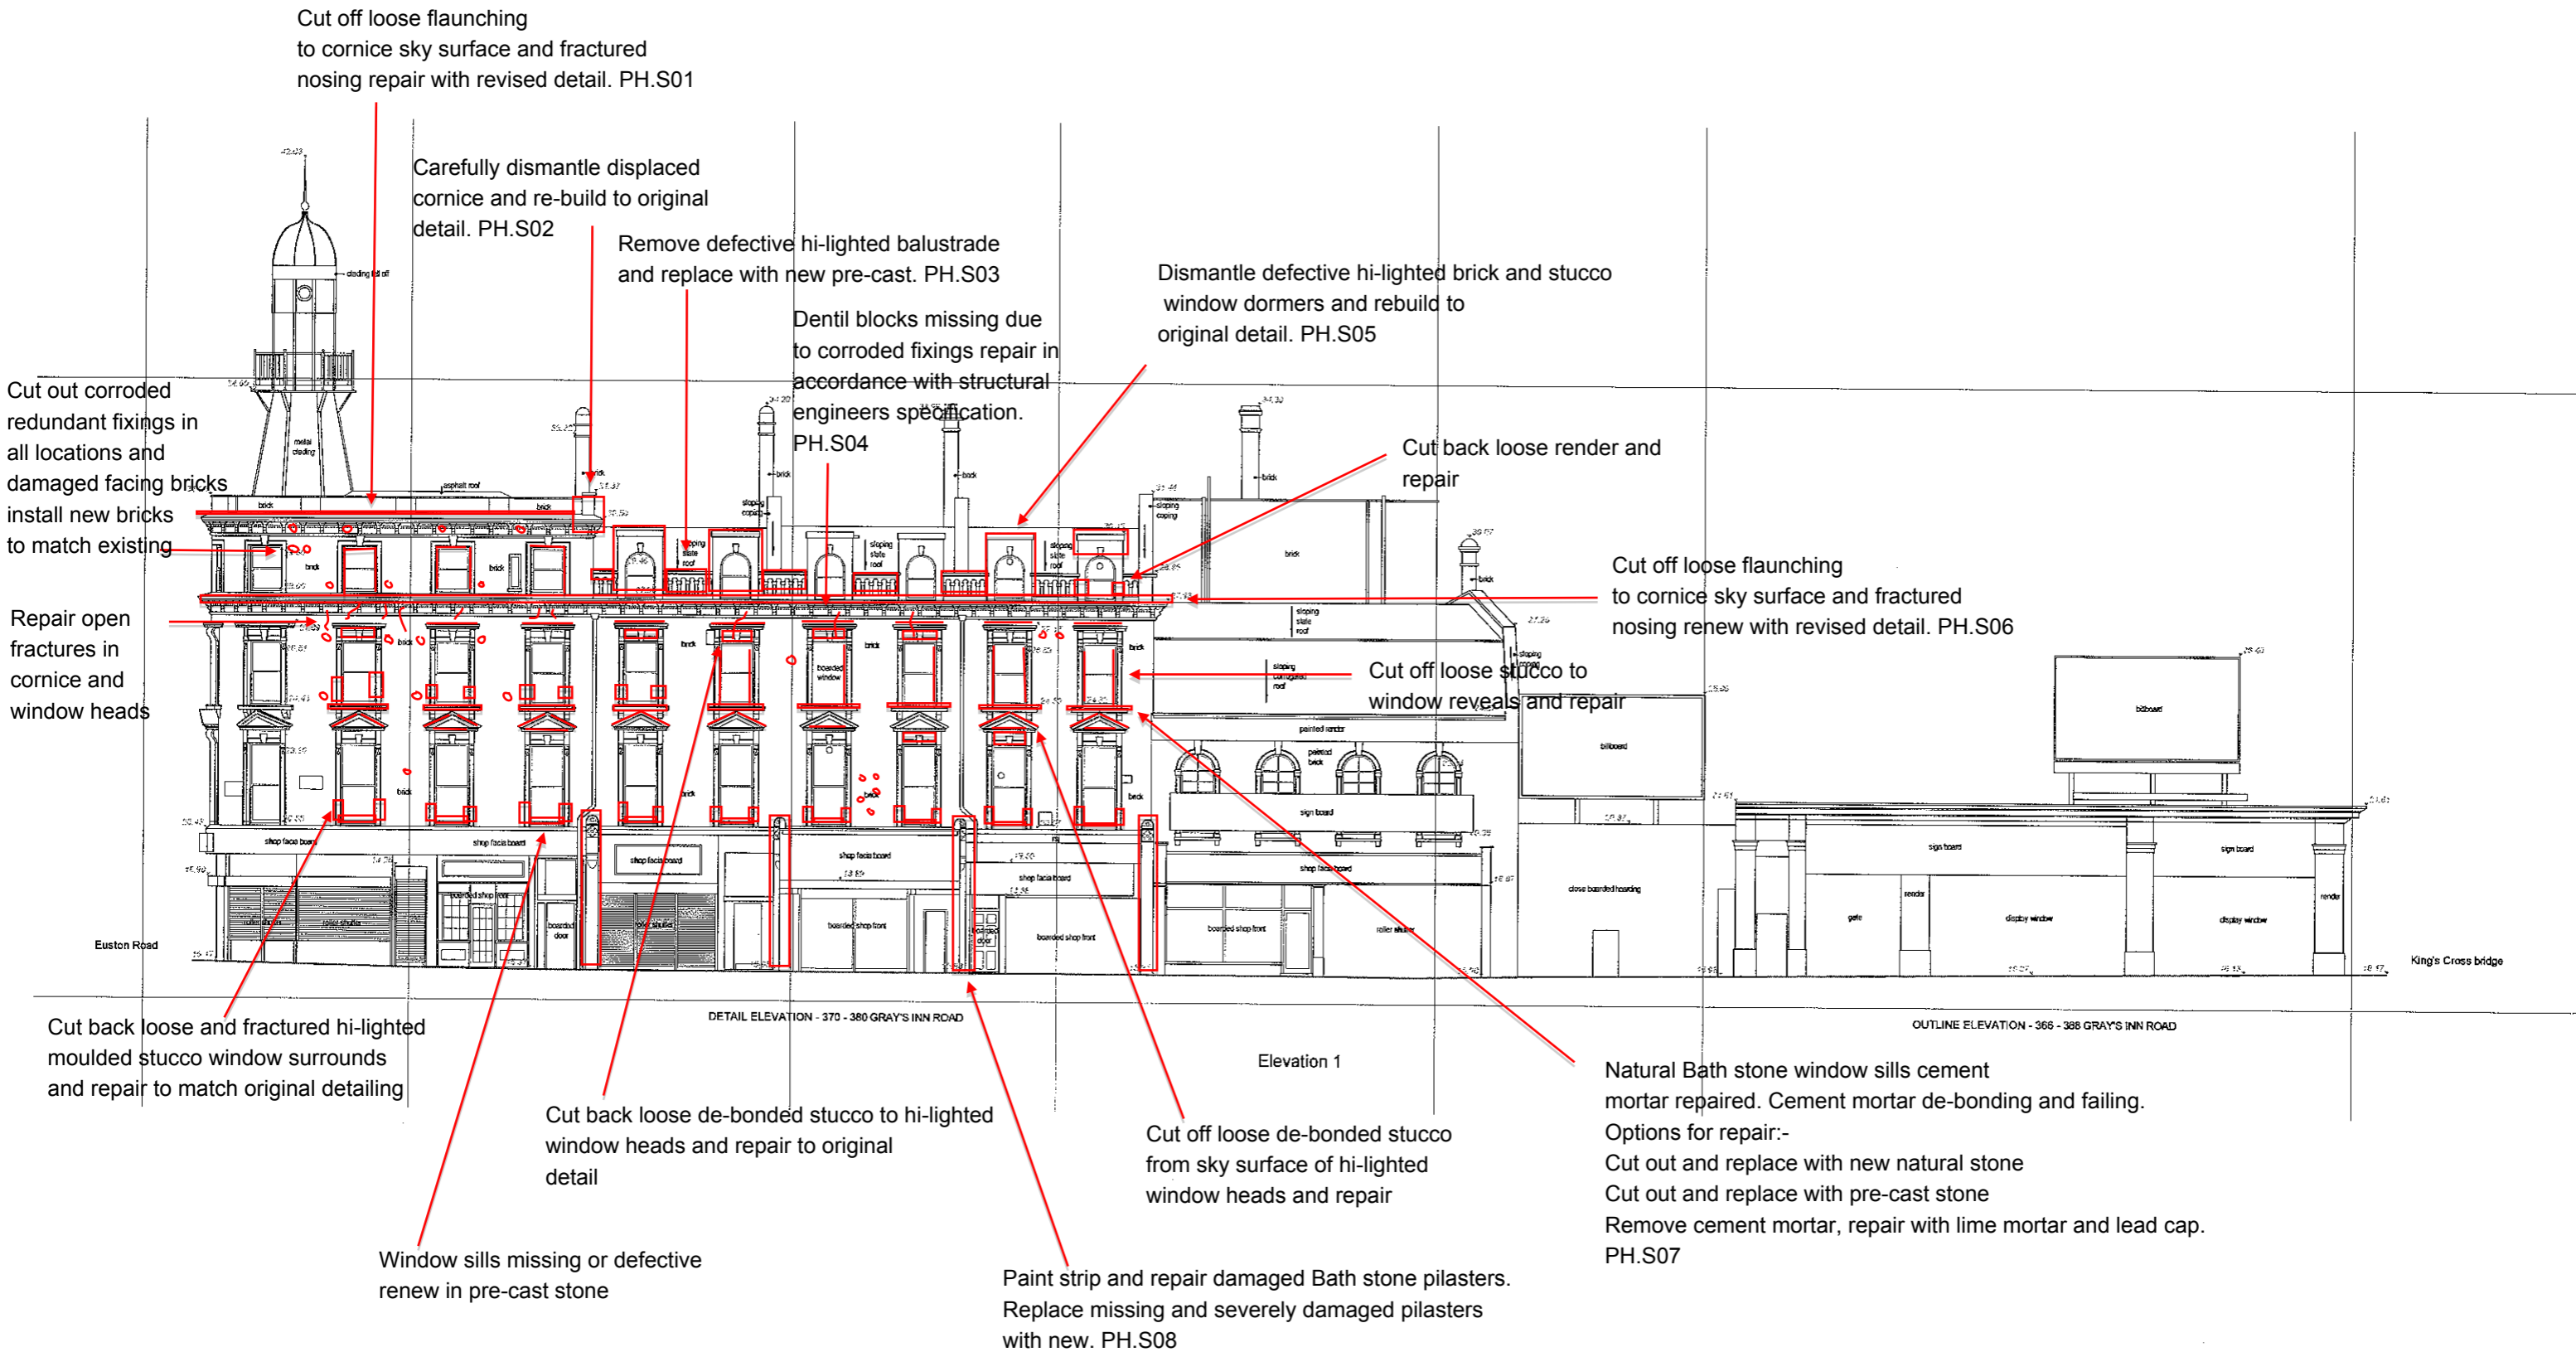
Cut off loose flanching to cornice sky surface and fractured nosing repair with revised detail. PH.S01

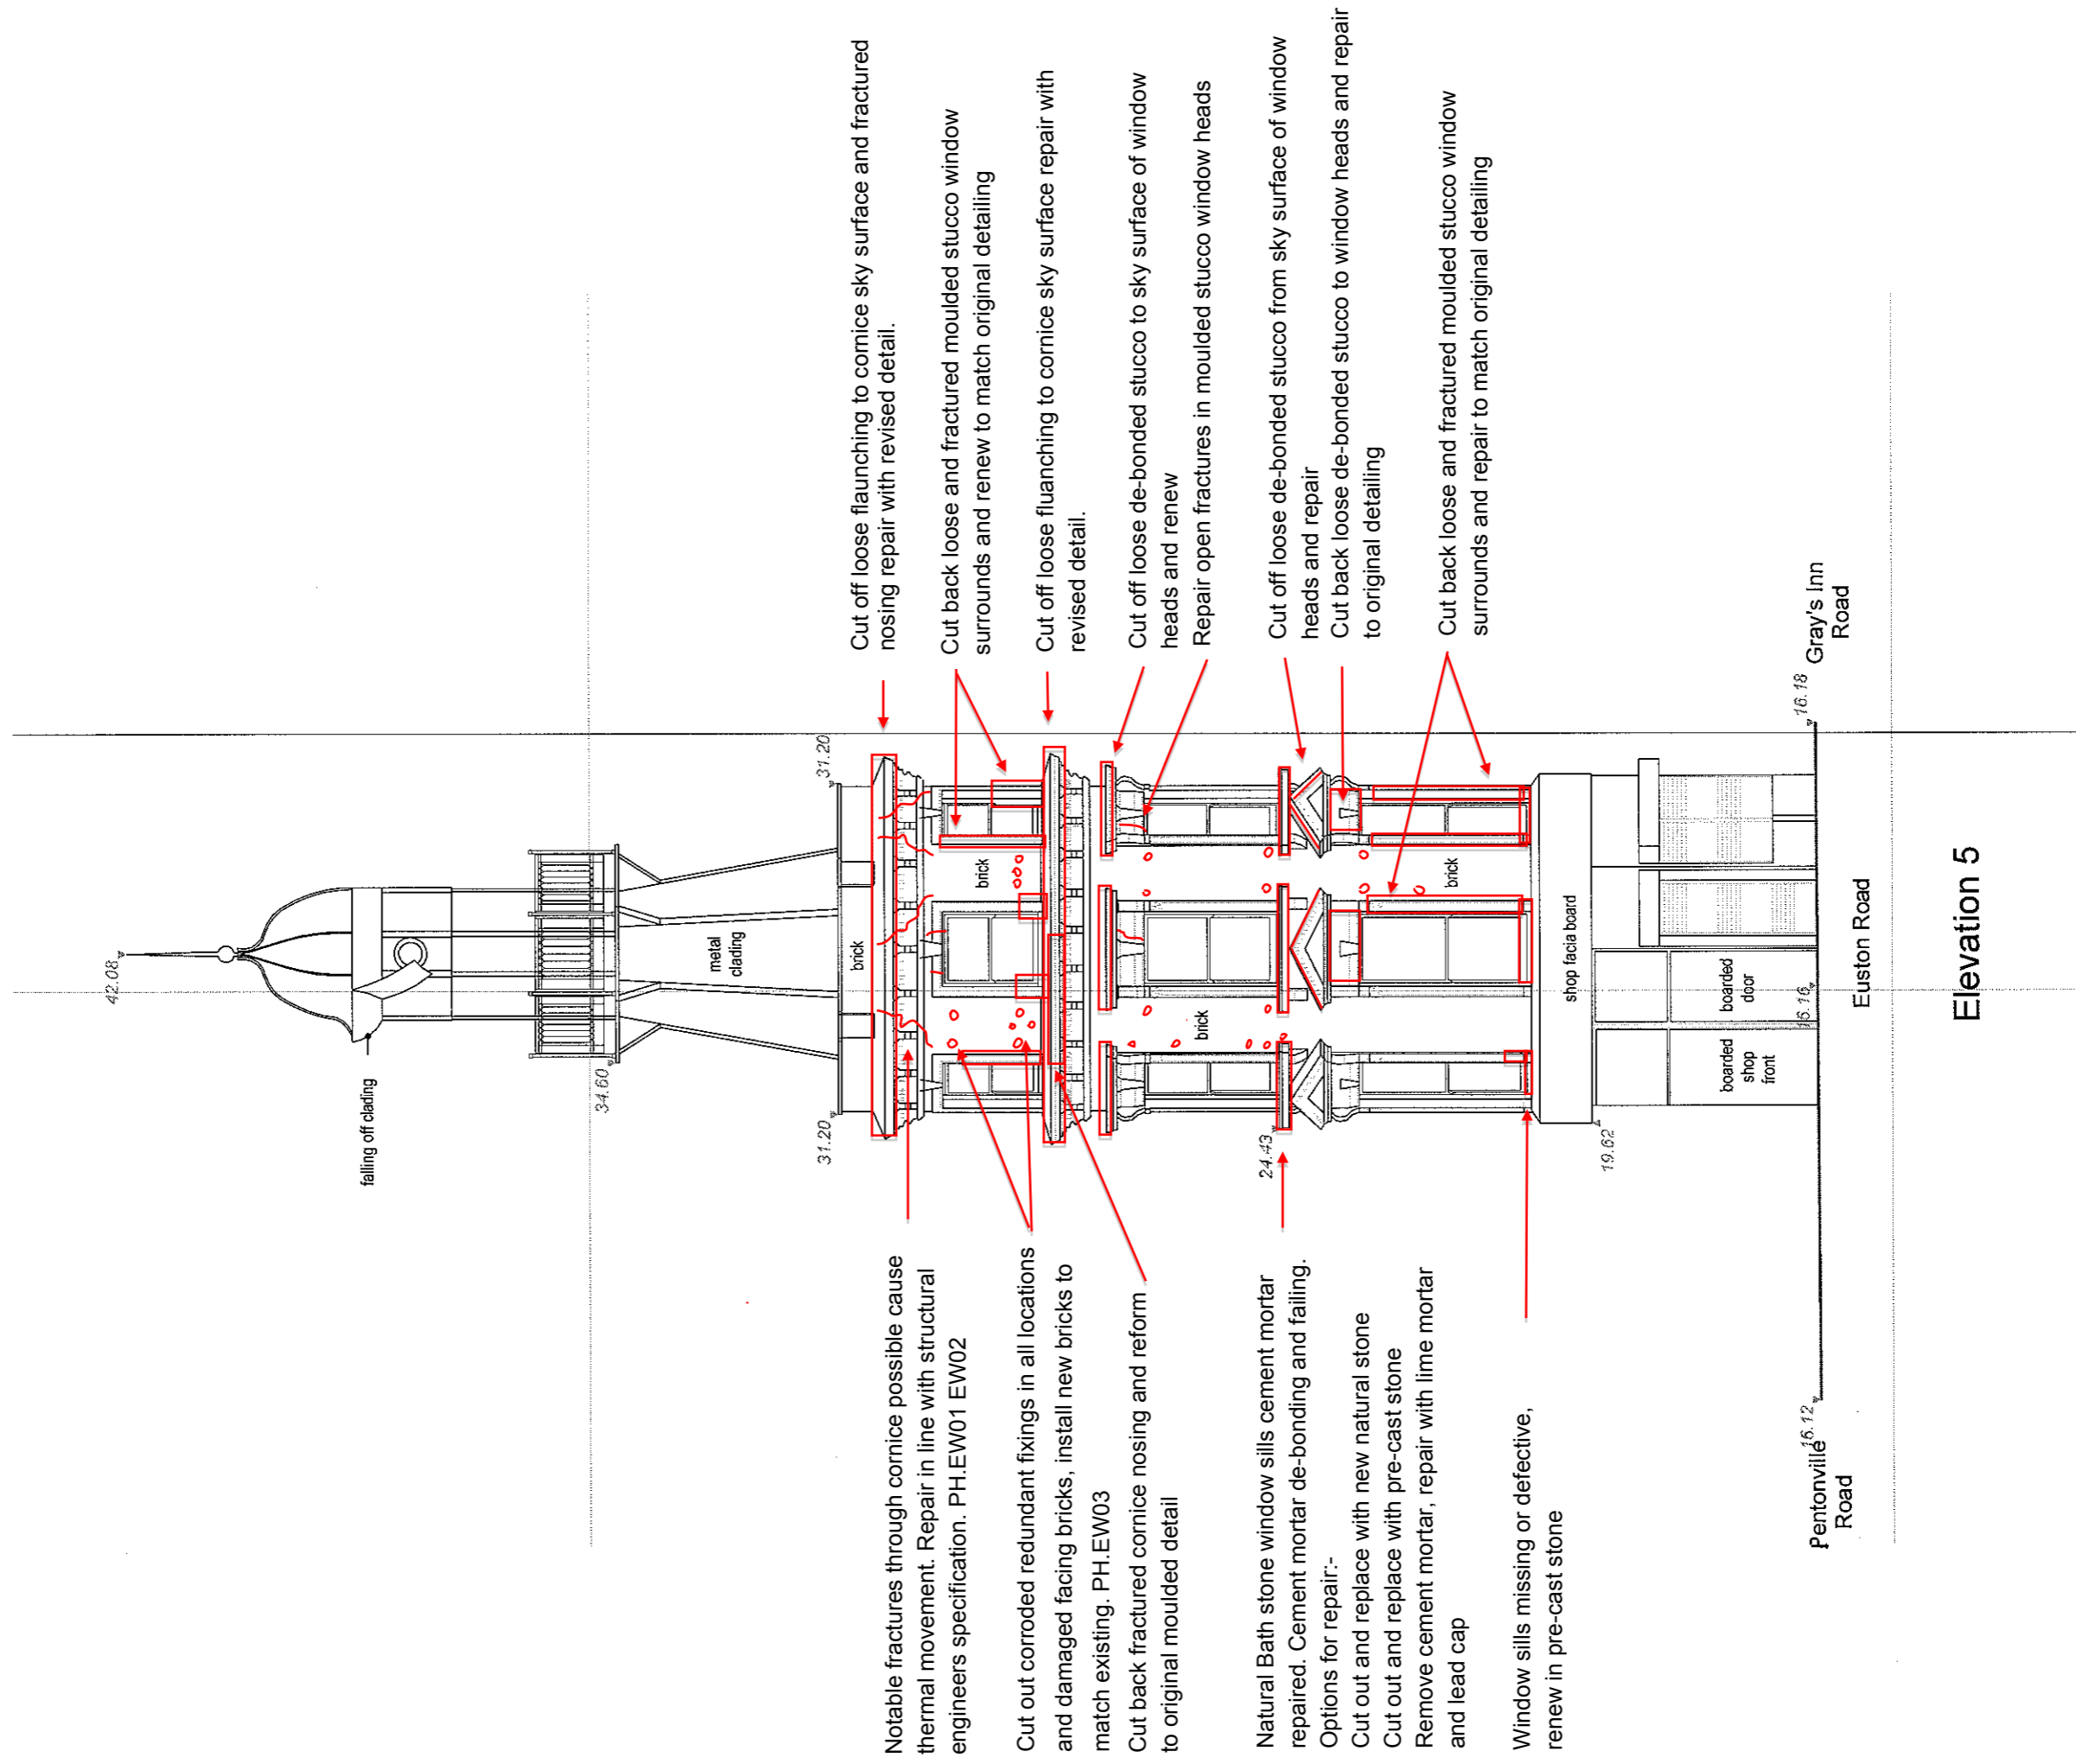
THE LIGHTHOUSE BLOCK KINGS CROSS
 FACADE CONDITION SURVEY EAST WEST ELEVATION

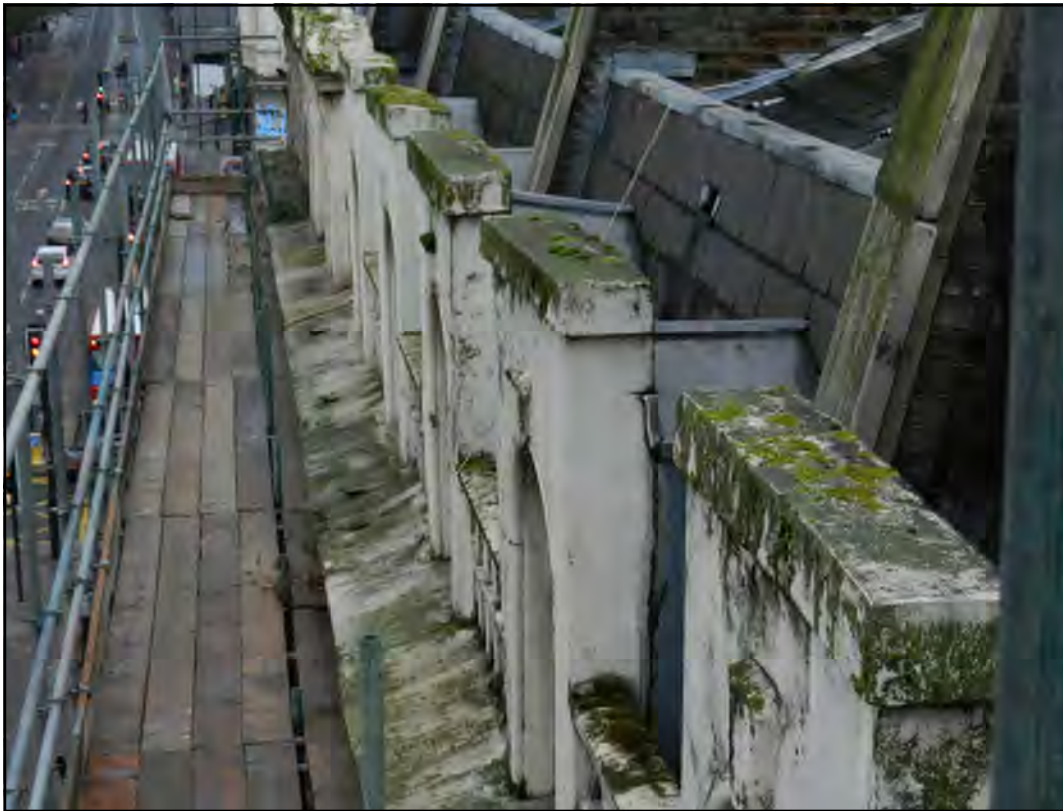
PH. N01. Dormer windows render loose and de-bonding, brickwork substrate frost damaged. Take down and re-build

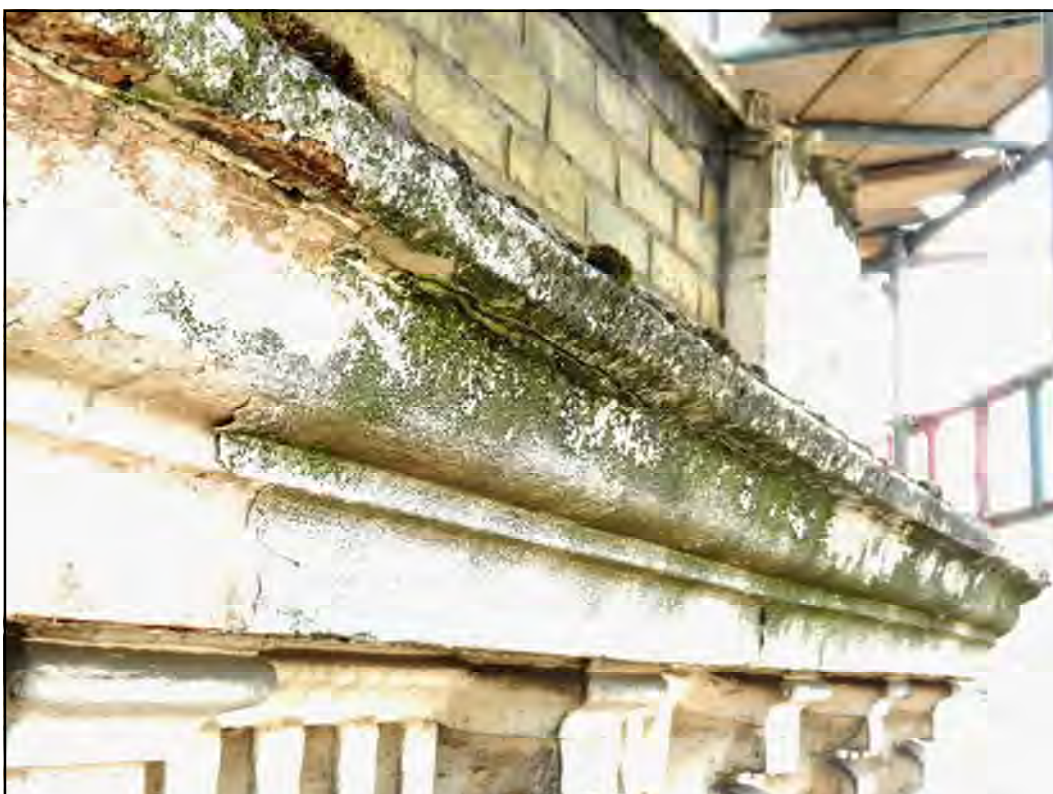
PH. N02. Cement mortar repair to upper cornice loose and de-bonding from the original substrate, continuous fracture through nosing. Remove complete and repair.

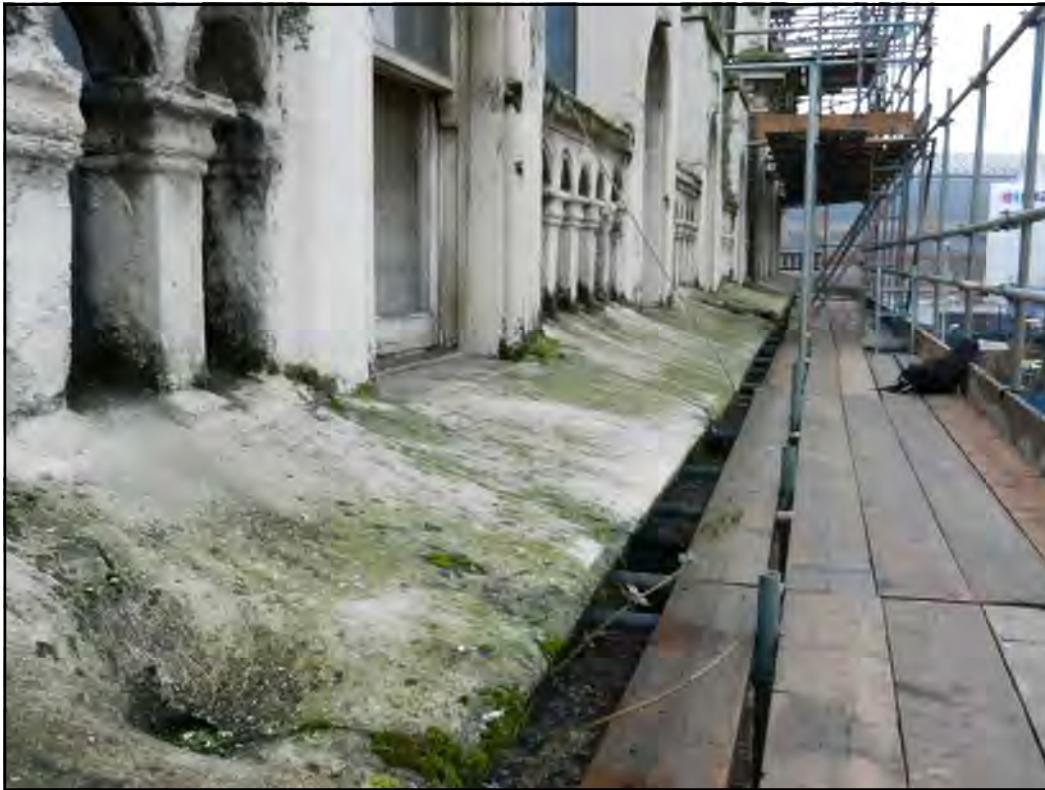
PH. N03. Cement mortar repair to lower cornice loose and de-bonding from original substrate, fracture through nosing, downpipe outlets blocked, weathering detail to window sills ineffective. Remove complete, repair substrate and revise weathering detail.

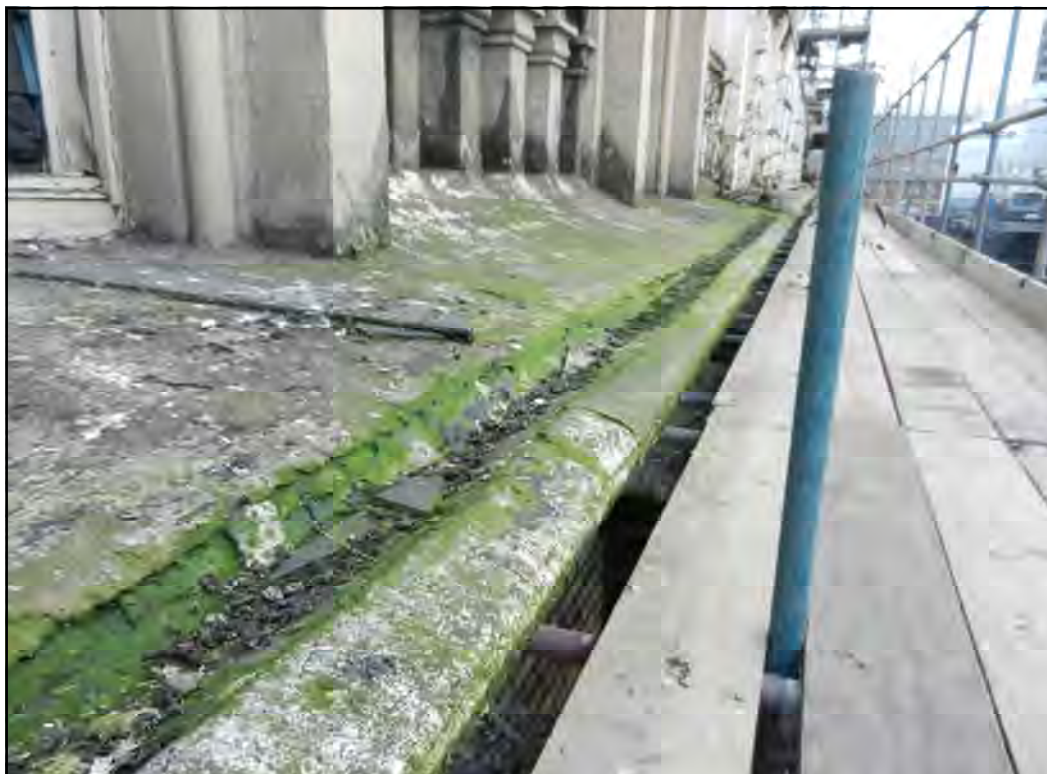
PH. N04. Original cornice detail with front gutter running to downpipe outlet. Flaunching below window sills and less built up to the base of balustrade.

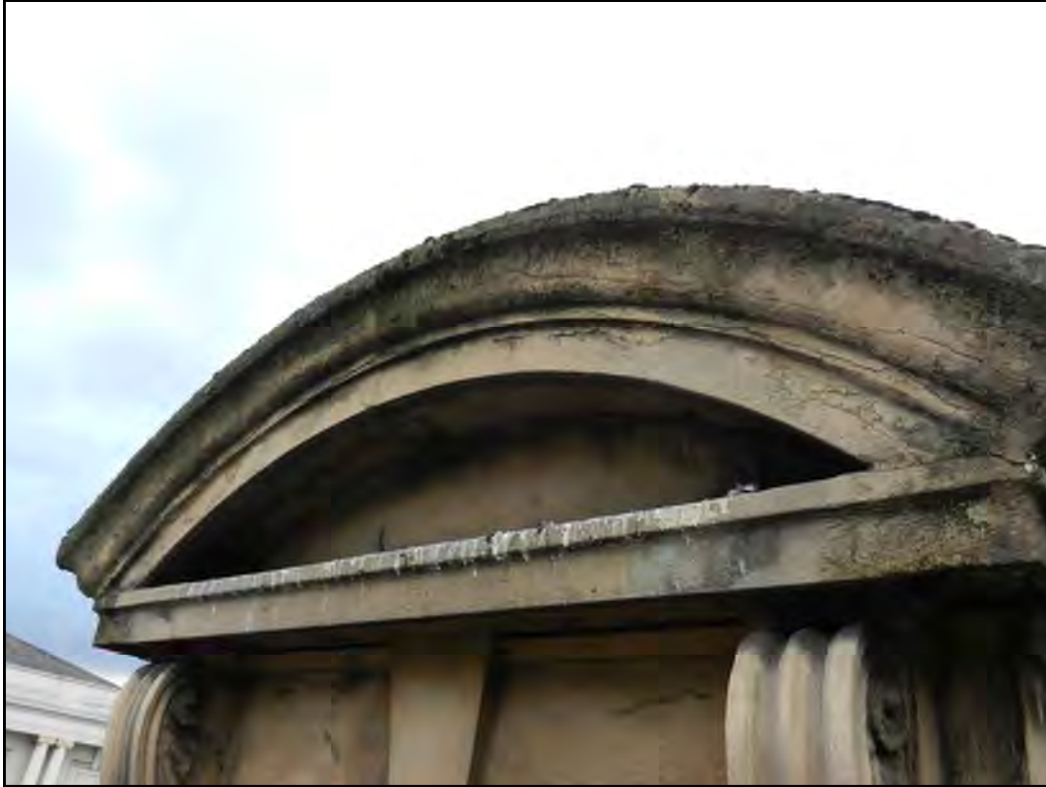
PH. N05. Curved pediment dormer window heads fractured and loose stucco, frost damaged brick and tile substrate. Take down and re-build new.

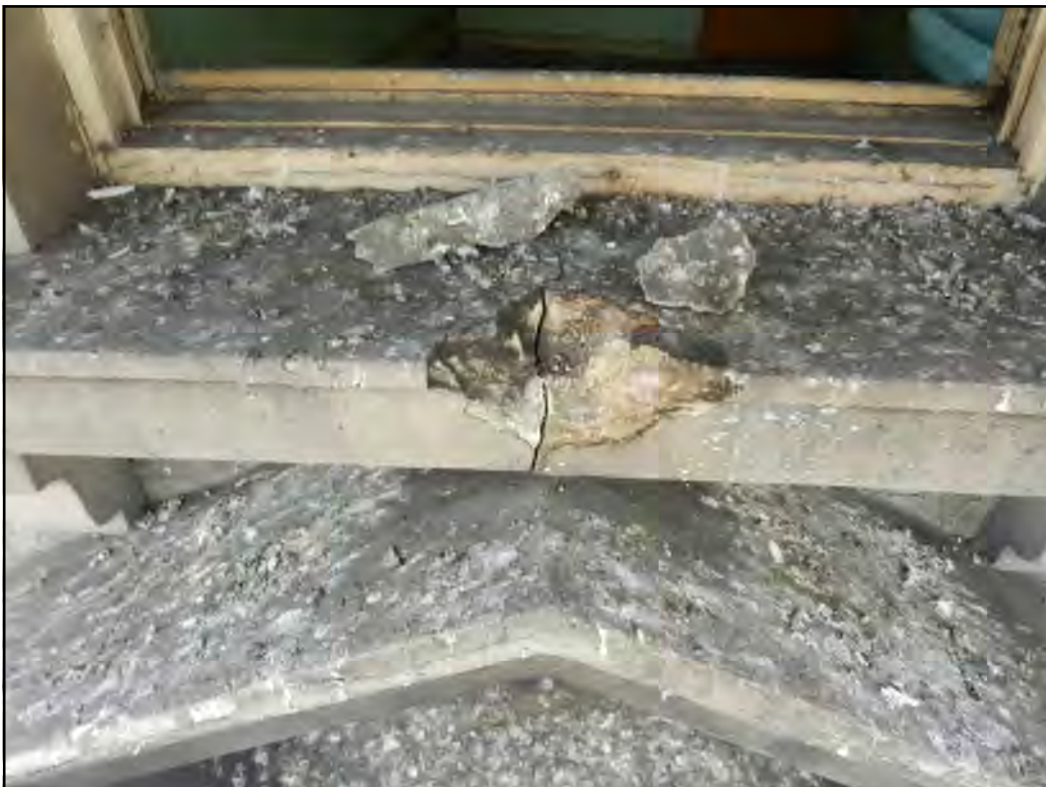
PH. N06. All natural Bath stone window sills cement mortar repaired. Repairs are loose and failing. Remove mortar and assess condition of exposed stone for most appropriate option on repair or replacement.

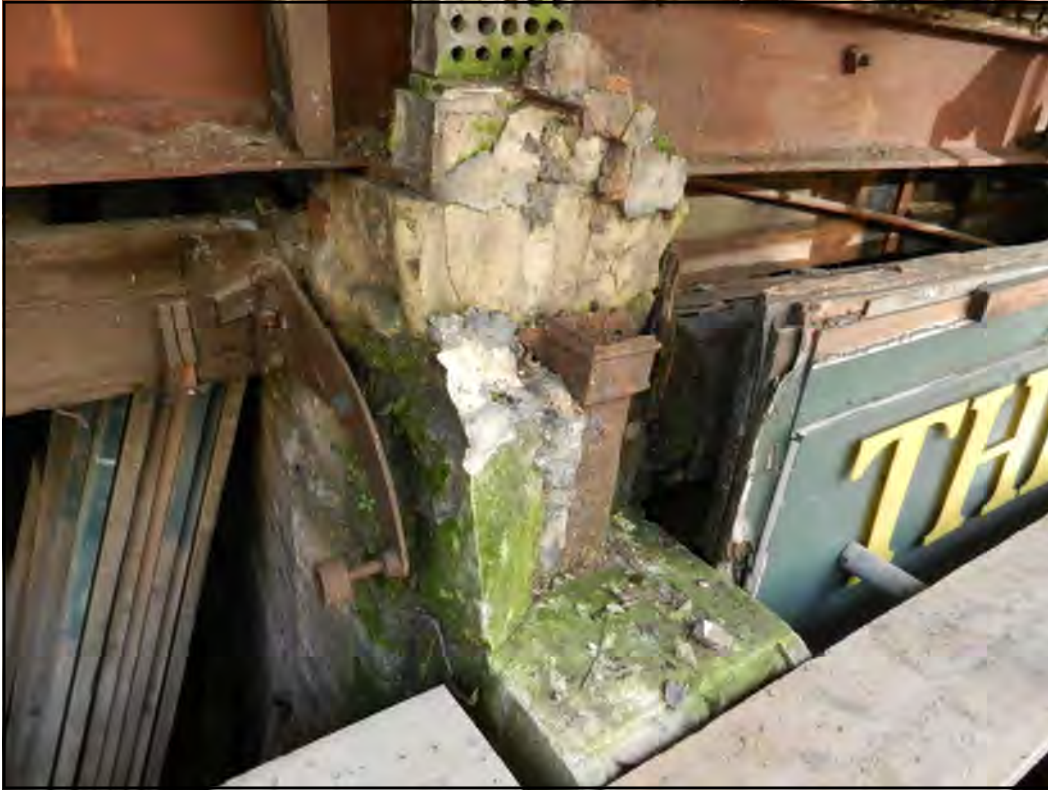
PH. N07. Natural Bath stone ground level pilasters. Stonework has been damaged by corroding embedded downpipes and inappropriate cement mortar repairs.

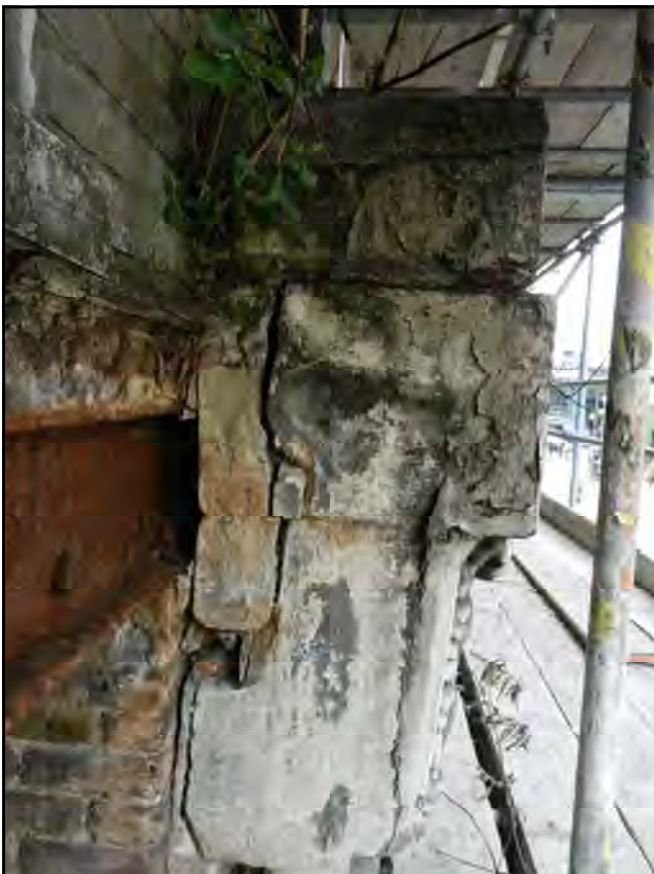
PH. N08. Top section of pilaster fractured and displaced. Carved detailing painted and mortar repaired.

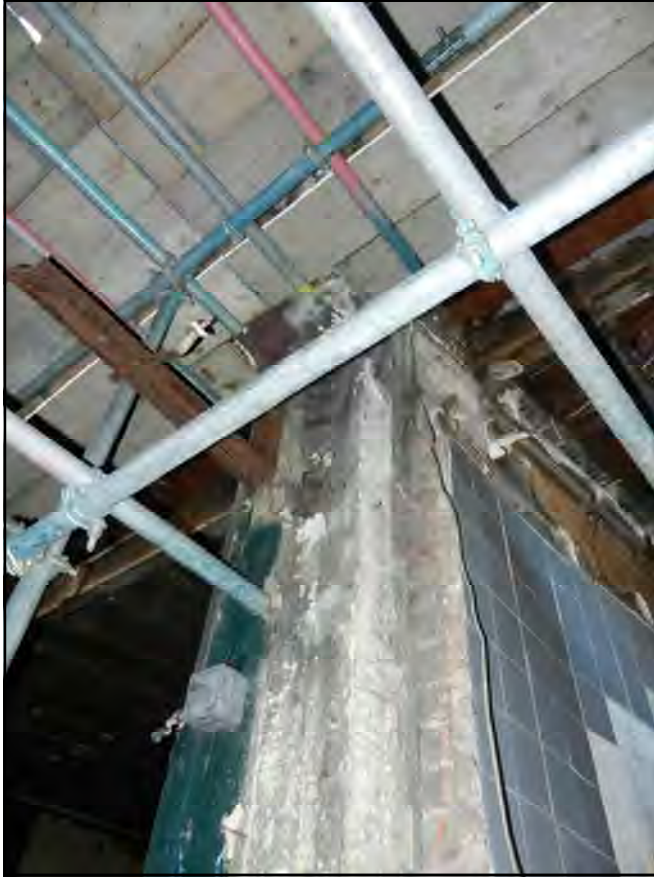
PH. N09. Lower section of pilaster which has been previously cut and altered to accommodate a change in shopfront.

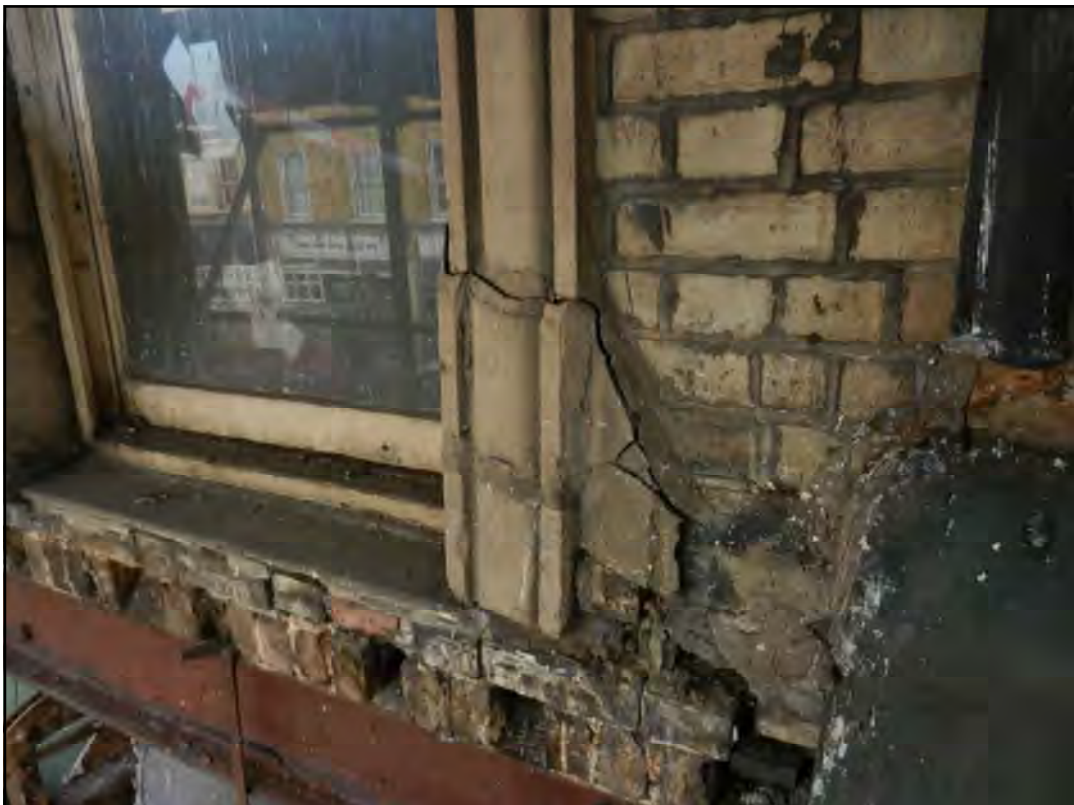
PH. N010. Moulded stucco window surrounds loose and de-bonded from the brick substrate. Carefully remove and repair to match original detailing.

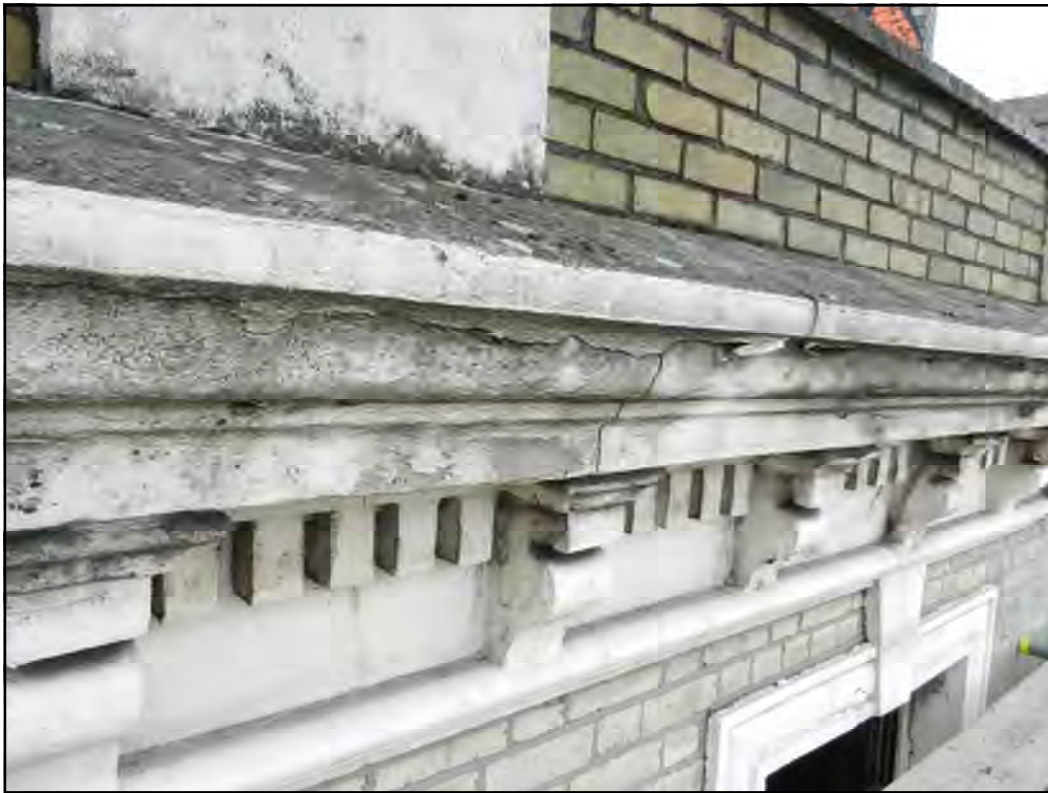
PH. S01. Cement mortar repair to upper cornice loose and de-bonding from the original substrate, continuous fracture through nosing. Remove complete and repair.

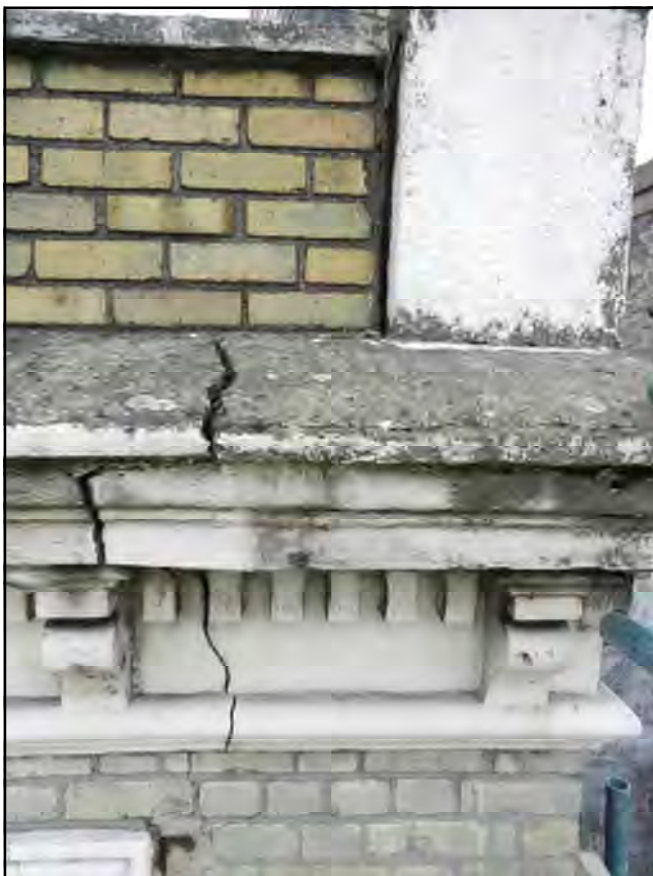
PH. S02. Significant fracture and displacement of stucco cornice. Carefully take down and re-build incorporating pre-cast corbel and dentil blocks

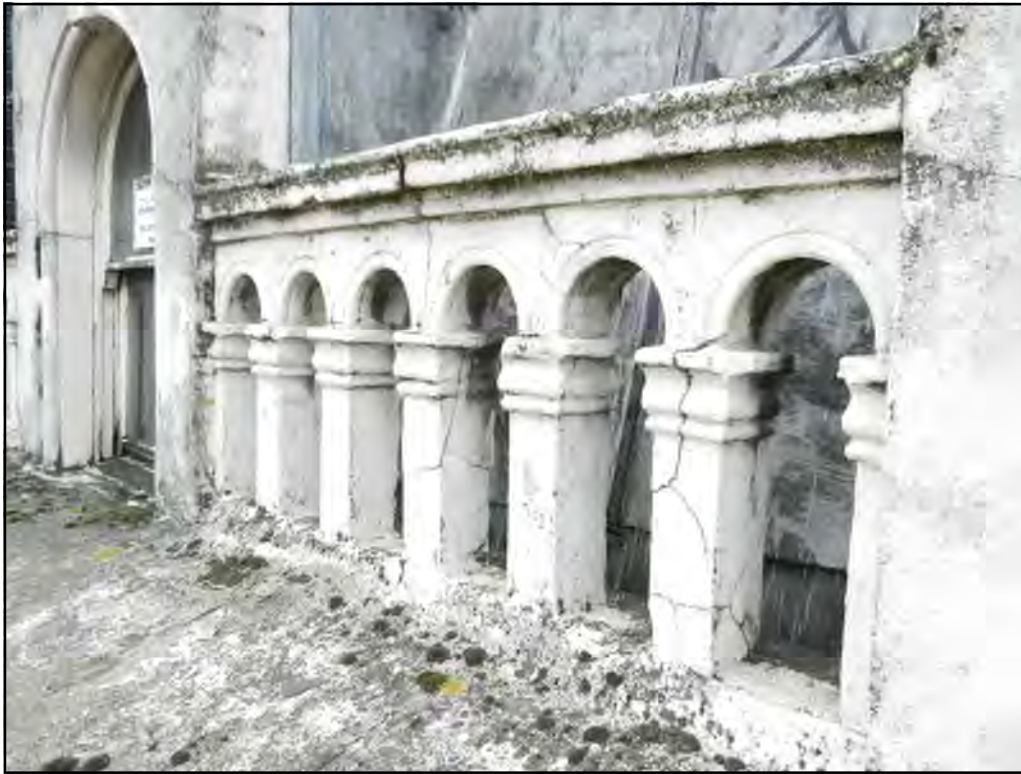
PH. S03. Sections of balustrade are fractured and extensively eroded. Remove and replace using pre-cast units.

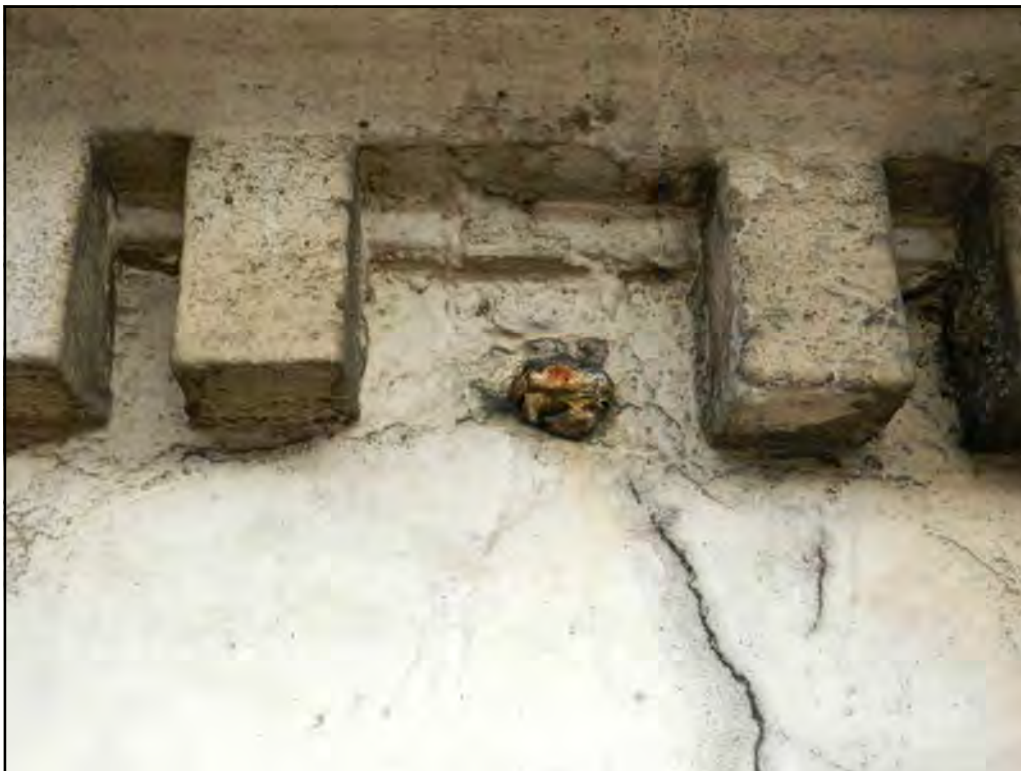
PH. S04. Dentil blocks missing from cornice damaged due to corrosion of embedded fixing dowel. Cut out corroded fixing and replace with new pre-cast block secured using stainless steel threaded rod.

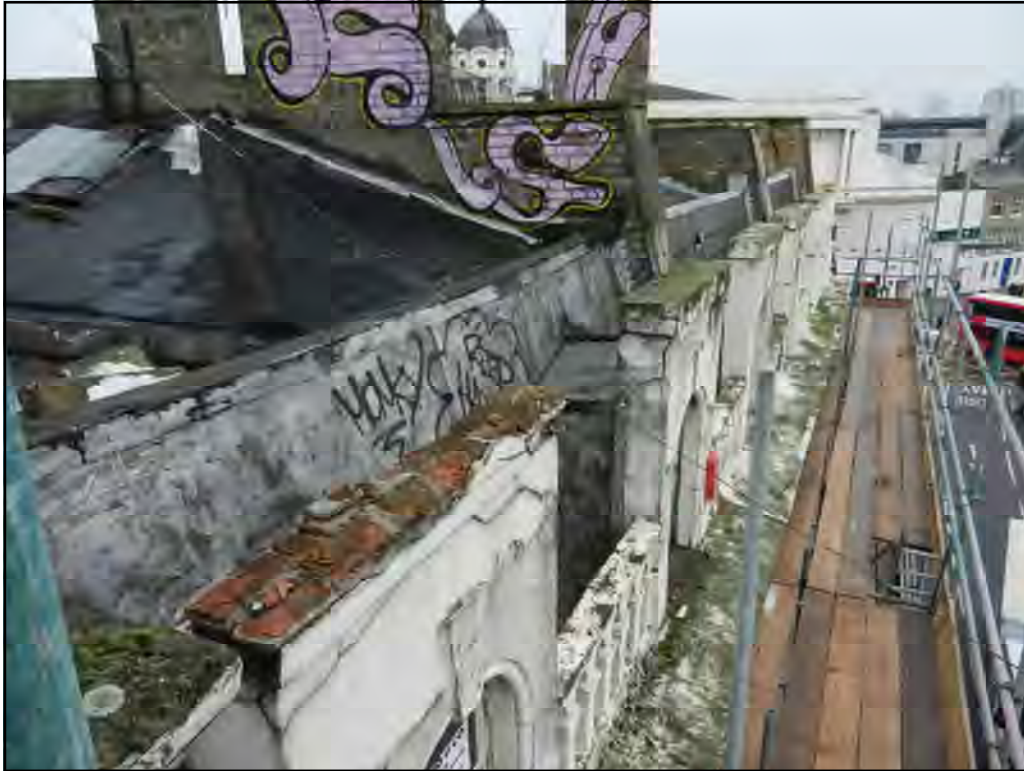
PH. S05. Dormer windows render loose and de-bonding, brickwork substrate frost damaged. Take down and re-build
