LIGHTHOUSE BLOCK KINGS CROSS

FAÇADE CONDITION SURVEY REPORT

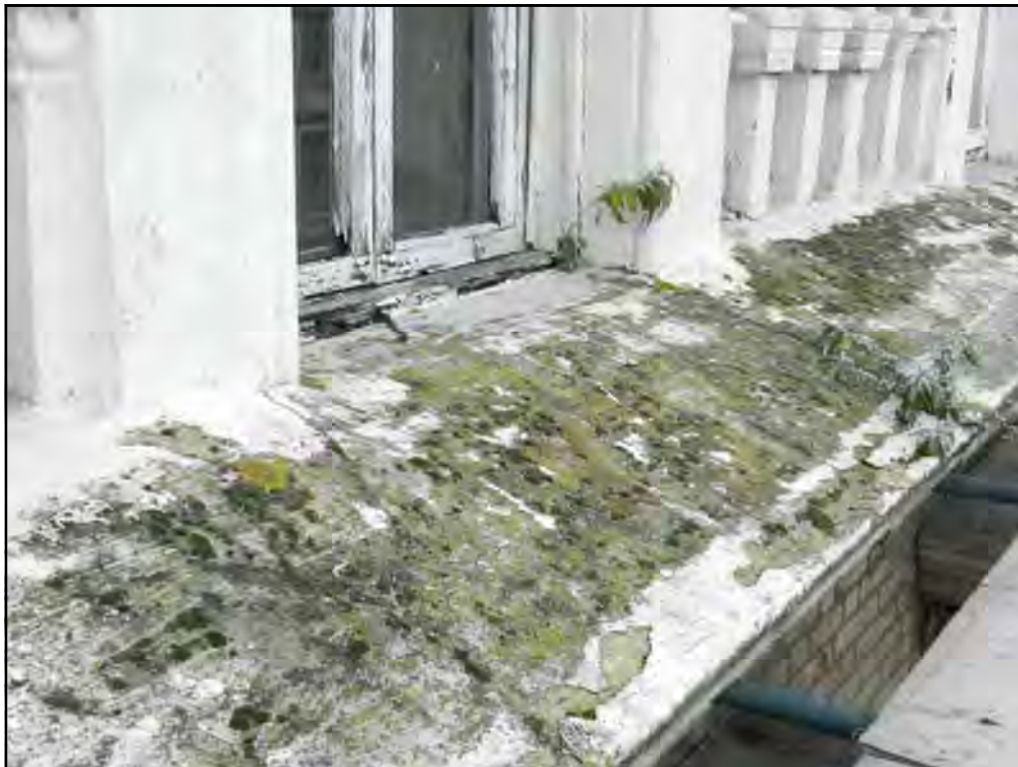
PH. S06. Cement mortar repair to lower cornice loose and de-bonding from original substrate, fracture through nosing, downpipe outlets blocked, weathering detail to window sills ineffective. Remove complete, repair substrate and revise weathering detail.

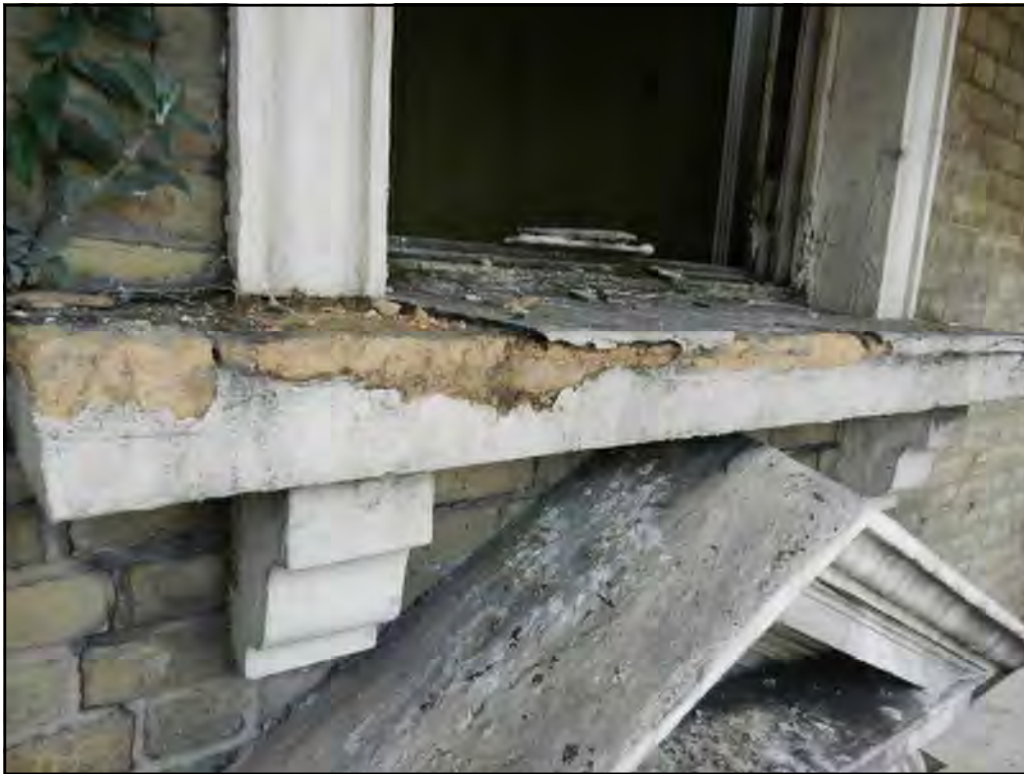
PH. N07. All natural Bath stone window sills cement mortar repaired. Repairs are loose and failing. Remove mortar and assess condition of exposed stone for most appropriate option on repair or replacement.

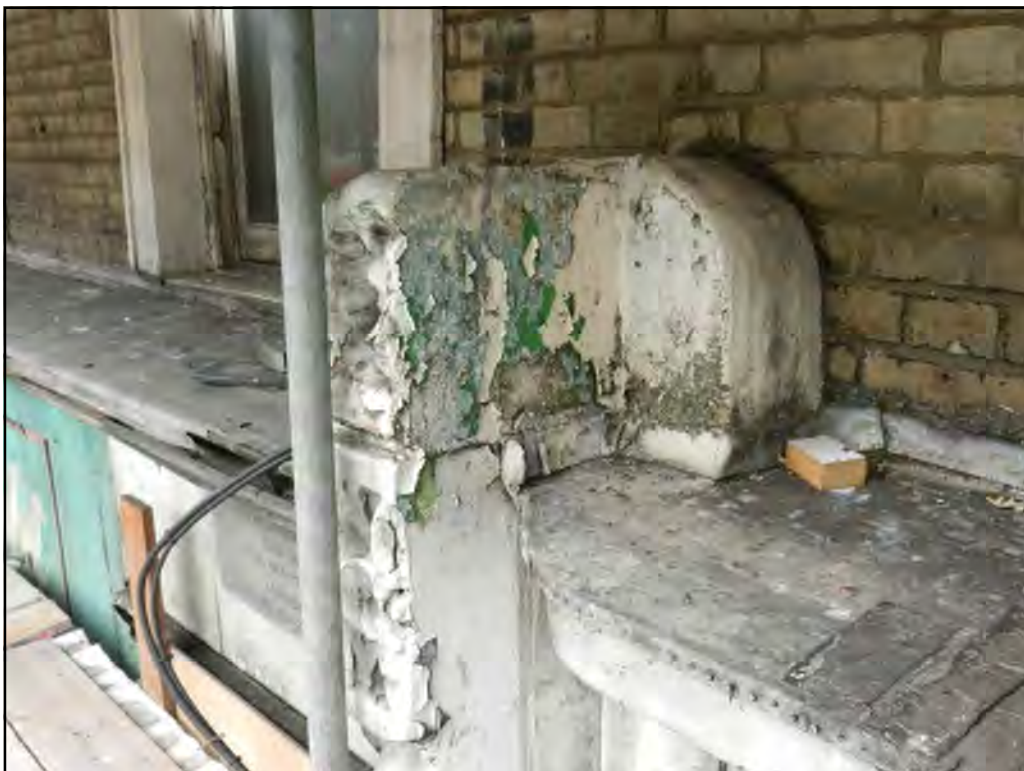
PH. N08. Natural Bath stone pilasters have been dramatically altered to accommodate previous change in shopfront. Remove and replace with new to match original carved detailing.

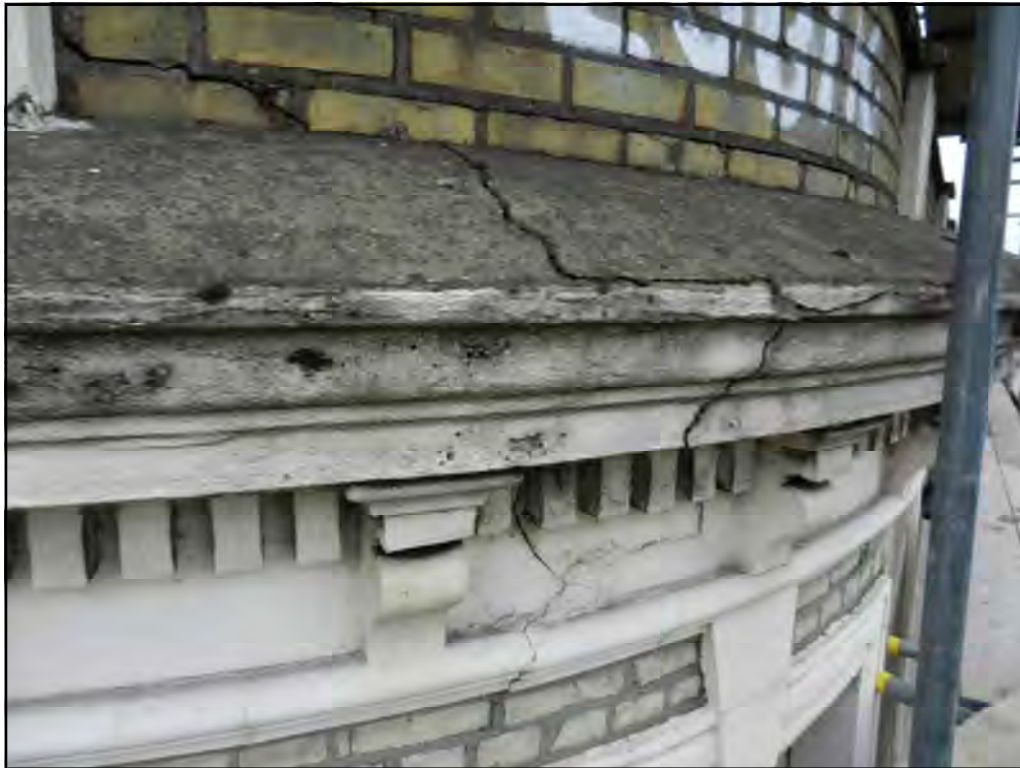
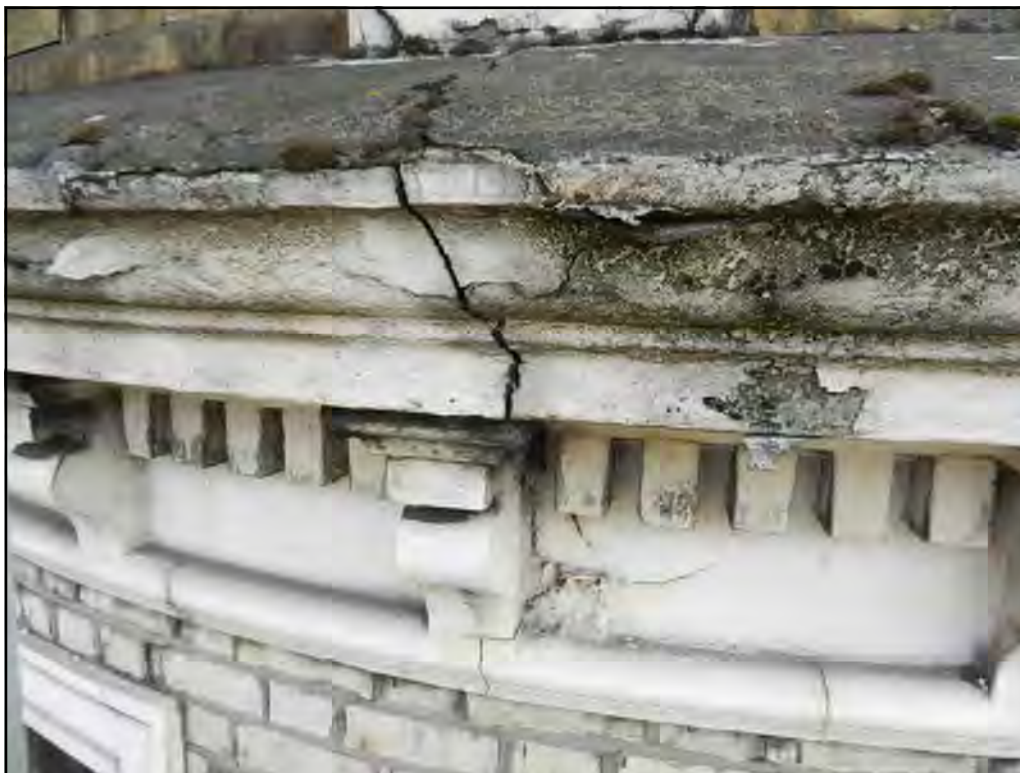
PH. EW01 EW02. Significant fractures through upper cornice and parapet wall possibly due to thermal movement. Replace and repair sky surface and nosing as previous. Introduce control measures as necessary in accordance with structural engineers specification to prevent further possible movement.

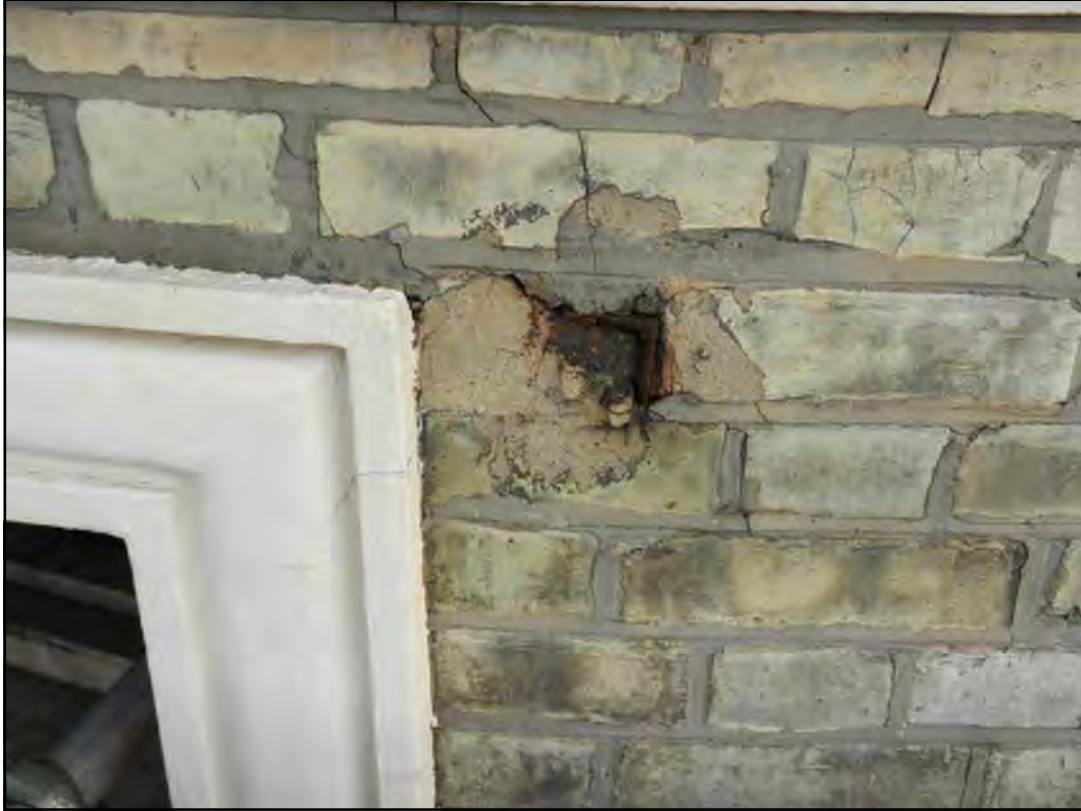
PH. EW03. Corroding sections of embedded steel and redundant fixings are causing damage to brickwork and stucco. Carefully cut out and repair using new matching bricks and stucco render
