HILL GARDEN PERGOLA OAK FRAMEWORK
Photos of Colonnade as Existing

HILL GARDEN PERGOLA OAK FRAMEWORK

Photos of oak frame and stone capitals defects

2253-01/05/03
April 2016

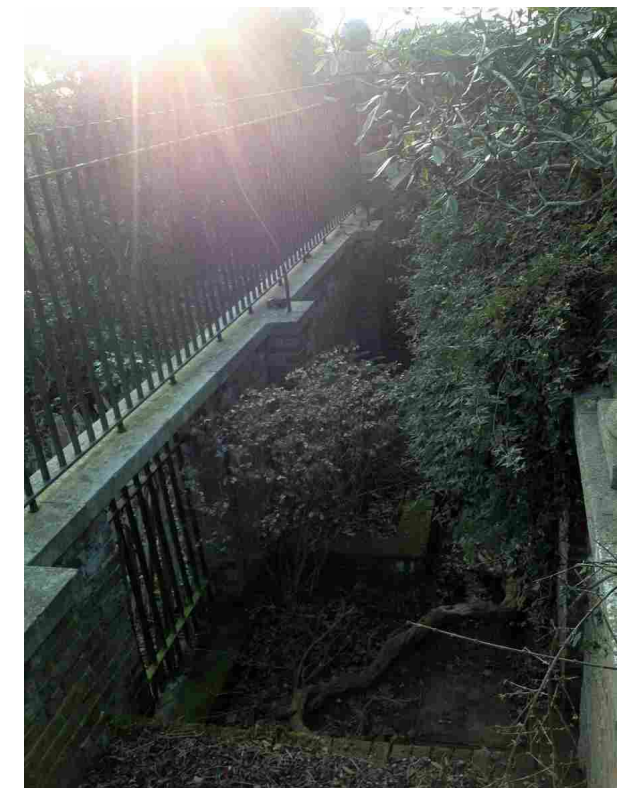
Photo showing vegetation in area South of Belvedere, between Colonnade steps and railings

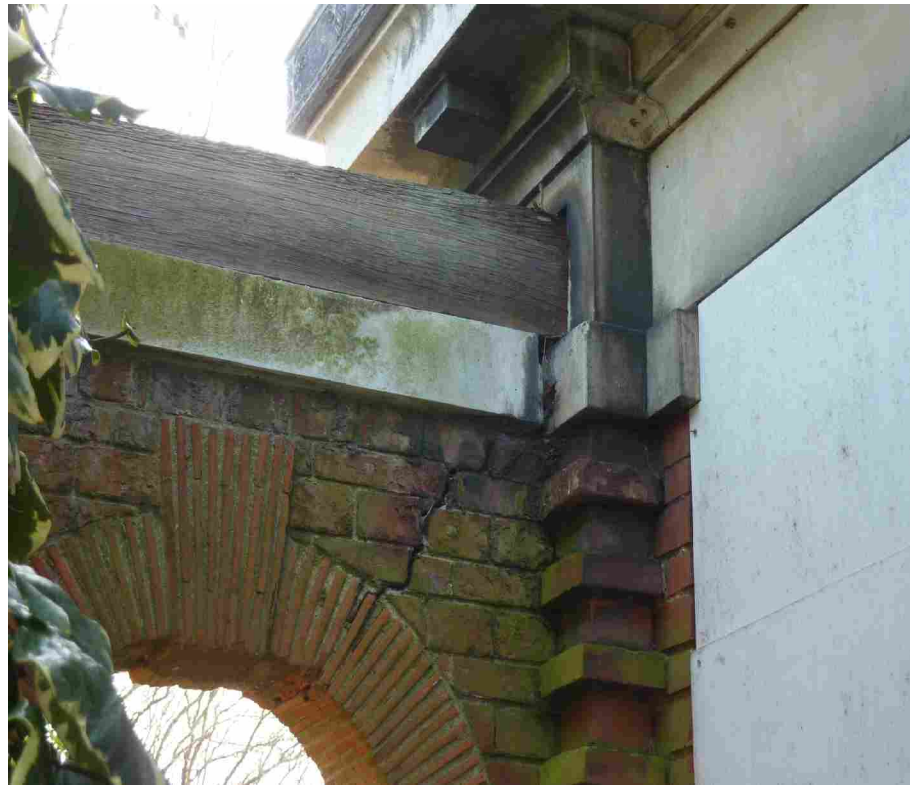
Photo showing primary timber frame connection to Belvedere wall
*note crack on stone cornice and brick masonry below

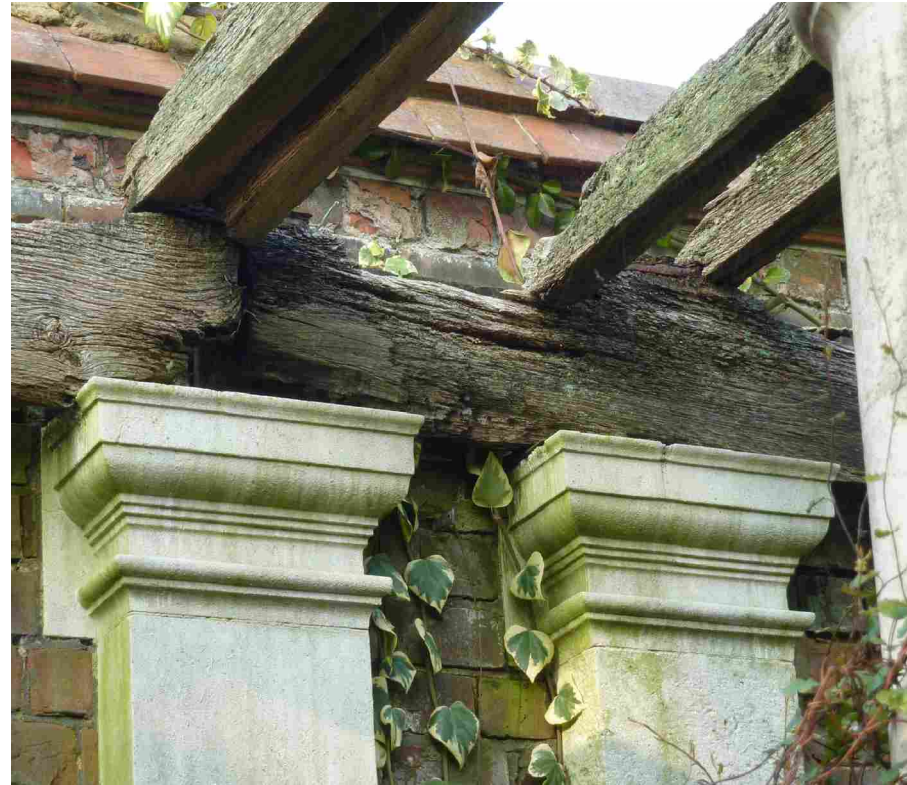
Photo showing timber decay to primary and secondary frame along
North boundary brick wall

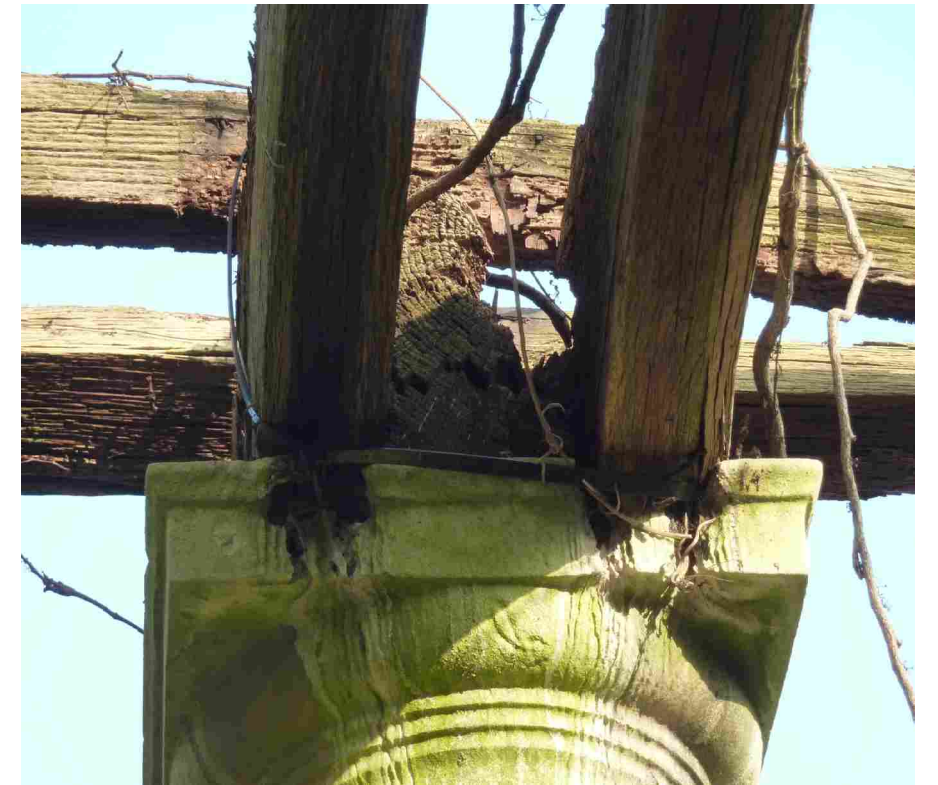
Photo showing timber decay to primary and secondary frame and
stone capital corrosion

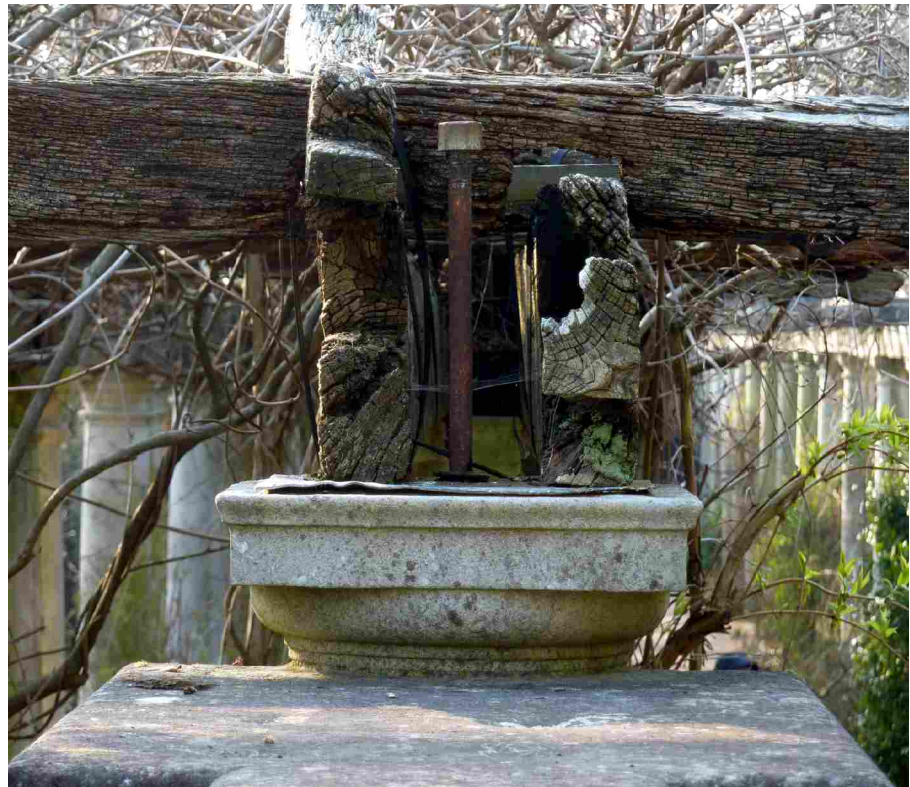
Photo showing timber decay to primary and secondary frame,
rusted iron bolt and inadequate lead sheet above capital

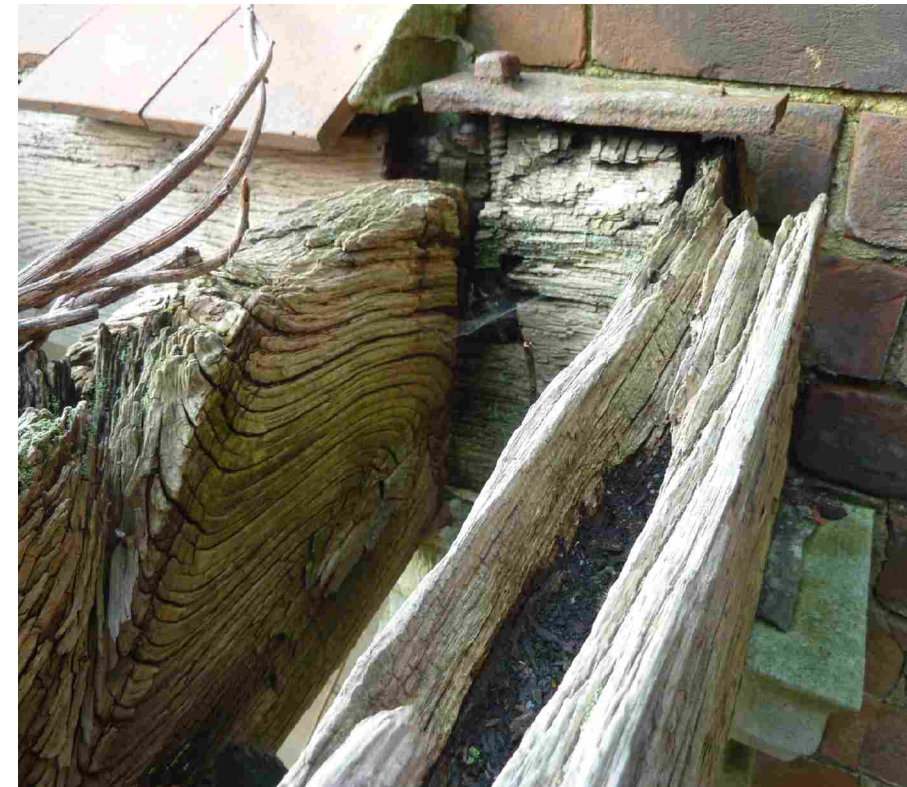
Primary oak frame decay at North-East end corner of Colonnade

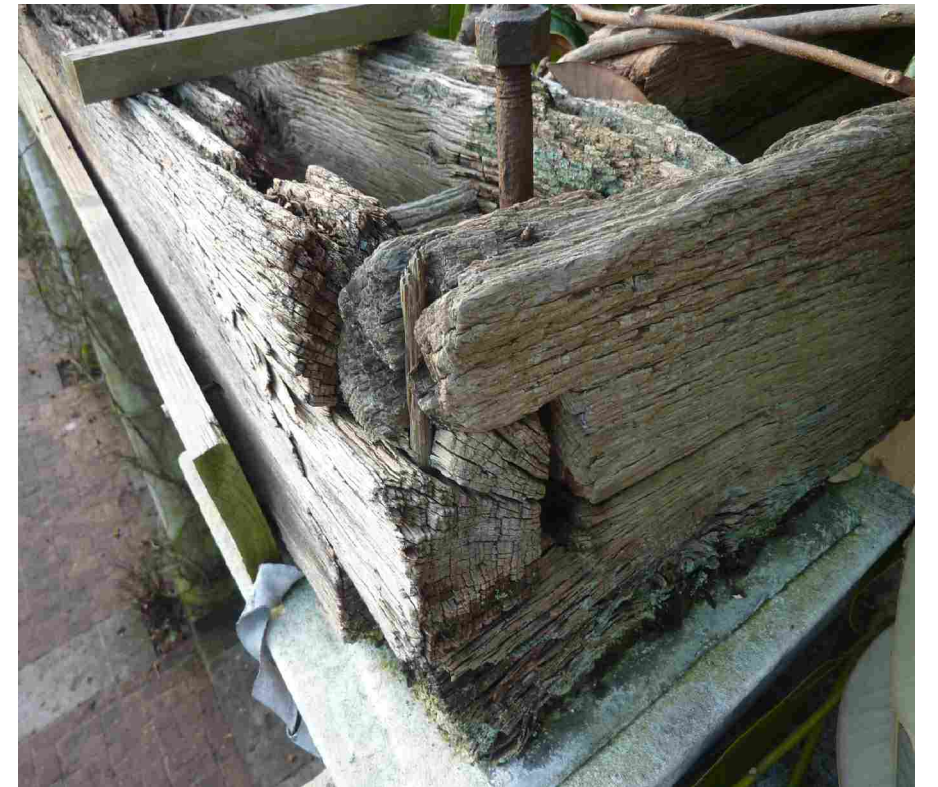
Primary oak frame decay at South-East end corner of Colonnade
