### **TECHNICAL NOTE**

**The geological and hydrological implications of the eye-witness evidence provided by David Harries who saw the aftermath of the Air Studios flooding by groundwater of July 1991.**

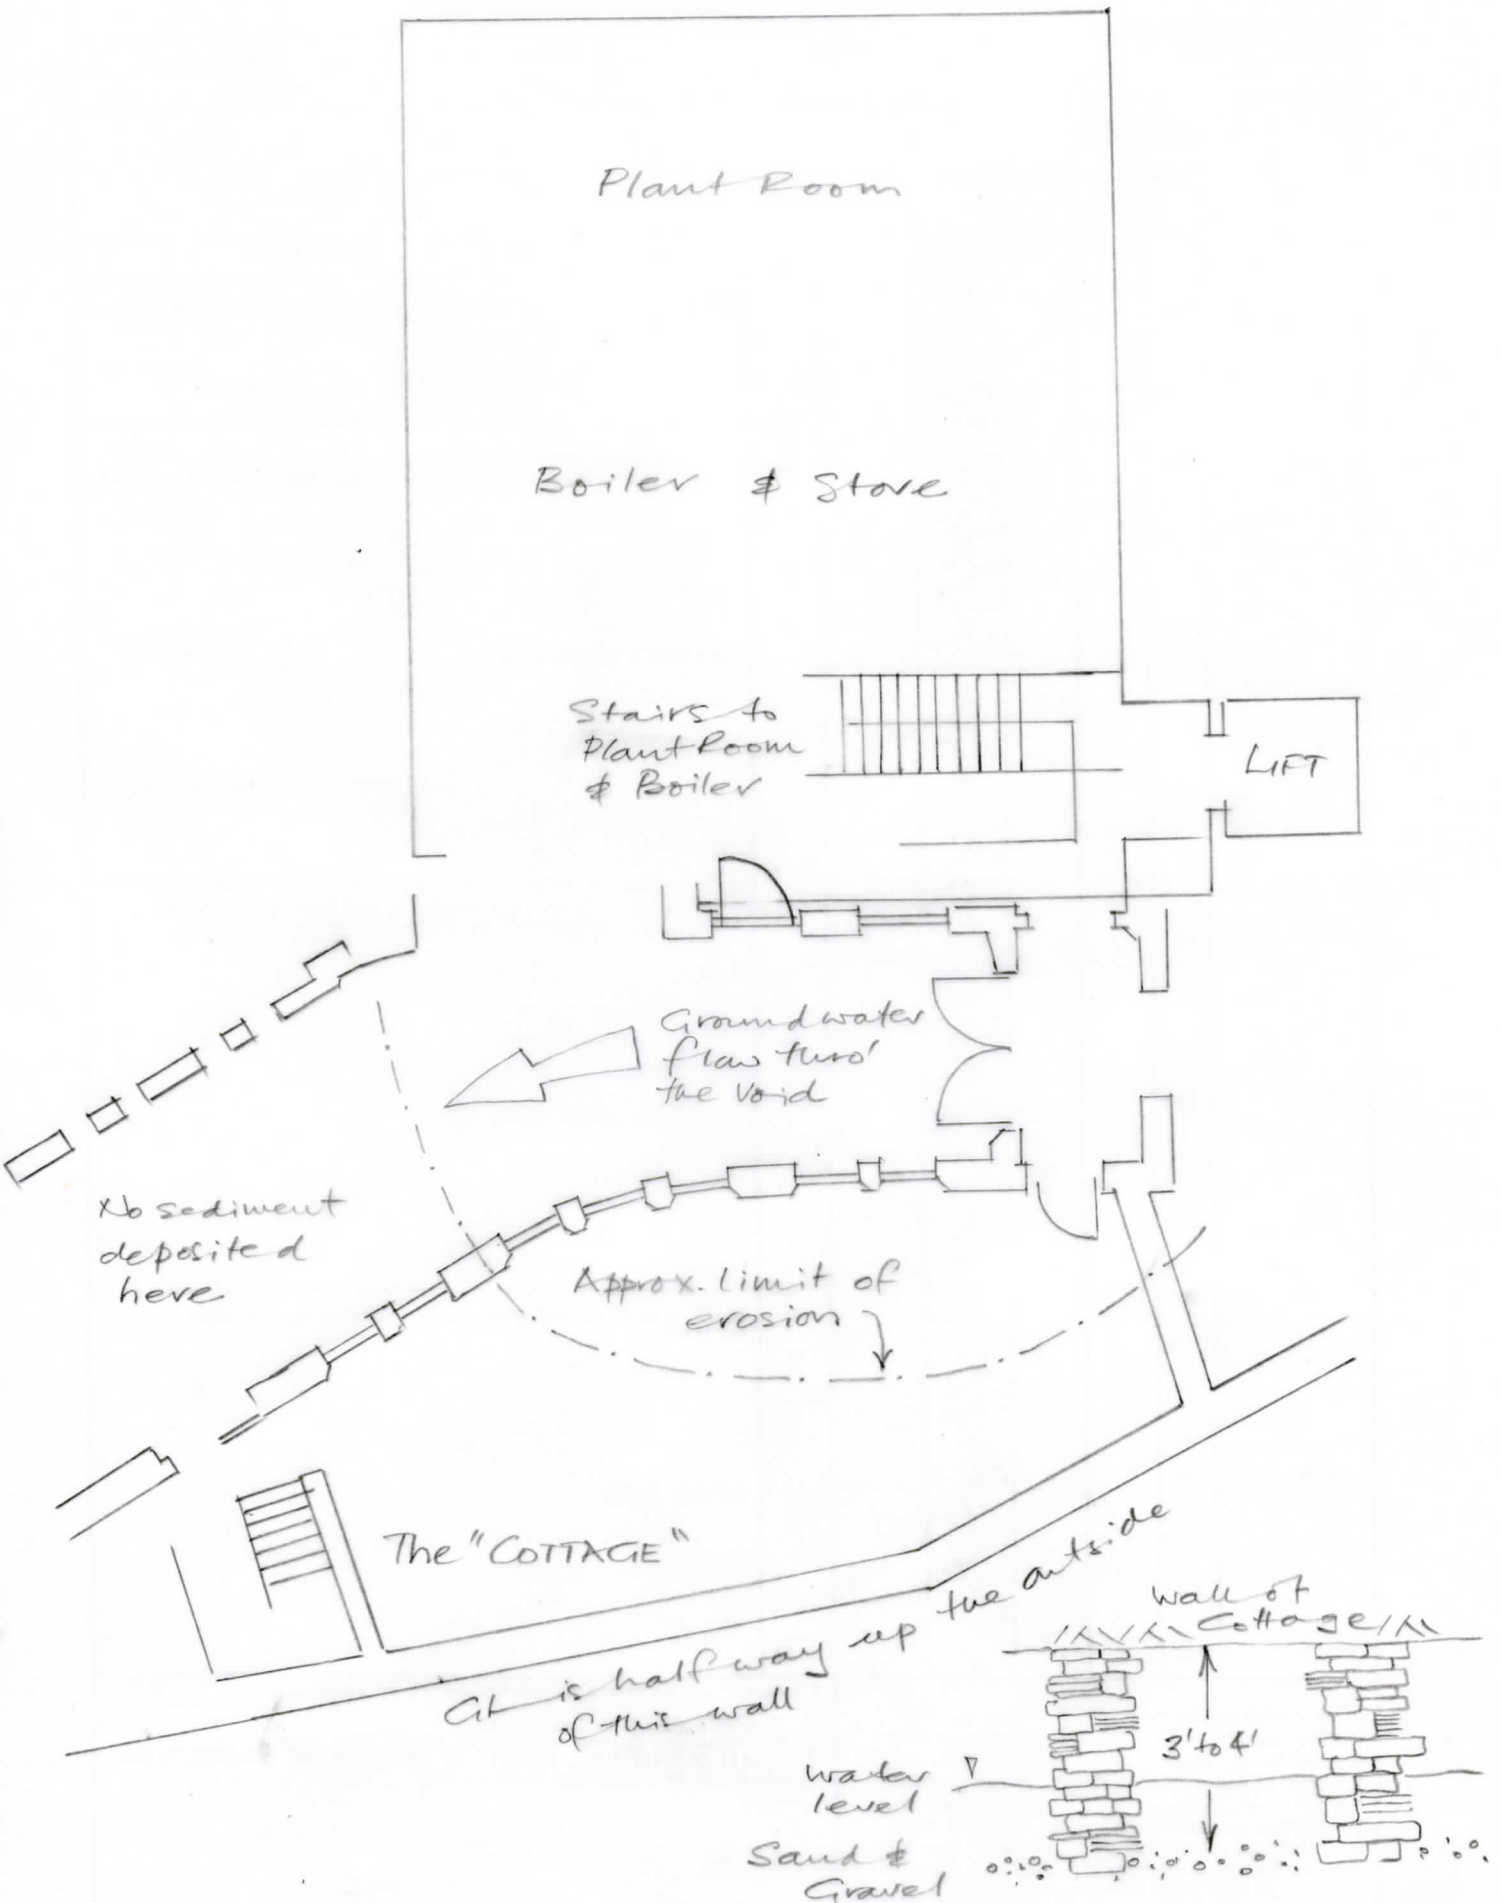
Traced from Herbert Perry & Parker  
 Drwg 672 Oct 1989

The opportunity was also taken to read with Mr Harries the Minutes of site meetings of the time to remind him as far as possible of details that may have been forgotten. Fig.1 illustrates the descriptive parts of the conversation.

3. The walls for the basement for the Plant Room and Boiler etc (Fig.1) were complete and the floor had its reinforcing bars in place ready for a pour on the morning of the 31<sup>st</sup> July. Up until that time groundwater had not been a problem; i.e. it was controllable from sump pumping whilst each panel had been excavated; the basement walls underpinned those of the building above. A borehole (almost certainly shell and auger, and dated 14.02.91) had been drilled to assess the ground conditions and recorded 1.3m of Made Ground (silty clay with flint gravel) over weathered London Clay. No water was recorded *“during the short time the hole was open”* (quote from BH log). Formation level for the basement was approximately 4.5m below ground level and thus within the weathered London Clay, (Fig.2).

5. That appears to be the situation immediately prior to the inrush. When Mr Harries arrived the next morning he saw the void, the lake within it, water moving through the lake and the Cottage standing on brick stilts. These stilts were of bricks and tiles and had a most irregular profile (Fig.1).

6. Mr Harries described the approximate limits of the void eroded from beneath the Cottage and what is now the Reception (10m long x 4m wide x 1.5m deep; Fig.1 ) and these give an approximate volume of 60m<sup>3</sup>. None of this material was seen outside the building – it had not washed away out of what is now the front door and down the hill towards Pond Street. The void contained groundwater which could be seen flowing from the area of the lift towards the front door, but in the ground. Water level was below ground level but above the base of the void. Samples of water revealed it contained traces of sewage; i.e. it was a mixture of pure ground water and leaking utilities.

10. There appear to be no records of the details of such a failure – if ever they were recorded, but it is also known that an arch between the Cottage and that part of the church which is now the access to the stairs to the basement (shown with the swing doors in Fig.1), dropped and had to be repaired – a repair that can still be seen; i.e. the base of the brick column upon which the arch had been sitting had been eroded. So the inrush was probably most severe towards that part of the excavation and eroded down to the top of the London Clay on which, it is presumed, the brick column was founded.
