Arboricultural Appraisal Report

Subsidence Damage Investigation at:

Somerset House
31 Dartmouth Park Hill
London
NW5 1HR

CLIENT:	Crawford & Company
CLIENT REF:	SU1505185
MWA REF:	SUB160406-614
MWA CONSULTANT:	David Mahon (B.Sc Hons MICFor MArborA)
REPORT DATE:	18-04-2016

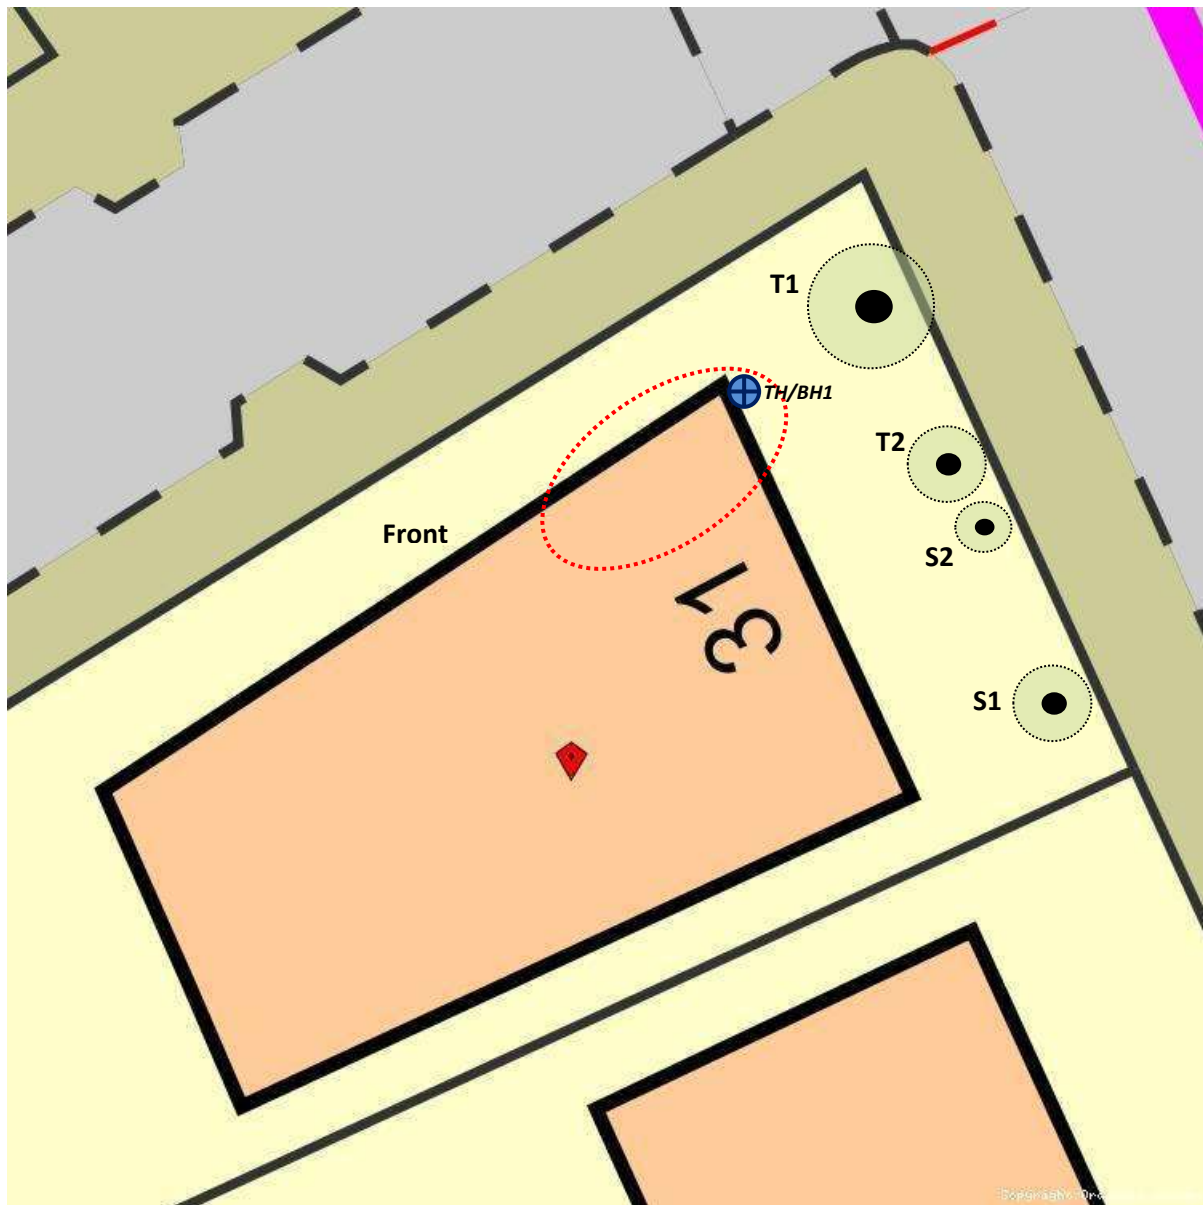
SITE PLAN

Approximate areas of damage

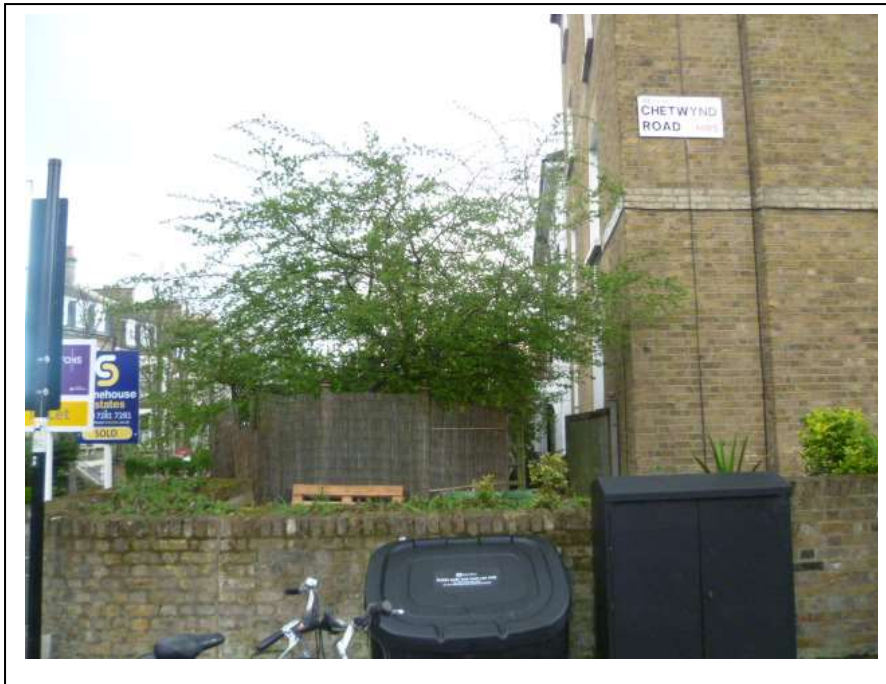
Roots were observed to a depth of 1800mm bgl in BH1 and recovered samples have been positively identified (using anatomical analysis) as Pomoideae, the origin of which will be T1 confirming its influence on the soils below the foundations.

Based on the technical reports currently available, engineering opinion and our own site assessment we conclude the damage is consistent with shrinkage of the clay subsoil related to moisture abstraction by vegetation. Having considered the available information, it is our opinion that T1 is the principal cause of the current subsidence damage. If an arboricultural solution is to be implemented to mitigate the current damage and allow the soils beneath the property to recover to a position such that an effective repair solution can be implemented we recommend that T1 is removed.

View of T1

Tree No.	Species	Ht (m)	Dia (mm)	Crown Spread (m)	Dist. to building (m)	Age Classification	Ownership
T1	Hawthorne	5.0	150	6.0	3.5	Younger than property	Policy Holder
Management history		No recent management.					
Recommendation		Remove and treat stump to inhibit regrowth

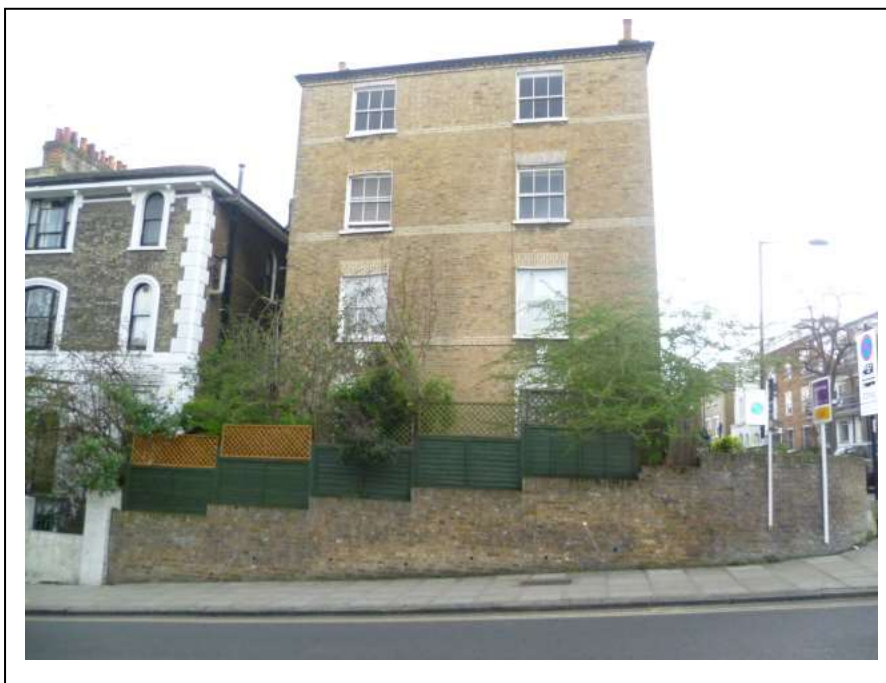
General view of vegetation

Tree No.	Species	Ht (m)	Dia (mm)	Crown Spread (m)	Dist. to building (m)	Age Classification	Ownership
S1	Elder	5.5	100	6.0	2.5	Older than property	Policy Holder
Management history		No recent management.					
Recommendation		Remove					
T2	Prunus	5.5	<70	2.0	3.5		Policy Holder
Management history		Very small crown. Young tree.					
Recommendation		Do not allow to exceed current dimensions					
S2	Bamboo	2.5	<70	2.5	3.5		Policy Holder
Management history		No recent management.					
Recommendation		Do not allow to exceed current dimensions
