TECHNICAL REPORT ON A SUBSIDENCE CLAIM

Crawford Reference: SU1505185

**Deauville Securities Limited
Somerset House
31 Dartmouth Park Hill
London
NW5 1HR**

SUBSIDENCE CLAIM

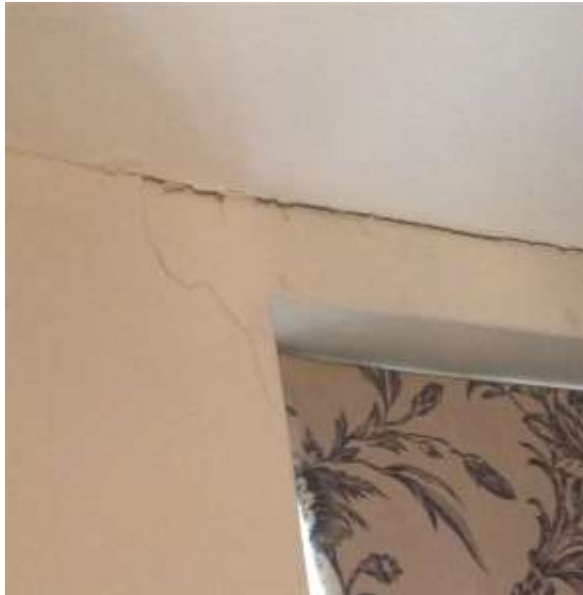
Cracking in lounge above window

Hairline diagonal crack above window opening.

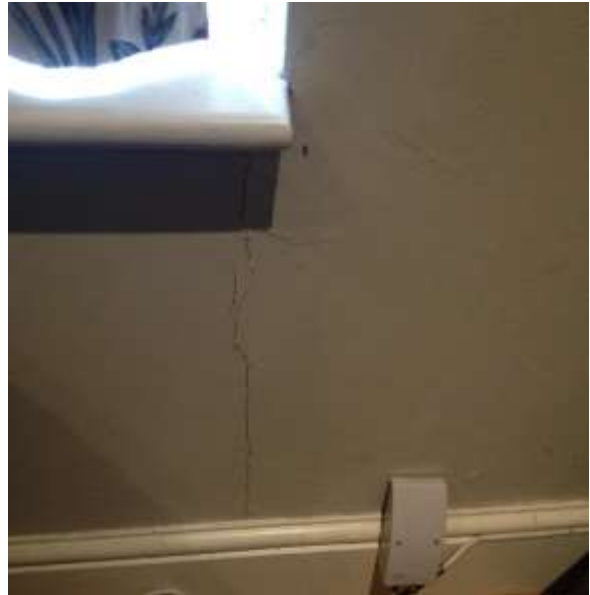
Cracking in lounge below window

1mm vertical crack below window opening mirroring external vertical crack.

Rucking of lining paper below window opening mirroring external diagonal crack.

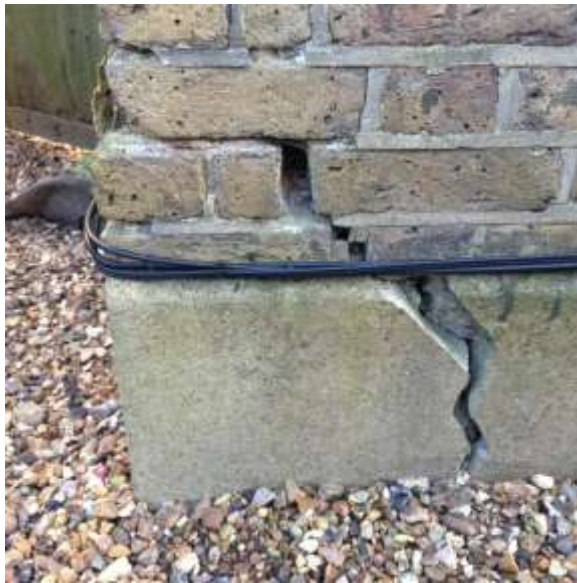
Cracking to front left corner

Tapering diagonal crack up to 20mm in width to front left hand corner of building extending from ground level.

In structural terms the damage falls into Category 4 of Table 1, Building Research Establishment⁶ Digest 251, which describes it as "severe".

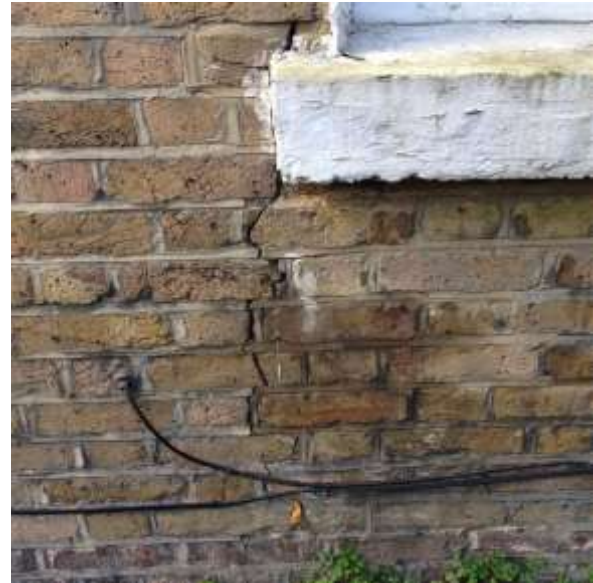
Cracking below lounge window

1mm diagonal crack below ground floor lounge window opening.

4mm vertical crack below ground floor lounge window opening.

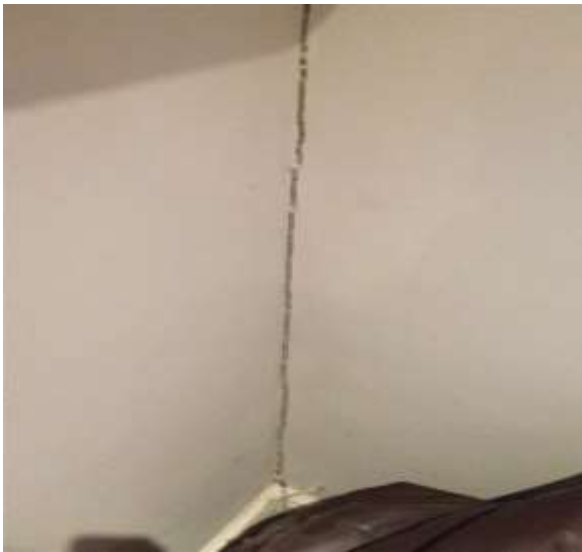
5mm tapering separation at abutment of external left hand wall and internal cross wall.

Cracking to wall junction in lounge

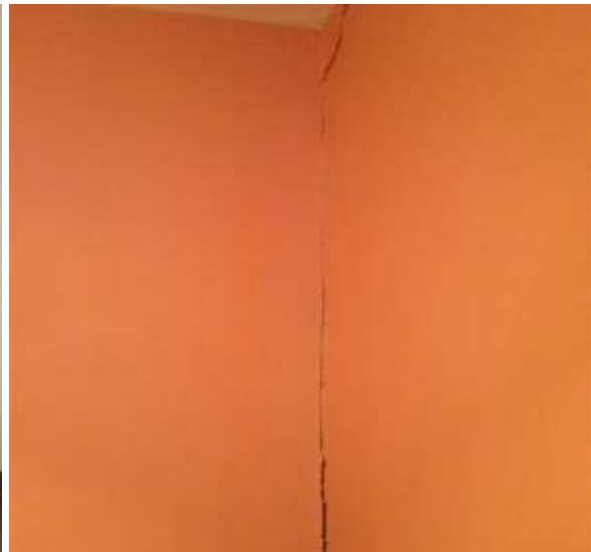
5mm tapering separation at abutment of external left hand wall and internal cross wall.

Cracking to wall junction in bedroom

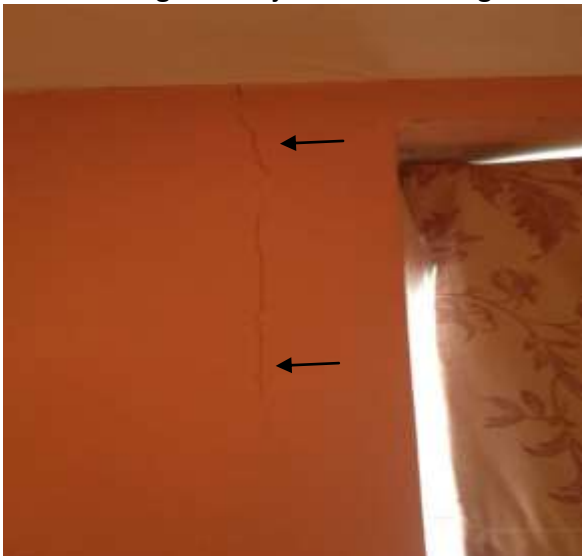
1mm vertical crack above window opening.

Cracking above window to bedroom

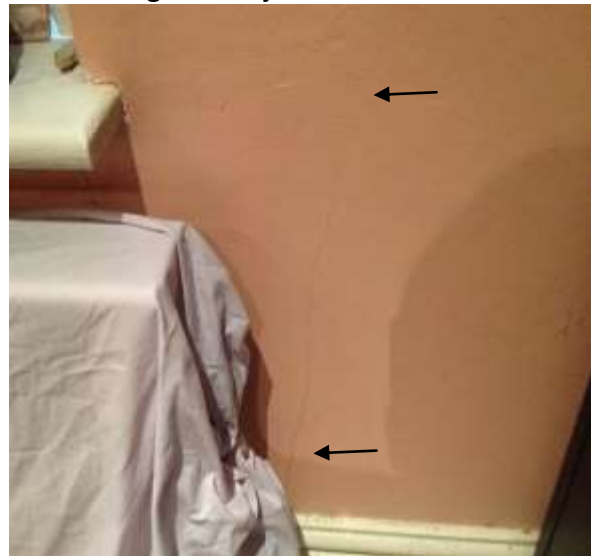
Hairline diagonal crack below window opening.

Cracking below window to bedroom

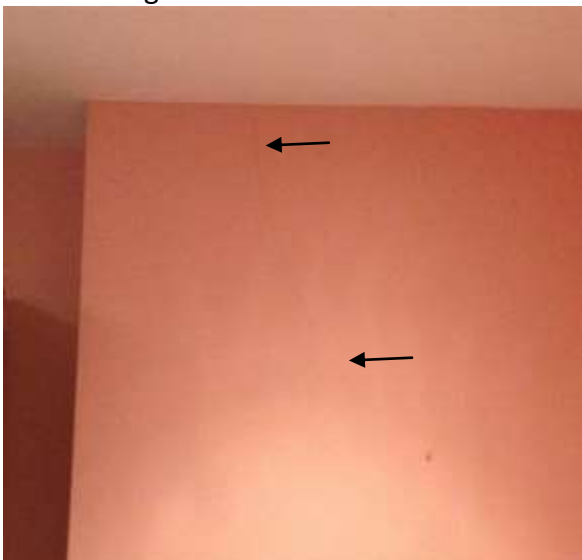
Hairline diagonal crack to chimney breast.

Hairline cracking to chimney breast

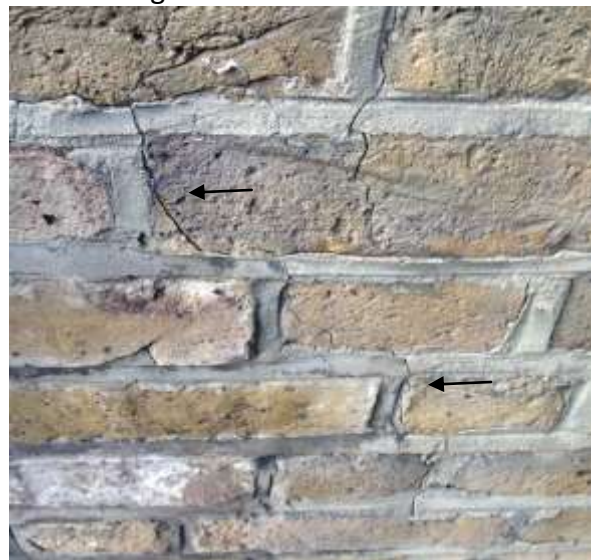
Cracking below lounge window

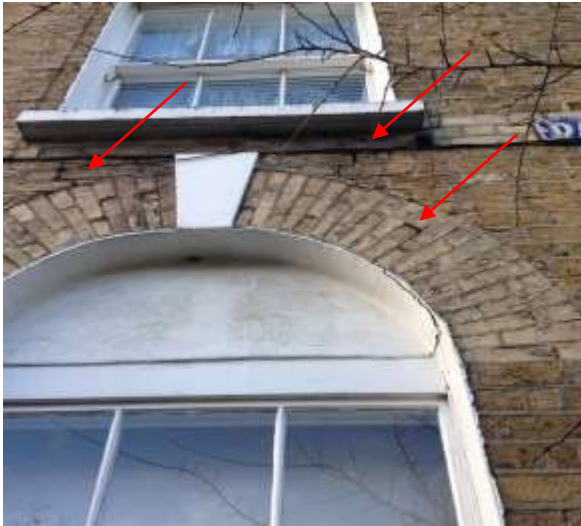
5mm stepped diagonal cracking above either side of arch to lounge window opening.

Cracking above arch to lounge

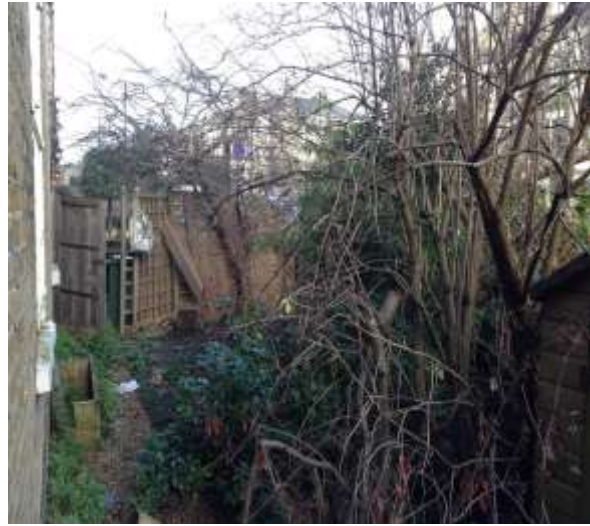
Type	Height	Distance	Ownership
Deciduous	5 m	2 m	Owners
Deciduous	3 m	2 m	Owners

Vegetation to left
