## SITE INVESTIGATION FACTUAL REPORT

Report No: 311290  
Client: Crawford Claims Management  
Site: Somerset House, 31 Dartmouth Park Hill

Client Ref: SU1505185-  
Date of Visit: 01/02/2016

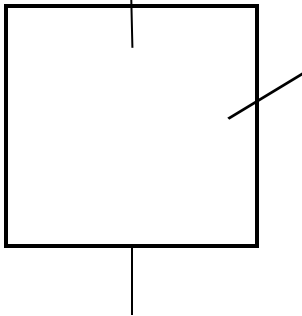
M/H: 1 Depth: 870mm

Chamber Dimension (mm): 450 X 600

As built
