Langland Mansions 228 Finchley Road, London NW3 6QA

BRIEFING NOTE

(23/02/2016)

Ref: 966

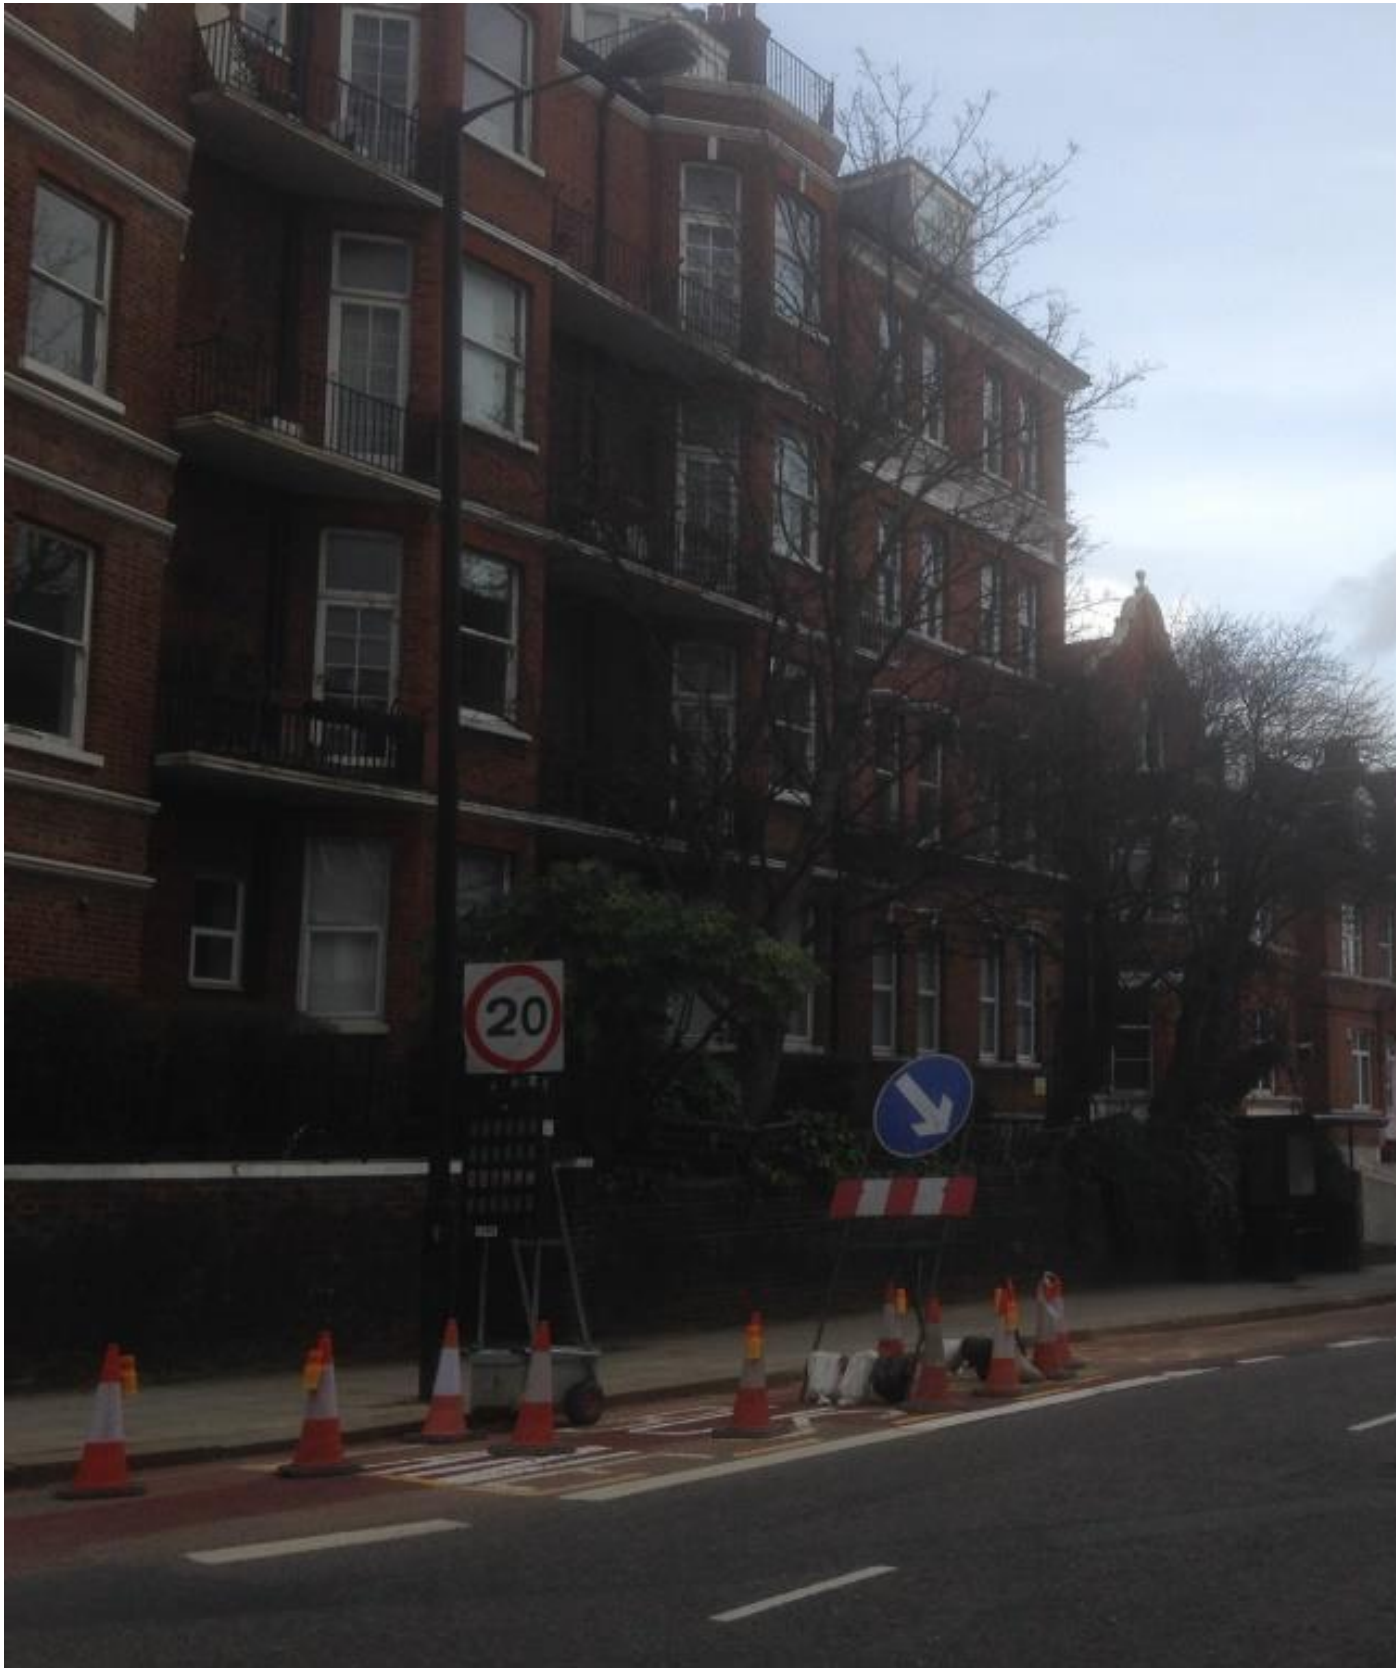
3.1 Fatsia T1: Although the law does not strictly define a tree, in our opinion in contrast to the trees T2-T5, T1 is merely a large C-grade shrub that provides only limited (not "a high level of") PVA (see photo no. 1 and 2). Looking at the Camden Council TPO informative No. 2 is difficult to see how pruning works to this large shrub could be (a) carried out in line with BS:3998 (2010) and moreover (b) how these works (quality of) could be enforced by Camden Council.

Photo No 1. To show the small insignificant Fatsia T1 contrasting with the larger more significant trees (T2-T5).

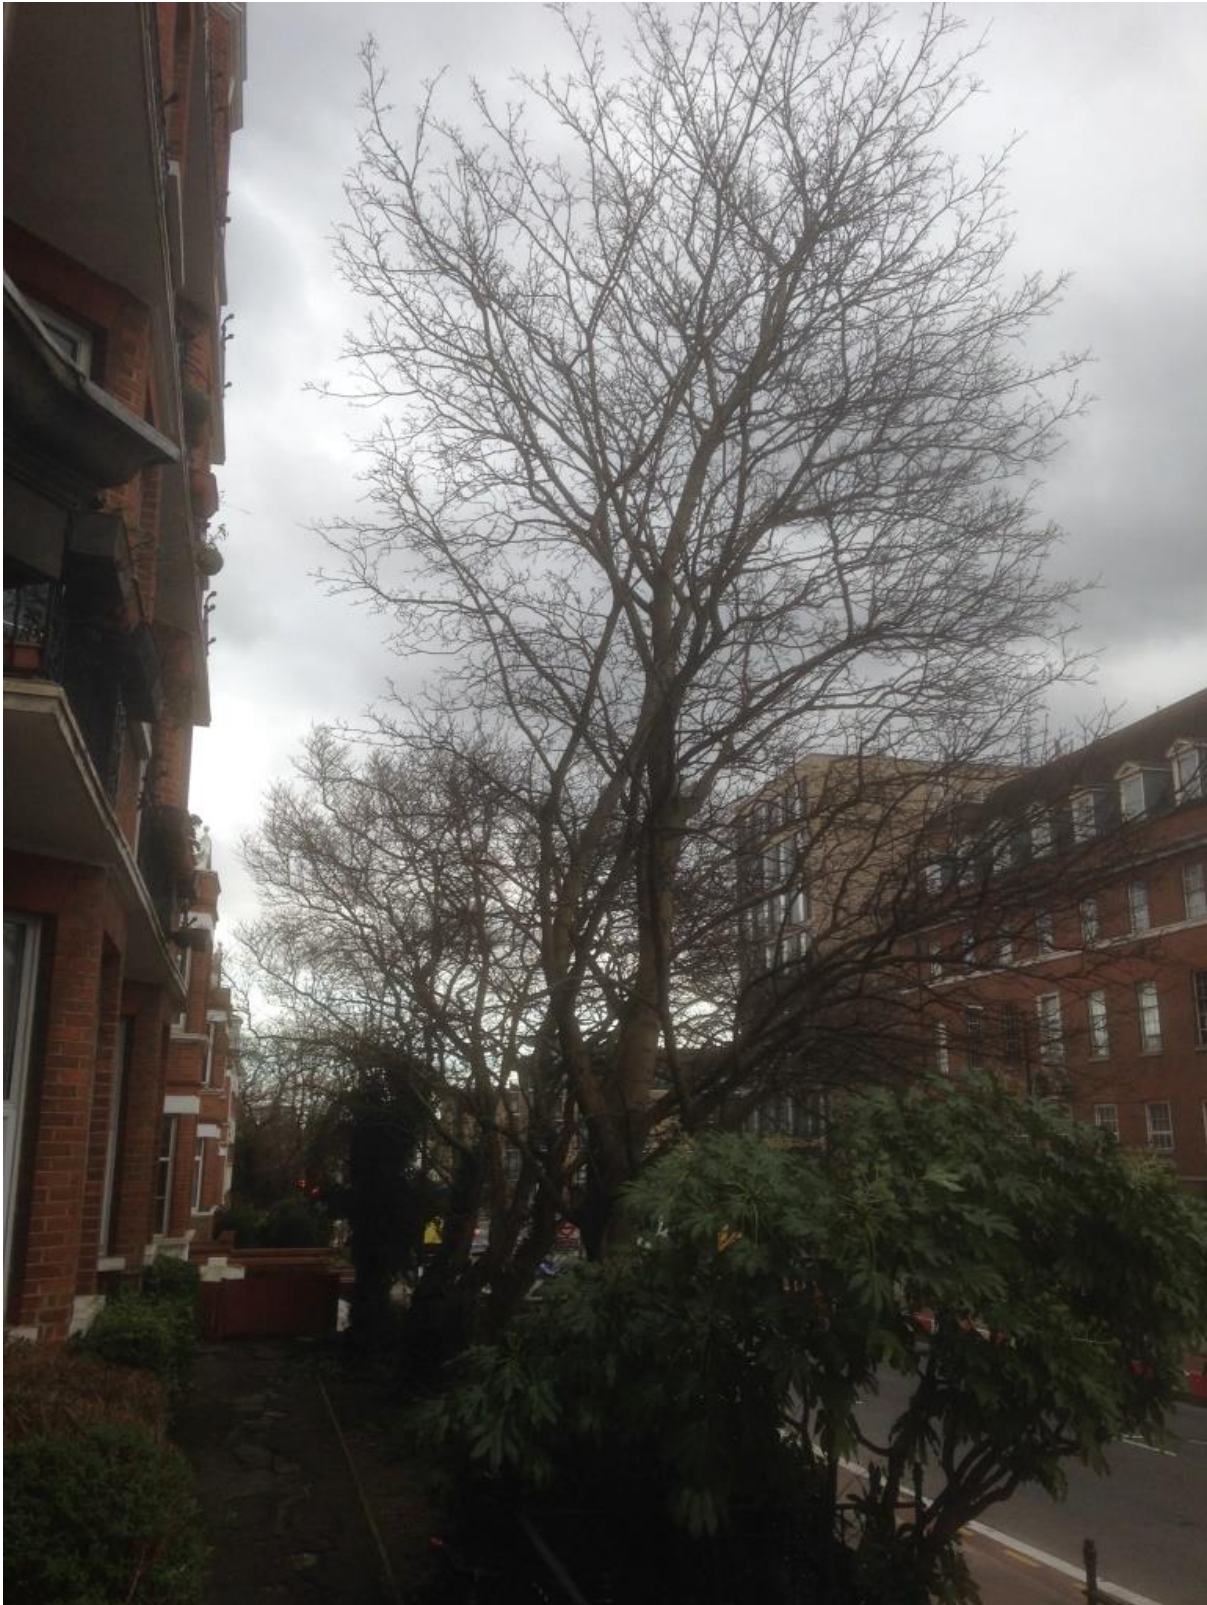
Photo No 2. To show the small insignificant Fatsia T1 contrasting with the larger more significant trees (T2-T5). Note the unbalanced crown on T2 growing away from the mansion block and towards/over Finchley Road

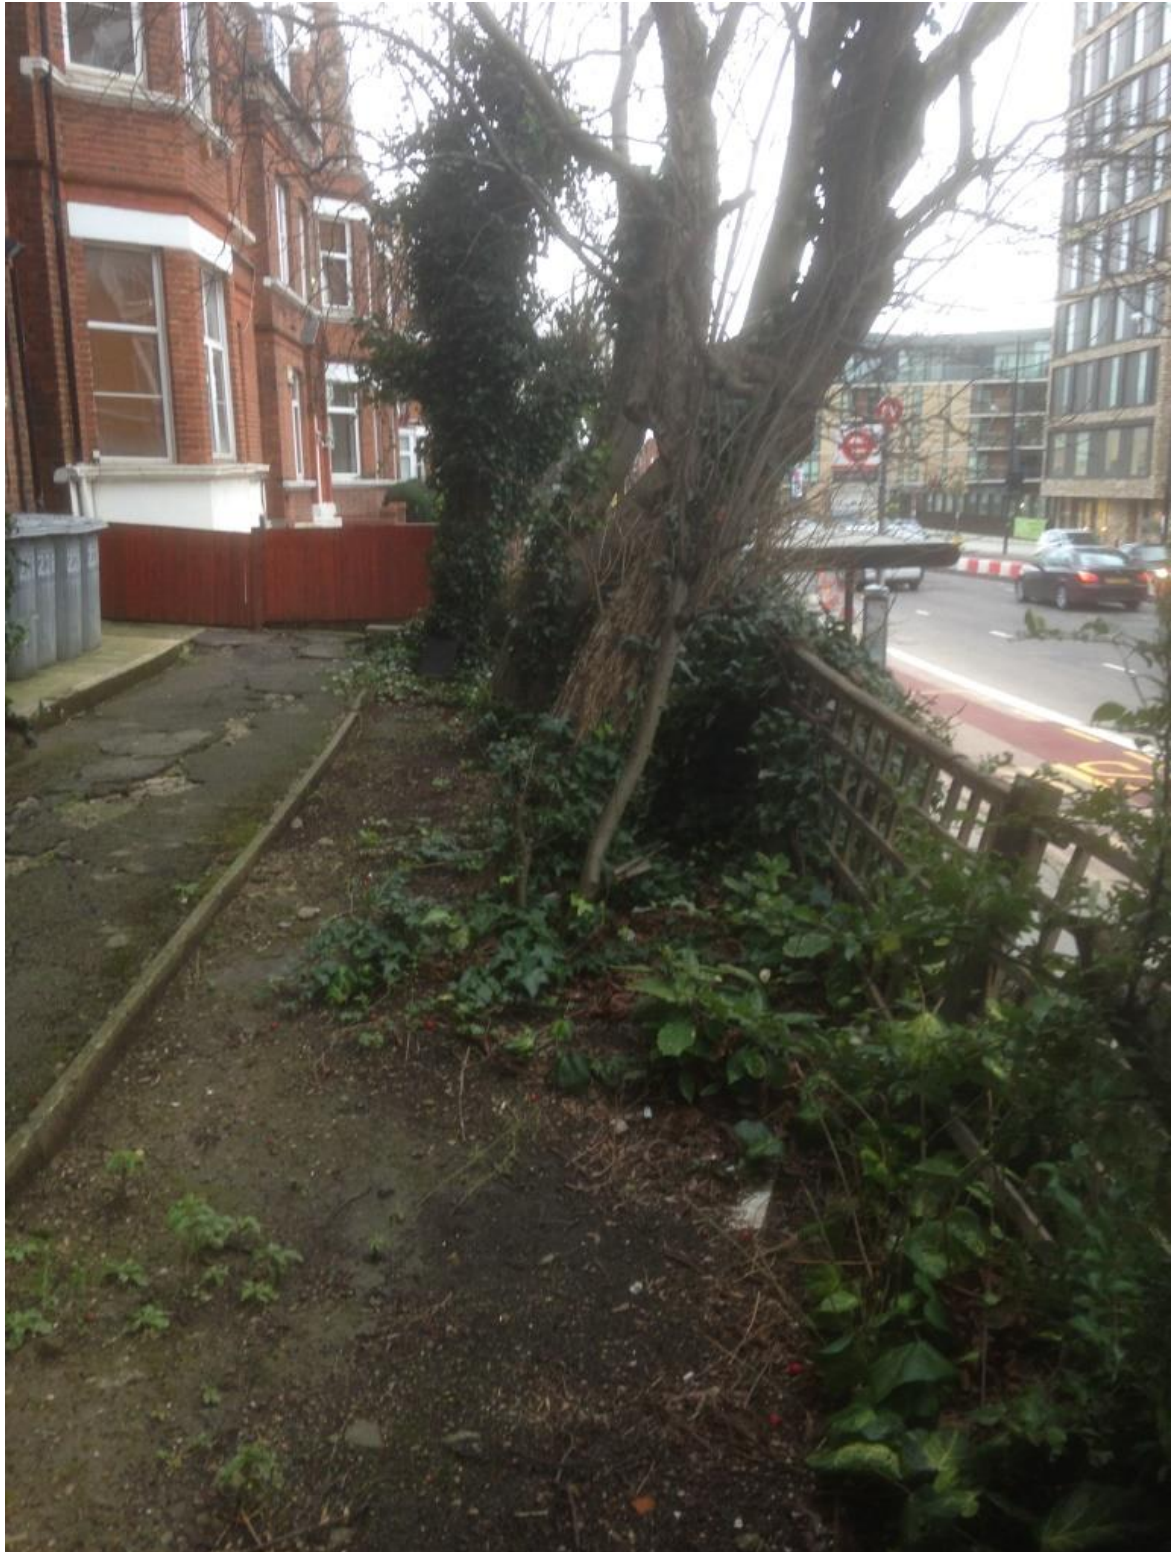
3.3 Hawthorn T3, Whitebeam T4 and Elderberry T5: These C-grade trees are part of a linear group that provides significant PVA. In terms of the SULE of T3 and T4 it can be seen from photos no. 3 and 4 that these trees are leaning away (growing toward light) from the adjacent mansion block. Such trees can reach heights (albeit in ideal growing conditions) of 15m* and 20m* respectively. As with T2, in our opinion the SULE of these trees is limited to an estimated 15-20 years and these trees will similarly have to be risk assessed in regard to the adjacent high risk target: Finchley Road (see photo no. 5). In this sense we differ from Camden Council's view that the SULE of T3 and T4 is "significant". Again we would also suggest that the pending tree risk assessment requirement would place an unfair burden on our client.

Photo No 3. To show leaning trunks on T3 and T4 (looking south)

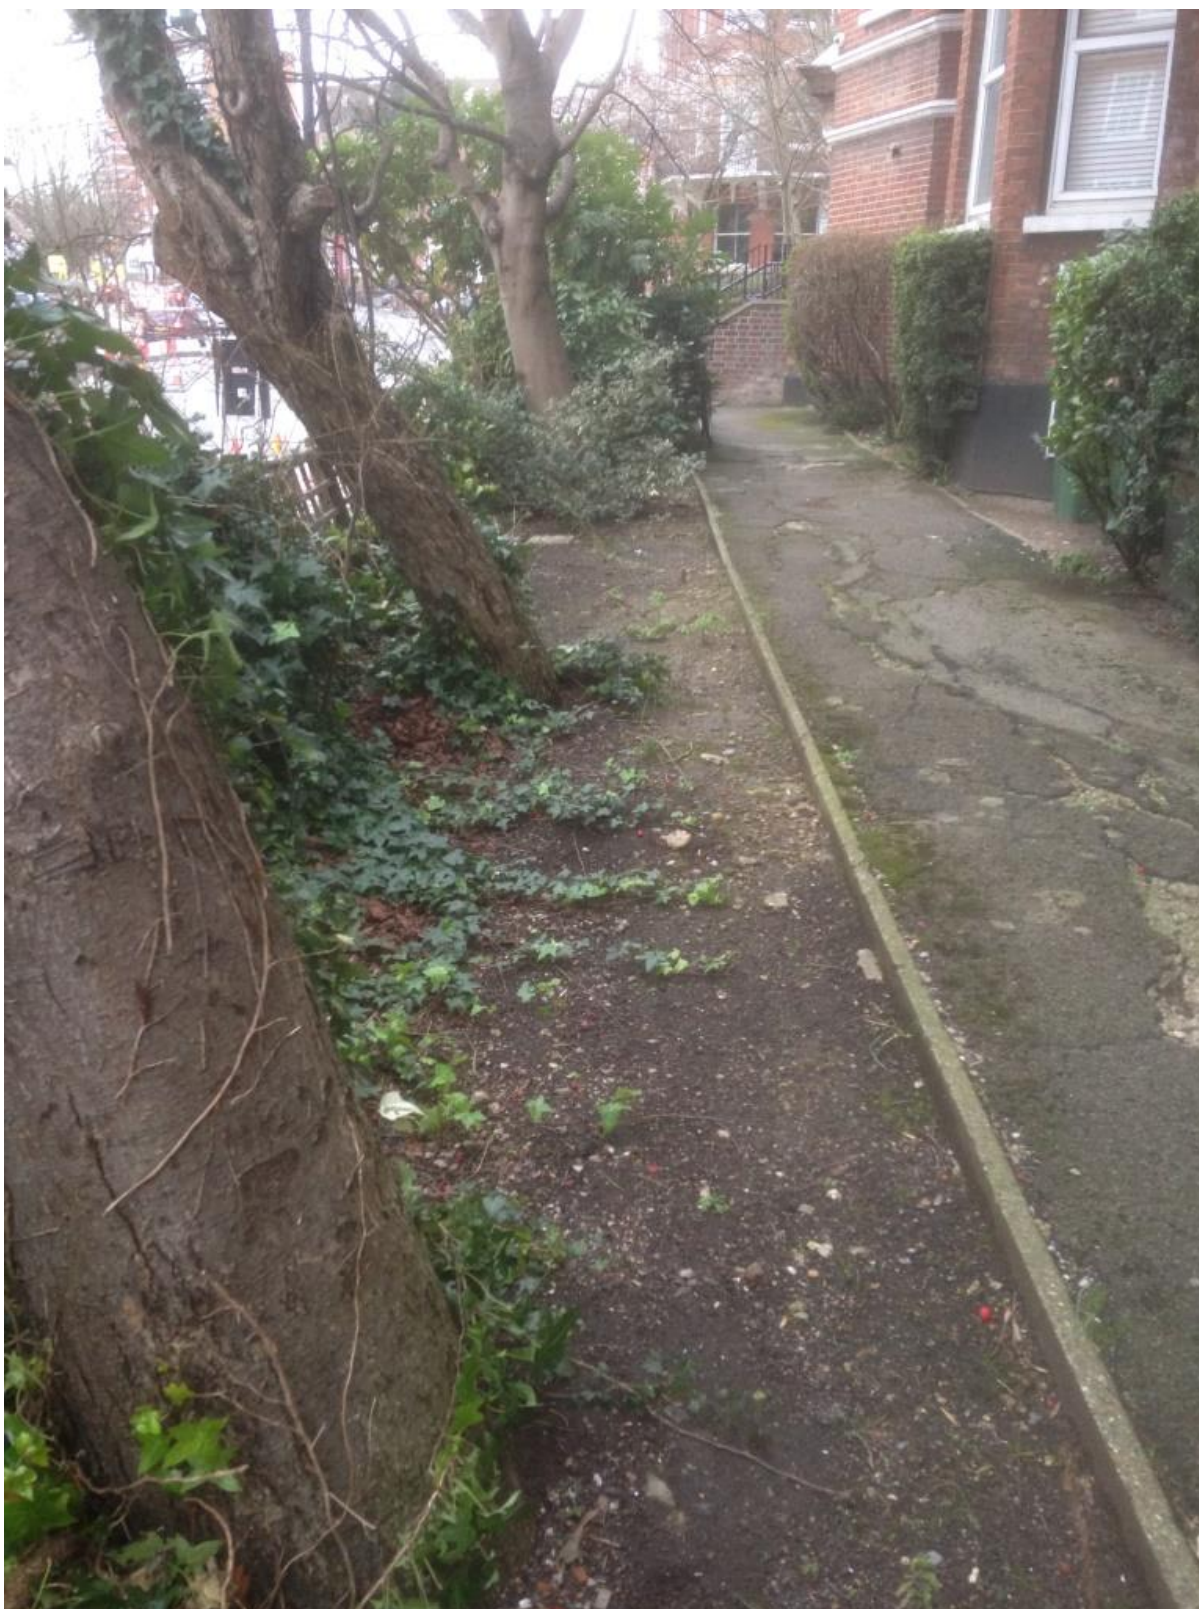
Photo No 4. To show leaning trunks on T3 and T4 (looking north)

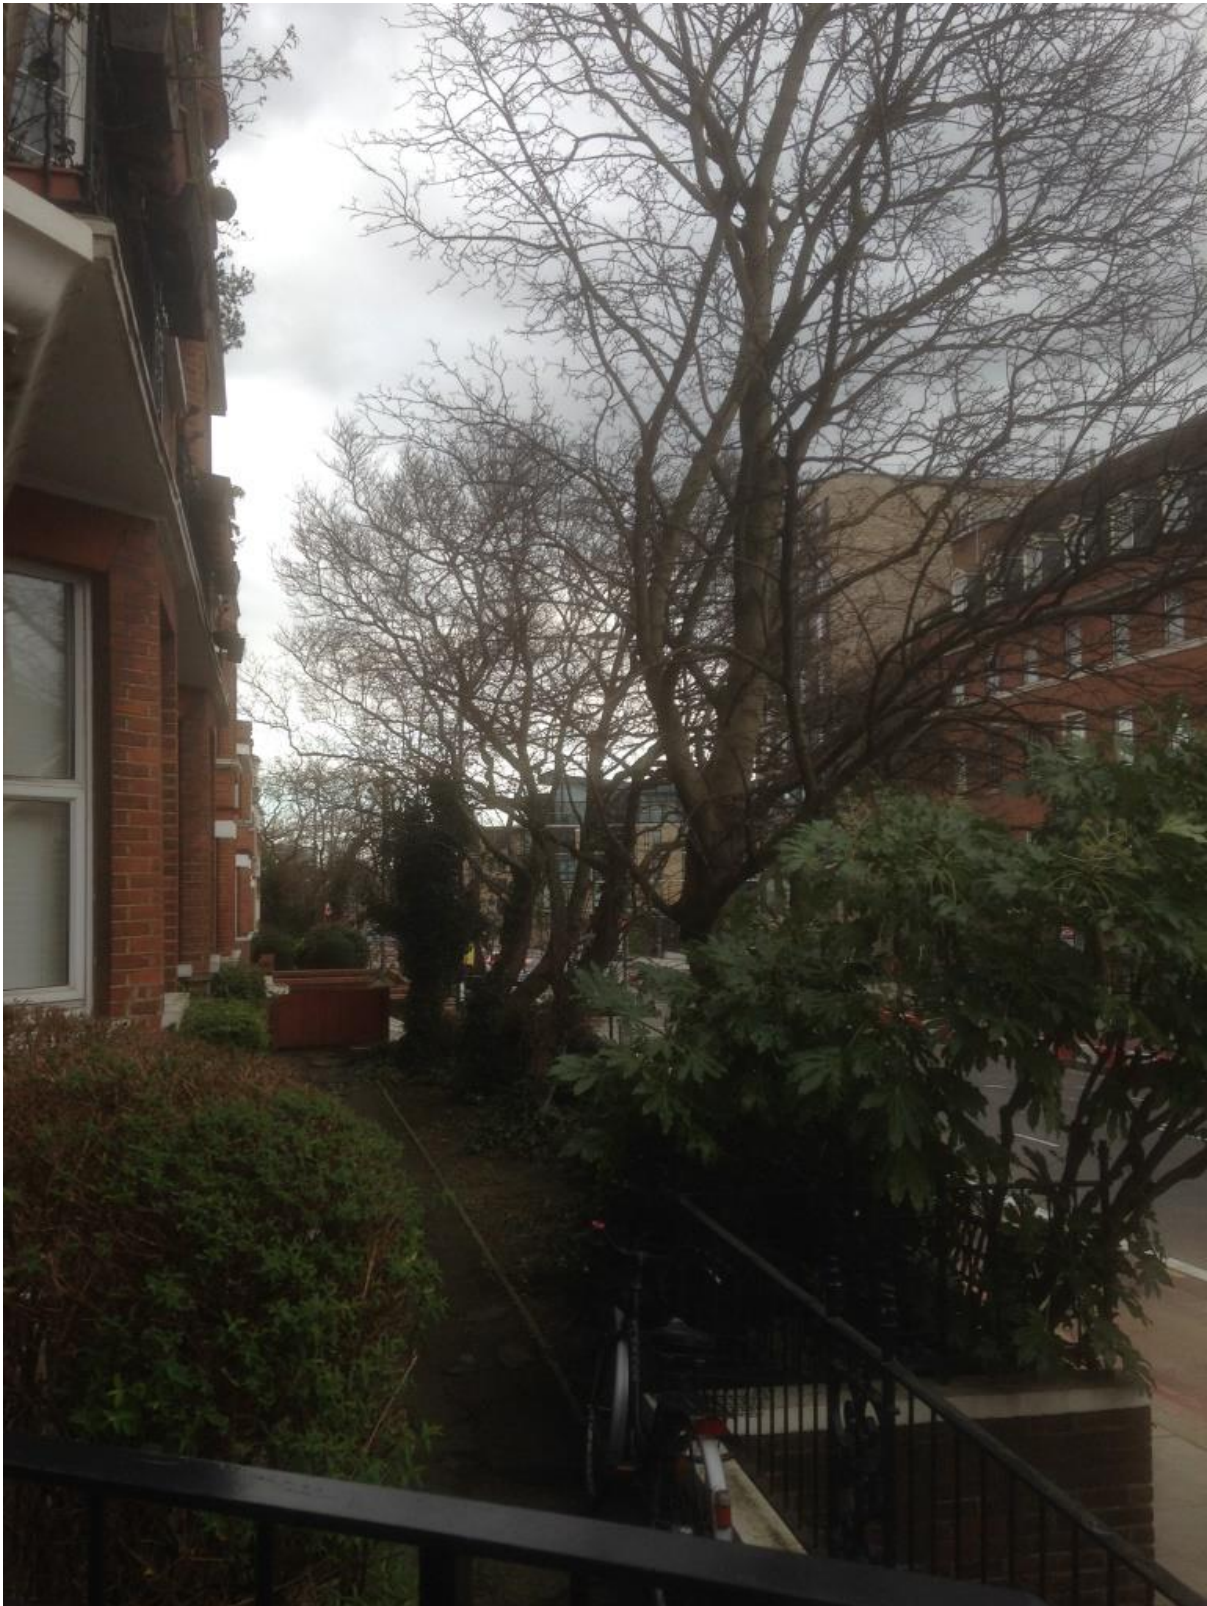
medium-term T2 will have to be risk assessed every 16 months to review the above factors in regard to potential tree failure on to the adjacent high risk target: Finchley Road (see photo no. 5). In this sense we differ from Camden Council's view that the SULE of T2 is "significant". We would also suggest that the pending tree risk assessment requirement would place an unfair burden on our client.

Photo No 5. To show how the crowns of T2-T4 are growing away from the mansion block and out over the (high target) Finchley Road coupled with a restricted space for radial root-plate development is likely to cause a future hazard feature for these trees.
