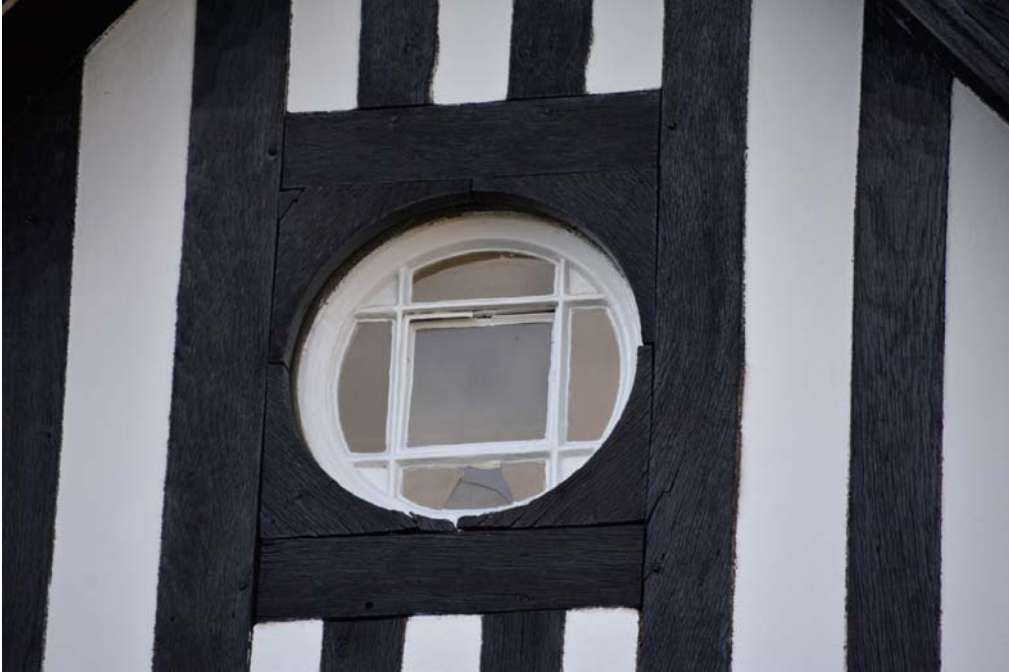
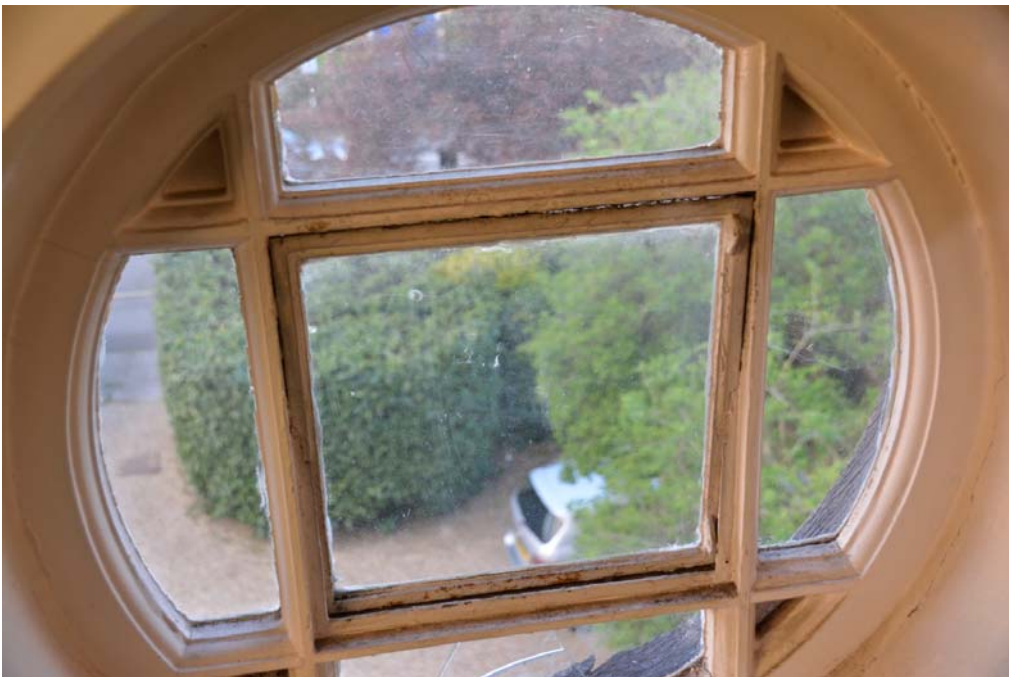
## WS05 Front central window

WS05 Existing timber central front window is in particularly poor condition so to be replaced. The new window will be a replica of the existing in timber with slimline double glazing;
