PROJECT TITLE
 SOAS INTO SENATE HOUSE
 MALET STREET
 LONDON, WC1E 7HU

DRAWING TITLE
 Existing window G06
 Precedent install - Stair 9

28731-SOAS-A-SKE-XXX-XX-162

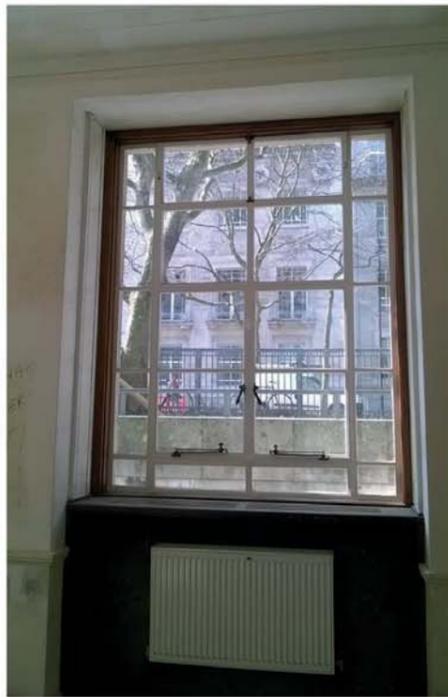
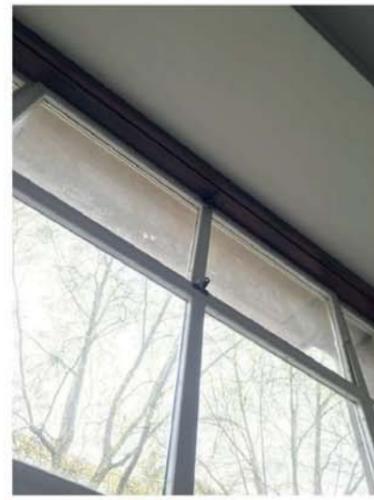
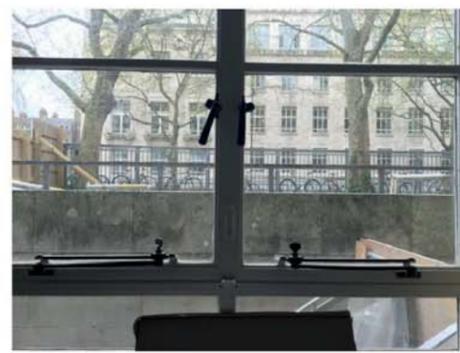
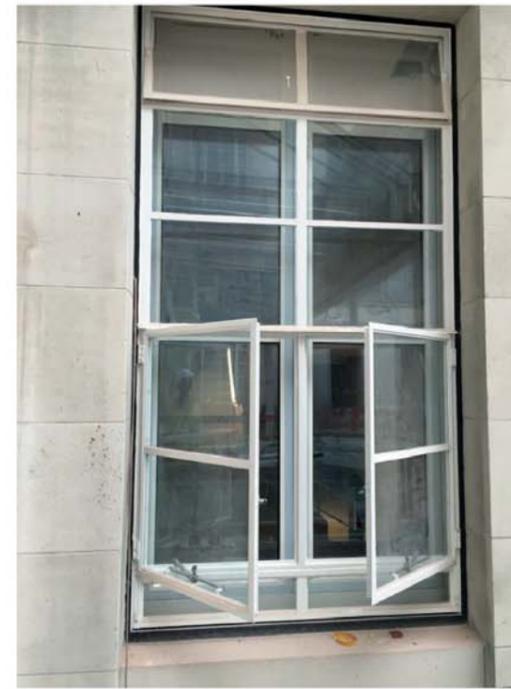
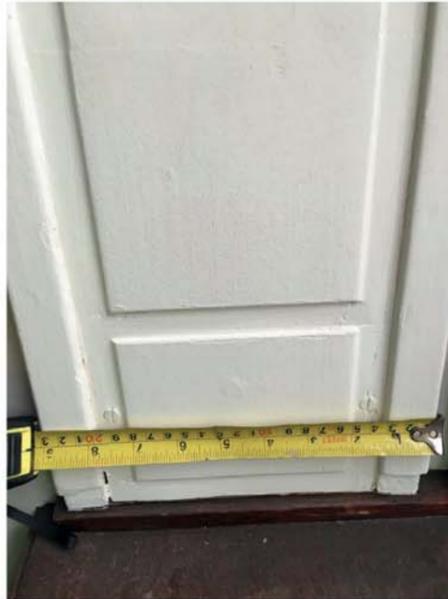
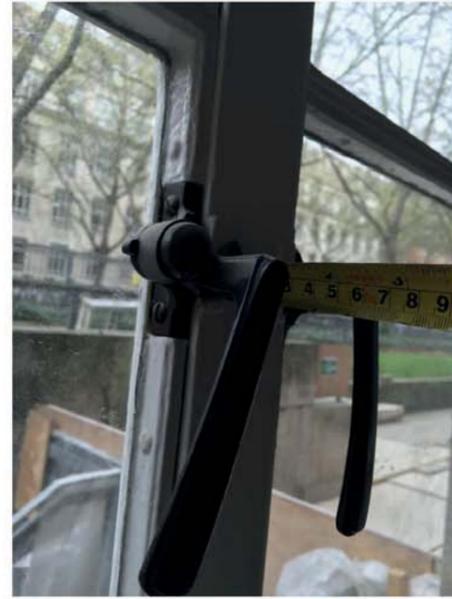
TOP LEFT: WINDOW W-G06-1
 TOP MIDDLE: TOP OF WINDOW
 TOP RIGHT: WINDOW IRONMONGERY
 MIDDLE LEFT: TIMBER SURROUND
 MIDDLE: EXISTING IRONMONGERY
 MIDDLE RIGHT: WINDOW DETAIL

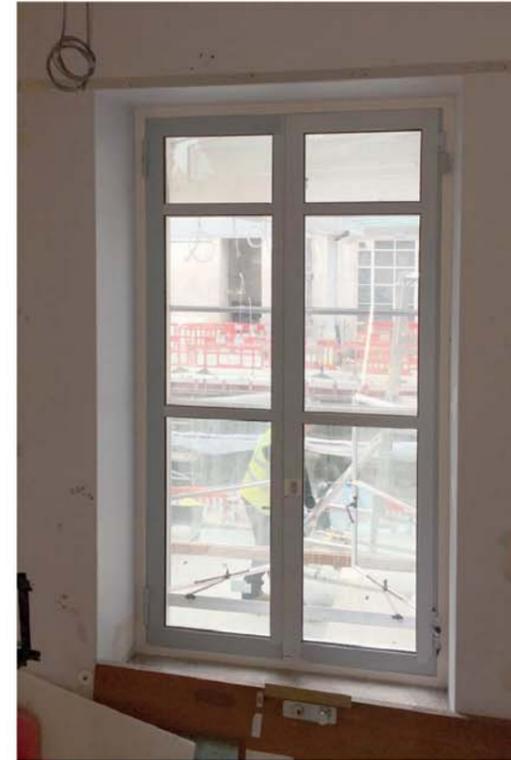
STAIR 9 SIDE
 PROTECTIVE FILM STILL ON WHITE FRAME

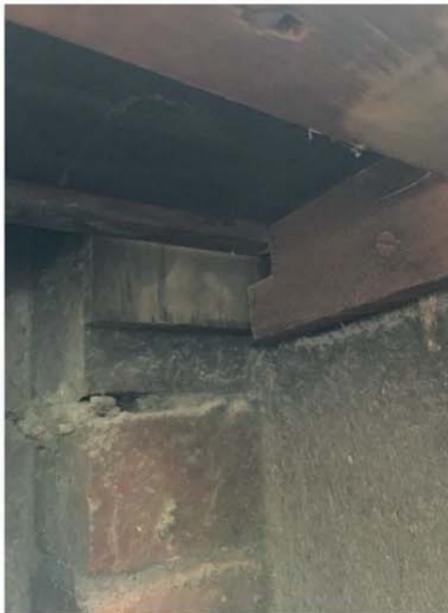
ABOVE: SLOTS TO TIMBER CILL
 BELOW: UNDERSIDE OF EXISTING
 TIMBER WINDOW CILL

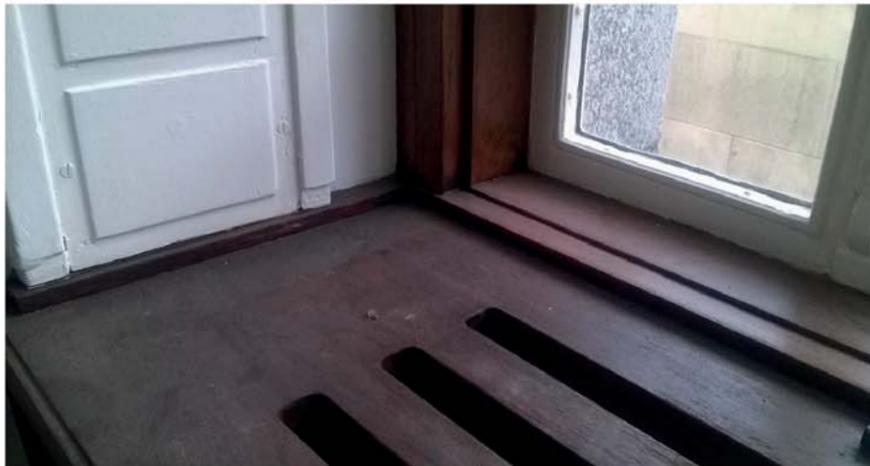
EXISTING WINDOW TO W-G06-1
 SINGLE GLAZED

FORSTER 30 MINUTE SECONDARY
 GLAZING INSTALLED TO STAIR 9
