HIGHGATE CEMETERY: REPAIRS TO THE COLONNADE

Planning issue, May 2016

PART 1A: DESIGN STATEMENT

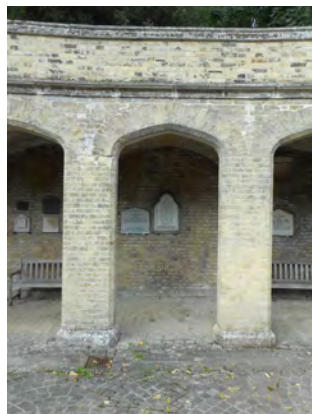
- The front wall of the colonnade is on good order with minor pointing defects.

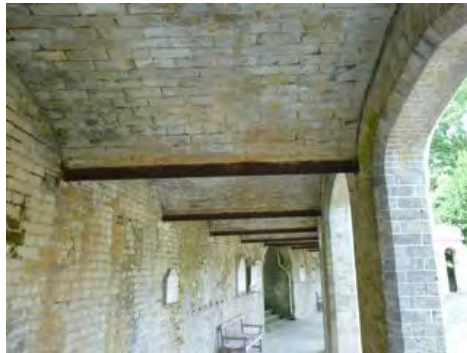
- The vault to the loggia is supported on iron beams at each column position. These are suffering surface corrosion, which is unsightly and progressive, but has not yet significantly compromised the structure.

- Micro-pinning repairs to cracked brick arch
- Minor repointing to vaults and front wall in lime mortar, to a mix derived from analysis of original mortar,
- Preparation and decoration of iron beams in a corrosion-inhibiting paint coating.

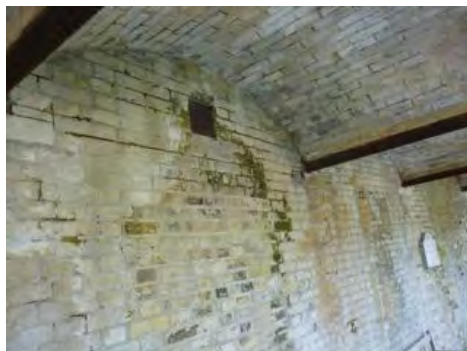
- The rear wall of the loggia (which has burial vaults behind it) suffers from extensive water penetration, largely from the top. It has been repointed in patches in the past with an unsuitable cement-rich pointing, and has extensive areas where the pointing has failed completely. The pointing that remains is contributing to problems and is unsightly. There are numerous failed or broken bricks, some associated with the fixing of memorial plaques which have now disappeared.

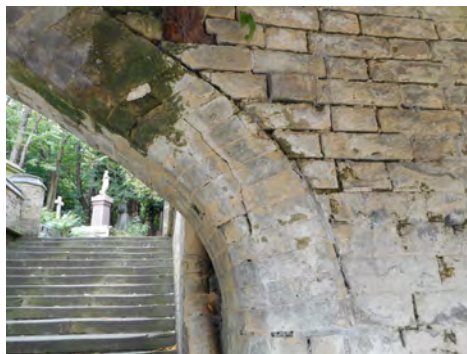
- There is serious cracking at the central arch opening carrying the vault over the steps.

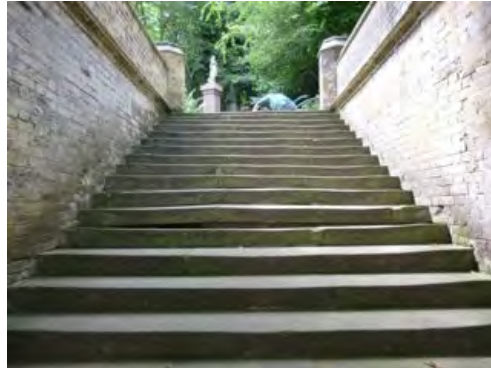
- The flanking walls to the steps have a large crack roughly where the vault structures behind them end and they become retaining walls

- The pointing to the flanking walls is degraded similarly to the rear wall.
- The steps have suffered structural movement, which has deformed them in the middle, making the risers of very unequal height.

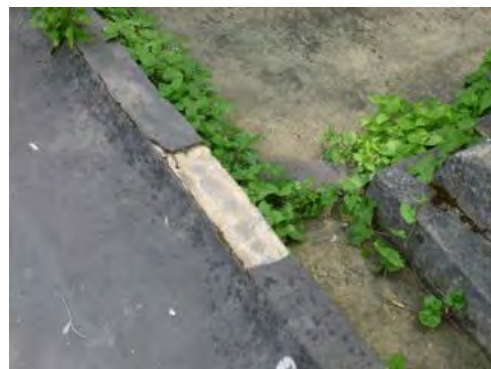
- The roof, in asphalt, has serious defects particularly along the rear edge, where any water penetrating it can go into the fabric of the rear wall.

- Removal of invasive vegetation
- Renewal of asphalt roofing and alterations to substructure detail of rear edge detail, abutment and flashing details etc.
- Repointing in lime mortar, to a mix derived from analysis of original mortar, of walls and parapets flanking the steps, with structural reinforcement at the cracks.
- Repairs to stabilise and mitigate damage to the steps. There are 2 options here, for a comprehensive resetting of the flight with all the risers regularised and the new fixings specified by the structural engineer concealed, and a less invasive proposal resetting just the worst affected steps but necessitating fixings which will have a visual impact on the steps.
- Repointing and brickwork repairs to rear wall of loggia in lime mortar, to a mix derived from analysis of original mortar,
