Notes for Highgate Cemetery Colonnade and Stair.

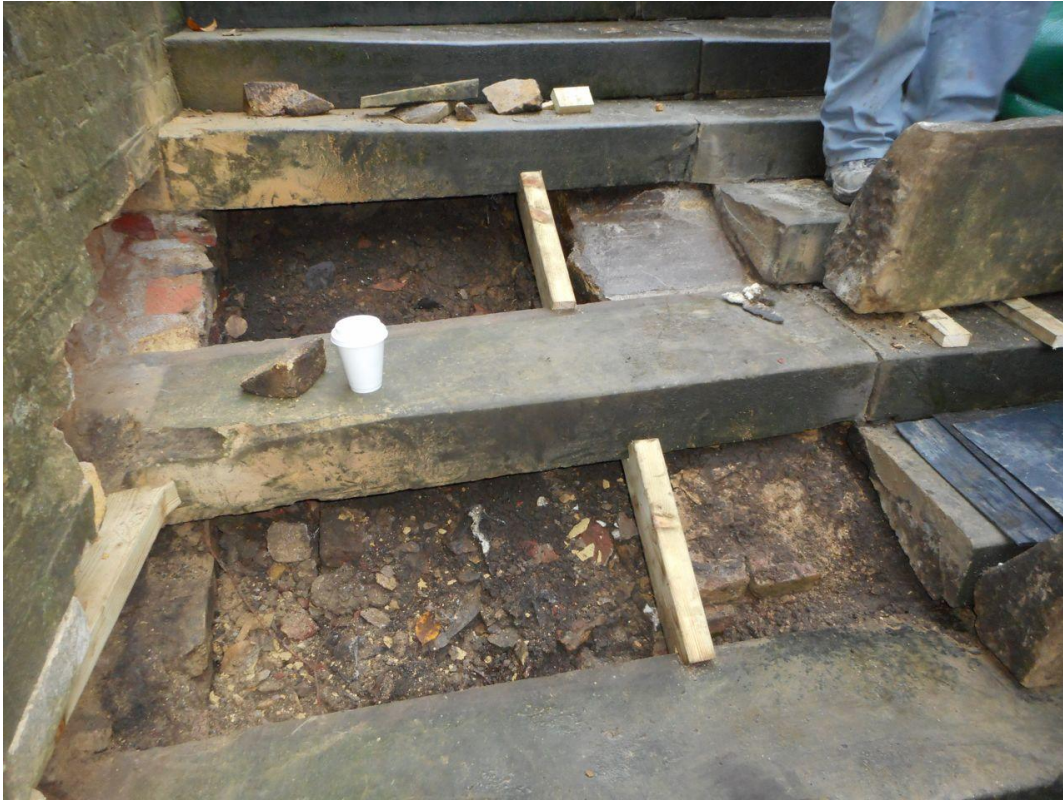
From the images taken during the site investigation, it can be seen that the treads register within the brickwork of the side walls but have no positive horizontal restraint at their intermediate joints.

Image taken during opening up works showing the treads have an inclined soffit bearing on a strip foundation support of unknown depth and quality. Treads are built into the side walls.

The lack of positive fixing at the intermediate supports is a defect that we advise should be addressed during the consolidation works. The sketch below indicates a potential failure mechanism.

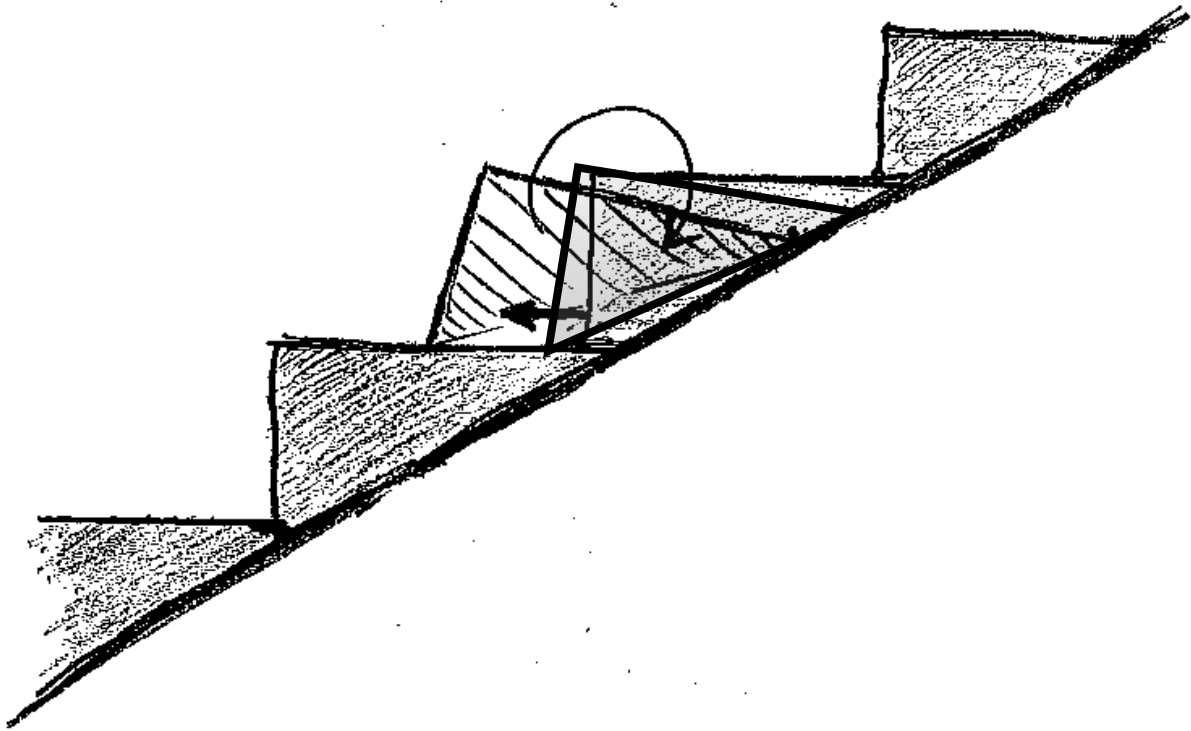
Analysis of the accurate level survey suggests this is not occurring throughout the entire flight of steps but there are locations where displacement has led to uneven rise and going. The most notable movement has occurred to steps 10 and 11 (flight numbered from the bottom up). The average rise of the flight is 155mm becomes 124mm at the rise of step 10 and 178mm at the rise of step 11. This coincides with a tapered open joint at the junction between the two stones forming step 11.

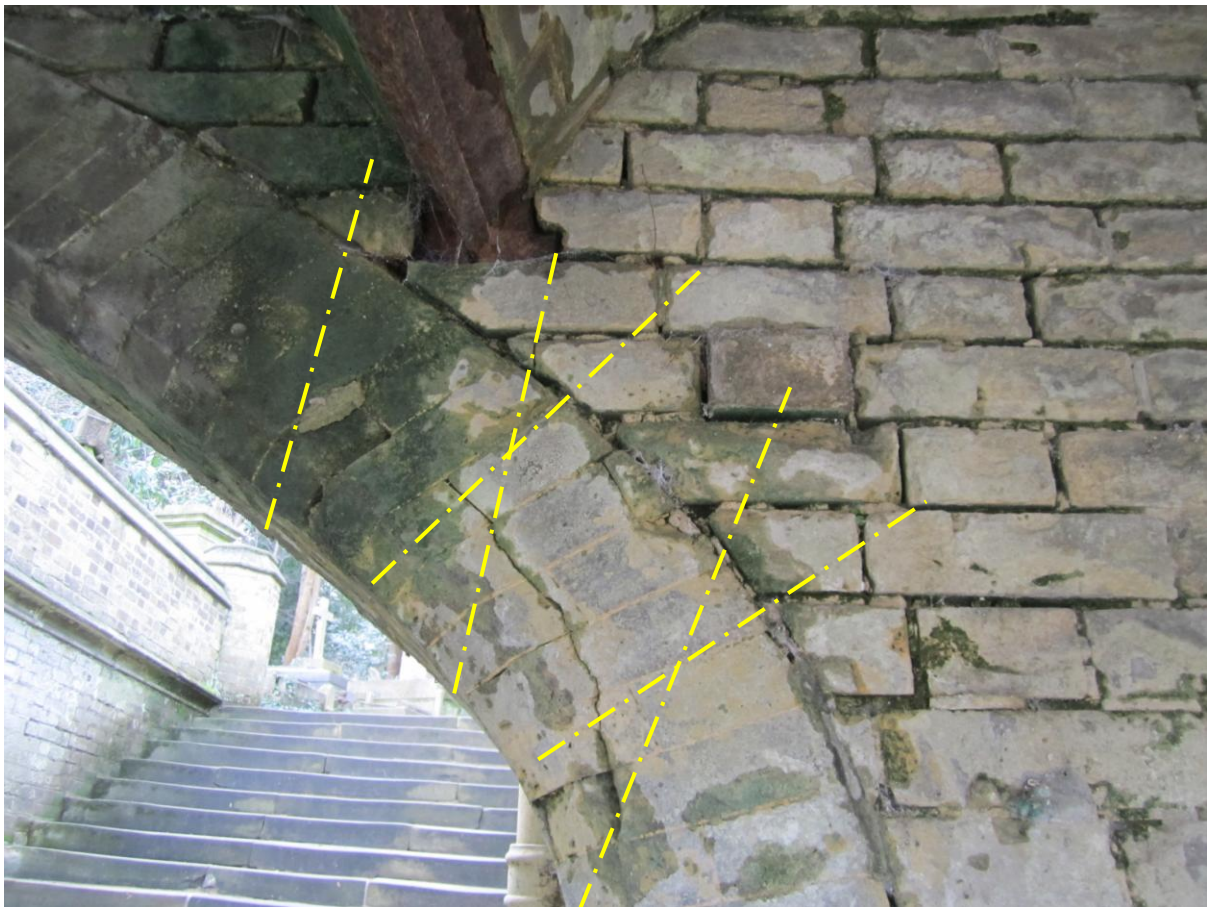
Cracking in the brick arch voussoir at each side of the entrance to the stair has been identified.

In situ pinning with 6mm diameter stainless steel helical reinforcement (approx 500mm in length) is required. This will conserve the original load path (line of thrust) and historic fabric. The method of installation should use non-percussive drilling.

The locations of the pins should be identified on site – but for initial costings we suggest alternate courses, and incline in opposite directions
