**Marine Ices
Haverstock Hill
Camden
NW3 2BL**

**Pre Demolition Asbestos
Survey Report**

**Document Ref
SUPN2324**

**Date
13-11-2014**

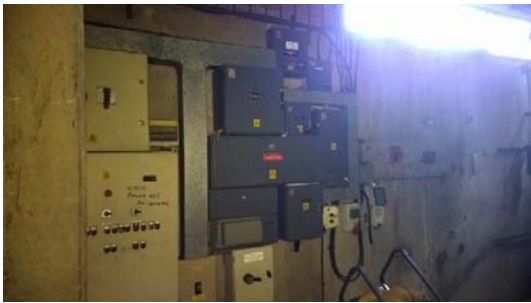
Sample Number:		Building:	Marine Ices	Area Number:	G.01
Visual Number:	V2324/1003	Floor:	Ground	Area Use:	Restaurant

Identification:	Presumed
				Product Type:	Textiles
				Damage:	Good condition
				Surface Treatment:	Encapsulated board or textiles
				Accessibility:	Difficult
				Location:	Internal
				Quantity:	<1m2
				Analysis Result:	Presume Chrysotile
				Priority Rating:	Very Low

Sample/Visual Comments: Presumed asbestos containing materials within live electrics.

Recommended Action: Remove				Comments: This item must be removed under locally controlled conditions by an approved Hse contractor prior to any works being carried out in this location.								
	V2324/1004	G.08	Plant Room	Presumed asbestos containing materials within live electrics.	Textiles	Good condition	Encapsulated board or textiles	Internal	Difficult	<1m2	Presume Chrysotile	Very Low
Recommended Action: Sample				Comments: It is recommended that this item should be sampled when all electricity has been shut off.								
	V2324/1005	G.09	Car Parking	Presumed asbestos containing materials within live electrics.	Textiles	Good condition	Encapsulated board or textiles	Internal	Difficult	<1m2	Presume Chrysotile	Very Low
Recommended Action: Sample				Comments: It is recommended that this item should be sampled when all electricity has been shut off.

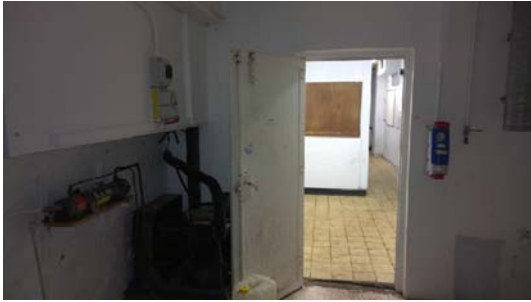
Sample Number:	S2324/0002	Building:	Marine Ices	Area Number:	G.04
Visual Number:		Floor:	Ground	Area Use:	Corridor

Identification:	Sampled
				Product Type:	Insulating board
				Damage:	Good condition
				Surface Treatment:	Encapsulated board or textiles
				Accessibility:	Easy
				Location:	Internal
				Quantity:	<4m2
				Analysis Result:	Amosite & Chrysotile
				Priority Rating:	Low

Sample/Visual Comments: Durasteel Door.

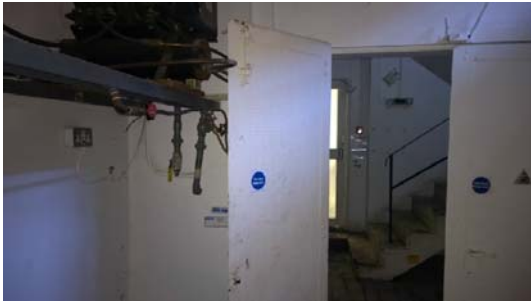
Sample Number:	S2324/0002	Building:	Marine Ices	Area Number:	G.05
Visual Number:	V2324/1001	Floor:	Ground	Area Use:	Corridor

Identification:	Strongly Presumed
				Product Type:	Insulating board
				Damage:	Good condition
				Surface Treatment:	Encapsulated board or textiles
				Accessibility:	Easy
				Location:	Internal
				Quantity:	<4m2
				Analysis Result:	Amosite & Chrysotile
				Priority Rating:	Low

Sample/Visual Comments: Durasteel Door.

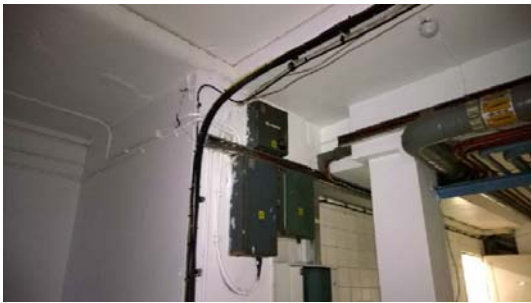
Sample Number:		Building:	Marine Ices	Area Number:	G.11
Visual Number:	V2324/1006	Floor:	Ground	Area Use:	Lobby

Identification:	Presumed
				Product Type:	Textiles
				Damage:	Good condition
				Surface Treatment:	Encapsulated board or textiles
				Accessibility:	Difficult
				Location:	Internal
				Quantity:	<1m2
				Analysis Result:	Presume Chrysotile
				Priority Rating:	Very Low

Sample/Visual Comments: Presumed asbestos containing materials within live electrics.

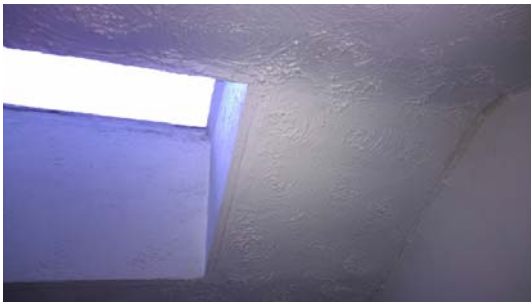
Sample Number:	S2324/0003	Building:	Marine Ices	Area Number:	ST.01
Visual Number:		Floor:	Ground - First	Area Use:	Stairwell

Identification:	Sampled
				Product Type:	Textured coating
				Damage:	Good condition
				Surface Treatment:	Reinforced & composite materials
				Accessibility:	Easy
				Location:	Internal
				Quantity:	<6m2
				Analysis Result:	NADIS
				Priority Rating:	--

Sample/Visual Comments: Textured coating to ceiling of stairwell.

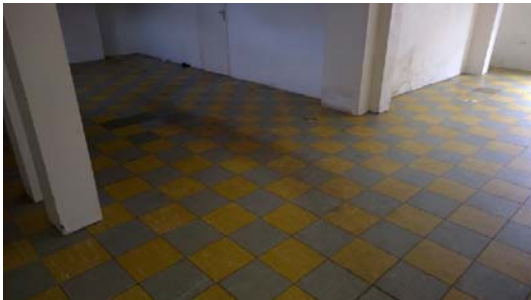
Sample Number:	S2324/0004	Building:	Marine Ices	Area Number:	01.12
Visual Number:		Floor:	First	Area Use:	Stores

Identification:	Sampled
				Product Type:	Vinyl products
				Damage:	Good condition
				Surface Treatment:	Resin & Vinyl products
				Accessibility:	Easy
				Location:	Internal
				Quantity:	>100m2
				Analysis Result:	NADIS
				Priority Rating:	--

Sample/Visual Comments: Vinyl floor tiles.

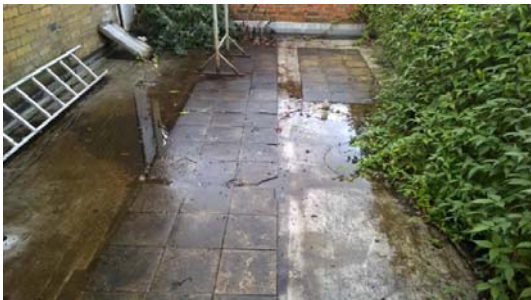
Sample Number:	S2324/0007	Building:	Marine Ices	Area Number:	E.01
Visual Number:		Floor:	First	Area Use:	External Areas

Identification:	Sampled
				Product Type:	Cement
				Damage:	Good condition
				Surface Treatment:	Cement products
				Accessibility:	Easy
				Location:	External
				Quantity:	36m2
				Analysis Result:	Chrysotile
				Priority Rating:	Very Low

Sample/Visual Comments: Cement promenade tiles.

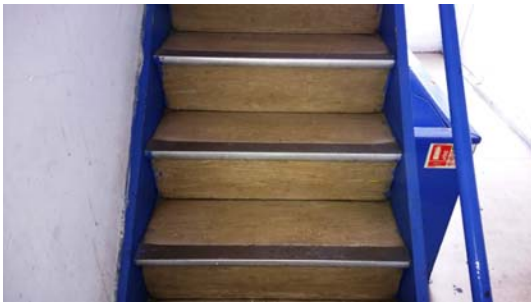
Sample Number:	S2324/0006	Building:	Marine Ices	Area Number:	ST.02
Visual Number:		Floor:	Ground - Second	Area Use:	Stairwell

Identification:	Sampled
				Product Type:	Stair Nosing
				Damage:	Good condition
				Surface Treatment:	Reinforced & composite materials
				Accessibility:	Easy
				Location:	Internal
				Quantity:	<4m2
				Analysis Result:	NADIS
				Priority Rating:	--

Sample/Visual Comments: Stair Nosing.

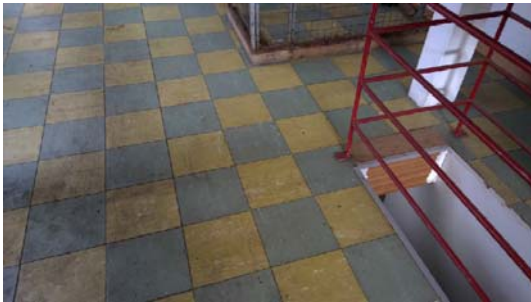
Sample Number:	S2324/0004	Building:	Marine Ices	Area Number:	02.02
Visual Number:	V2324/1008	Floor:	Second	Area Use:	Stores

Identification:	Strongly Presumed
				Product Type:	Vinyl products
				Damage:	Good condition
				Surface Treatment:	Resin & Vinyl products
				Accessibility:	Easy
				Location:	Internal
				Quantity:	>100m2
				Analysis Result:	NADIS
				Priority Rating:	--

Sample/Visual Comments: Vinyl floor tiles.
