HISTORIC ENGLAND
CIVIL & STRUCTURAL ENGINEERING TEAM
INTERNAL MEMO

Subject: St Stephens, Rosslyn Hill, Hampstead, London

To: Ian Harper (HE, London Office) **cc:**
From: Bridget Drake-Wilkes **Tel:** 07747 743 081
(Senior Engineer)
Date: 9th September 2015

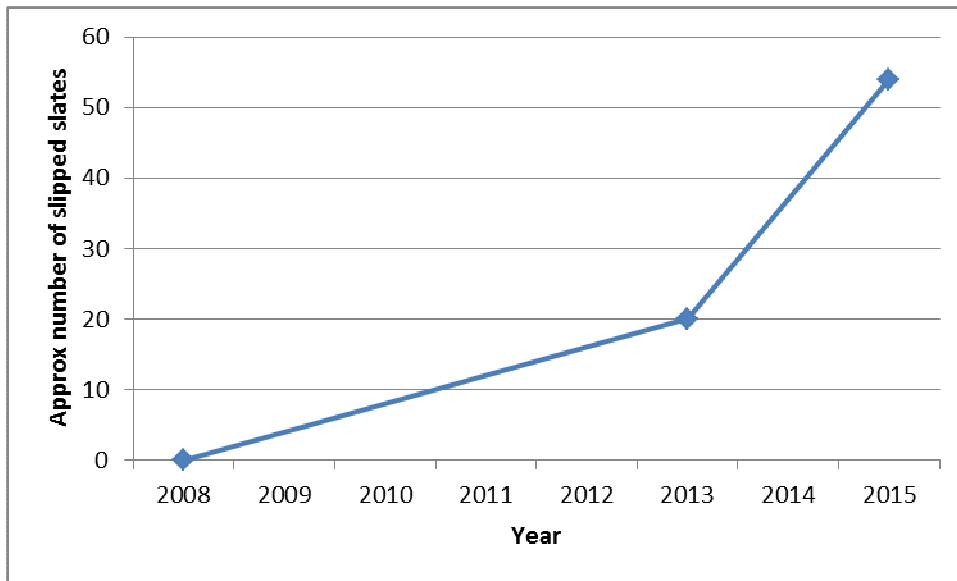
Figure 2. Slipped slates on main roof south elevation

4.8 Figure 2 shows the number of slipped slates observed graphically since it was last reset. It is possible that the vibration from the adjacent works may have accelerated the rate at which slates have slipped. Although exponential deterioration would be expected under normal environmental conditions as more of the roof structure becomes exposed.

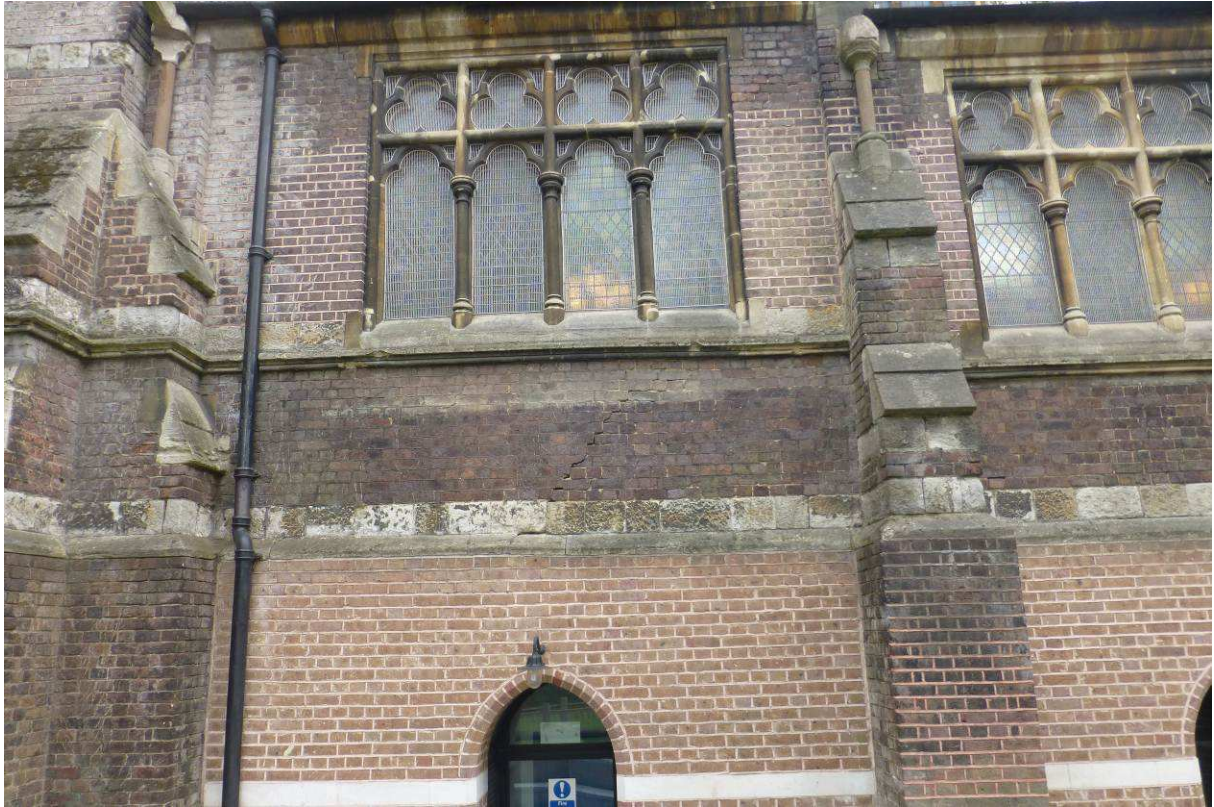
3.2 There were signs of historic distortion to the north elevation (Photo 2 & 3). Cracking to the masonry was also observed on the south porch (Photo 4).

Photo 2. Distortion to the east end of the north aisle externally

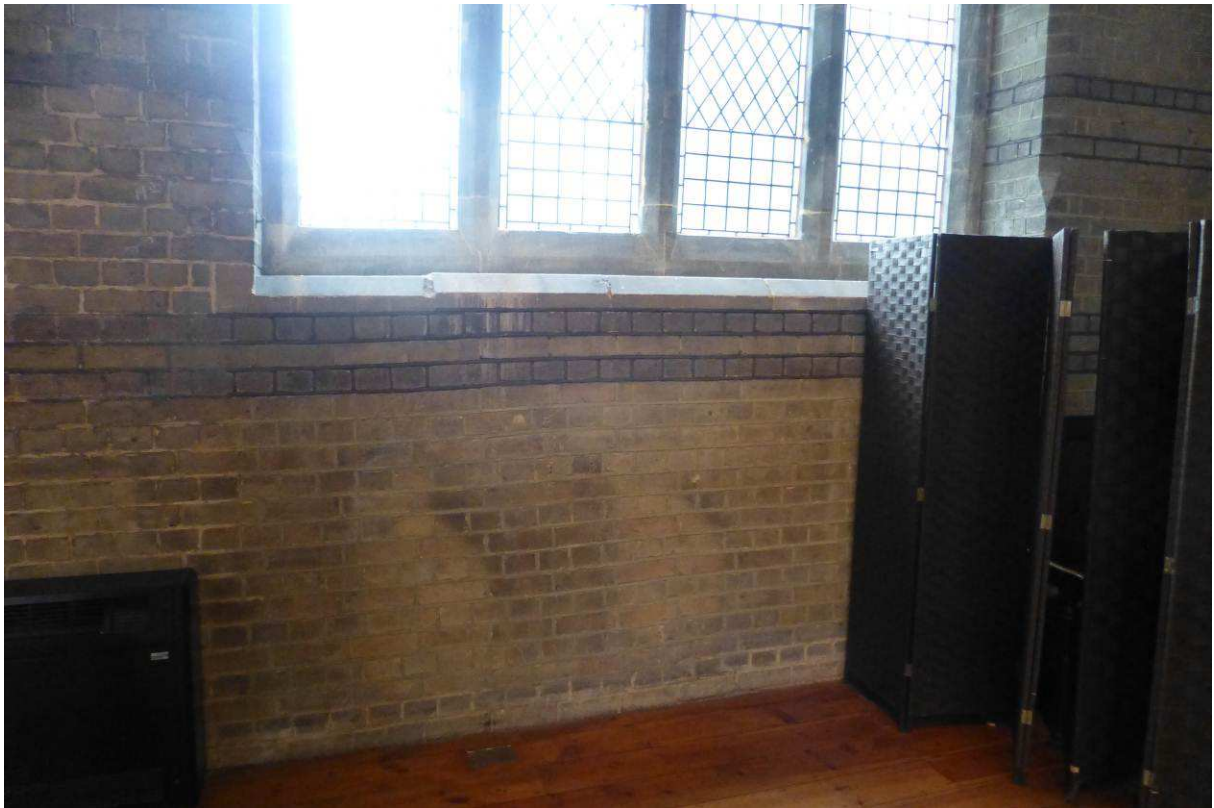
Photo 3. Distortion to the east end of the north aisle internally

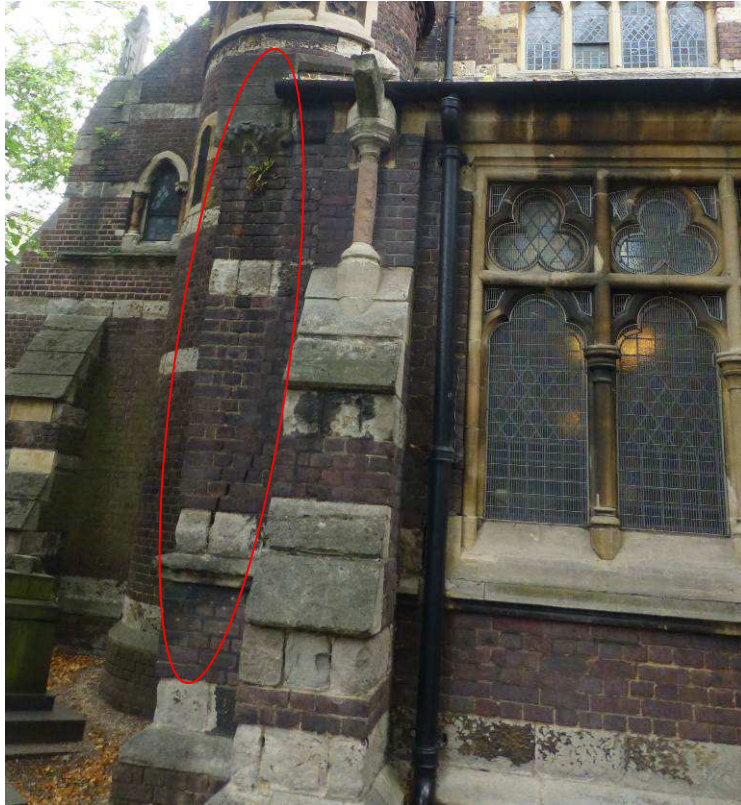
3.5 Vegetation was observed in gutters (Photo 4 & 8), suggesting some maintenance is outstanding, which if not attended to, could lead to local deterioration of the structure.

Photo 4. Cracking and vegetation to south porch

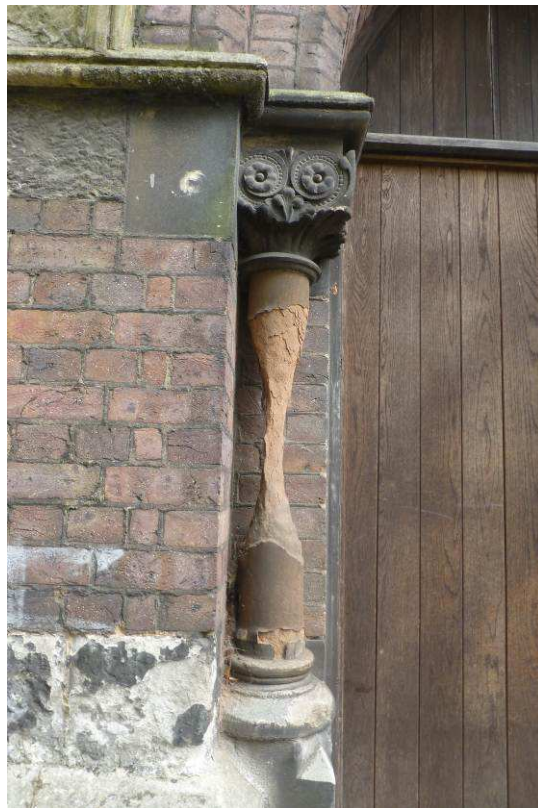
3.3 Deterioration of sandstone decorative columns beneath the limestone occurs in several locations with the worst observed on the north porch (Photo 5).

Photo 5. Sandstone decorative column to north porch.

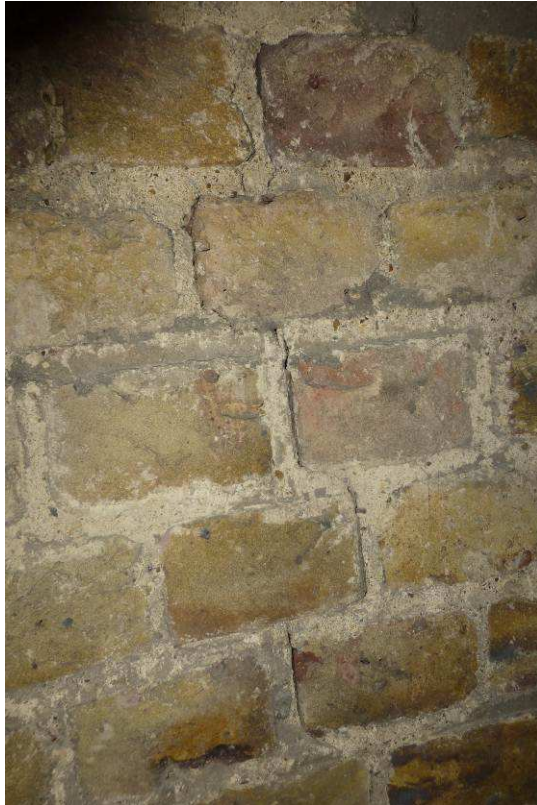
3.4 Some local vertical and horizontal cracking associated with embedded metalwork was observed in the tower staircase (Photo 6 & 7).

Photo 6. Vertical cracking to tower staircase

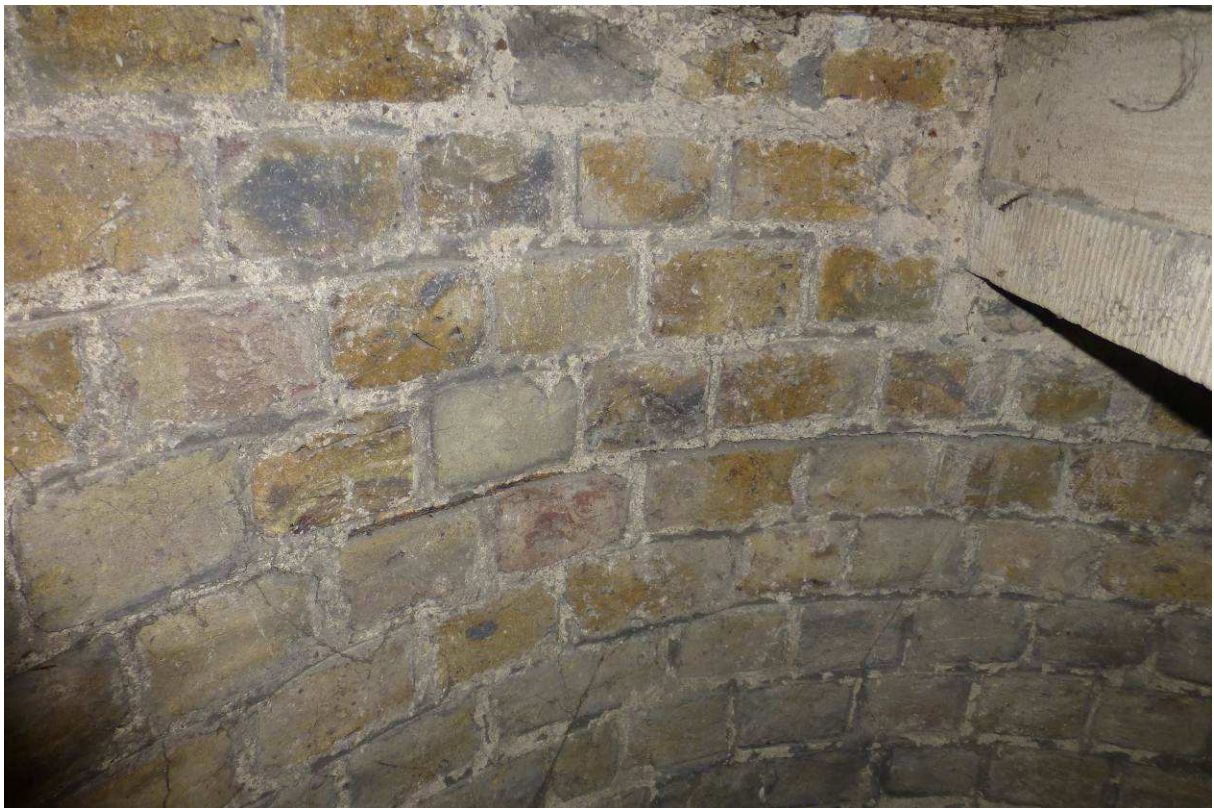
Photo 7. Horizontal cracking in the tower staircase

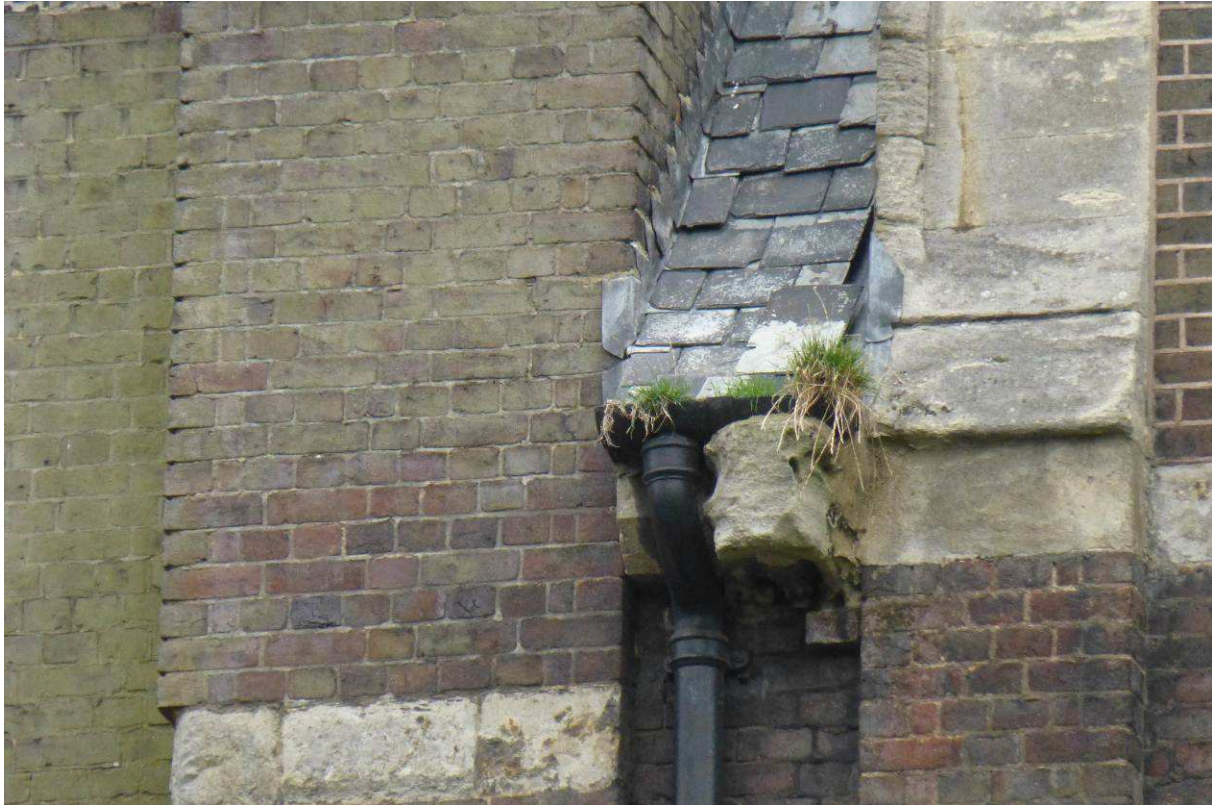
Photo 8. Vegetation and slipped tiles on north elevation adjacent to tower.

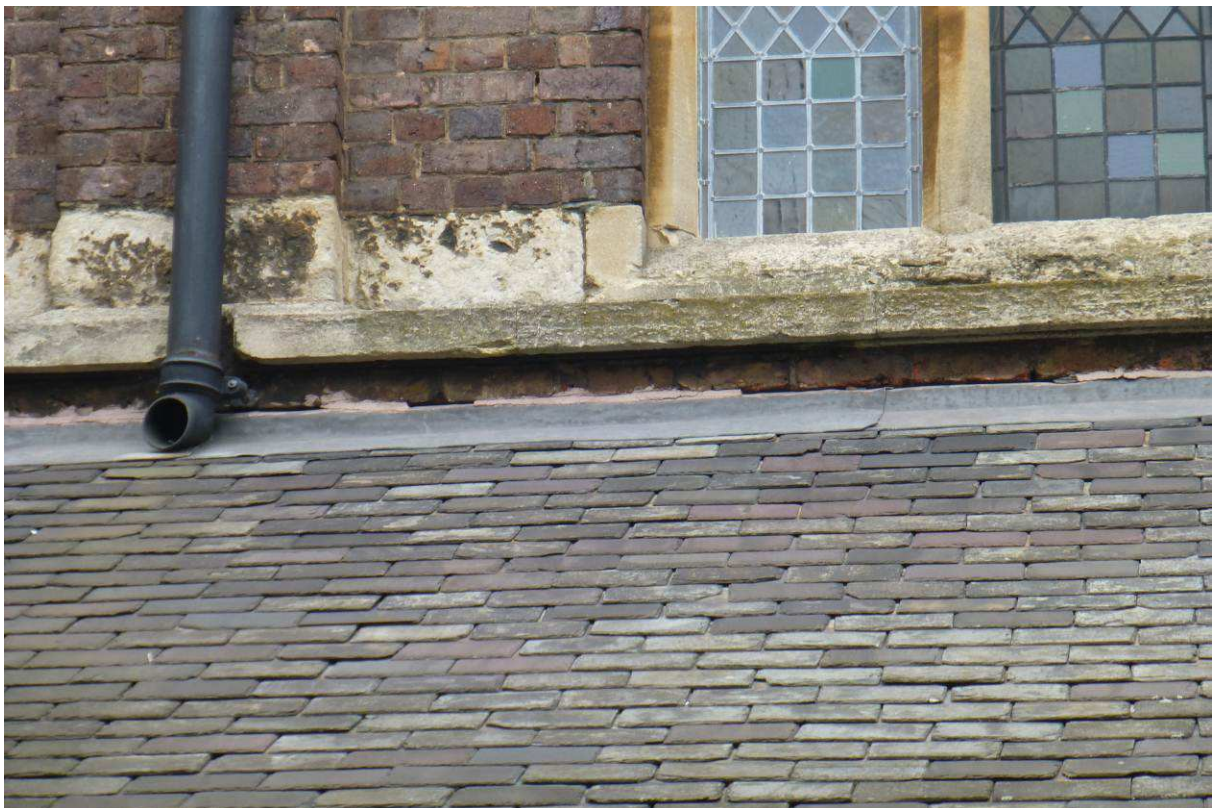
3.6 The lower roofs to the north and south aisles, were in good condition, although the mortar fillet to the south aisle roof is starting to fail (Photo 9).

Photo 9. Failure of mortar fillet between south aisle roof and clerestory wall.

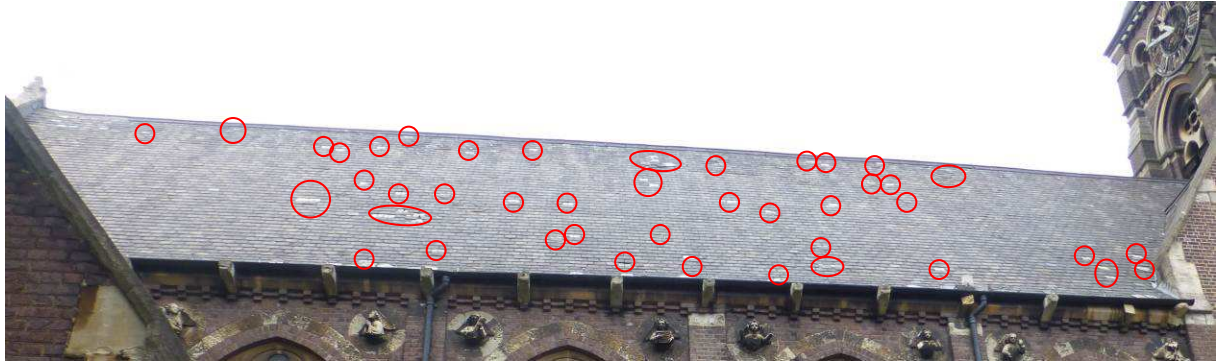
3.7 On the main roof south elevation 54 slates had slipped (Photo 10). On the main roof north elevation a few slates had slipped adjacent to the tower (Photo 11).

- 4.7 The lower roofs to the north and south isles were reroofed and the slipped slates on the main roof reset with tingles in approximately 2008. You visited site in December 2013 when on the south elevation approximately 20 slates had slipped. On our site visit in August 2015 we observed 54 slates had slipped in the same section of roof. It is not known when the main roof was last (if ever) renewed. I believe that the main roof has suffered from corrosion of the nails (nail sickness), which manifests itself by means of slipped slates.

Photo 10. Main roof, south elevation areas of slipped slates.

- 7.3 It would be prudent for the trustees to consider the timescale to undertake renewal of the main roof, particularly the south elevation as with more slates slipping, the risk of damage to the fabric of the building increases.

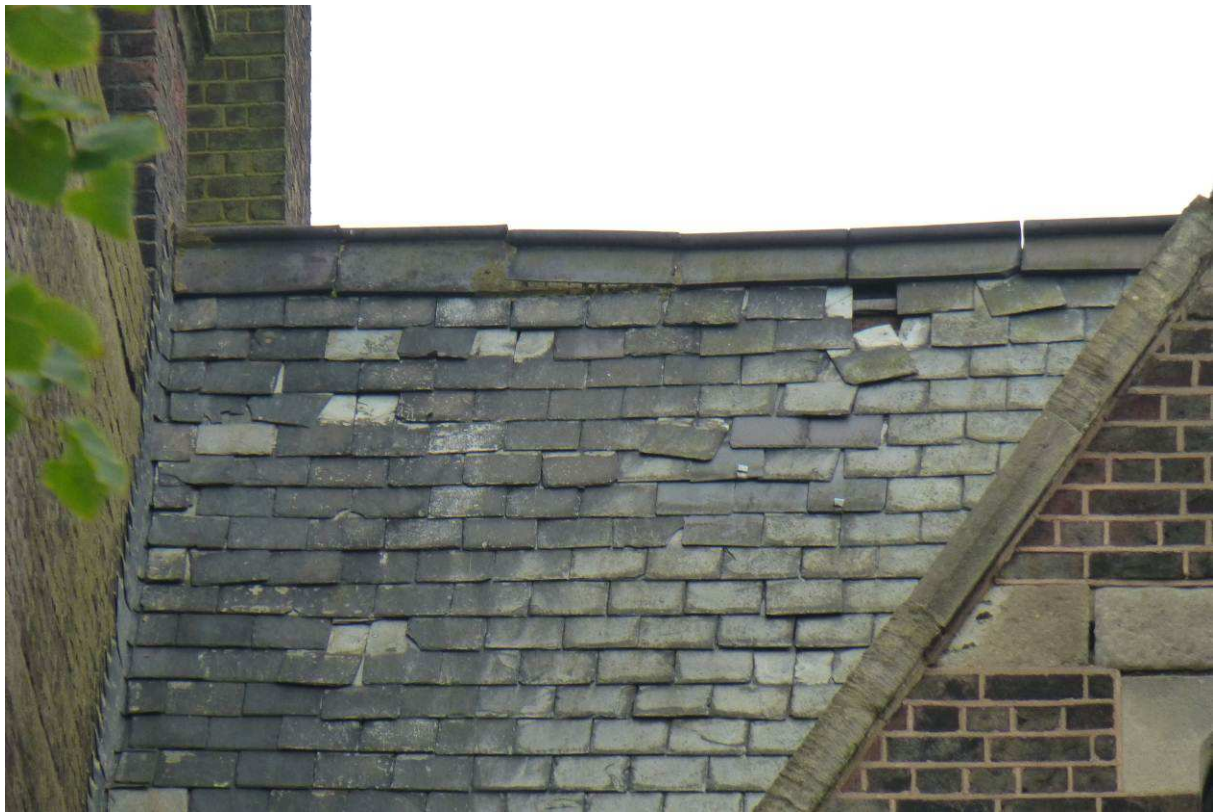
Photo 11. Main roof, north elevation areas of slipped slates.
