13 Mornington Crescent

Report on condition of the upper facade and recommendations for repairs.

Nicholas Weedon, AABC
HMDW Architects Ltd.

26 April 2015

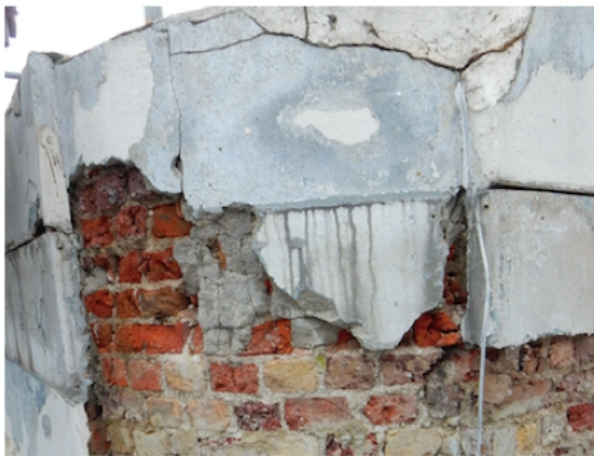
Fig.1 Parapet on corner

2.1 Visual inspection indicates that the building is generally sound, though surface cracking is evident above some windows, and along the roof parapet, in particular on the curved corner section, where the brick is also in poor condition, raising the question of whether any reconstruction should take place. The projecting cornice on the Clarkson Row side also raises a number of questions, dealt with further below.

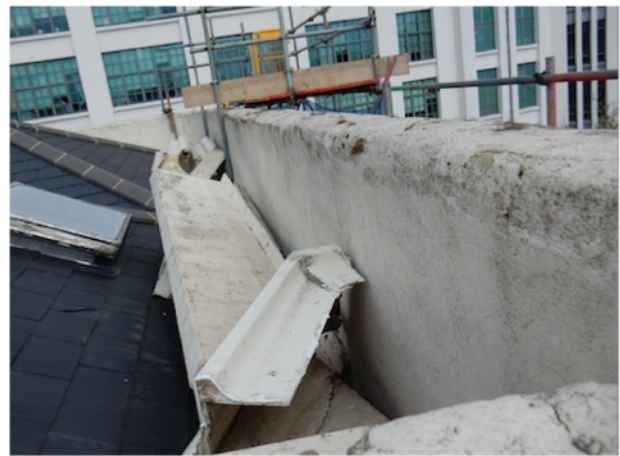
Fig. 2 Rear of south parapet

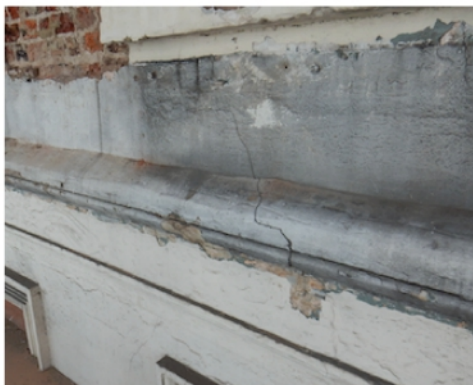
2.2 The cracking above the windows takes place along the natural weak points of the facade. They can persist due to minor cyclical movement from ground moisture or possible thermal expansion and contraction. If these look persistent, then 'Helibar' repairs are recommended. A chronic crack over one of the windows shows some slippage of the rendered profiles. This may indicate a problem with the lintel. If there is no evidence of stressing internally, or recent stressing externally, then no further remedial work is recommended.

Fig. 3 Crack through rendered string course above window on the east elevation.

It would be worth investigating whether this is superficial or also through the substrate. This could initially be done above the moulding, but the work may involve re-running of the moulding in render.

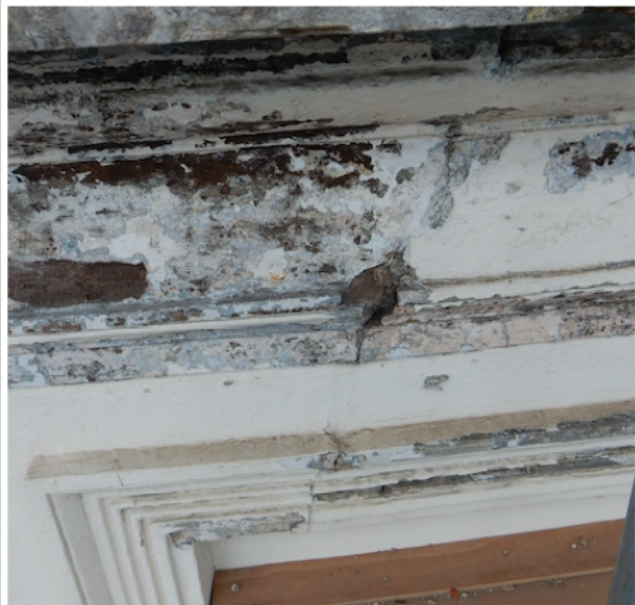
Fig 4. Old crack through mouldings

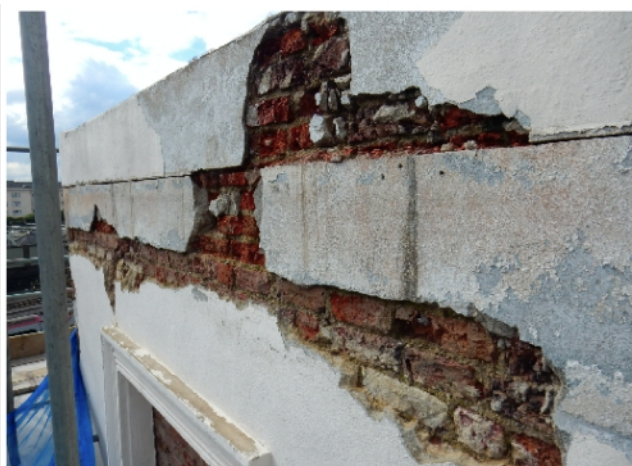
2.2 The poor condition of the parapet's external face contrasts with the internal face, whose modern render, including over the top surface, is intact, with no sign of cracking or stressing. Although the exterior surface is in very poor condition, retention and consolidation of the existing fabric should be possible, and would avoid the expense of dismantling and rebuilding the brickwork.

Fig. 5 Parapet on south side

3.1 The building, along with a number of its neighbours, has had its ornate projecting cornices replaced with glass reinforced plastic (GRP) versions. The methods by which these had been installed had not helped with the condition of the building. Chases were cut into which the top of the profiles were slotted (e.g. visible in Fig 5 and 6) but left in a way that was vulnerable to water ingress around the slots.

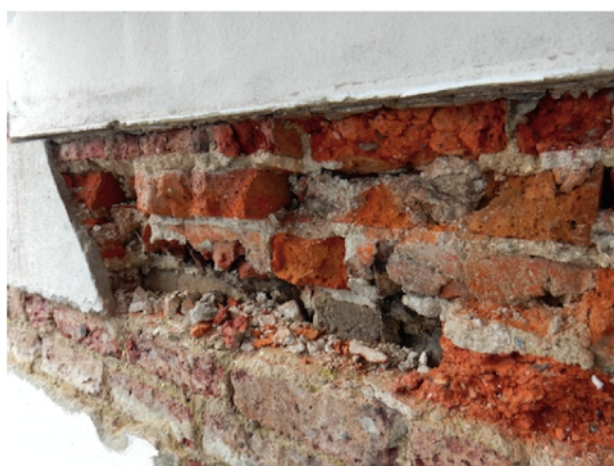
Fig. 6 Detail of poor brickwork

2.3 The brickwork below the parapet courses is in better condition, and would provide a stable base for the insertion of new bricks to replace the most severely damaged ones (i.e. those that have lost more than 35mm from the surface).

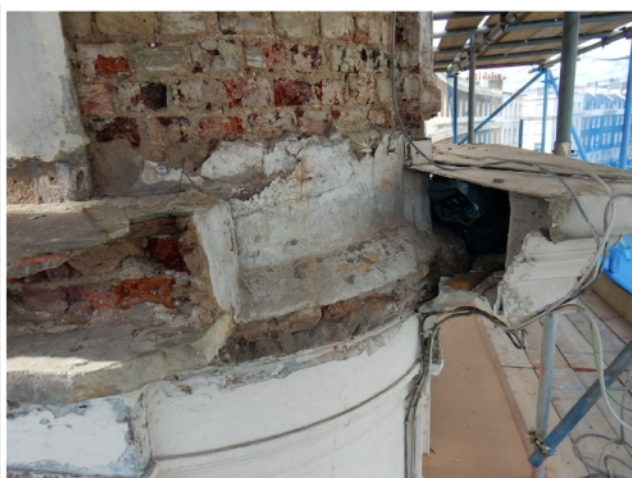
Fig. 7. Detail of mid height cornice

6.2 The mid height cornice to have had a similar detail, though water had been getting behind.

6.3 The vulnerability with this detail lies in the fact that the cover flashing to the fixing upstand was not very high, making the chase through the plaster very close to where rainwater could splash back from the top of the cornice. The recommendation is to form a high cover flashing in Code 5 lead two bricks high, so that the chase is higher up from the cornice. The bottom of the flashing should be welted so that the leading edge is robust. The lead should not be in contact with the cornice upstand, in case of capillary action allowing water to reach the screws fixing the cornice to the wall. The stopping of the render above the cornice upstand will ensure that the face of the flashing is well forward.

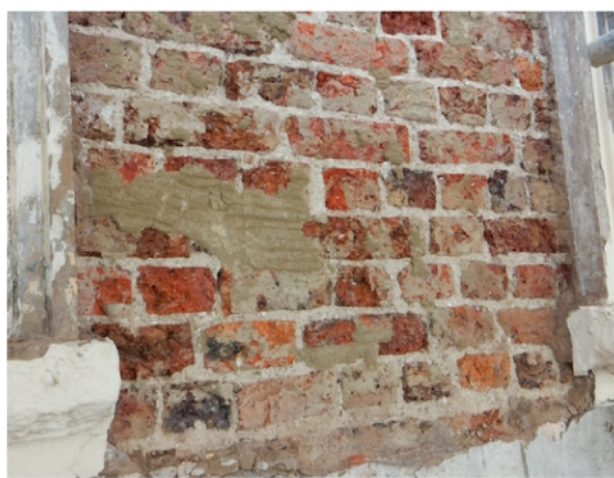
Fig.8 Wall at mid height in fair condition.

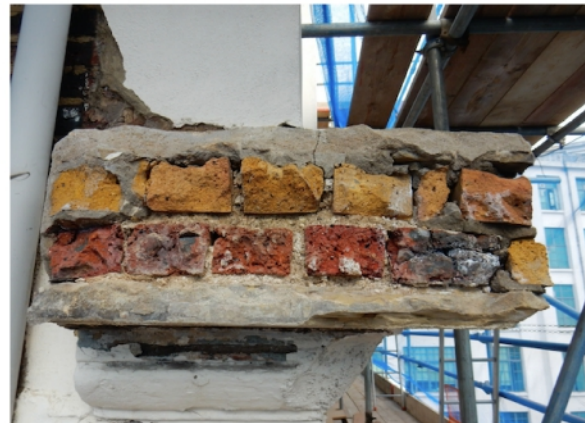
Fig.12 South cornice (west end)

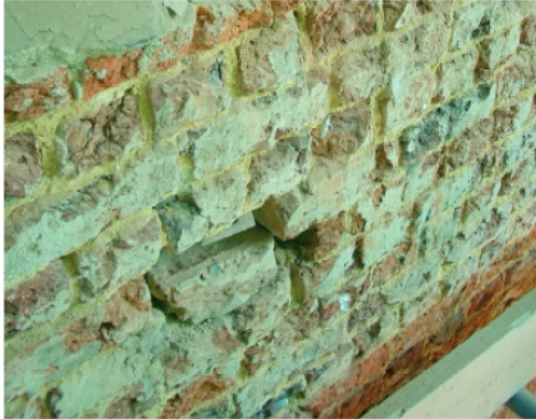
Example showing rough wall with loose bricks

Where bricks are missing, very loose, or the surface broken back more than 25mm from the surface, then cut out pockets for full length or half-bricks. Brush the wall to remove free fragments.

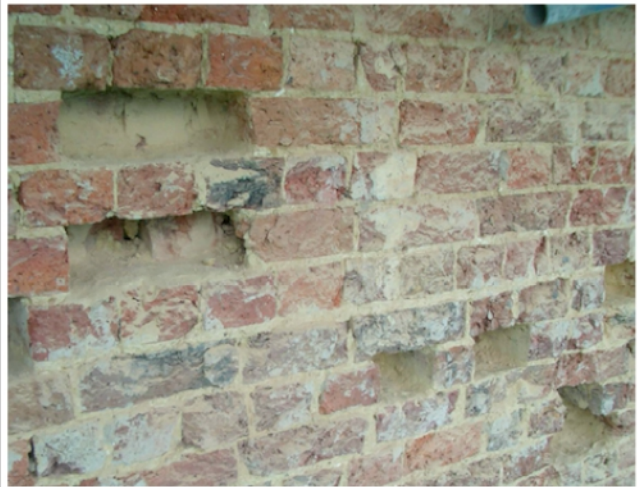
Example showing where defective or loose bricks have been cut out

Piece in replacement clay bricks (suggest salvaged or second hand), set in full bed to all sides of **lime mortar mix: 1 NHL3.5 hydraulic lime to 3 parts washed sharp sand.**
