# Sacha Barnes Ltd - Landscape and Arboriculture Consultants

## Site Monitoring Report Sheet 1

**Site Address :** 6 Templewood Avenue, London NW3.

**Development:** Extension to house.

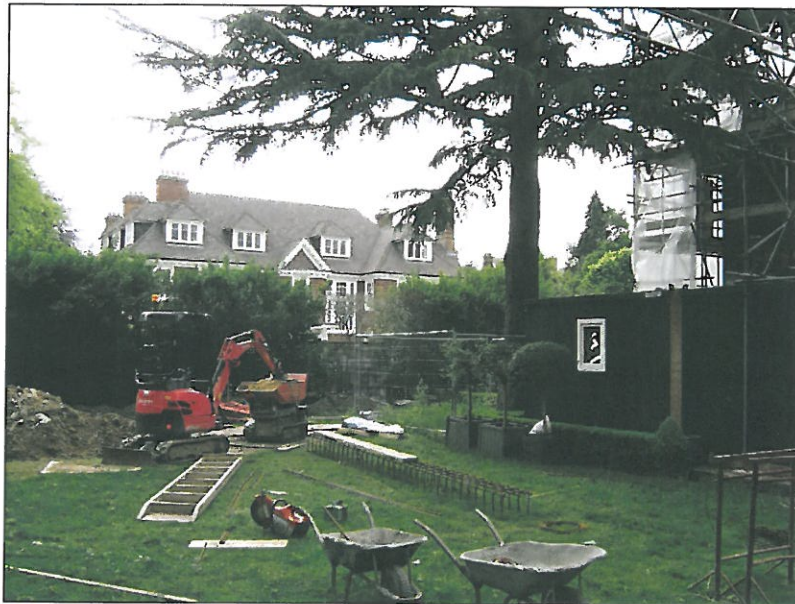
Protective fencing is in place but not to the full extent of the line shown on the approved plan. A mini excavator and mini dumper with rubber tracks was parked on the lawn area and had tracked across the root protection area. Protective boarding had been laid across the RPA. A service trench had been dug along the edge of the lawn just outside the RPA. This will be back filled early next week and the mini excavator and dumper and the pile of spoil will be removed. The protective fencing will then be moved back to the outer edge of the RPA in accordance with the approved Tree Protection Plan and secured in position. Tree Protection signs will be clearly displayed on each face of the fencing. The area below the protective boarding will then be forked over to relieve any compacted ground within the RPA. If the ground remains dry the lawn area below the tree canopy should be thoroughly irrigated.

**Photograph 1** – Mini excavator and mini dumper and pile of spoil on the lawn area. Protective boarding had been laid across the Root Protection Area. This must all be removed early next week and the protective fencing shall be put back and secured in position in accordance with the approved Tree Protection Plan.

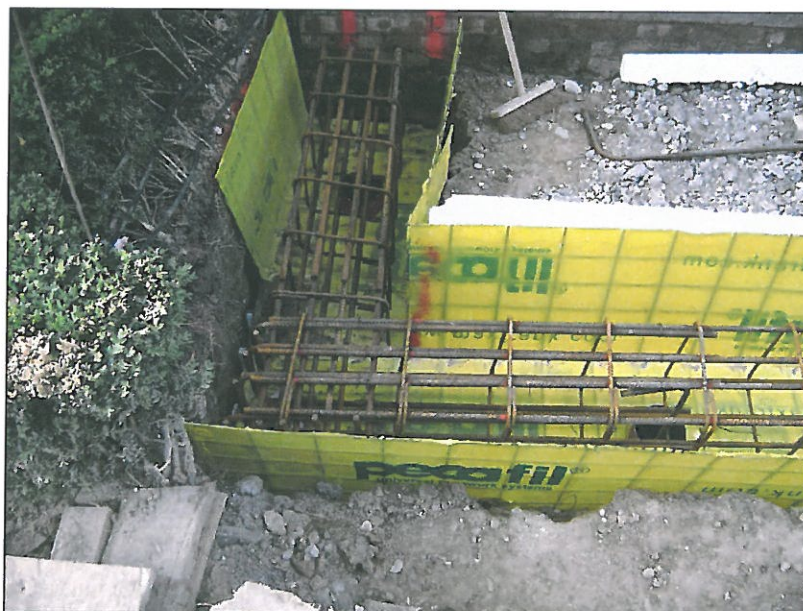
The excavation for the new piled foundation / ring beam was inspected and there were no signs of any significant roots. Machinery had operated off the existing paved area. Scaffolding had been erected up the face of the building so the tree canopy was inspected. There were no signs of any split or damaged branches. No additional scaffolding is now required as the extension only goes up to first floor level.

**Photograph 2** – The excavation for the piles and reinforced ring beam foundation. There were no signs of any significant roots.

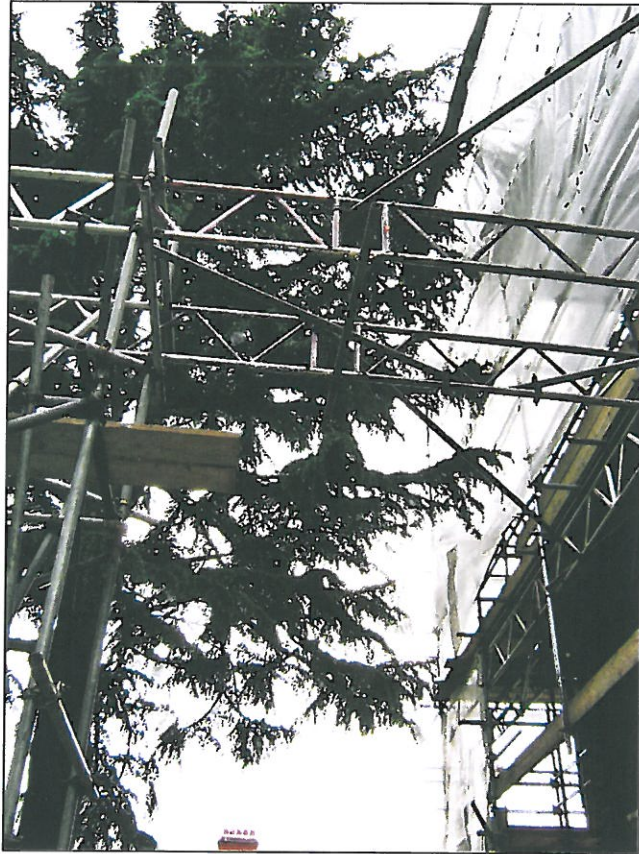
**Photograph 3** – Looking up into the tree canopy and the scaffolding erected on the face of the building. There were no signs of any split or damaged branches. Scaffolding had been erected on the existing hard paved area.
