13 Kemplay Road, Hampstead

Tree Survey Report

11th April 2016

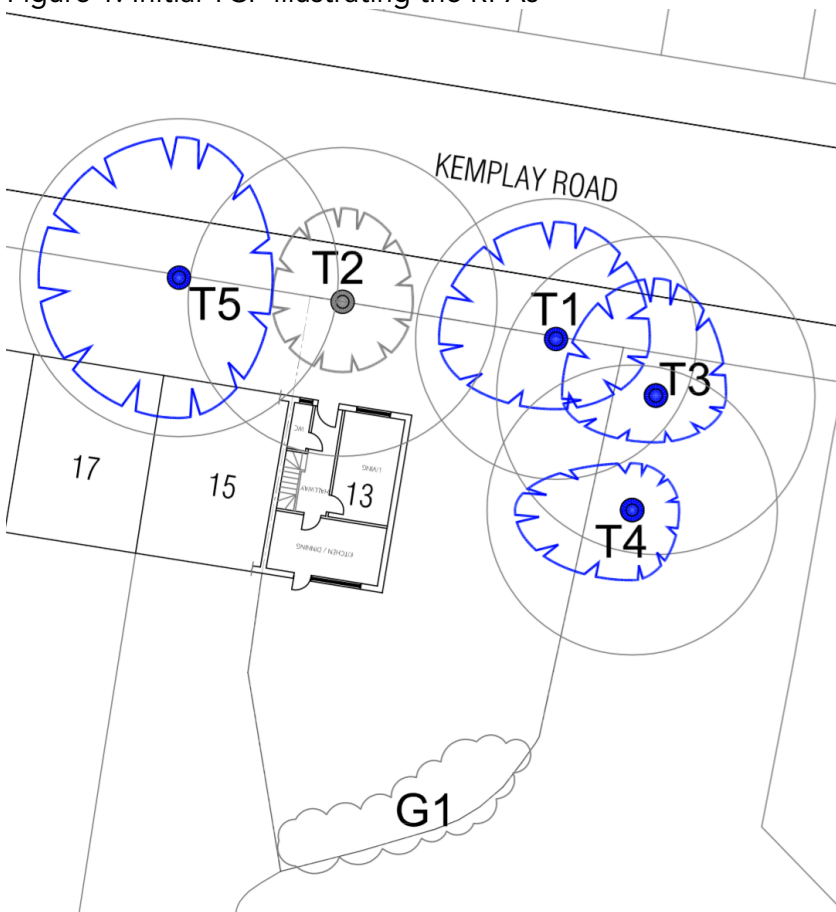
Figure 1: Initial TCP illustrating the RPAs

The detailed results of the initial tree survey are provided in the TSS (Appendix 3). In summary, the on-site trees include one category B tree, one category C tree and a category C group of small trees/shrubs. Off-site trees include three category B trees, along with two category B trees that are off-site:

- T1 – on-site sycamore “B”
- T2 – on-site sycamore “C” (significant decay)
- T3 – off-site lime “B”
- T4 – off-site lime “B”
- T5 – off site sycamore “B”
- G1 – on-site elder “C”

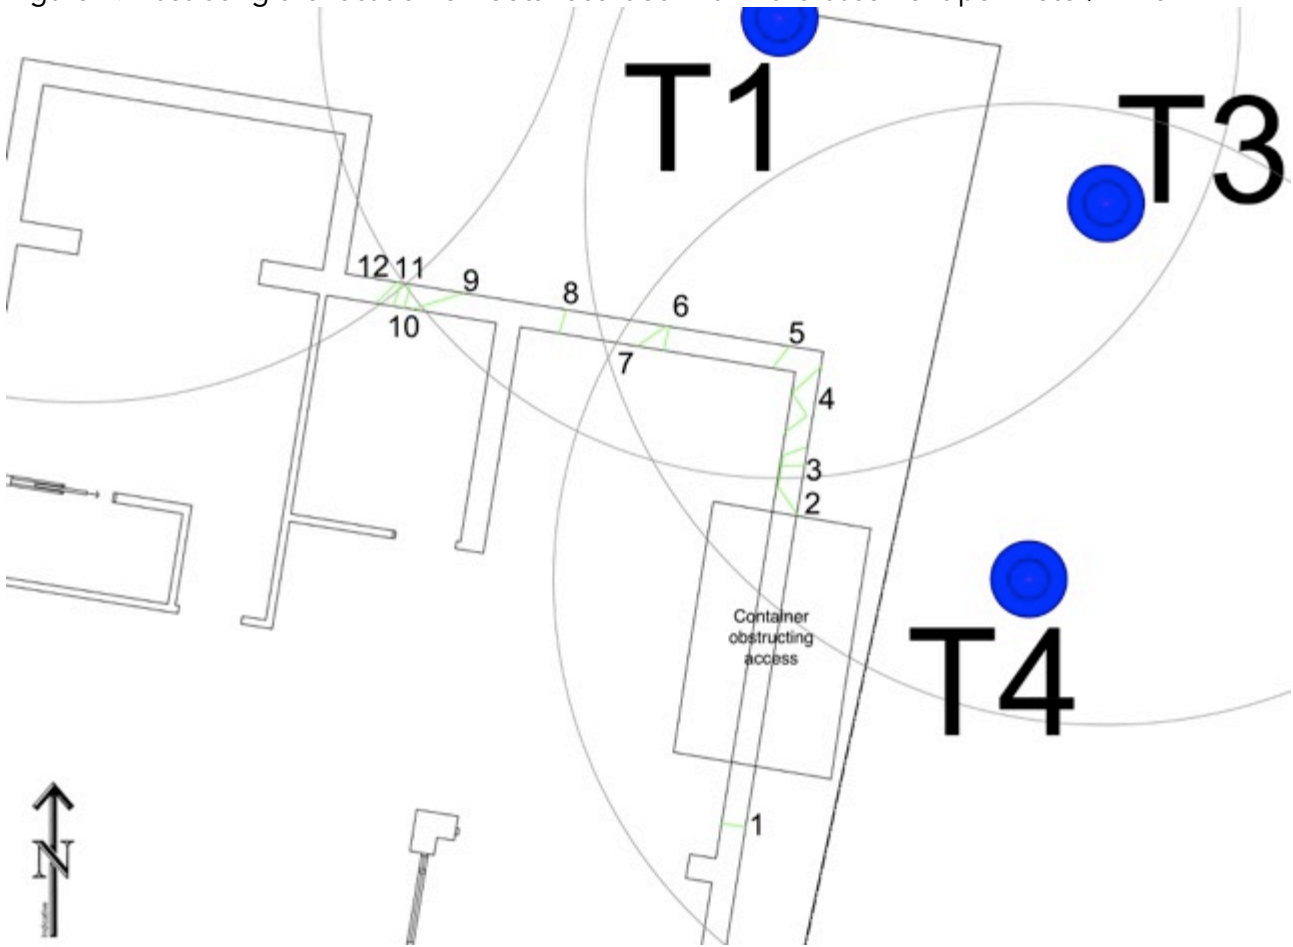
Figure 2: Illustrating the location of roots recorded within the basement perimeter/RPAs

Many roots were identified but only roots with a diameter of 20mm or above were recorded. For the purpose of presenting the results, each recorded root has been assigned a number from 1 to 12 as per the following photographs, which can be cross-referenced with Figure 2 below.

In relation to T1 and T3-4 and the exploratory root investigations, of the twelve roots identified in Section 3, the majority (10) have a diameter of 25mm or below and two roots have a diameter 35mm.

To minimise the impact of the proposed works on the trees, it is recommended that the excavation line of the northern flank is moved one metre south from the current position, which will ensure that a total of 5.5m² of available rooting space can be retained. The wall of the ground floor can continue along the line of the existing dwelling as the foundation can be cantilevered from the basement wall.

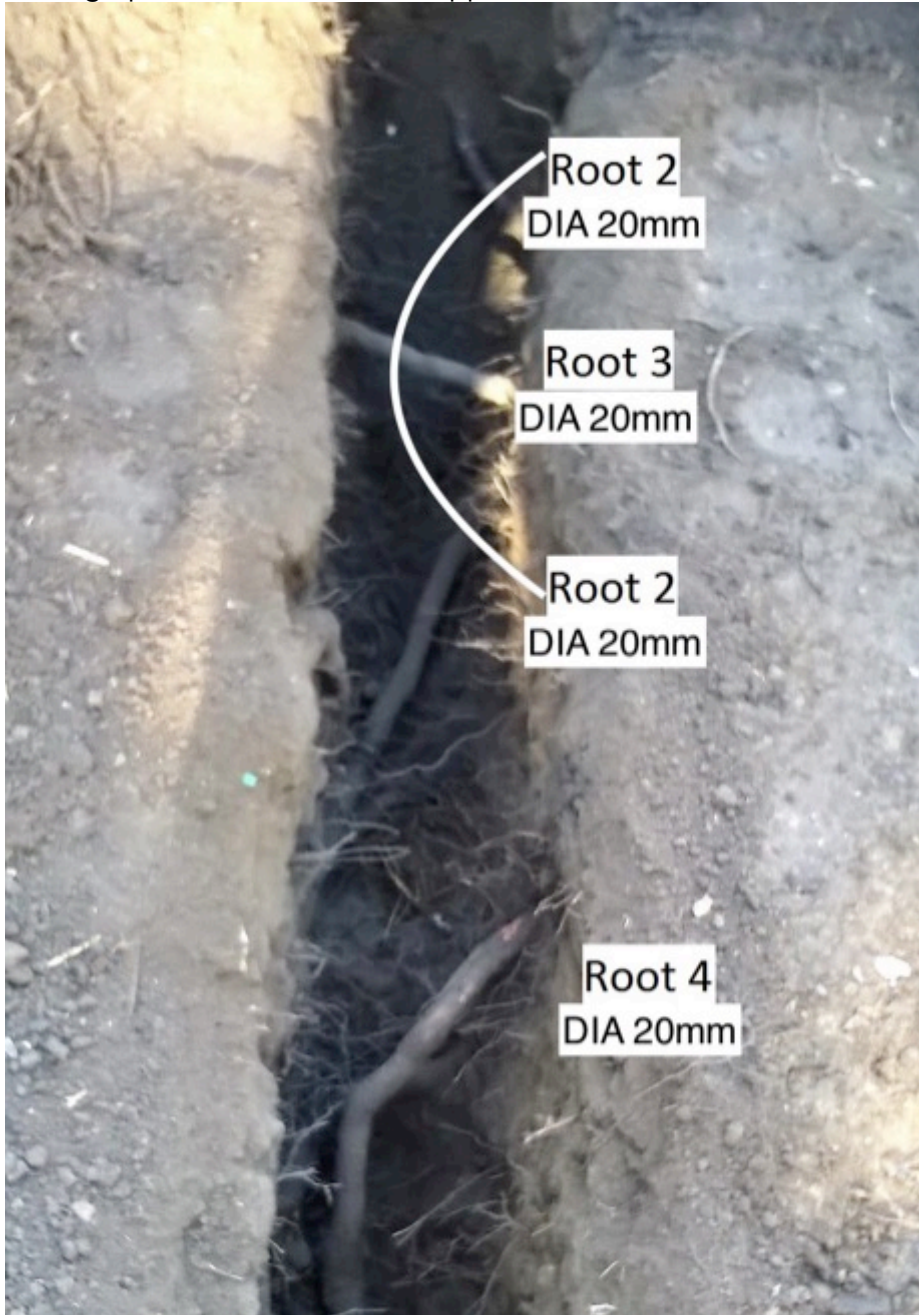
Photograph 2: Roots 2-4 (root 2 appears twice in the trench)
