Asbestos Management and Refurbishment Survey

Undertaken at
1A Ainsworth Way
Camden
London
NW8 0SR

Survey completion date: 8 Jan 2016
Report revision number: 1
Areas included in this survey report: Areas Specified by Customer
Survey Job Number: J000266
Report Date: 21 Jan 2016

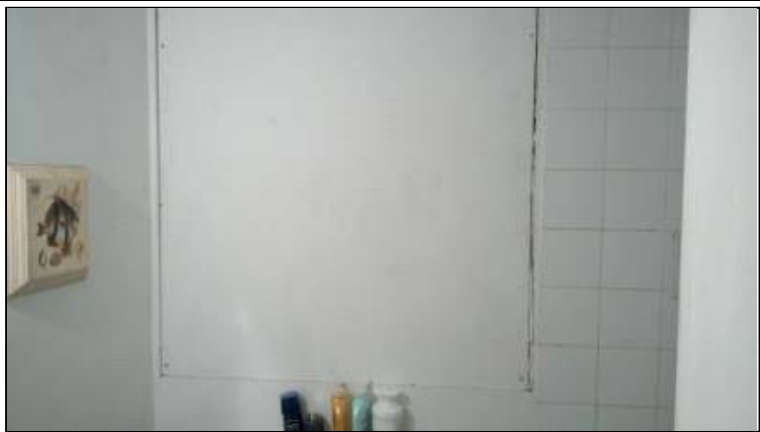
Sample Inspection Records					
Building:	Main Building	Surveyor:	Lee Barnett		
Floor:	Ground Floor	Sample/Inspection Date:	08 Jan 2016		
Room:	001 Bathroom	Survey or Inspection:	Refurbishment

Item:	Boardwork	Asbestos Type:	No Asbestos Detected

Sample Number:	AD000180	Sample Taken:	YES
		Comment:	Boardwork access panel to riser		
		Extent of Material	N/A		
		Recommendations	No action required		
		Hazard Warning Level	No Asbestos Hazard		
Material Assessment					
Product Type:	Unknown	Score:	N/A	Material Assessment Score:	0
Condition:	N/A	Score:	N/A		
Surface Treatment:	N/A	Score:	N/A	Hazard Band:	E
Asbestos Type:	No Asbestos Detected	Score:	N/A		
Priority Assessment					
Occupant Activity					
Primary Occupant Activity:	N/A	Occupancy Score:		0	
Secondary Occupant Activity:	N/A				
Likelihood of Disturbance					
Location:	N/A	Disturbance Score:		0	
Accessibility:	N/A				
Extent of Material:	N/A				
Human Exposure Potential					
Number of Occupants:	N/A	Human Exposure Score:		0	
Frequency of Use:	N/A				
Average Time Area in Use:	N/A				
Maintenance Activity					
Type of Maintenance:	N/A	Maintenance Score:		0

Frequency of Maintenance:	N/A				
Total Assessment:	Not applicable			Total Risk Band	E

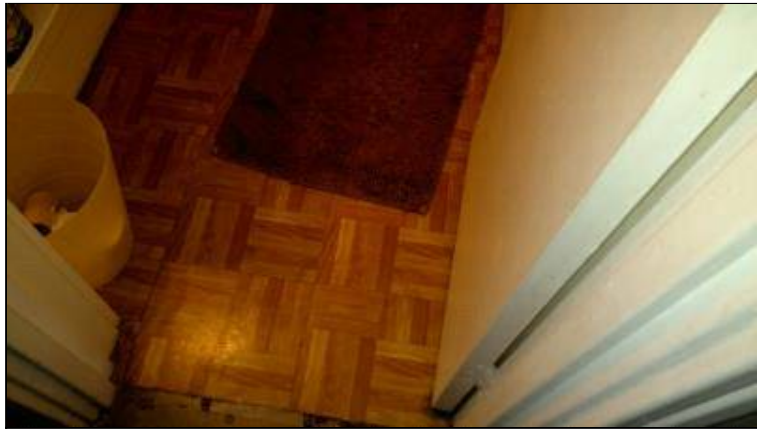
Sample Inspection Records						
Building:	Main Building	Surveyor:	Lee Barnett			
Floor:	Ground Floor	Sample/Inspection Date:	08 Jan 2016			
Room:	001 Bathroom	Survey or Inspection:	Refurbishment

Item:	Bitumen adhesive	Asbestos Type:	Chrysotile

Sample Number:	AD000181	Sample Taken: YES		
		Comment:	Bitumen adhesive below 1 layer of non-ACM floor covering			
		Extent of Material	4m ²			
		Recommendations	Remove Prior To Demolition or Refurbishment			
		Hazard Warning Level	Minor Hazard Material			
Material Assessment						
Product Type:	Well Bound Material	Score:	1	Material Assessment Score:	2	
Condition:	Good Condition	Score:	0			
Surface Treatment:	Completely Sealed	Score:	0	Hazard Band:	D	
Asbestos Type:	Chrysotile	Score:	1			
Priority Assessment						
Occupant Activity						
Primary Occupant Activity:	Periodic disturbance	Occupancy Score:		2		
Secondary Occupant Activity:	Periodic disturbance					
Likelihood of Disturbance						
Location:	Confined spaces (including rooms less than 10 square metres)		Disturbance Score:		2	
Accessibility:	Occasionally disturbed					
Extent of Material:	Up to 10 square metres or 10 linear metres

Human Exposure Potential						
Number of Occupants:	4 to 10		Human Exposure Score:		3	
Frequency of Use:	Daily					
Average Time Area in Use:	3 to 6 hours					
Maintenance Activity						
Type of Maintenance:	Low disturbance		Maintenance Score:		1	
Frequency of Maintenance:	Less than once a year					
Total Assessment:	Low risk material requiring regular inspection			Total Risk Band	10 C

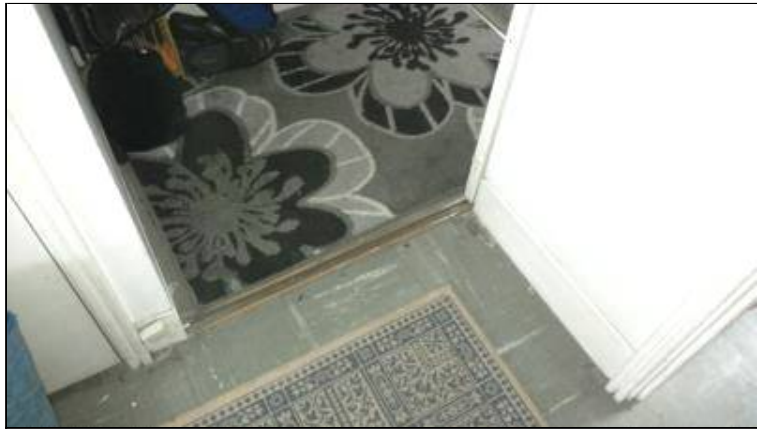
Sample Inspection Records						
Building:	Main Building	Surveyor:	Lee Barnett			
Floor:	Ground Floor	Sample/Inspection Date:	08 Jan 2016			
Room:	002 Hallway	Survey or Inspection:	Management

Item:	Grey floor tiles and bitumen adhesive	Asbestos Type:	Presumed Chrysotile

Sample Number:	As AD000176	Sample Taken:	NO	
		Comment:	Grey floor tiles and bitumen adhesive to floor – strongly presume the same as sample AD000176			
		Extent of Material	10m ²			
		Recommendations	Label & Manage			
		Hazard Warning Level	Minor Hazard Material			
Material Assessment						
Product Type:	Well Bound Material	Score:	1	Material Assessment Score:	3	
Condition:	Low Damage	Score:	1			
Surface Treatment:	Completely Sealed	Score:	0	Hazard Band:	D	
Asbestos Type:	Presumed Chrysotile	Score:	1			
Priority Assessment						
Occupant Activity						
Primary Occupant Activity:	Periodic disturbance	Occupancy Score:		2		
Secondary Occupant Activity:	Periodic disturbance					
Likelihood of Disturbance						
Location:	Rooms up to 100 square metres	Disturbance Score:		2		
Accessibility:	Easily disturbed					
Extent of Material:	10 — 50 square metres or linear metres

Human Exposure Potential						
Number of Occupants:	4 to 10	Human Exposure Score:		3		
Frequency of Use:	Daily					
Average Time Area in Use:	3 to 6 hours					
Maintenance Activity						
Type of Maintenance:	Low disturbance	Maintenance Score:		1		
Frequency of Maintenance:	Less than once a year					
Total Assessment:	Low risk material requiring regular inspection			Total Risk Band	11 C

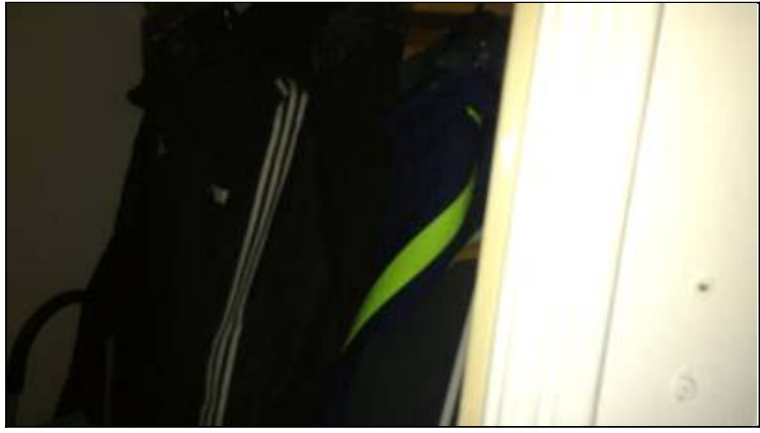
Sample Inspection Records						
Building:	Main Building	Surveyor:	Lee Barnett			
Floor:	Ground Floor	Sample/Inspection Date:	08 Jan 2016			
Room:	003 Hallway Cupboard	Survey or Inspection:	Management

Item:	Non-accessed item.	Asbestos Type:	Not Known

Sample Number:	N/A 14	Sample Taken: NO		
		Comment:	No access due to stored items			
		Extent of Material	N/A			
		Recommendations	This requires inspection before any works are undertaken.			
		Hazard Warning Level	High Hazard Material			
Material Assessment						
Product Type:	N/A	Score:	N/A	Material Assessment Score:	N/A	
Condition:	N/A	Score:	N/A			
Surface Treatment:	N/A	Score:	N/A	Hazard Band:	A	
Asbestos Type:	Not Known	Score:	N/A			
Priority Assessment						
Occupant Activity						
Primary Occupant Activity:	N/A	Occupancy Score:		N/A		
Secondary Occupant Activity:	N/A					
Likelihood of Disturbance						
Location:	N/A	Disturbance Score:		N/A		
Accessibility:	N/A					
Extent of Material:	N/A					
Human Exposure Potential						
Number of Occupants:	N/A	Human Exposure Score:		N/A		
Frequency of Use:	N/A					
Average Time Area in Use:	N/A					
Maintenance Activity

Type of Maintenance:	N/A	Maintenance Score:		N/A		
Frequency of Maintenance:	N/A					
Total Assessment:	This requires inspection before any works are undertaken				Total Risk Band	N/A

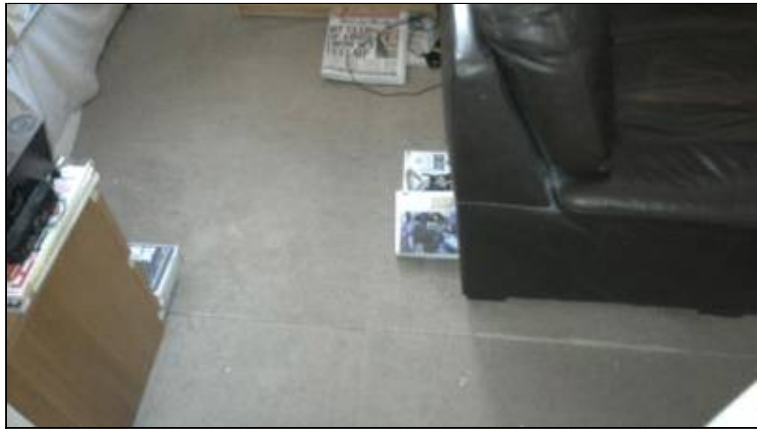
Sample Inspection Records						
Building:	Main Building	Surveyor:	Lee Barnett			
Floor:	Ground Floor	Sample/Inspection Date:	08 Jan 2016			
Room:	005 Bedroom 3	Survey or Inspection:	Management

Item:	Grey floor tiles and bitumen adhesive	Asbestos Type:	Presumed Chrysotile

Sample Number:	As AD000176	Sample Taken:	NO	
		Comment:	Grey floor tiles and bitumen adhesive below 1 layer of non-ACM floor covering – strongly presume the same as sample AD000176			
		Extent of Material	20m ²			
		Recommendations	Label & Manage			
		Hazard Warning Level	Minor Hazard Material			
Material Assessment						
Product Type:	Well Bound Material	Score:	1	Material Assessment Score:	3	
Condition:	Low Damage	Score:	1			
Surface Treatment:	Completely Sealed	Score:	0	Hazard Band:	D	
Asbestos Type:	Presumed Chrysotile	Score:	1			
Priority Assessment						
Occupant Activity						
Primary Occupant Activity:	Periodic disturbance	Occupancy Score:		2		
Secondary Occupant Activity:	Periodic disturbance					
Likelihood of Disturbance						
Location:	Rooms up to 100 square metres	Disturbance Score:		2		
Accessibility:	Occasionally disturbed

Extent of Material:	10 — 50 square metres or linear metres					
Human Exposure Potential						
Number of Occupants:	4 to 10	Human Exposure Score:		3		
Frequency of Use:	Daily					
Average Time Area in Use:	>6 hours					
Maintenance Activity						
Type of Maintenance:	Low disturbance	Maintenance Score:		1		
Frequency of Maintenance:	Less than once a year					
Total Assessment:	Low risk material requiring regular inspection				Total Risk Band	11 C

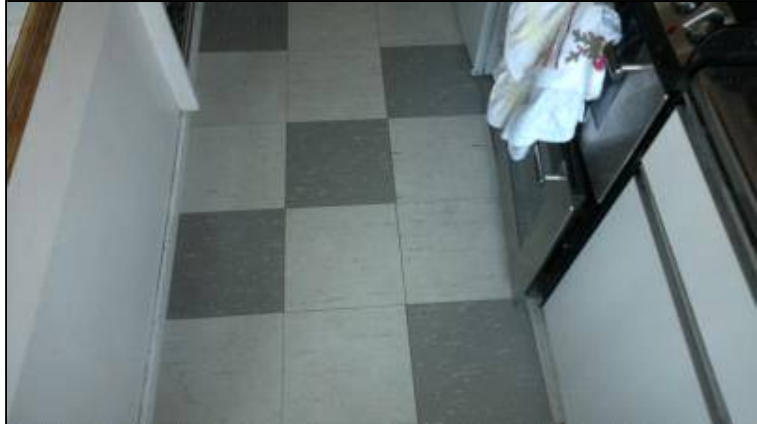
Sample Inspection Records						
Building:	Main Building	Surveyor:	Lee Barnett			
Floor:	1st Floor	Sample/Inspection Date:	08 Jan 2016			
Room:	001 Kitchen	Survey or Inspection:	Refurbishment

Item:	Grey patterned floor tiles and bitumen adhesive	Asbestos Type:	Chrysotile

Sample Number:	AD000175	Sample Taken:	YES	
		Comment:	Grey patterned floor tiles and bitumen adhesive to floor - asbestos identified in bitumen backing only			
		Extent of Material	8m ²			
		Recommendations	Remove Prior To Demolition or Refurbishment			
		Hazard Warning Level	Minor Hazard Material			
Material Assessment						
Product Type:	Well Bound Material	Score:	1	Material Assessment Score:	3	
Condition:	Low Damage	Score:	1			
Surface Treatment:	Completely Sealed	Score:	0			
Asbestos Type:	Chrysotile	Score:	1	Hazard Band:	D	
Priority Assessment						
Occupant Activity						
Primary Occupant Activity:	Periodic disturbance	Occupancy Score:		2		
Secondary Occupant Activity:	Periodic disturbance					
Likelihood of Disturbance						
Location:	Rooms up to 100 square metres	Disturbance Score:		2		
Accessibility:	Easily disturbed

Extent of Material:	Up to 10 square metres or 10 linear metres					
Human Exposure Potential						
Number of Occupants:	4 to 10	Human Exposure Score:		3		
Frequency of Use:	Daily					
Average Time Area in Use:	>6 hours					
Maintenance Activity						
Type of Maintenance:	Low disturbance	Maintenance Score:		1		
Frequency of Maintenance:	Less than once a year					
Total Assessment:	Low risk material requiring regular inspection			Total Risk Band	11 C

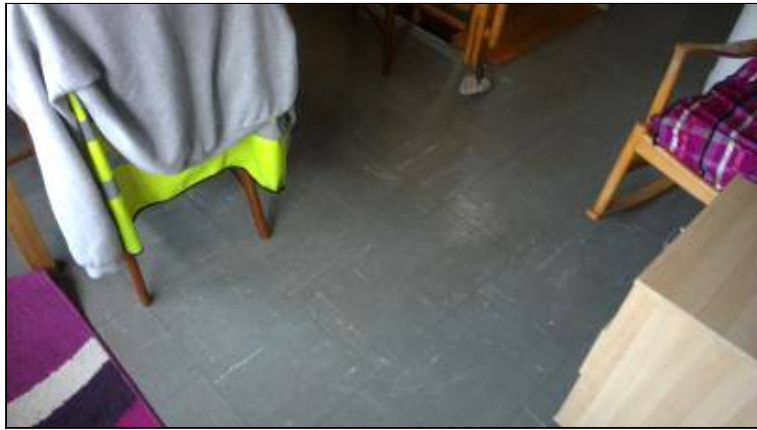
Sample Inspection Records						
Building:	Main Building	Surveyor:	Lee Barnett			
Floor:	1st Floor	Sample/Inspection Date:	08 Jan 2016			
Room:	002 Dining Room	Survey or Inspection:	Management

Item:	Grey floor tiles and bitumen adhesive	Asbestos Type:	Chrysotile

Sample Number:	AD000176	Sample Taken: YES		
		Comment:	Grey floor tiles and bitumen adhesive to floor			
		Extent of Material	18m ²			
		Recommendations	Label & Manage			
		Hazard Warning Level	Minor Hazard Material			
Material Assessment						
Product Type:	Well Bound Material	Score:	1	Material Assessment Score:	2	
Condition:	Good Condition	Score:	0		Hazard Band:	D
Surface Treatment:	Completely Sealed	Score:	0			
Asbestos Type:	Chrysotile	Score:	1			
Priority Assessment						
Occupant Activity						
Primary Occupant Activity:	Periodic disturbance	Occupancy Score:		2		
Secondary Occupant Activity:	Periodic disturbance					
Likelihood of Disturbance						
Location:	Rooms up to 100 square metres	Disturbance Score:		2		
Accessibility:	Easily disturbed					
Extent of Material:	10 — 50 square metres or linear metres					
Human Exposure Potential

Number of Occupants:	4 to 10	Human Exposure Score:		3		
Frequency of Use:	Daily					
Average Time Area in Use:	>6 hours					
Maintenance Activity						
Type of Maintenance:	Low disturbance	Maintenance Score:		1		
Frequency of Maintenance:	Less than once a year					
Total Assessment:	Low risk material requiring regular inspection			Total Risk Band	10 C

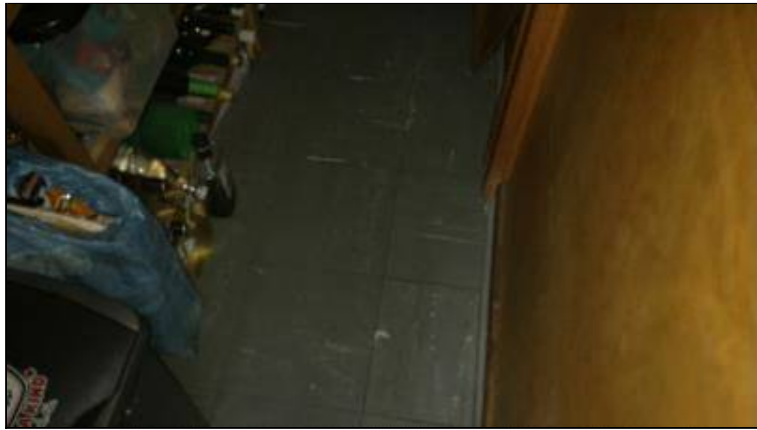
Sample Inspection Records						
Building:	Main Building	Surveyor:	Lee Barnett			
Floor:	1st Floor	Sample/Inspection Date:	08 Jan 2016			
Room:	003 Store	Survey or Inspection:	Management

Item:	Grey floor tiles and bitumen adhesive	Asbestos Type:	Presumed Chrysotile

Sample Number:	As AD000176	Sample Taken:	NO	
		Comment:	Grey floor tiles and bitumen adhesive to floor – strongly presume the same as sample AD000176			
		Extent of Material	3			
		Recommendations	Label & Manage			
		Hazard Warning Level	Minor Hazard Material			
Material Assessment						
Product Type:	Well Bound Material	Score:	1	Material Assessment Score:	3	
Condition:	Low Damage	Score:	1			
Surface Treatment:	Completely Sealed	Score:	0	Hazard Band:	D	
Asbestos Type:	Presumed Chrysotile	Score:	1			
Priority Assessment						
Occupant Activity						
Primary Occupant Activity:	Low disturbance	Occupancy Score:		1		
Secondary Occupant Activity:	Low disturbance					
Likelihood of Disturbance						
Location:	Confined spaces (including rooms less than 10 square metres)	Disturbance Score:		2		
Accessibility:	Easily disturbed

Extent of Material:	Up to 10 square metres or 10 linear metres					
Human Exposure Potential						
Number of Occupants:	1 to 3	Human Exposure Score:		2		
Frequency of Use:	Daily					
Average Time Area in Use:	1 to 3 hours					
Maintenance Activity						
Type of Maintenance:	Low disturbance	Maintenance Score:		1		
Frequency of Maintenance:	Less than once a year					
Total Assessment:	Low risk material requiring regular inspection			Total Risk Band	9 C

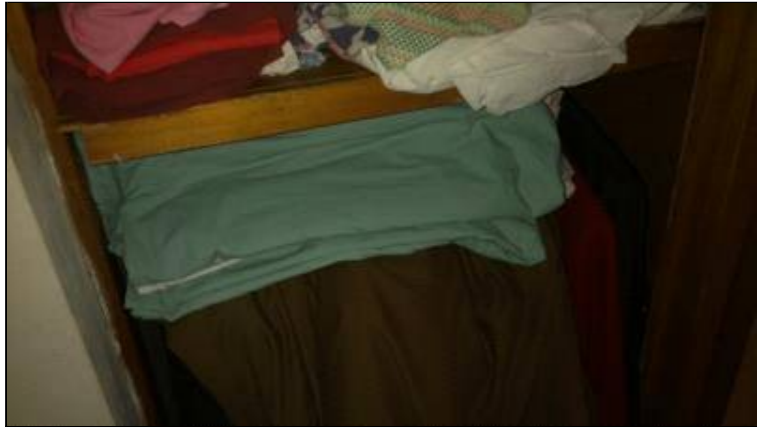
Sample Inspection Records					
Building:	Main Building	Surveyor:	Lee Barnett		
Floor:	1st Floor	Sample/Inspection Date:	08 Jan 2016		
Room:	004 Store Cupboard	Survey or Inspection:	Management

Item:	Boardwork	Asbestos Type:	No Asbestos Detected

Sample Number:	AD000177	Sample Taken:	YES
		Comment:	Boardwork Infill panel to wall behind stored items		
		Extent of Material	N/A		
		Recommendations	No action required		
		Hazard Warning Level	No Asbestos Hazard		
Material Assessment					
Product Type:	Unknown	Score:	N/A	Material Assessment Score:	0
Condition:	N/A	Score:	N/A		
Surface Treatment:	N/A	Score:	N/A	Hazard Band:	E
Asbestos Type:	No Asbestos Detected	Score:	N/A		
Priority Assessment					
Occupant Activity					
Primary Occupant Activity:	N/A	Occupancy Score:		0	
Secondary Occupant Activity:	N/A				
Likelihood of Disturbance					
Location:	N/A	Disturbance Score:		0	
Accessibility:	N/A				
Extent of Material:	N/A				
Human Exposure Potential					
Number of Occupants:	N/A	Human Exposure Score:		0	
Frequency of Use:	N/A				
Average Time Area in Use:	N/A				
Maintenance Activity					
Type of Maintenance:	N/A	Maintenance Score:		0

Frequency of Maintenance:	N/A				
Total Assessment:	Not applicable		Total Risk Band E

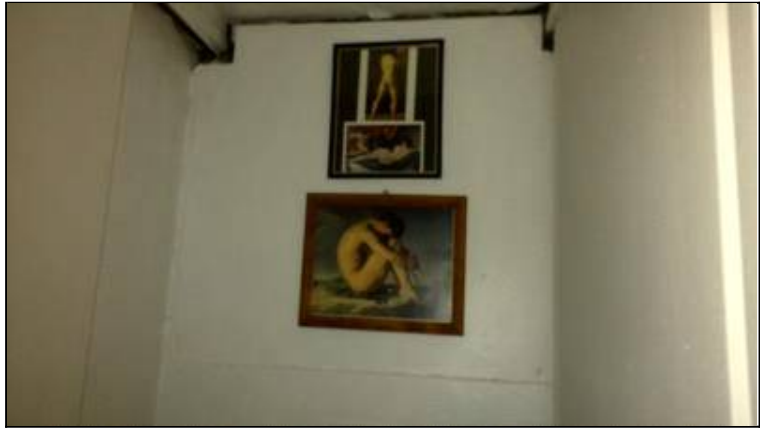
Sample Inspection Records					
Building:	Main Building	Surveyor:	Lee Barnett		
Floor:	1st Floor	Sample/Inspection Date:	08 Jan 2016		
Room:	005 Toilet	Survey or Inspection:	Refurbishment

Item:	Boardwork	Asbestos Type:	No Asbestos Detected

Sample Number:	AD000178	Sample Taken:	YES
		Comment:	Boardwork access panel to riser		
		Extent of Material	N/A		
		Recommendations	No action required		
		Hazard Warning Level	No Asbestos Hazard		
Material Assessment					
Product Type:	Unknown	Score:	N/A	Material Assessment Score:	0
Condition:	N/A	Score:	N/A		
Surface Treatment:	N/A	Score:	N/A	Hazard Band:	E
Asbestos Type:	No Asbestos Detected	Score:	N/A		
Priority Assessment					
Occupant Activity					
Primary Occupant Activity:	N/A	Occupancy Score:		0	
Secondary Occupant Activity:	N/A				
Likelihood of Disturbance					
Location:	N/A	Disturbance Score:		0	
Accessibility:	N/A				
Extent of Material:	N/A				
Human Exposure Potential					
Number of Occupants:	N/A	Human Exposure Score:		0	
Frequency of Use:	N/A				
Average Time Area in Use:	N/A				
Maintenance Activity					
Type of Maintenance:	N/A	Maintenance Score:		0

Frequency of Maintenance:	N/A				
Total Assessment:	Not applicable		Total Risk Band E

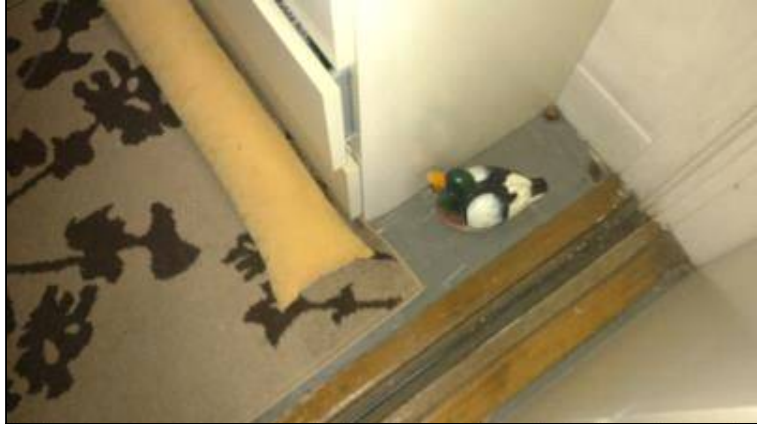
Sample Inspection Records						
Building:	Main Building	Surveyor:	Lee Barnett			
Floor:	1st Floor	Sample/Inspection Date:	08 Jan 2016			
Room:	006 Bedroom 1	Survey or Inspection:	Management

Item:	Grey floor tiles and bitumen adhesive	Asbestos Type:	Presumed Chrysotile

Sample Number:	As AD000176	Sample Taken:	NO	
		Comment:	Grey floor tiles and bitumen adhesive below 1 layer of non-ACM floor covering – strongly presume the same as sample AD000176			
		Extent of Material	12m ²			
		Recommendations	Label & Manage			
		Hazard Warning Level	Minor Hazard Material			
Material Assessment						
Product Type:	Well Bound Material	Score:	1	Material Assessment Score:	3	
Condition:	Low Damage	Score:	1			
Surface Treatment:	Completely Sealed	Score:	0	Hazard Band:	D	
Asbestos Type:	Presumed Chrysotile	Score:	1			
Priority Assessment						
Occupant Activity						
Primary Occupant Activity:	Periodic disturbance	Occupancy Score:		2		
Secondary Occupant Activity:	Periodic disturbance					
Likelihood of Disturbance						
Location:	Rooms up to 100 square metres	Disturbance Score:		2		
Accessibility:	Occasionally disturbed

Extent of Material:	10 — 50 square metres or linear metres					
Human Exposure Potential						
Number of Occupants:	4 to 10	Human Exposure Score:		3		
Frequency of Use:	Daily					
Average Time Area in Use:	>6 hours					
Maintenance Activity						
Type of Maintenance:	Low disturbance	Maintenance Score:		1		
Frequency of Maintenance:	Less than once a year					
Total Assessment:	Low risk material requiring regular inspection				Total Risk Band	11 C

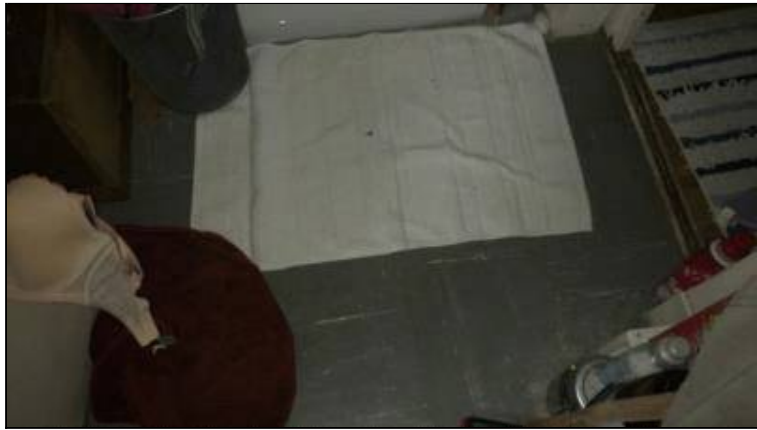
Sample Inspection Records						
Building:	Main Building	Surveyor:	Lee Barnett			
Floor:	1st Floor	Sample/Inspection Date:	08 Jan 2016			
Room:	007 Bedroom Cupboard	Survey or Inspection:	Management

Item:	Grey floor tiles and bitumen adhesive	Asbestos Type:	Presumed Chrysotile

Sample Number:	As AD000176	Sample Taken:	NO	
		Comment:	Grey floor tiles and bitumen adhesive below 1 layer of non-ACM floor covering – strongly presume the same as sample AD000176			
		Extent of Material	5m ²			
		Recommendations	Label & Manage			
		Hazard Warning Level	Minor Hazard Material			
Material Assessment						
Product Type:	Well Bound Material	Score:	1	Material Assessment Score:	3	
Condition:	Low Damage	Score:	1			
Surface Treatment:	Completely Sealed	Score:	0	Hazard Band:	D	
Asbestos Type:	Presumed Chrysotile	Score:	1			
Priority Assessment						
Occupant Activity						
Primary Occupant Activity:	Low disturbance	Occupancy Score:		1		
Secondary Occupant Activity:	Low disturbance					
Likelihood of Disturbance						
Location:	Confined spaces (including rooms less than 10 square metres)	Disturbance Score:		2

Accessibility:	Easily disturbed					
Extent of Material:	Up to 10 square metres or 10 linear metres					
Human Exposure Potential						
Number of Occupants:	1 to 3	Human Exposure Score:		2		
Frequency of Use:	Daily					
Average Time Area in Use:	1 to 3 hours					
Maintenance Activity						
Type of Maintenance:	Low disturbance	Maintenance Score:		1		
Frequency of Maintenance:	Less than once a year					
Total Assessment:	Low risk material requiring regular inspection				Total Risk Band	9 C
