Schedule of Significance

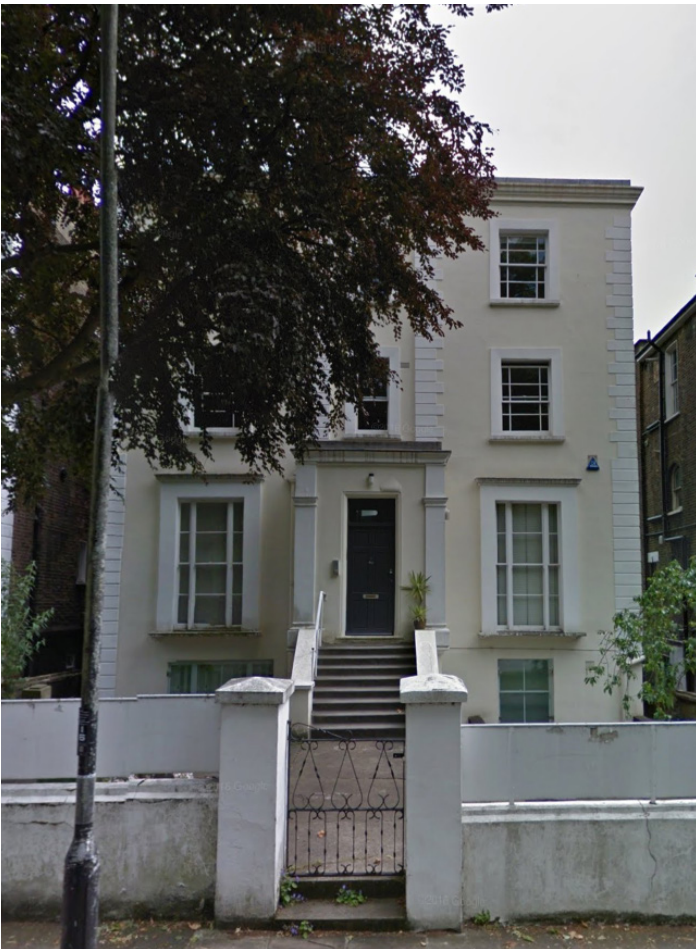
Figure 6.1 Front facade. **Figure 6.2** Rear facade, showing the incoherency of the lower ground floor windows and their style. **Figure 6.3** Kitchen on lower ground floor. **Figure 6.4** Showing undesirable compromise of bathroom door. **Figure 6.5** Showing original looking window of front facade which is to be kept intact but repaired. **Figure 6.6** The blocked rear elevation bathroom window. **Figure 6.7** One of the airy reception rooms. **Figure 6.8** The garden, lush but needs tending to.

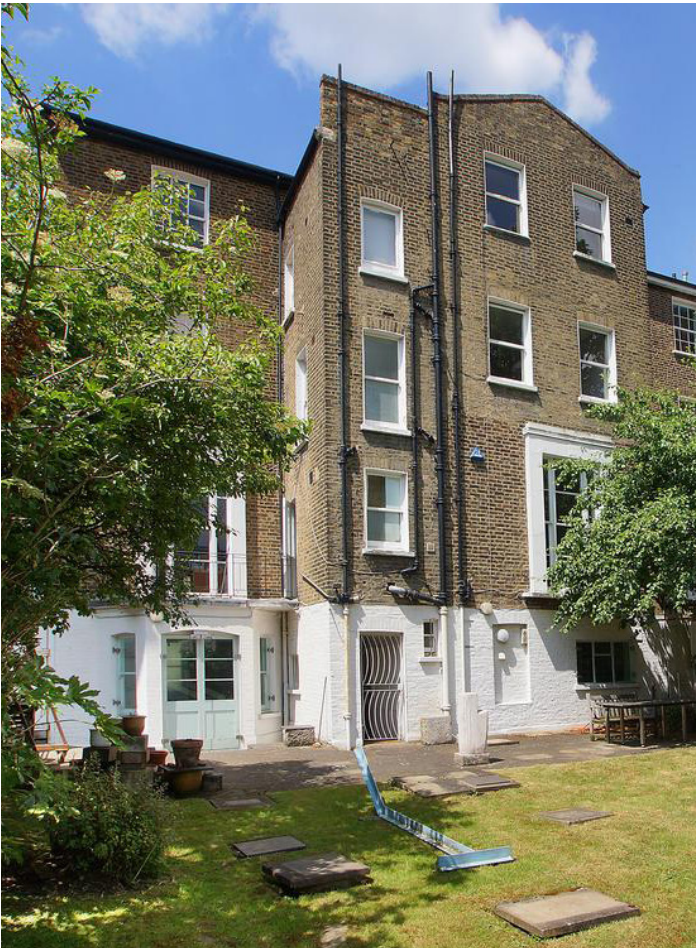
Figure 6.2

The front elevation is harmonious, but the rear elevation (especially the lower ground floor) requires great amendments to look more coherent.

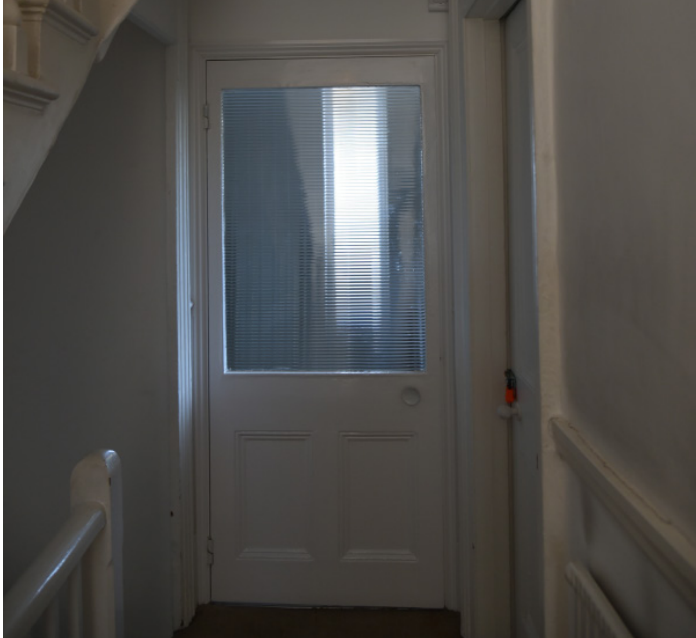
Figure 6.4

Internally, there is limited original cornicing and skirting, and most of the fireplaces are blocked up. Some rooms feature carpet, some seem to have a original wooden floors whilst others have new wooden floors. A few internal doors feature a compromise between traditional door and functional bathroom door, which leaves an undesirable impression. One of the bathroom windows on the upper ground floor is half covered from the inside by a new wall, which affects the rear elevation in a negative manor.
