# Simon Pryce Arboriculture

**Client:** Ms A Knight

**Site:** 40 Camden Square, London, NW1 9XA

**Subject:** Tree survey

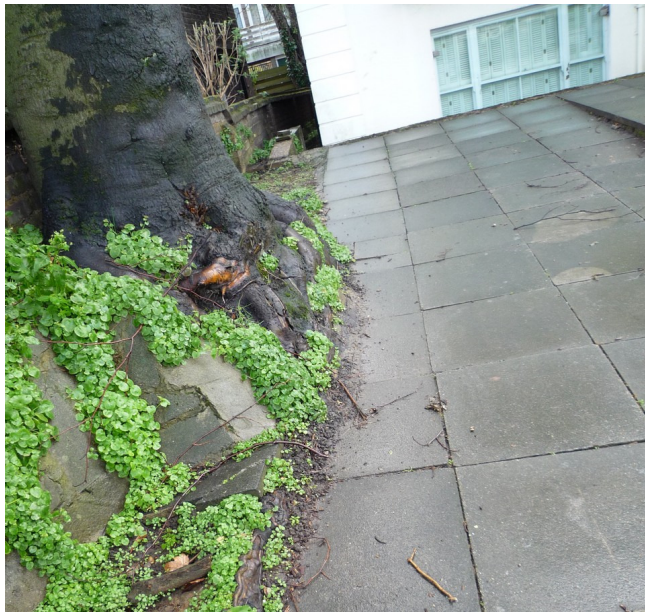
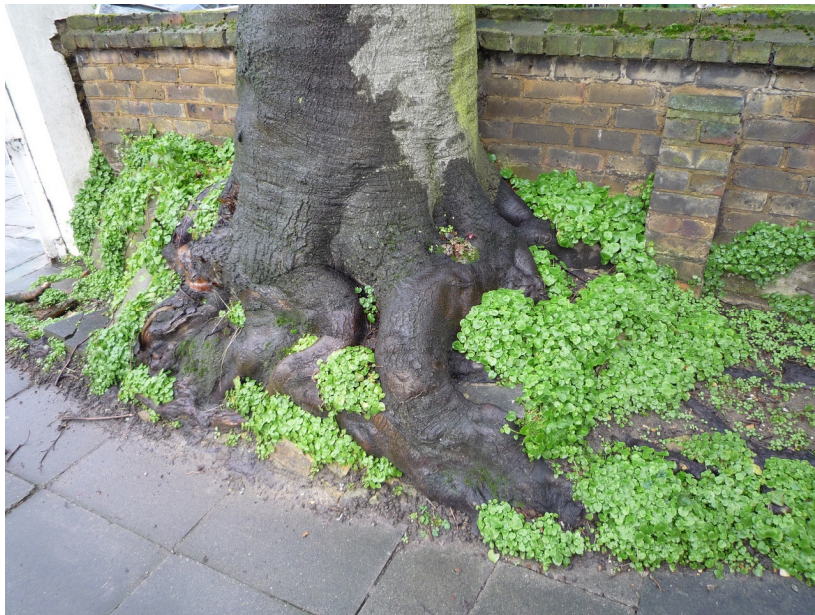
- 4.4 It is not clear how the left hand side of the front garden was landscaped before the drive was laid, but the roots at the base of the copper beech spread parallel with the drive, which suggests that they had been contained until then by a retaining wall or planting bed edge, which restricted their spread while they were developing. There are some minor superficial wounds caused by vehicle wheels on the roots, but no signs that any major roots were cut in order to lay the drive, which also suggests that there were no large ones where the drive now is. This was done almost fifty years ago, there are no signs of decay and the tree is in good physiological condition, so it has evidently recovered from any damage that occurred. Also the drive is flat with no signs of any subsequent major root development underneath.

Views of the base of the copper beech, showing where roots were contained and directed parallel with the drive early in the tree's life. The surface has remained flat and level suggesting that no large roots have spread under the drive since it was laid.

- 4.5 This area is well within the tree's potential root zone, as indicated by the RPA circle, so the work here will need to take that into account. However the points outlined above indicate that it will be possible to replace the existing drive, possibly keeping the existing sub base, and carry out some low key landscaping in the front garden without harming the tree. Some protective measures and work methods will be needed, but this is a small scale project and the tree is not unduly vulnerable.
