16 Prince of Wales Road

Photographic Schedule for proposed localised repairs

07/06/16

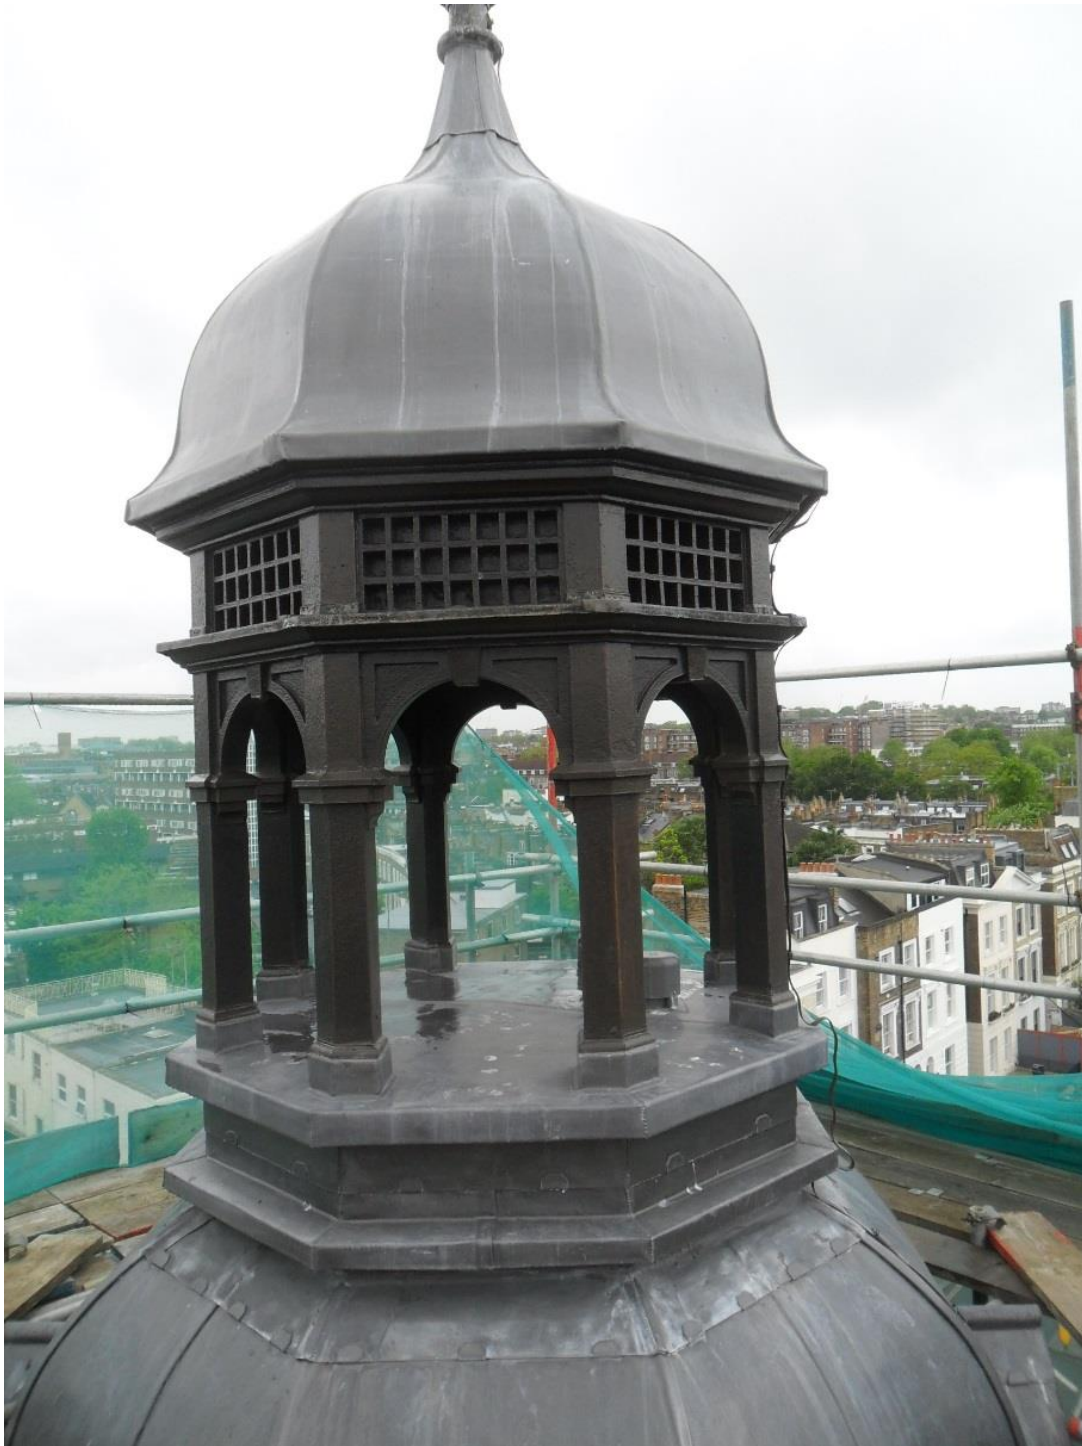
1) Upper part of cupola – for information

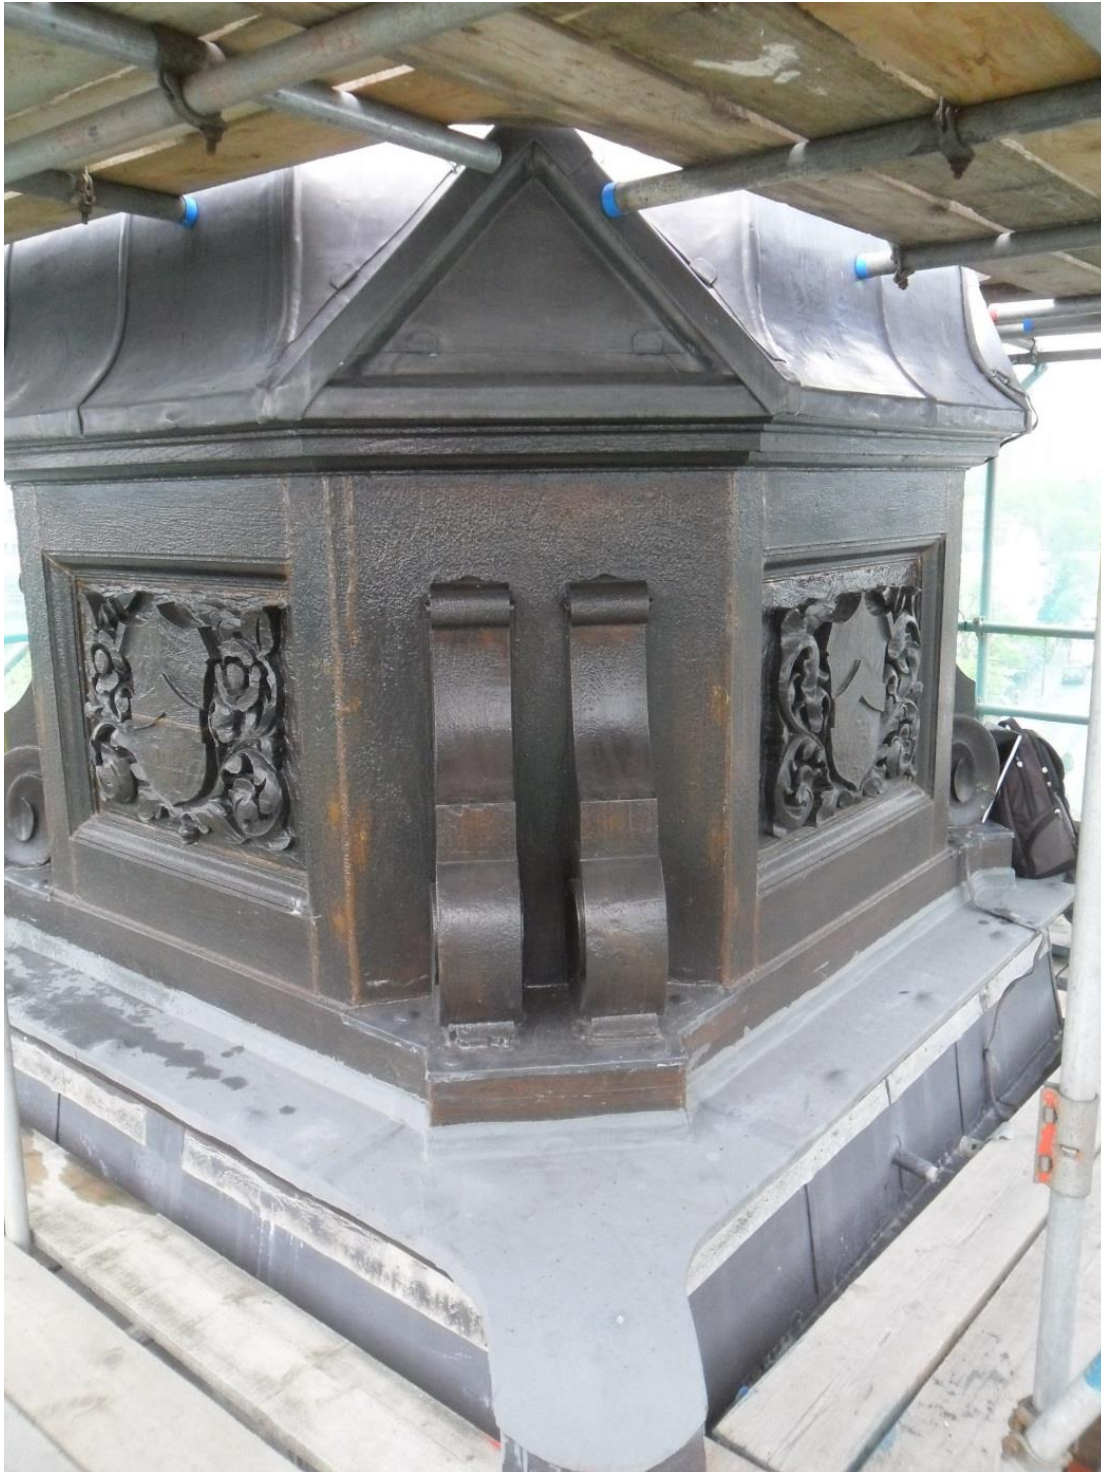
- 2) Lower part of cupola showing typical double scroll detail to corner. This sits on a timber plinth weathered by a lead flashing. Immediately below is a lead covered cornice that has been sheathed in Kemperol, a reinforced liquid coating. It is not known when this was applied, but it was not part of the lead replacement works carried out in 2014 & therefore pre-dates it.

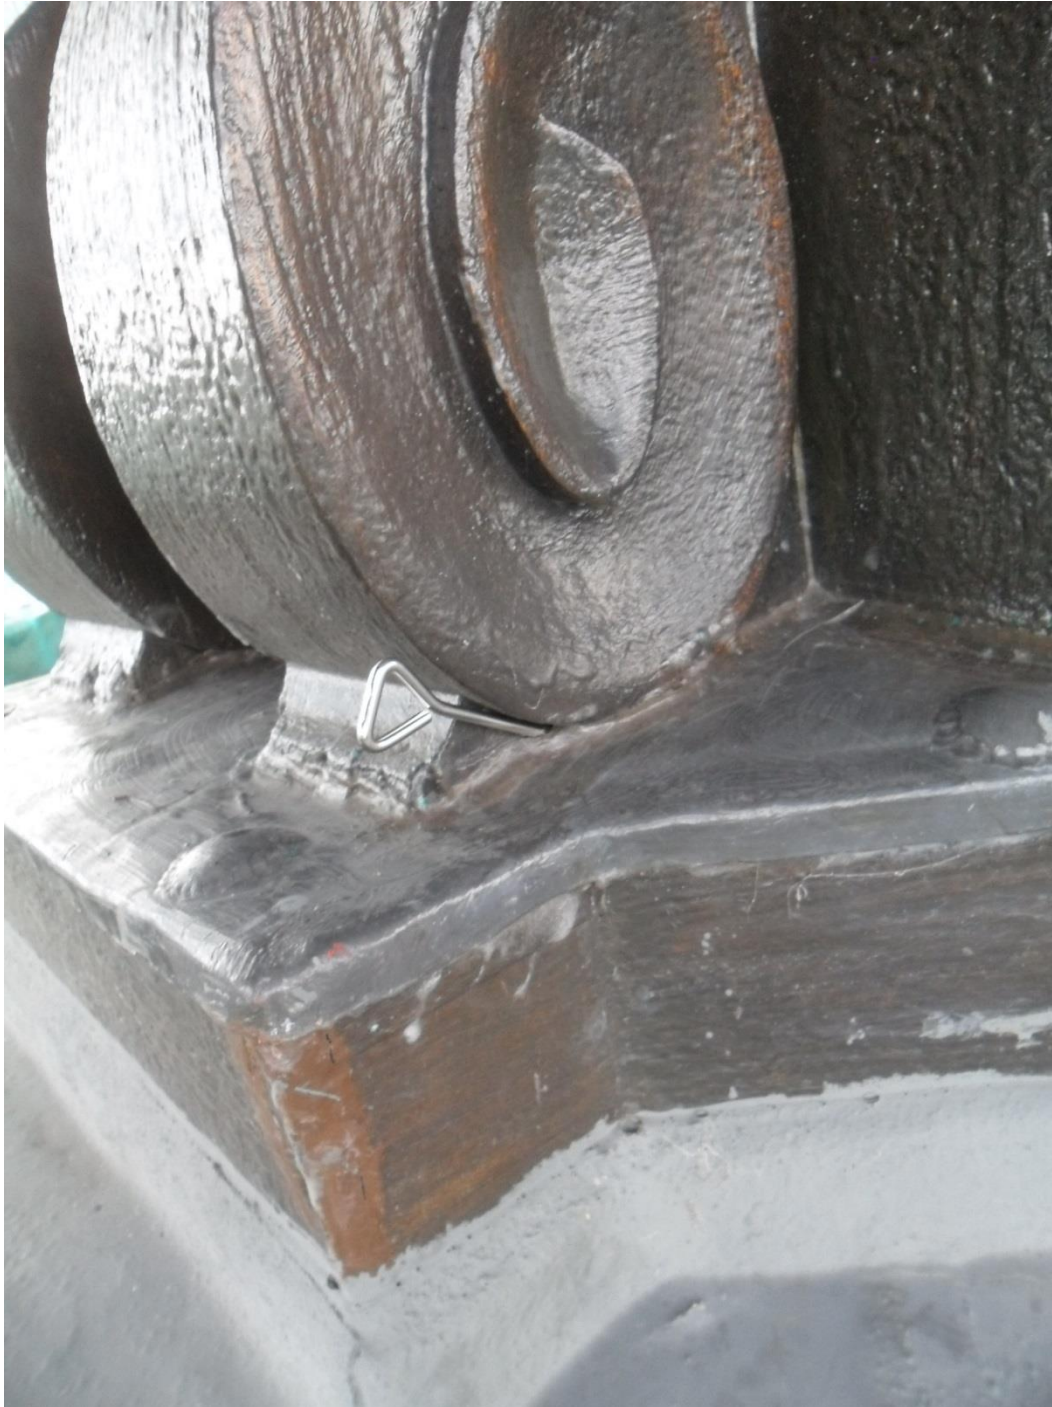
Typical abutment junction between lead capping & timber scroll. The screwdriver shows loss of bond to the perimeter sealant in an awkward internal corner. The capping is cut to follow the perimeter of the scrolls & relies on the sealant for weatherproofing. This & other similar points of failure leak under particular conditions of wind & rain. The capping downturn is also far too short & vulnerable to penetration from wind-blown rain.

The repair proposal is to sheathe the lead corner cappings in Kemperol, turned up to the abutments & also down to meet the existing Kemperol upstand.

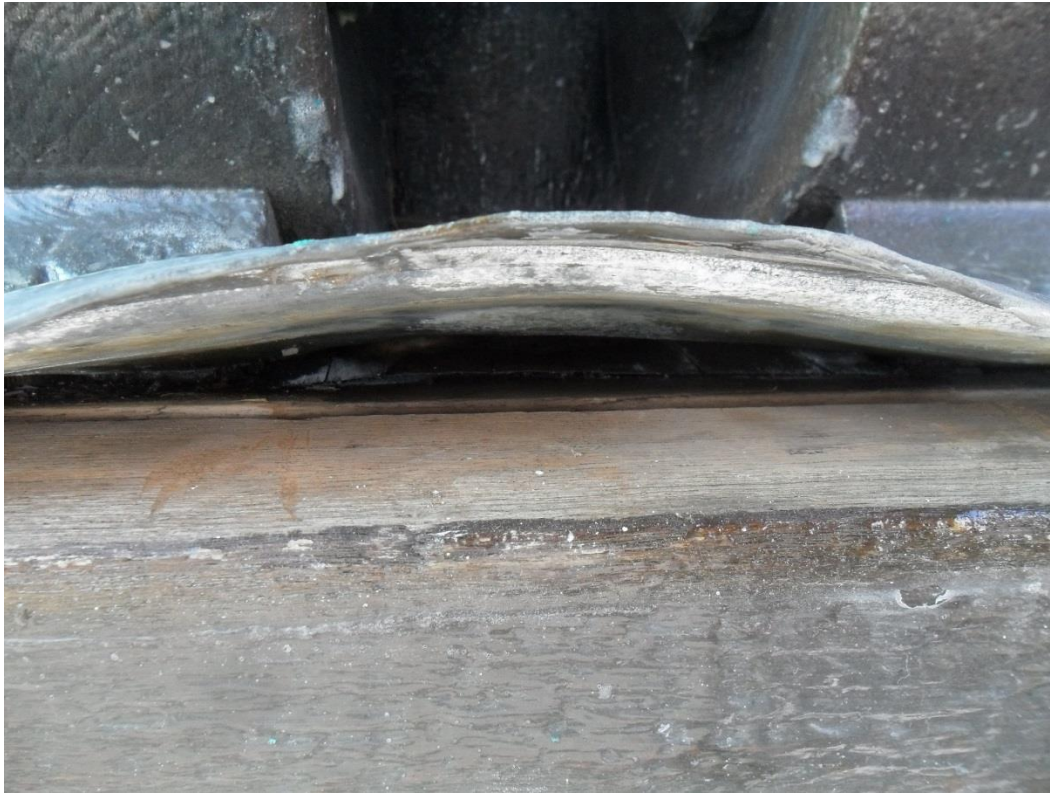
3) Close up of timber plinth immediately beneath scrolls with lead capping lifted. This shows the vulnerability of the plinth to leakage due to the built up construction.

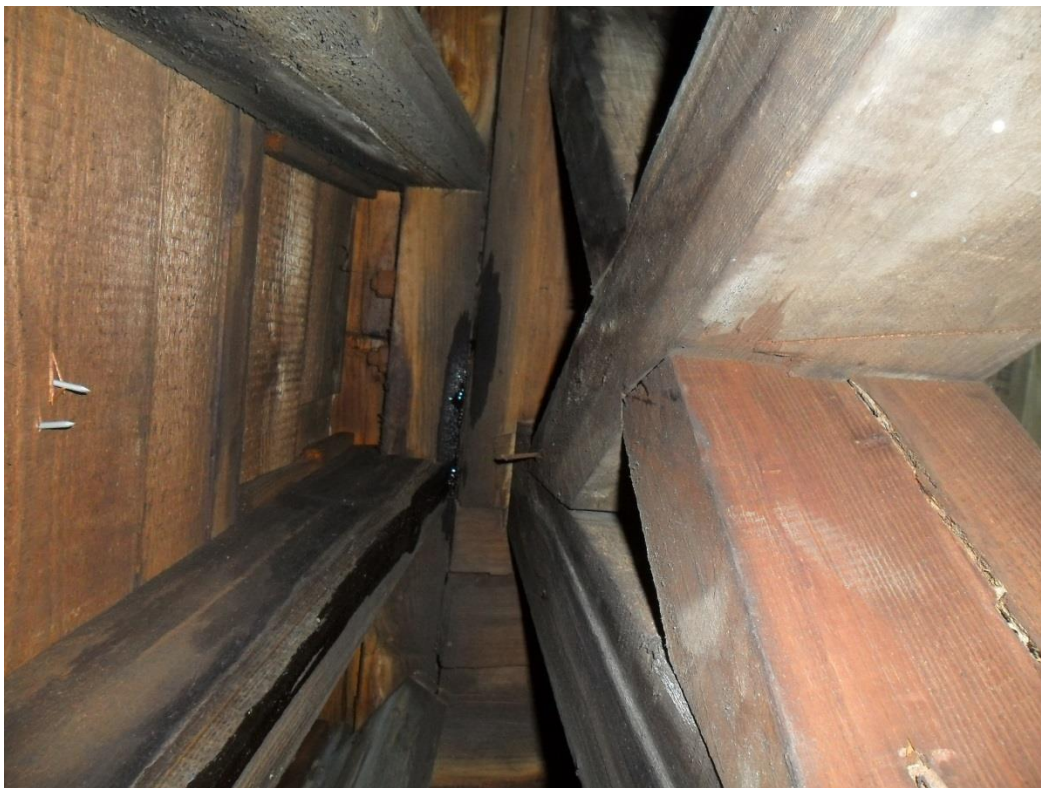
4) Typical leak beneath scroll plinth (looking upwards).
