22 Denmark Place - The Smithy
Western Elevation
Brickwork Assesment

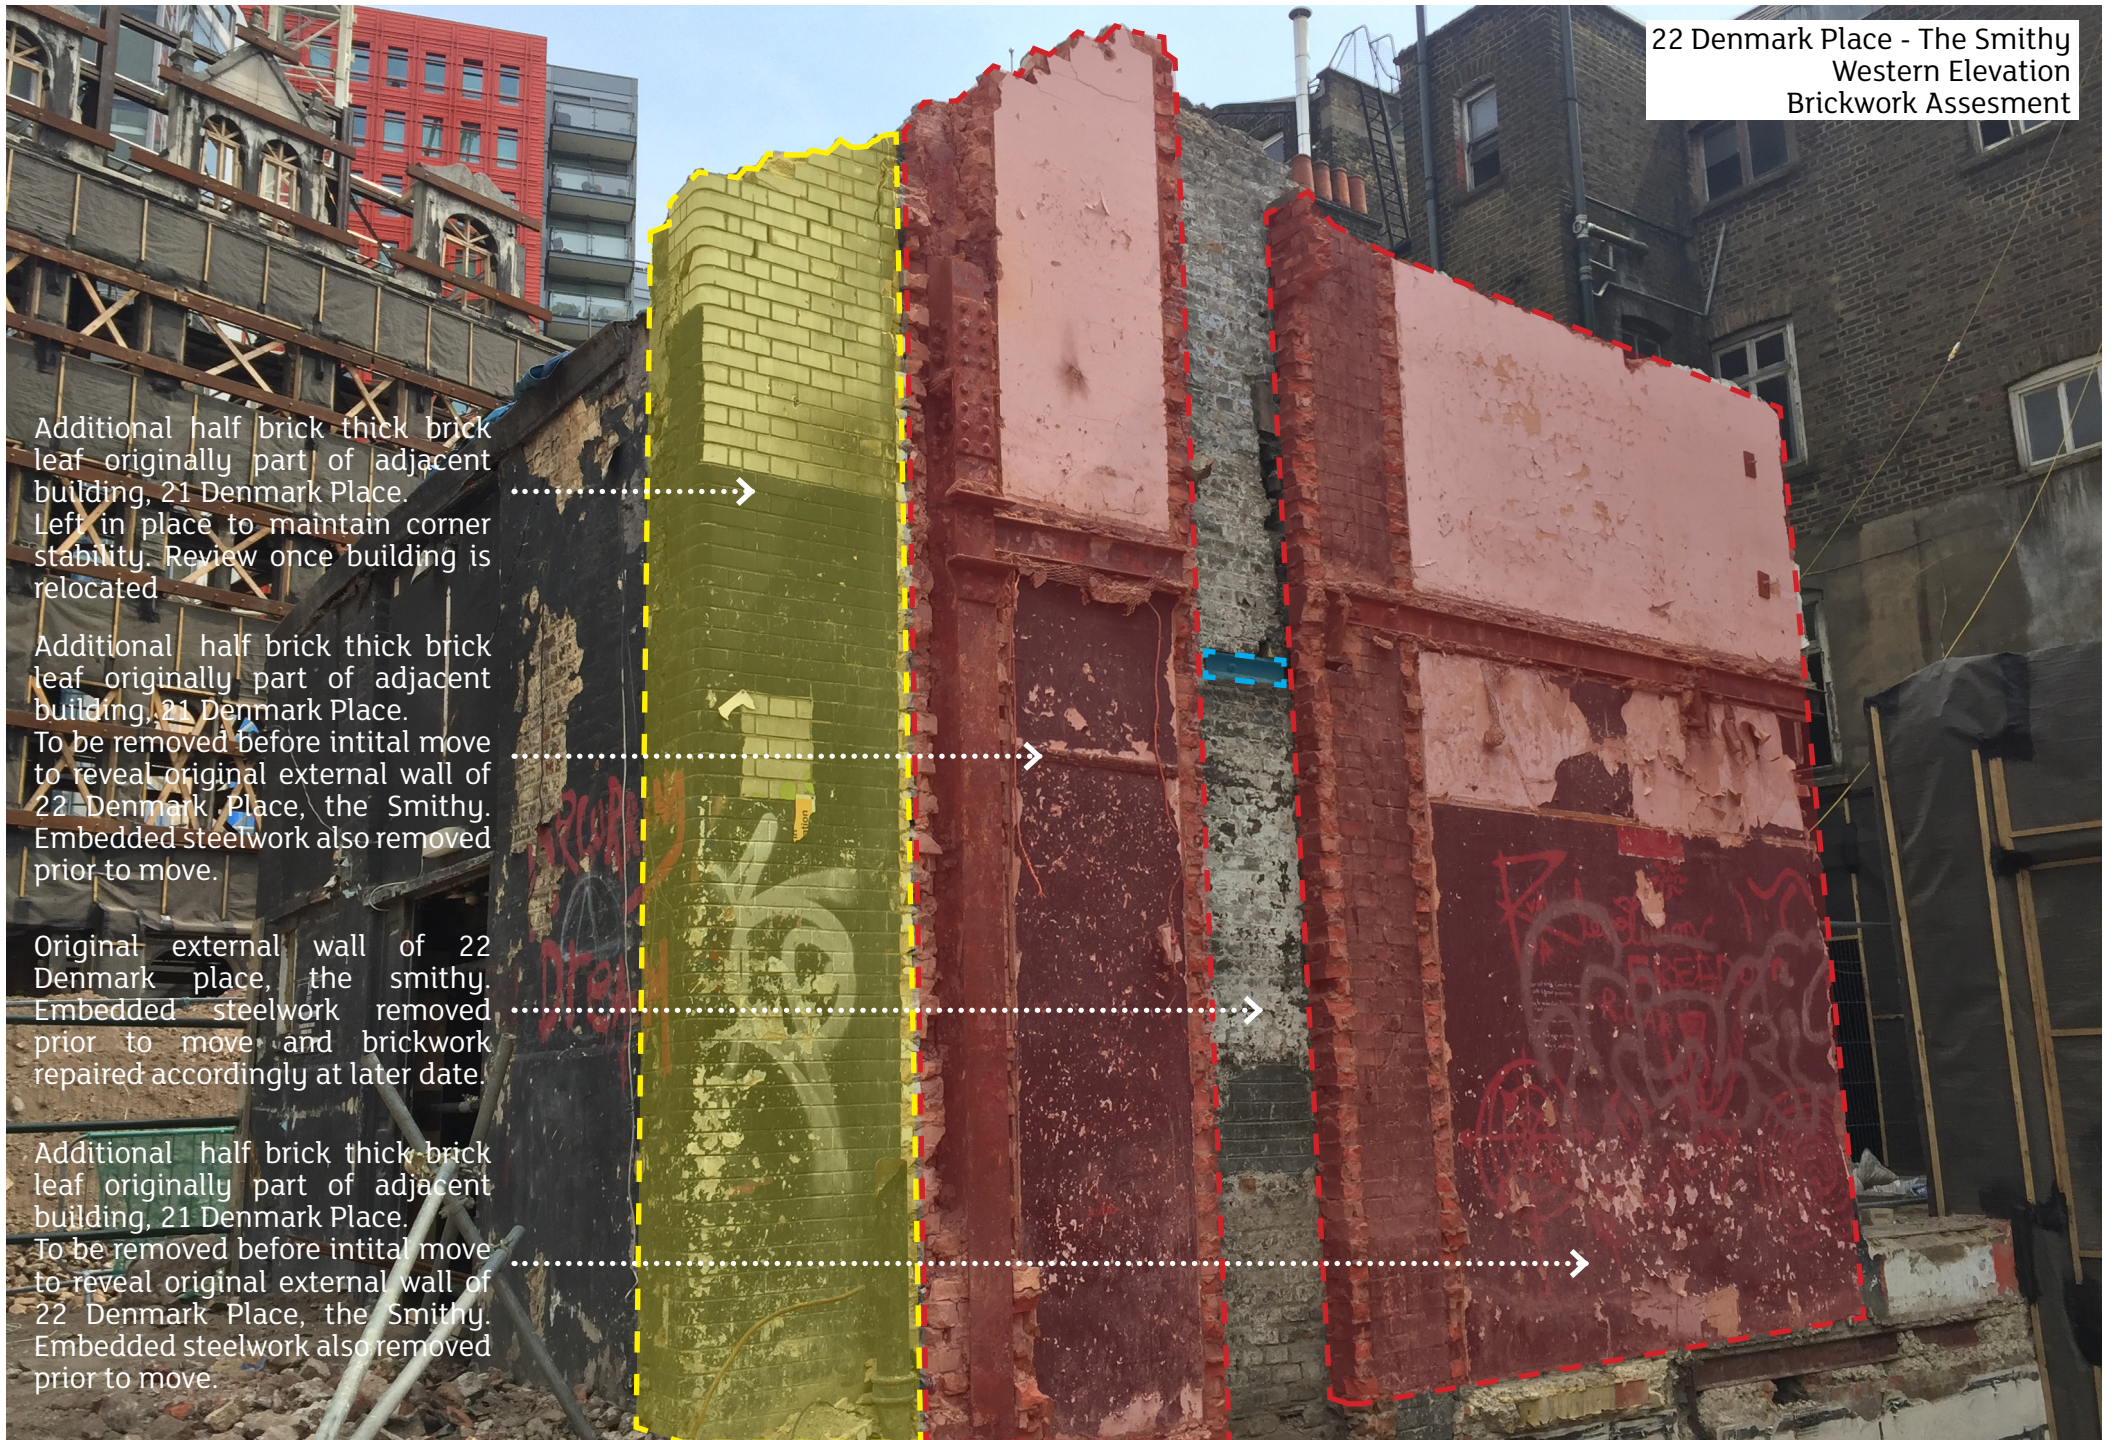
Additional half brick thick brick leaf originally part of adjacent building, 21 Denmark Place. Left in place to maintain corner stability. Review once building is relocated

Additional half brick thick brick leaf originally part of adjacent building, 21 Denmark Place. To be removed before intital move to reveal original external wall of 22 Denmark Place, the Smithy. Embedded steelwork also removed prior to move.

Original external wall of 22 Denmark place, the smithy. Embedded steelwork removed prior to move and brickwork repaired accordingly at later date.

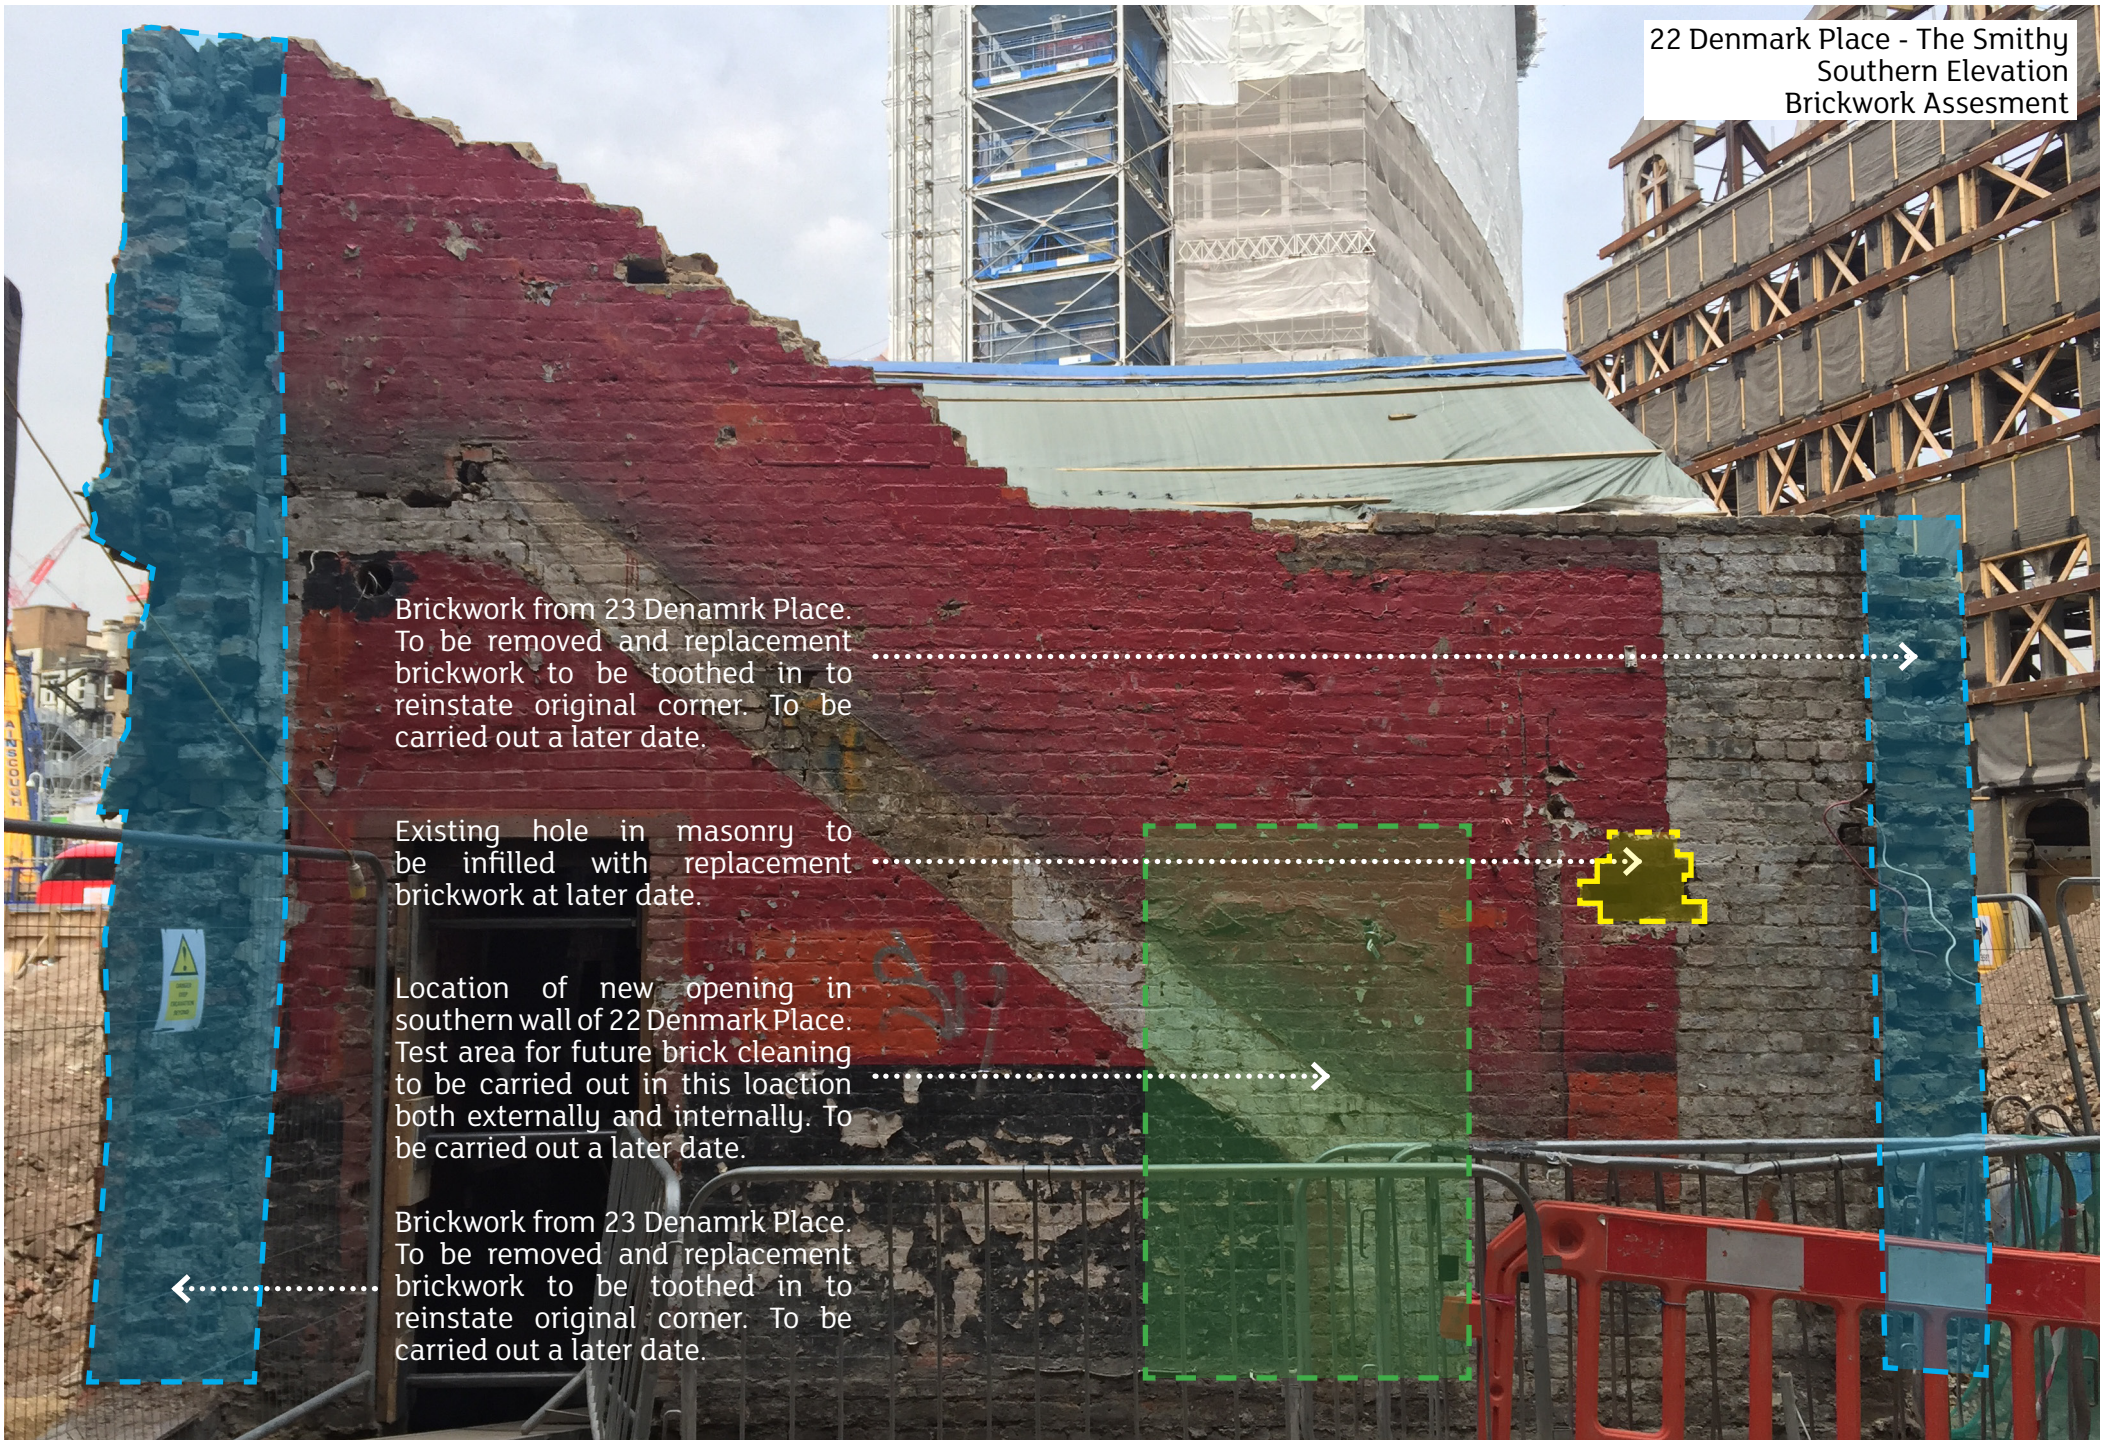
Brickwork from 23 Denamrk Place.
To be removed and replacement
brickwork to be toothed in to
reinstate original corner. To be
carried out a later date.

Existing hole in masonry to
be infilled with replacement
brickwork at later date.

Location of new opening in
southern wall of 22 Denmark Place.
Test area for future brick cleaning
to be carried out in this loaction
both externally and internally. To
be carried out a later date.
